CEN23FA314

## INVESTIGATION PHOTOGRAPHS

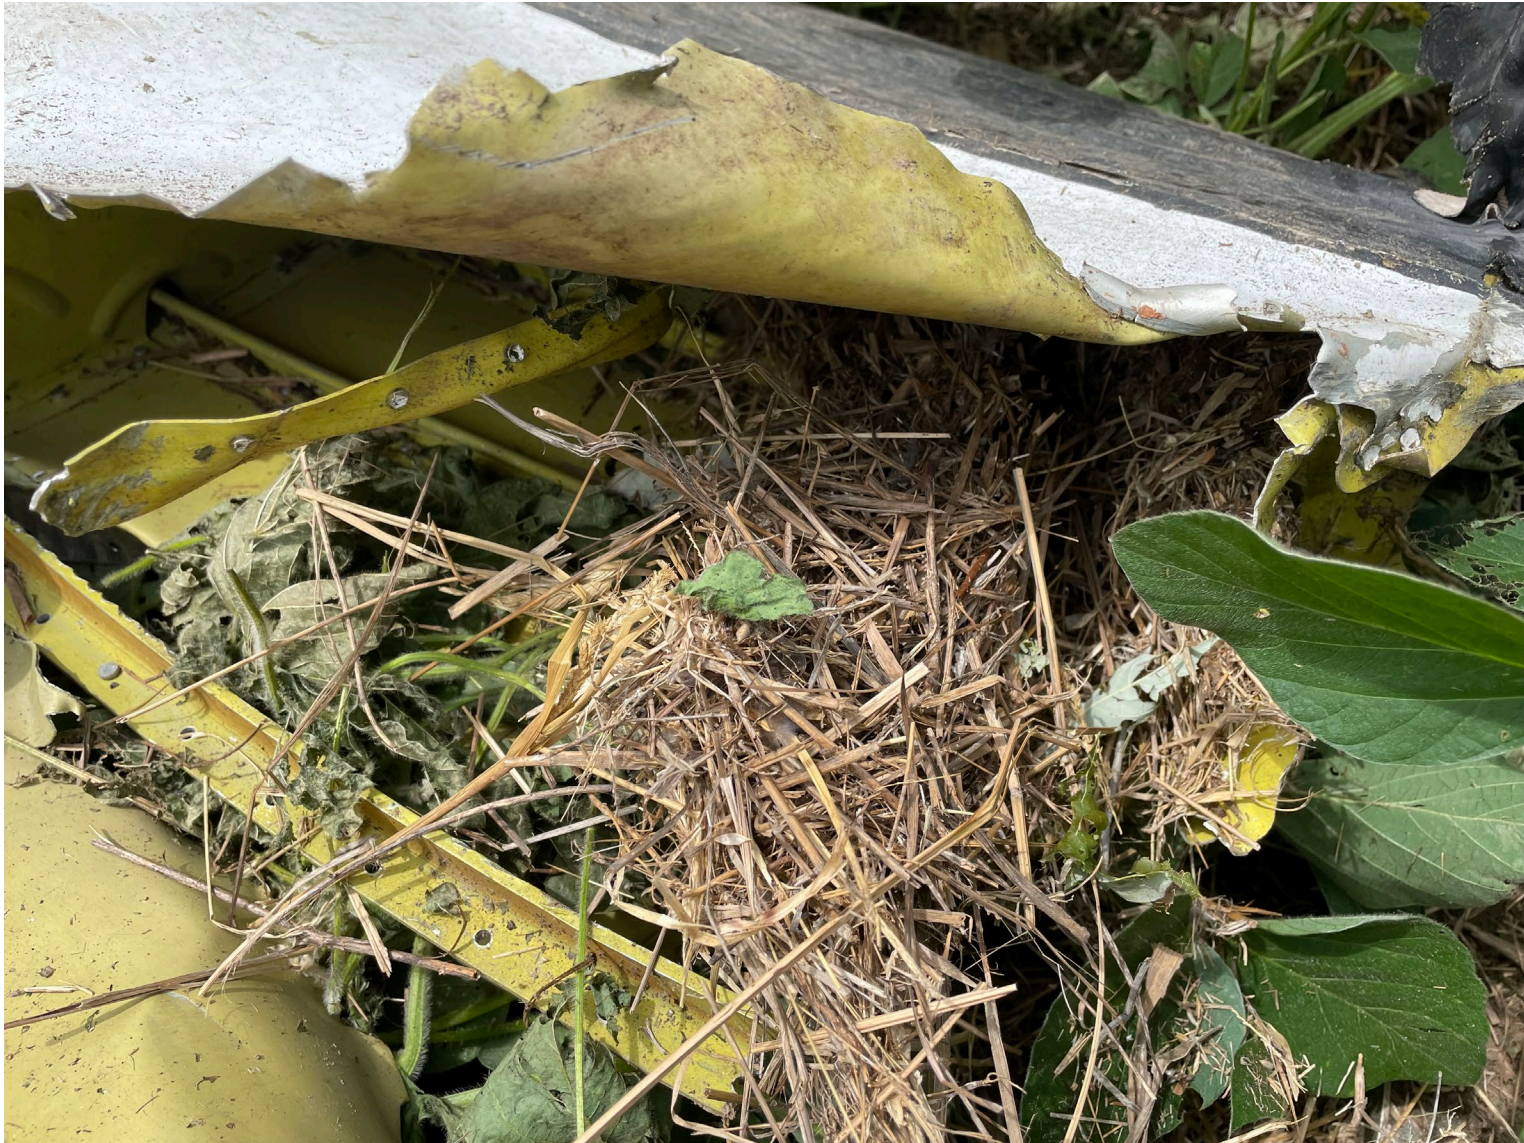
**Photograph 5 - Preaccident Animal Nest Right Wing Leading Edge**

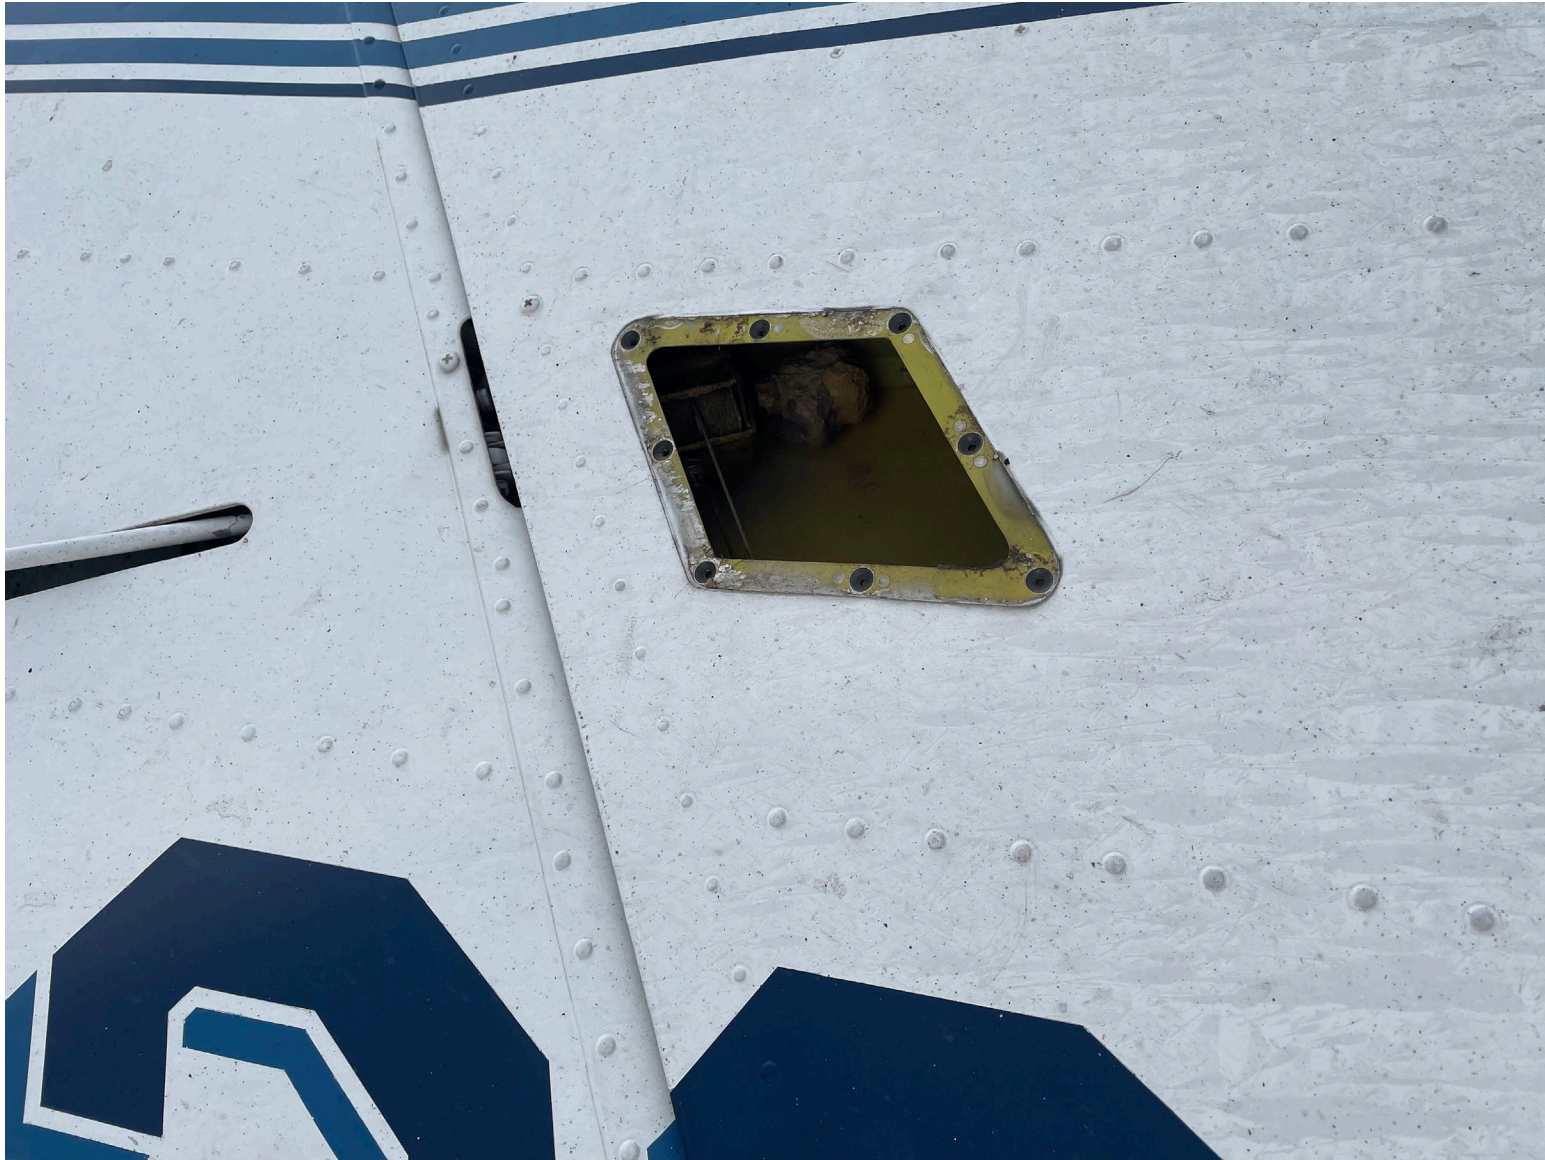
**Photograph 6 - Preaccident Insect Nest around Elevator Trim Jackscrew**

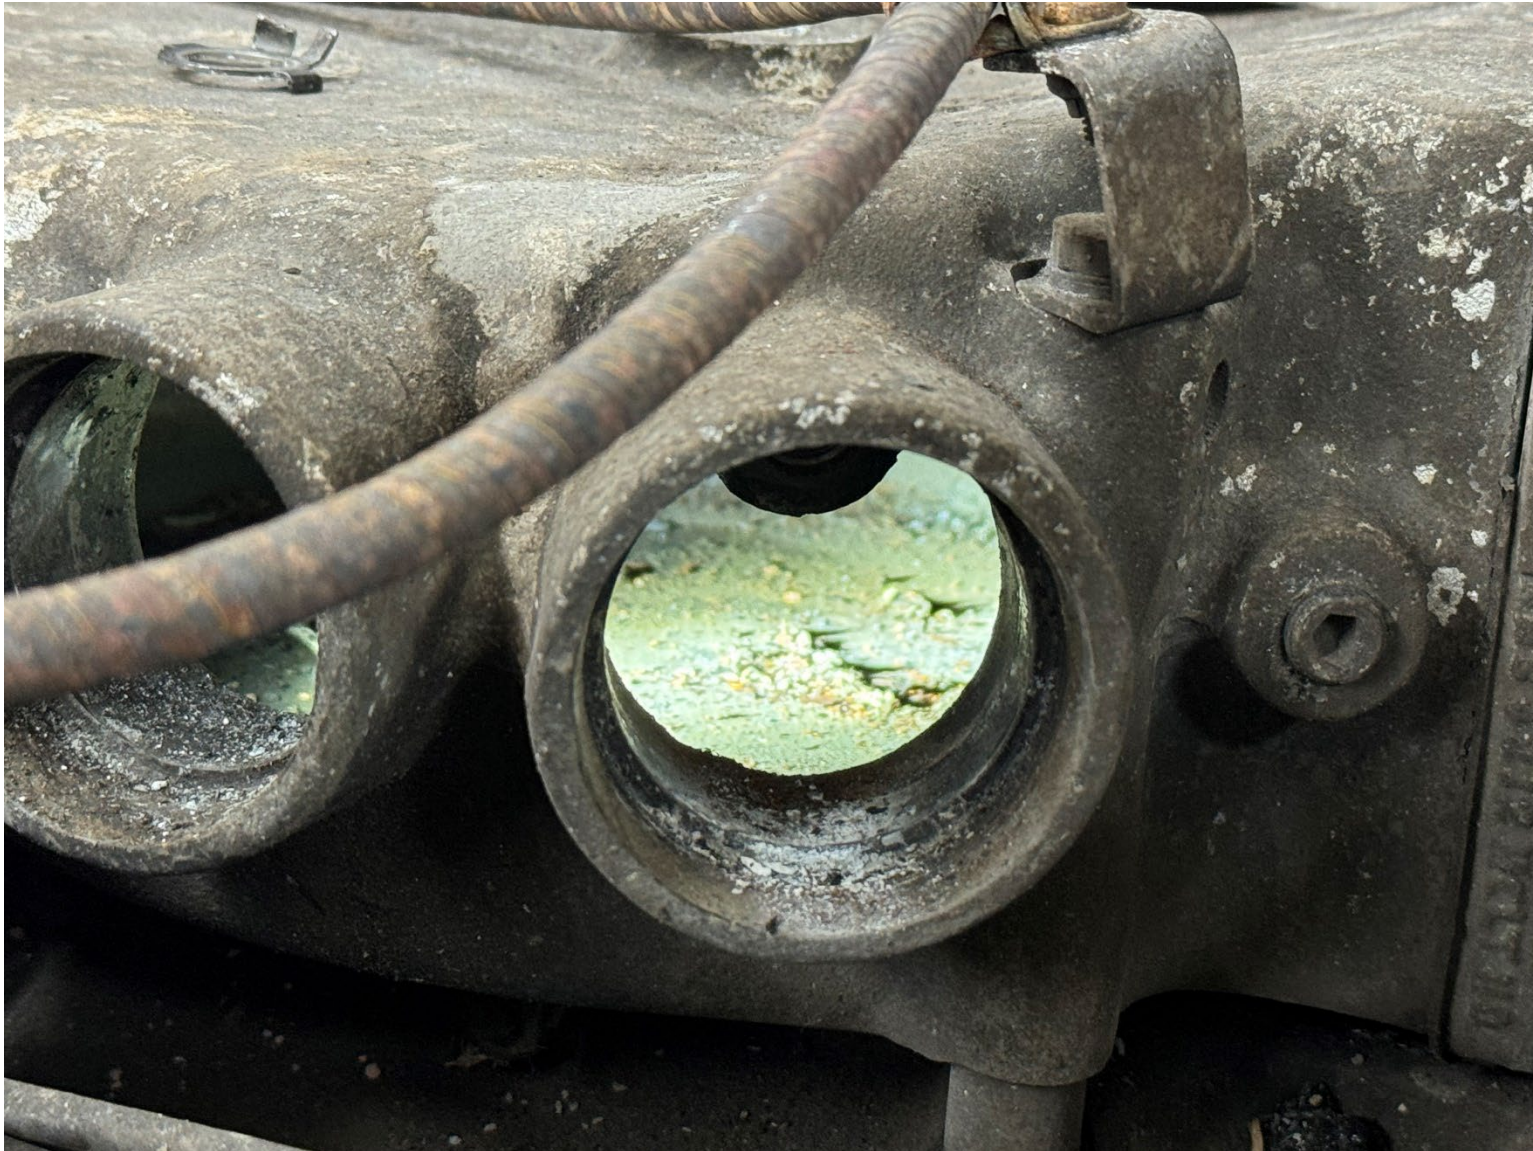
**Photograph 10 - Right Engine Induction Housing Assembly Debris**

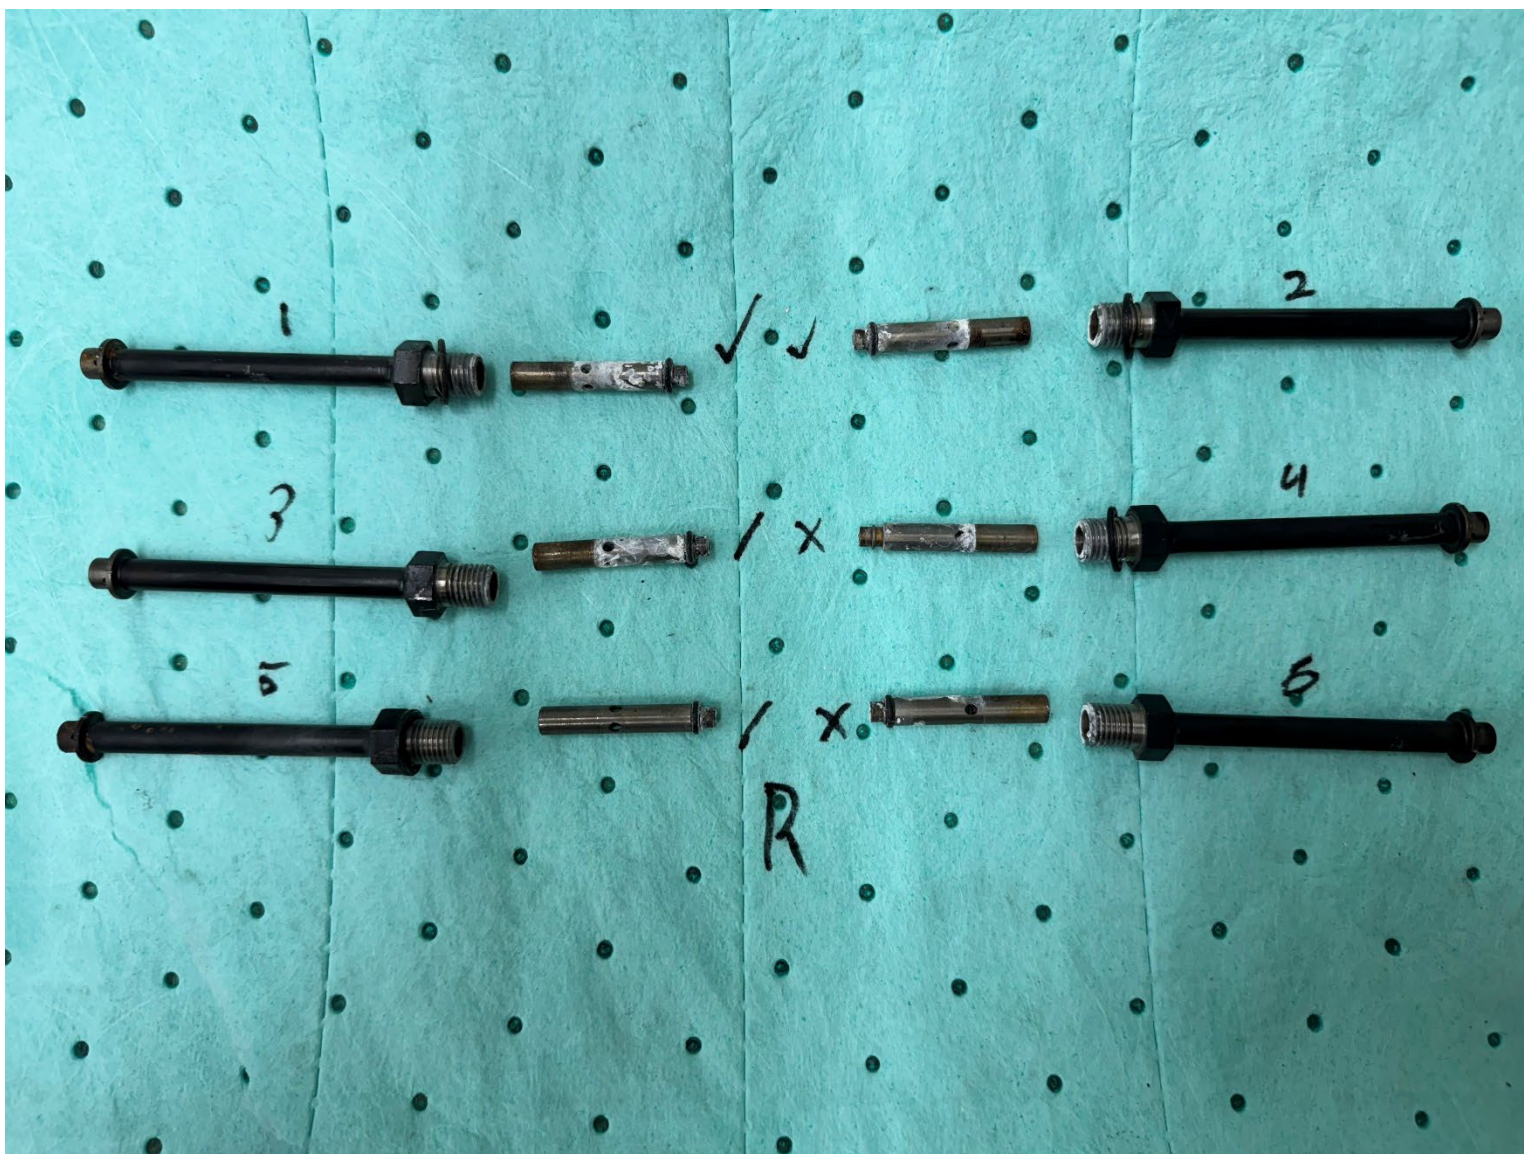
**Photograph 11 - Right Engine Fuel Injectors - X Indicates Full Blockage - / Indicates Partial**

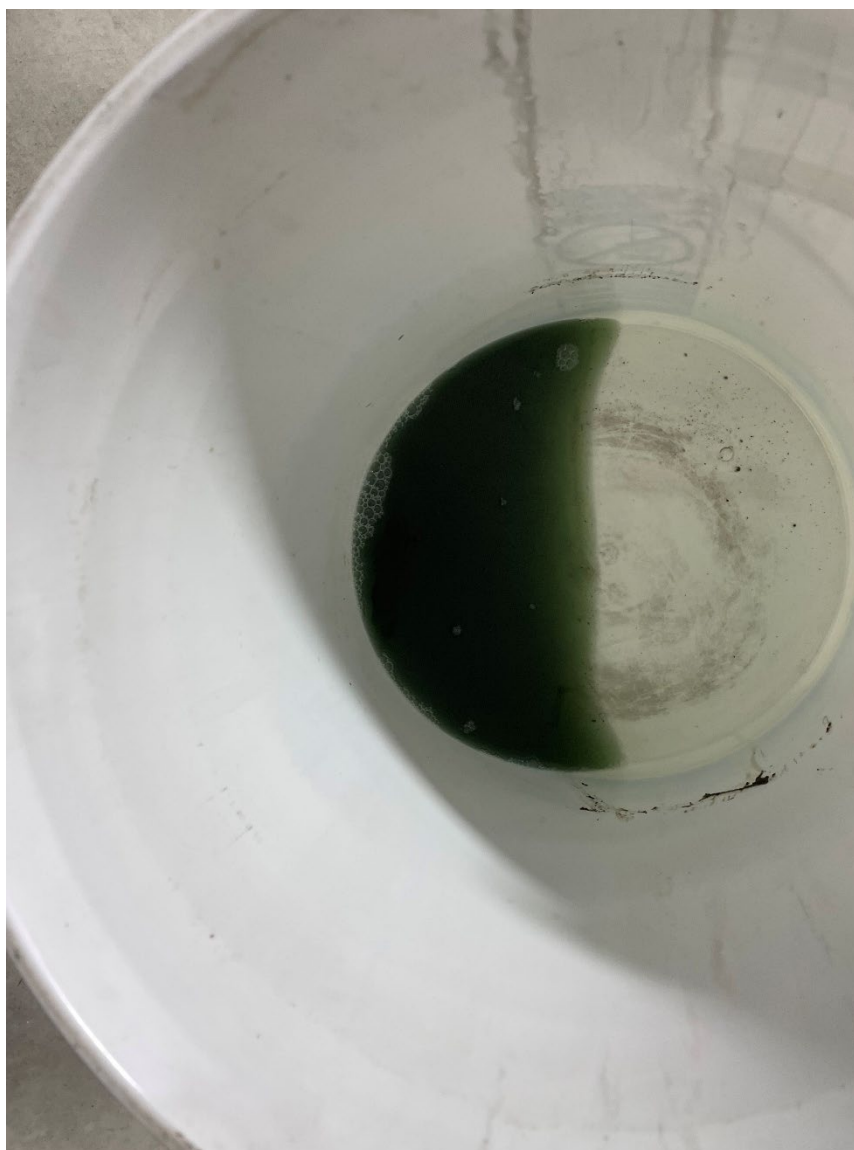
**Photograph 12 - Preaccident Drained Fuel**
