## Air Safety Investigations Aircraft Incident/Accident Technical Report

| Aircraft Incident/<br>Accident Information | Year: 1972 | Make: Cessna | Model: 150L |
| Air Safety Investigator: Casey J. Love | | Report #: ASI-23-BT-T | Report date: 01-04-24 |

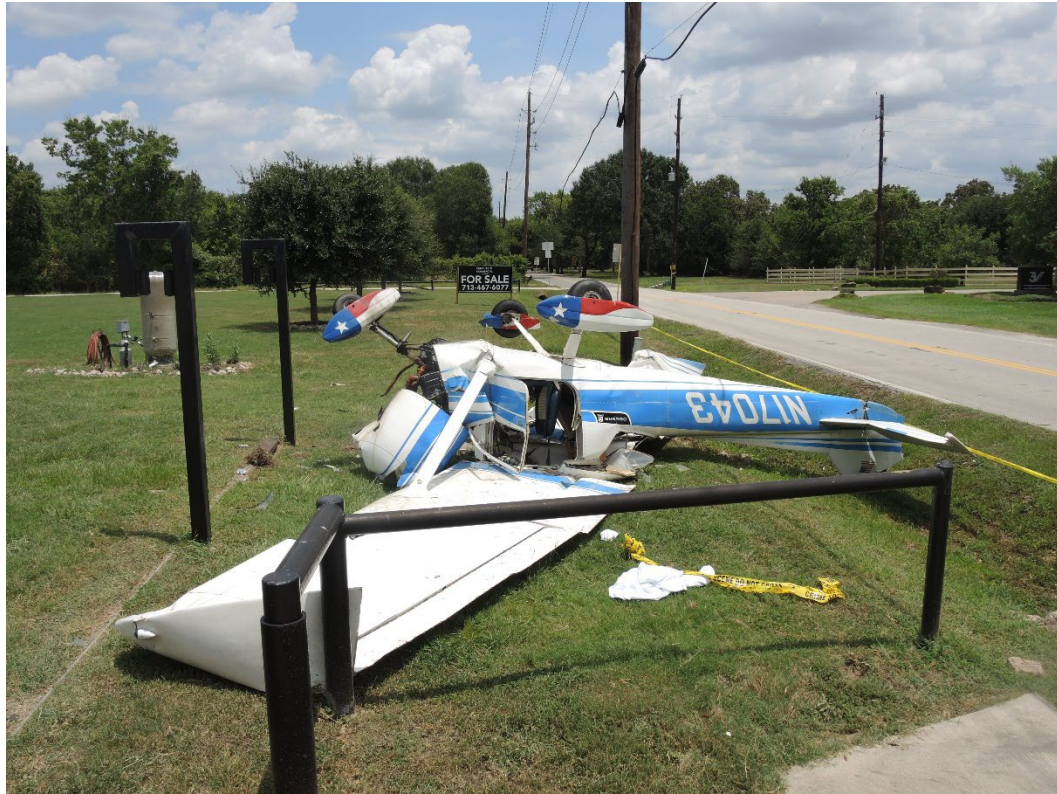
The aircraft impacted power wires with the right main landing gear and the lower fuselage skin forward of the right landing gear. The aircraft then impacted the ground, left wing low-inverted, and came to rest inverted below the wire strike locations. There were also wire striations on the left- and right-wing leading edges. The right-wing leading-edge striation was oriented vertically about 10 feet from the wing root. The left wing leading edge wire striation was oriented horizontally about 3 feet from the wing root. Evidence of electrical arcing was observed on the left-wing strut leading edge. The outboard three feet of the left-wing leading edge sustained impact crushing damage upon impact with the ground, partly separating the wing from the cabin structure. The remainder of the leading edge also sustained impact crushing damage to a lesser extent.

The engine was displaced upward but remained partly attached to the mount and by cables and wires.

The empennage remained attached. The horizontal stabilizer was unremarkable. The vertical stabilizer and rudder sustained downward crushing damage to the upper portion.

NTSB Photograph DSCN8953 (Wreckage Overview)

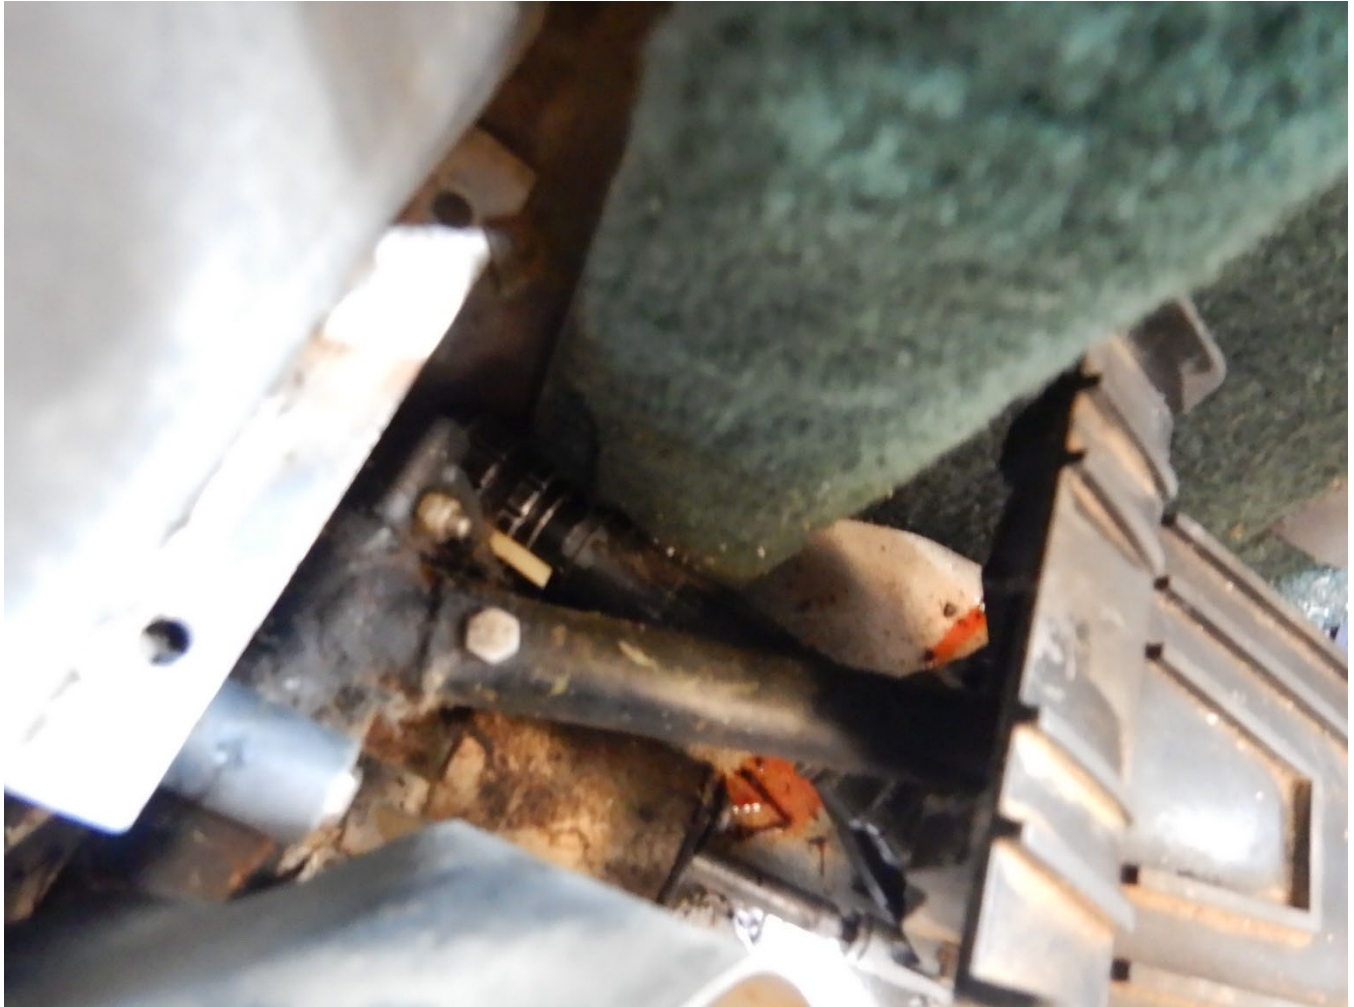
During the examination an aluminum flashlight was found between the pilot's left rudder pedal and the brake cylinder with the bulb end pointed upward. The light did not illuminate when the on/off button was pressed. It did not obstruct movement of the pedals during the examination. The flashlight did not have signatures that indicated it had been damaged by pedal movement.

TAI Examination ASI-23-BT-030 (flashlight in rudder pedal)

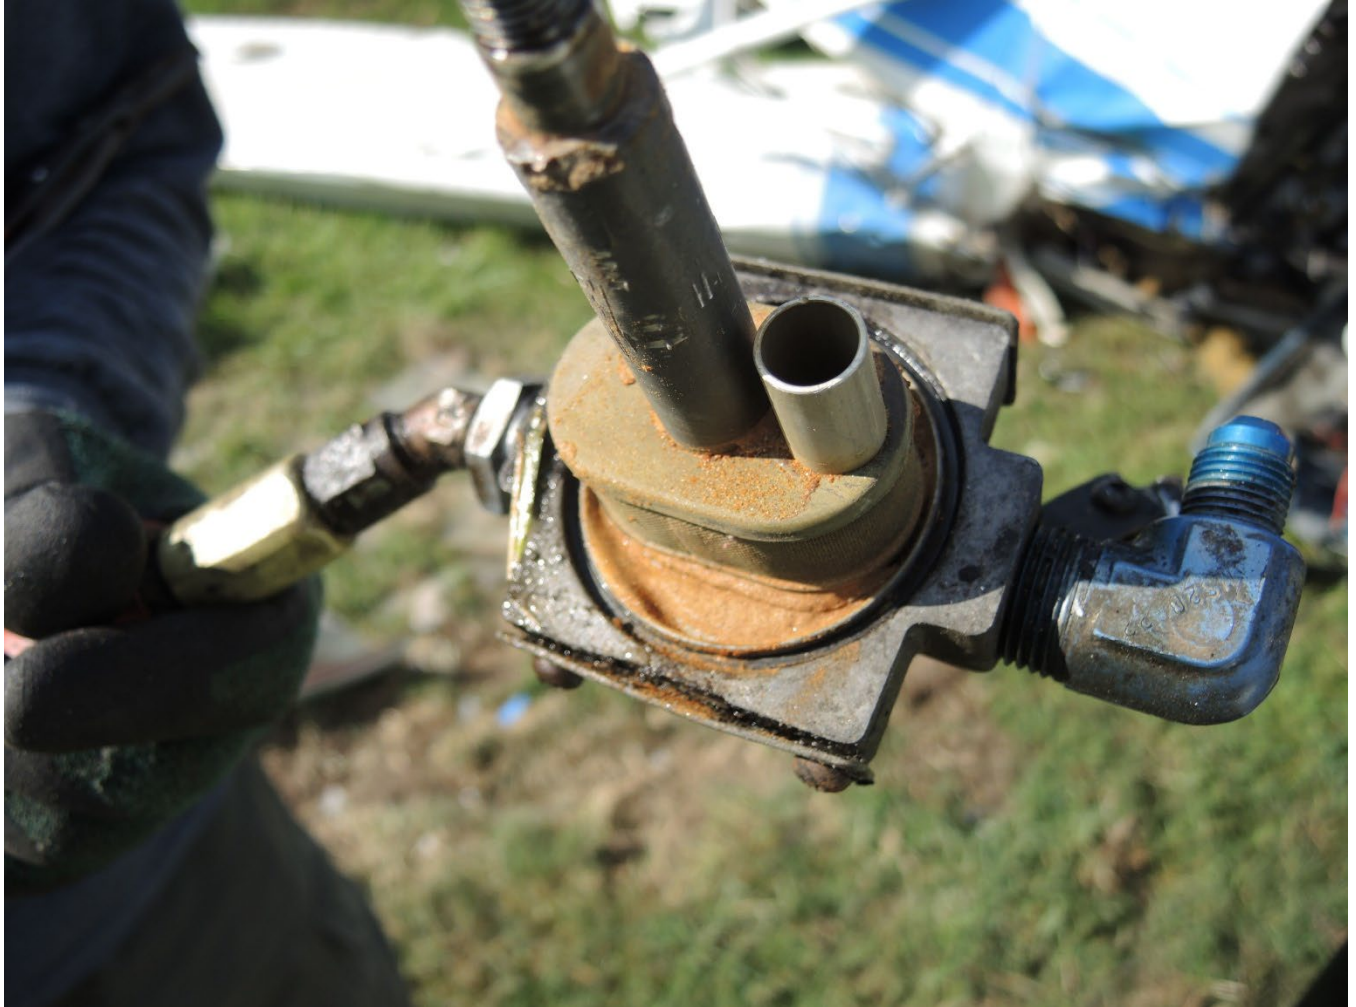
The fuel strainer contained debris that was sandy or rusty in appearance similar to the residue left behind when automotive gasoline evaporates. According to preliminary airport records the aircraft was last fueled in June and had been flown periodically since. During the examination the fuel selector was removed and found to be free from obstructions.

ASI-23-BT-115 (fuel strainer screen) (powder that lined fuel system)

The carburetor was removed and disassembled for examination and found to be clean inside. No abnormalities were observed. The fuel inlet fitting was fracture separated from the carburetor. No fuel was present inside the carburetor bowl. Inside the fuel tanks, lines, fuel strainer, and fuel selector valve were all lined with a thin layer of brown powdery substance of unknown material.

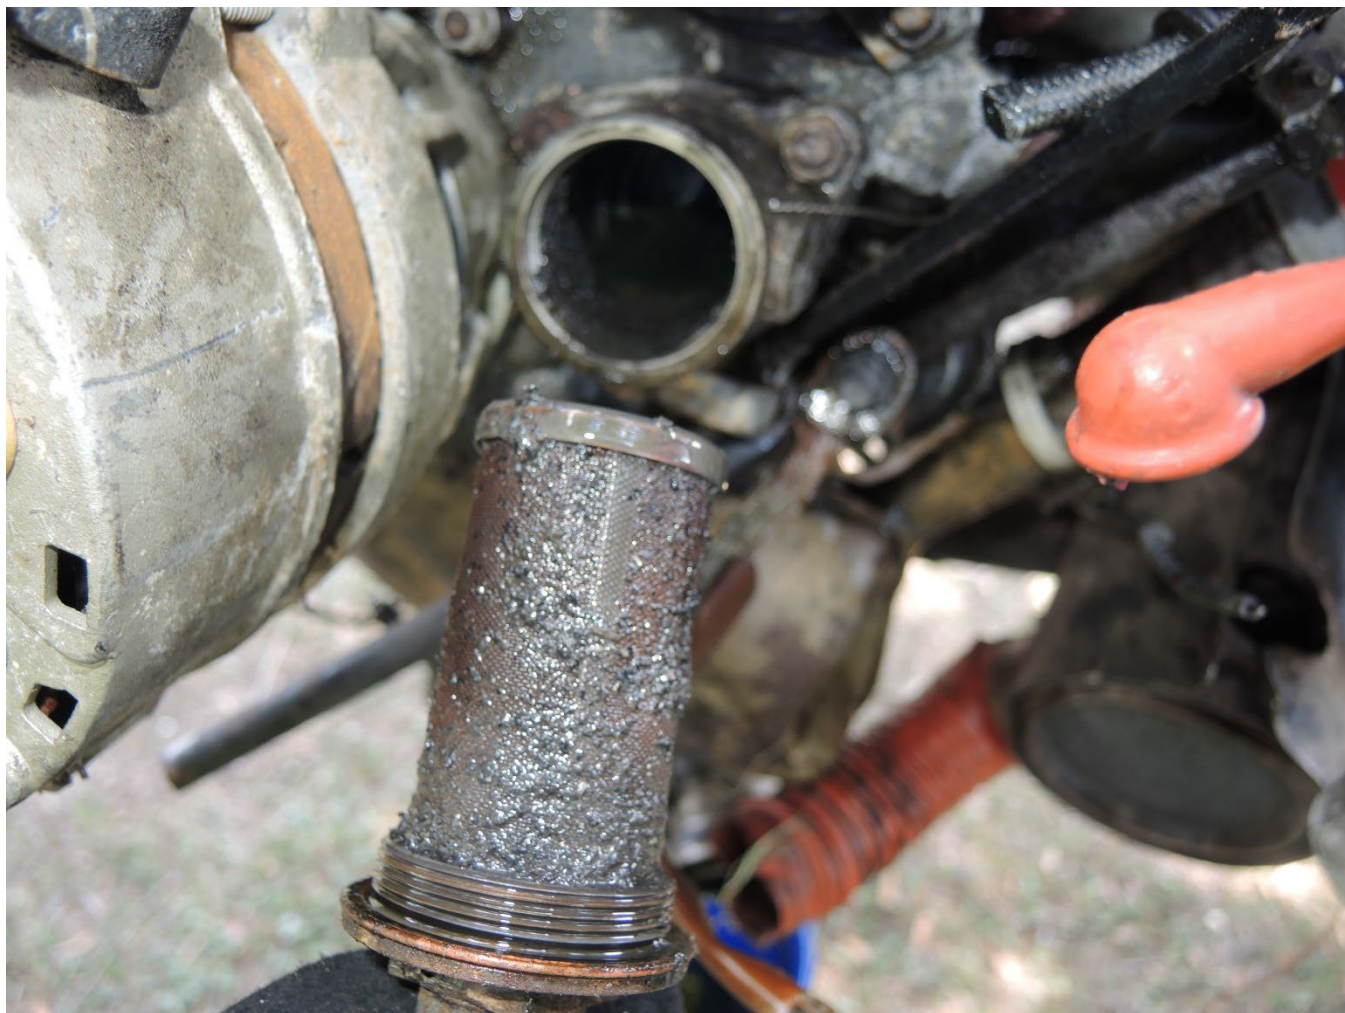
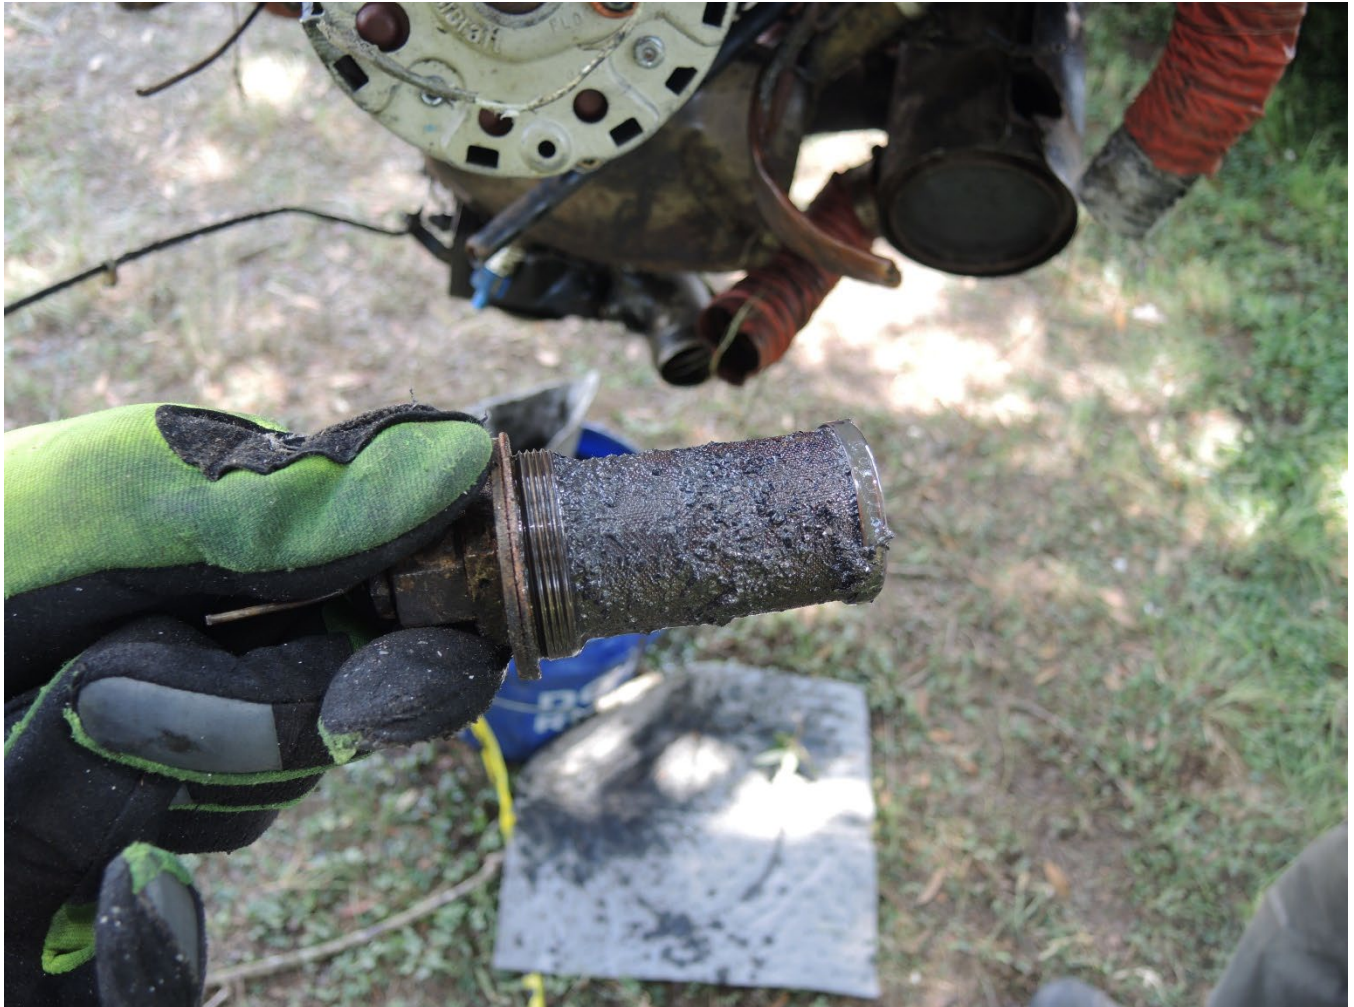
The engine remained attached to the mounts and displaced upward. The engine mounts were fractured in multiple locations. All engine control cables remained attached and were pulled to the forward positions in the cockpit. The oil sump sustained compression damage upon impact. The carburetor remained intact and attached. The carburetor mount on the induction system was cracked upon impact. The engine exhibited corrosion in multiple locations. The exterior of the accessory housing exhibited extensive corrosion and flaking. The carburetor, both ignition harnesses, and spark plugs appeared to be new. The #3 and #4 cylinders appeared newer than the others.

During the engine examination the #4 cylinder and magnetos were removed. Inside the accessory was corroded. The #3 & #4 intake lifter exhibited some galling. The #4 piston exhibited some light scoring. The crankshaft assembly and valve train were intact and rotated freely. There were no obvious signs of internal damage or preimpact anomalies. The exhaust muffler flame cones were fractured inside the left and right mufflers. The fracture areas were thin and rusty. The exhaust ports and tailpipe were not obstructed by the fractured flame cones.

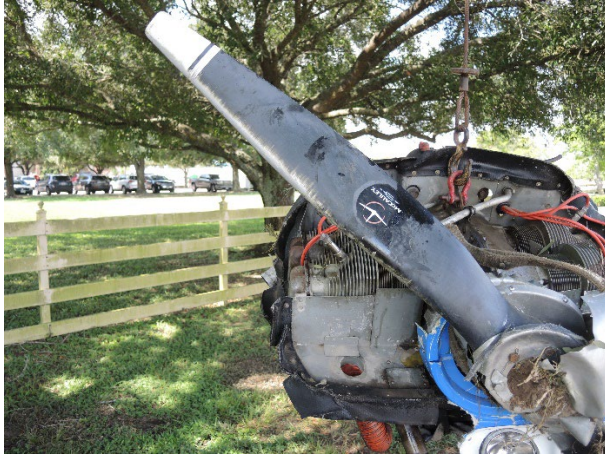
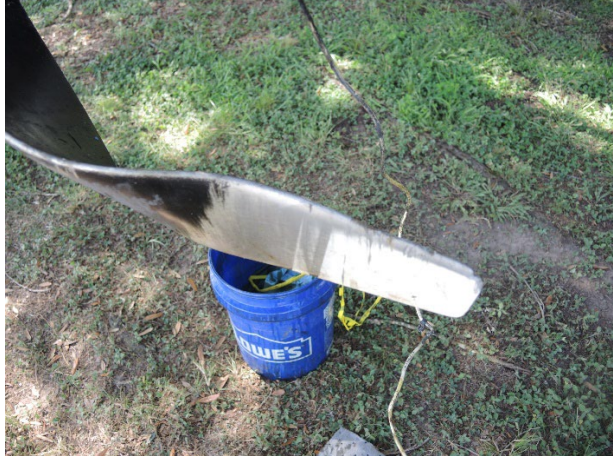
The propeller remained attached to the crankshaft. Blade A was bent aft approximately 90° just outboard of midspan. The blade exhibited polishing and leading edge scoring outboard of the bend. Blade B exhibited polishing and leading-edge scoring and was bent aft approximately 10° about 1/3<sup>rd</sup> span.

NTSB photograph of propeller

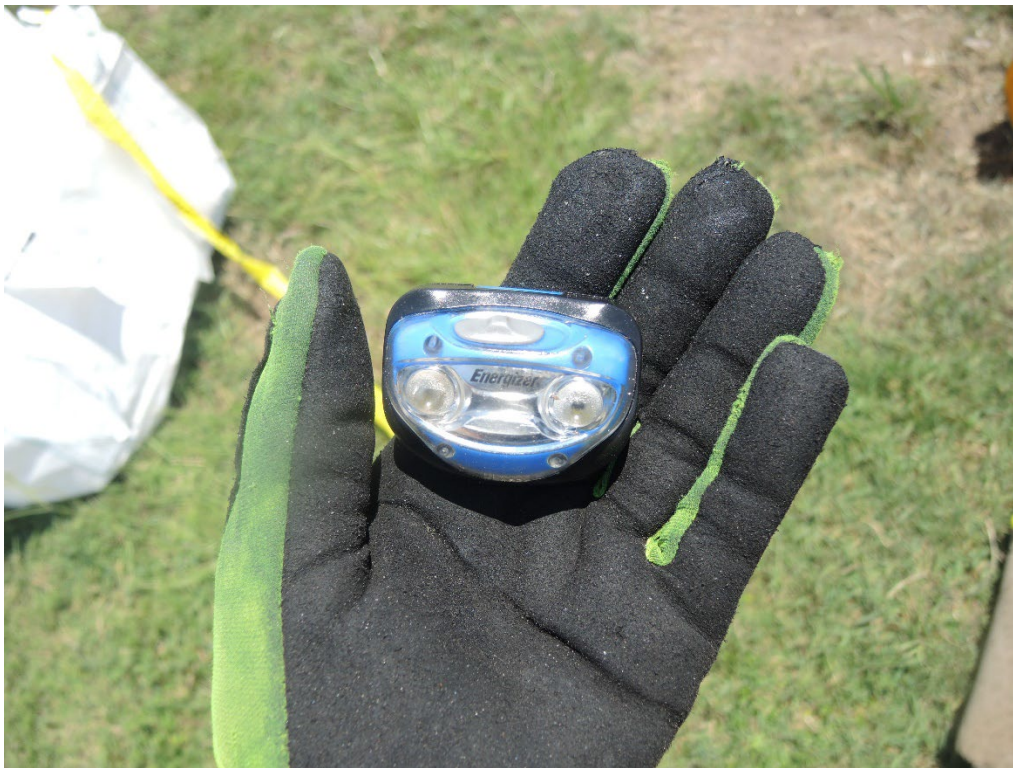
During the on-scene examination a headlamp was found under the cabin portion of the wreckage. It was located near the pilots glasses and baseball cap. The headband for the lamp was also found in the same vicinity. When the lamp was initially spotted the light was on/illuminated. The NTSB-IIC placed new AAA batteries in the lamp, without changing the switch position, and the lamp was found to have been on the brightest setting. The lamp did not have a red lens or setting to prevent flash blindness.
