CEN23FA315

## INVESTIGATION PHOTOGRAPHS

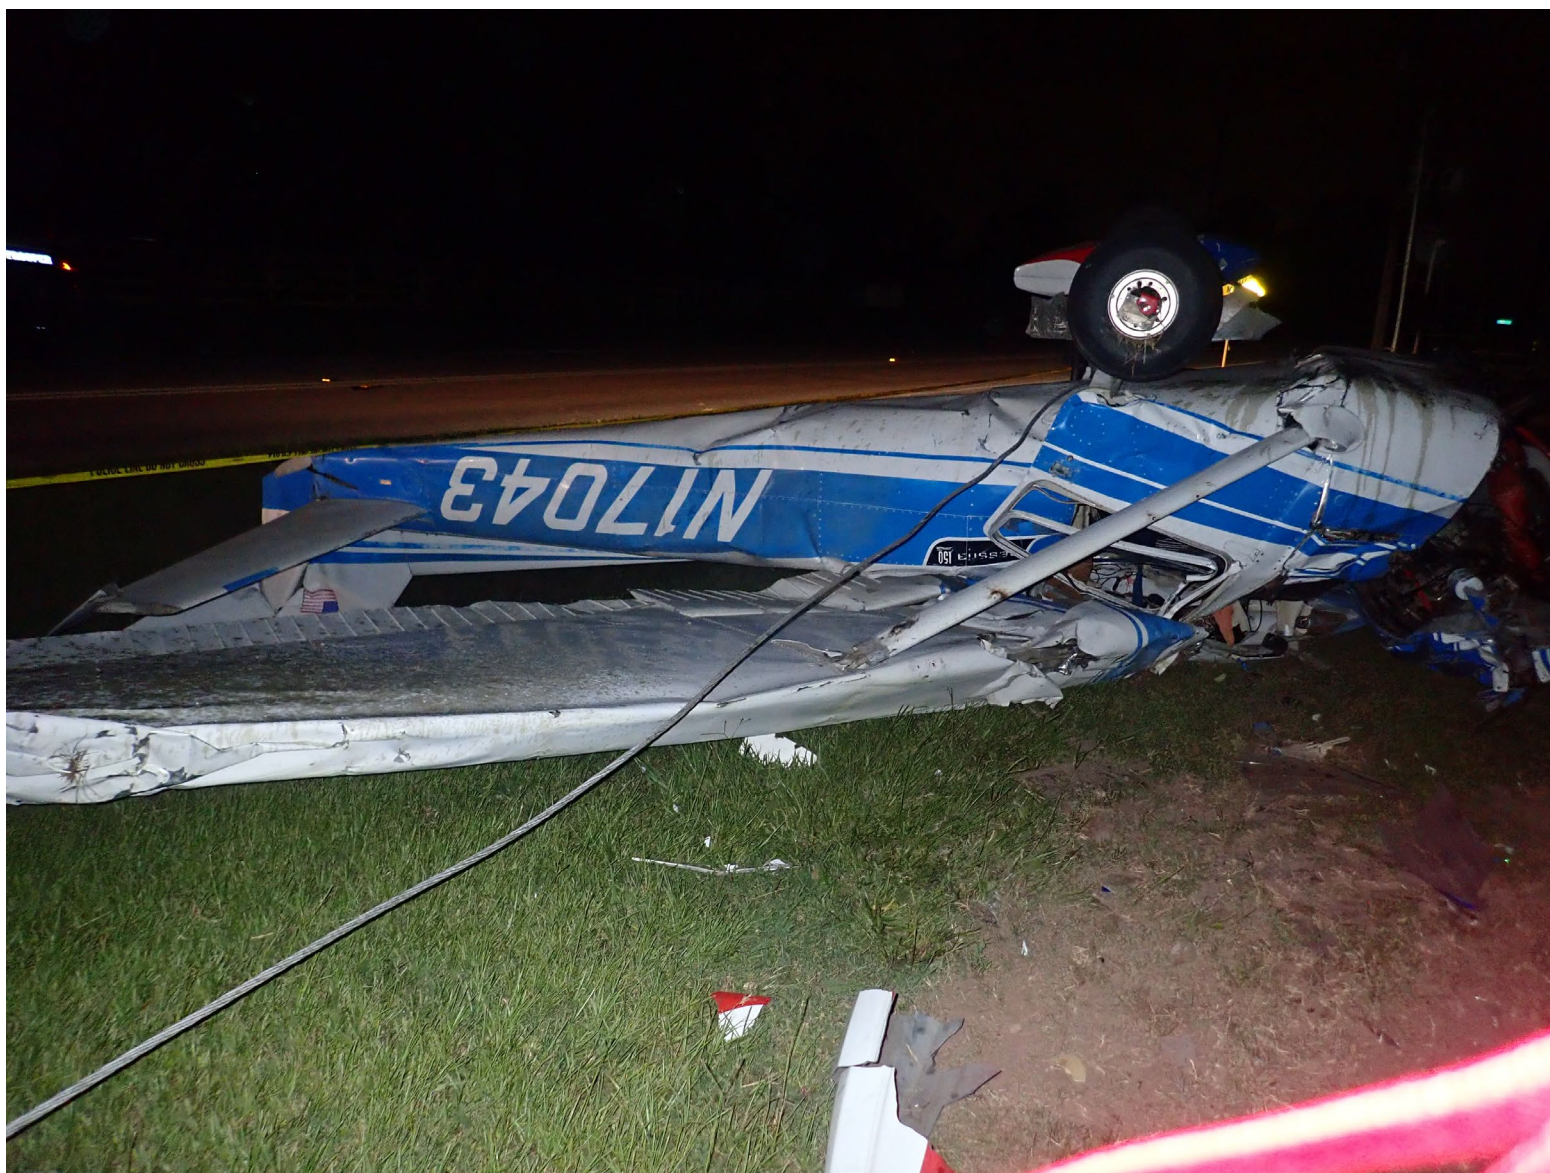
**Photograph 1 - Accident site (Courtesy of FAA)**

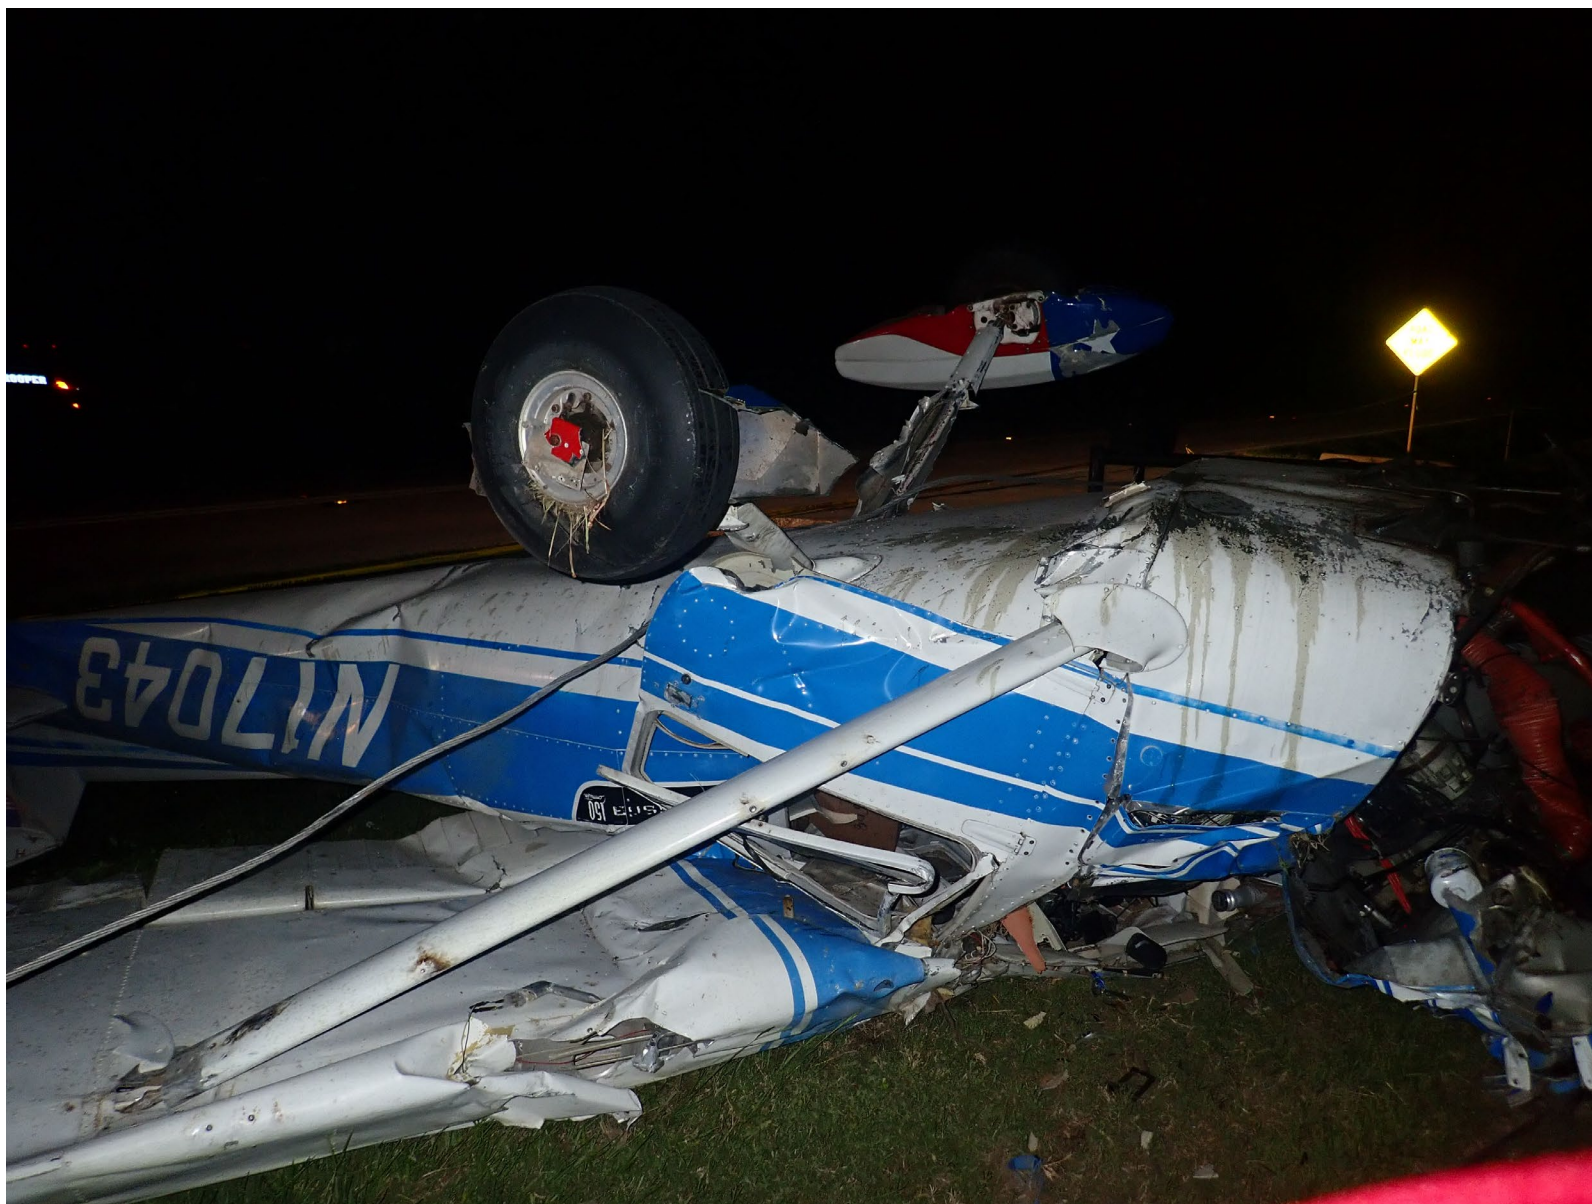
**Photograph 2 - Accident site (Courtesy of FAA)**

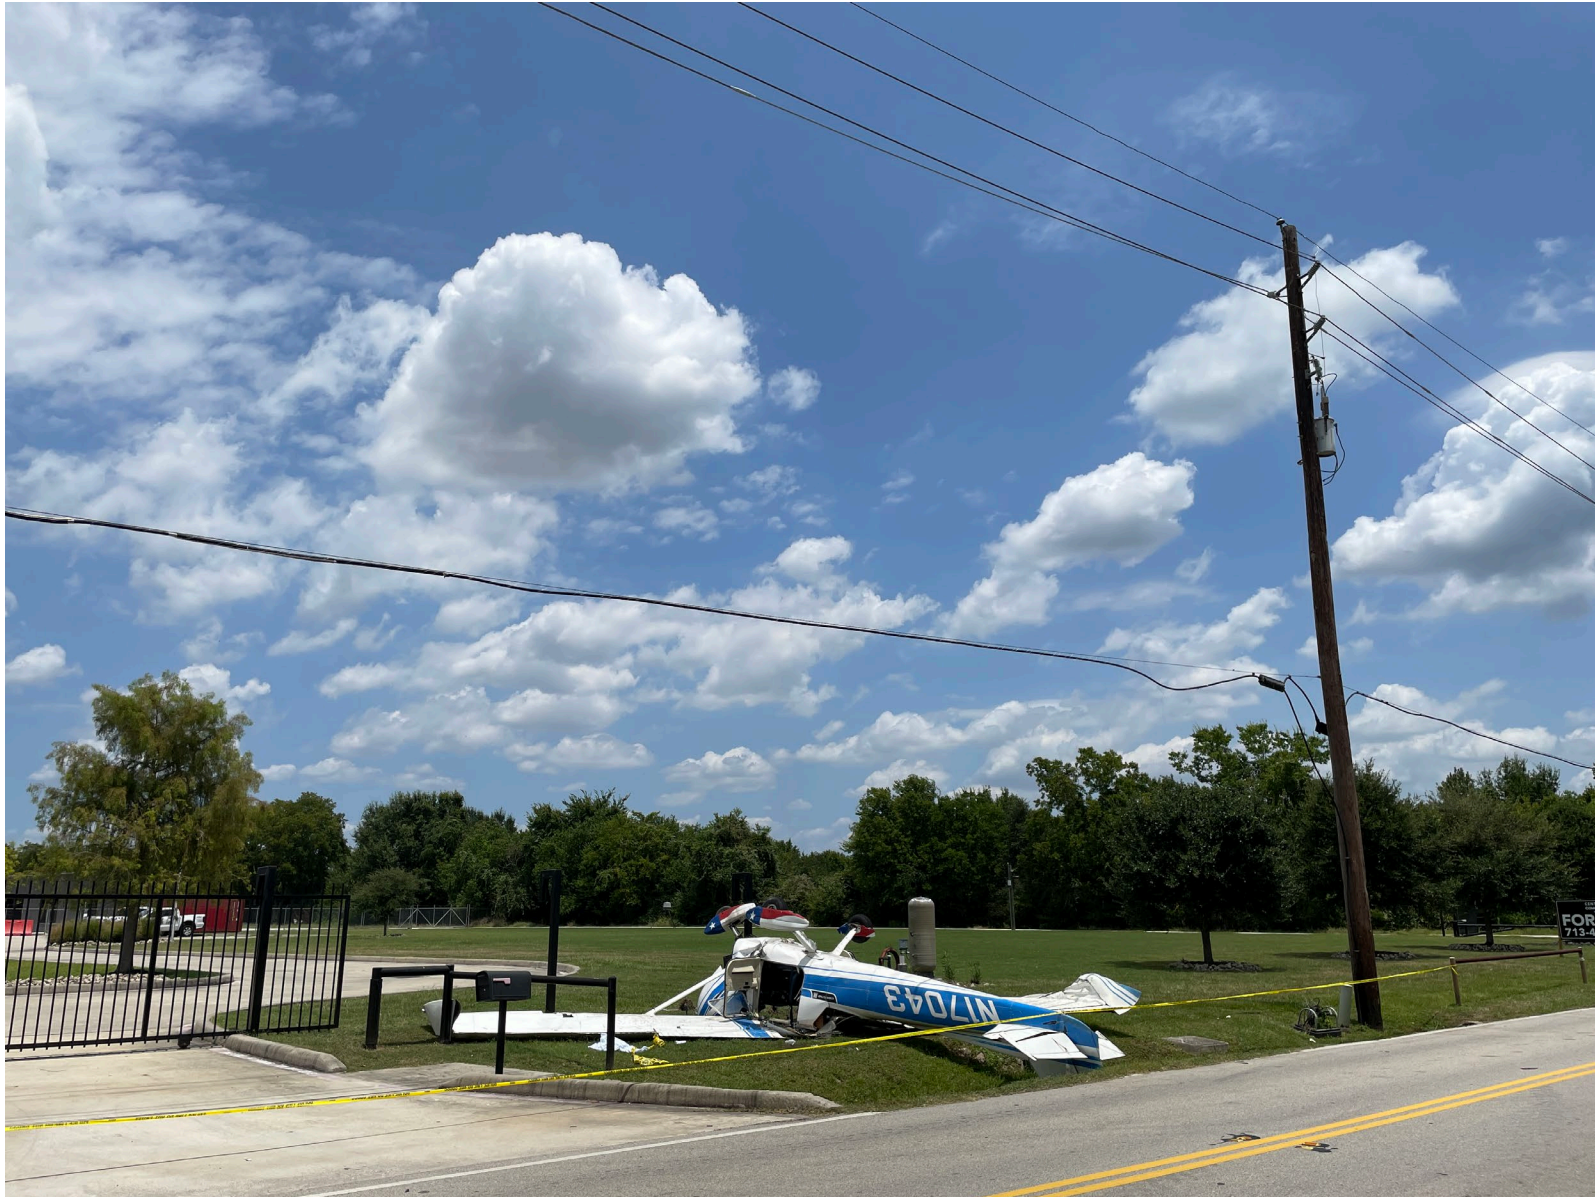
**Photograph 3 - Accident site**

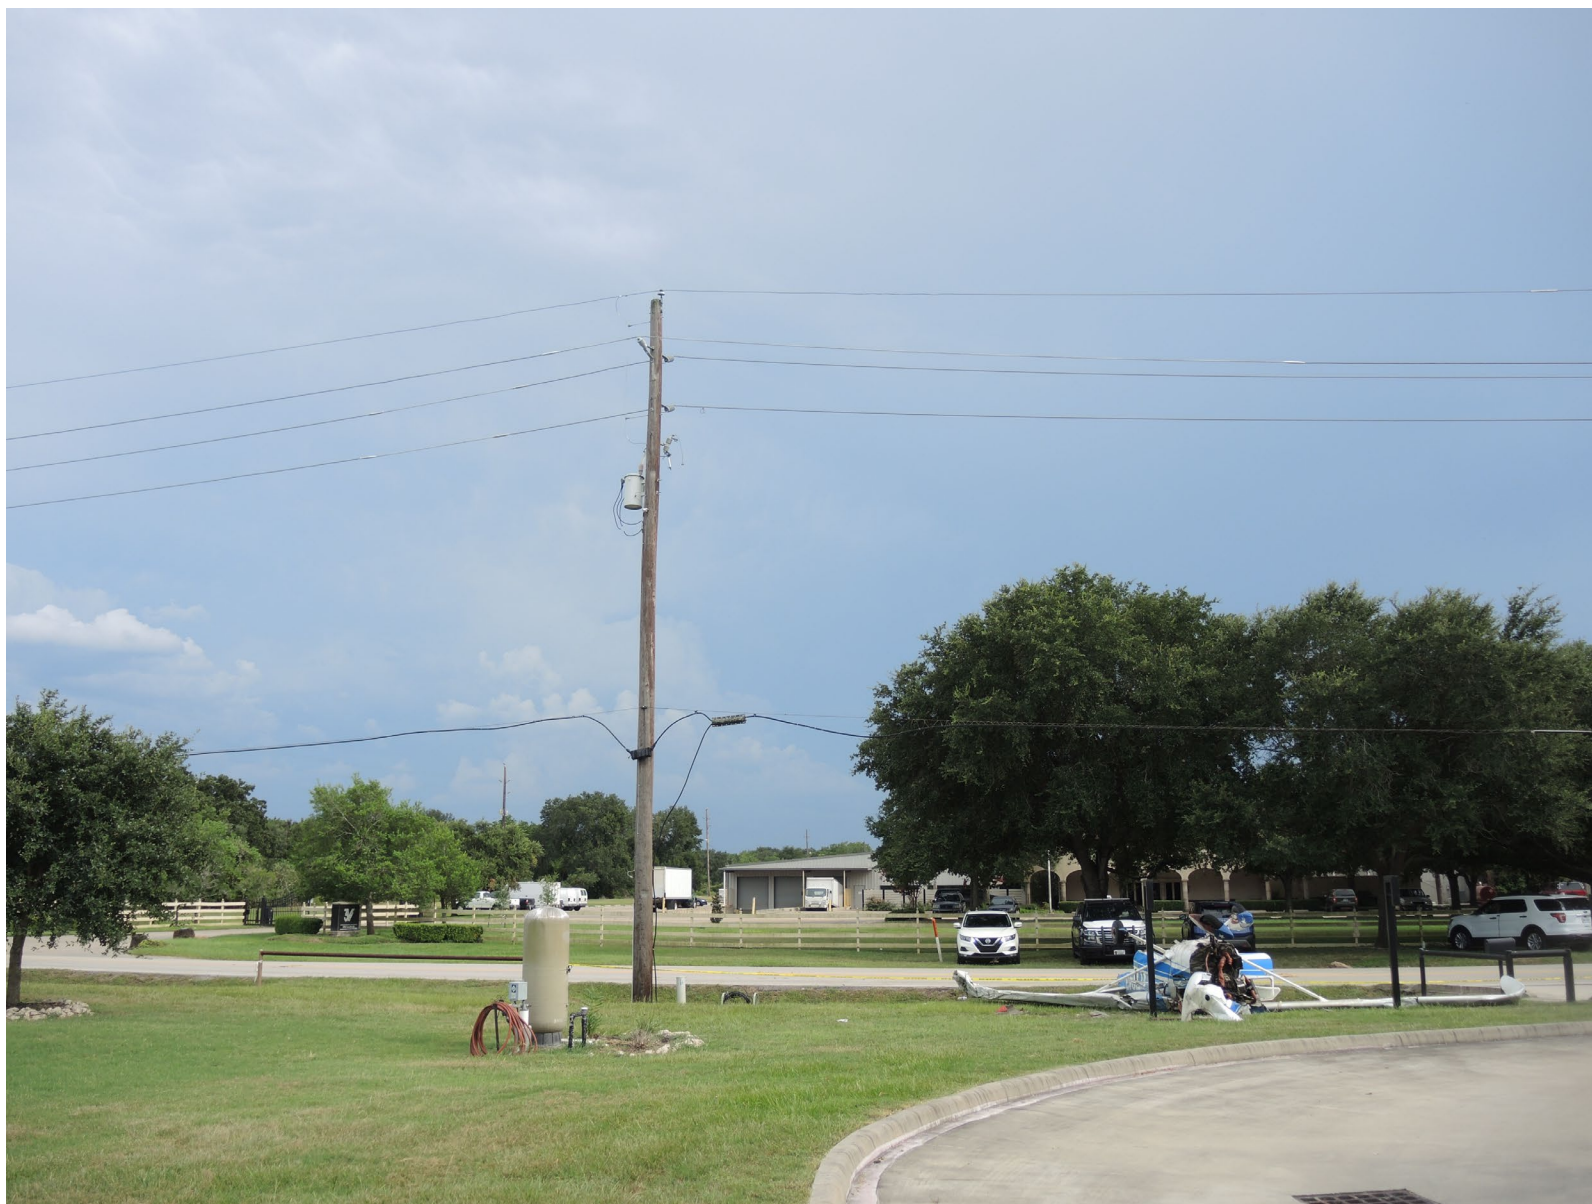
**Photograph 4 - Accident site**

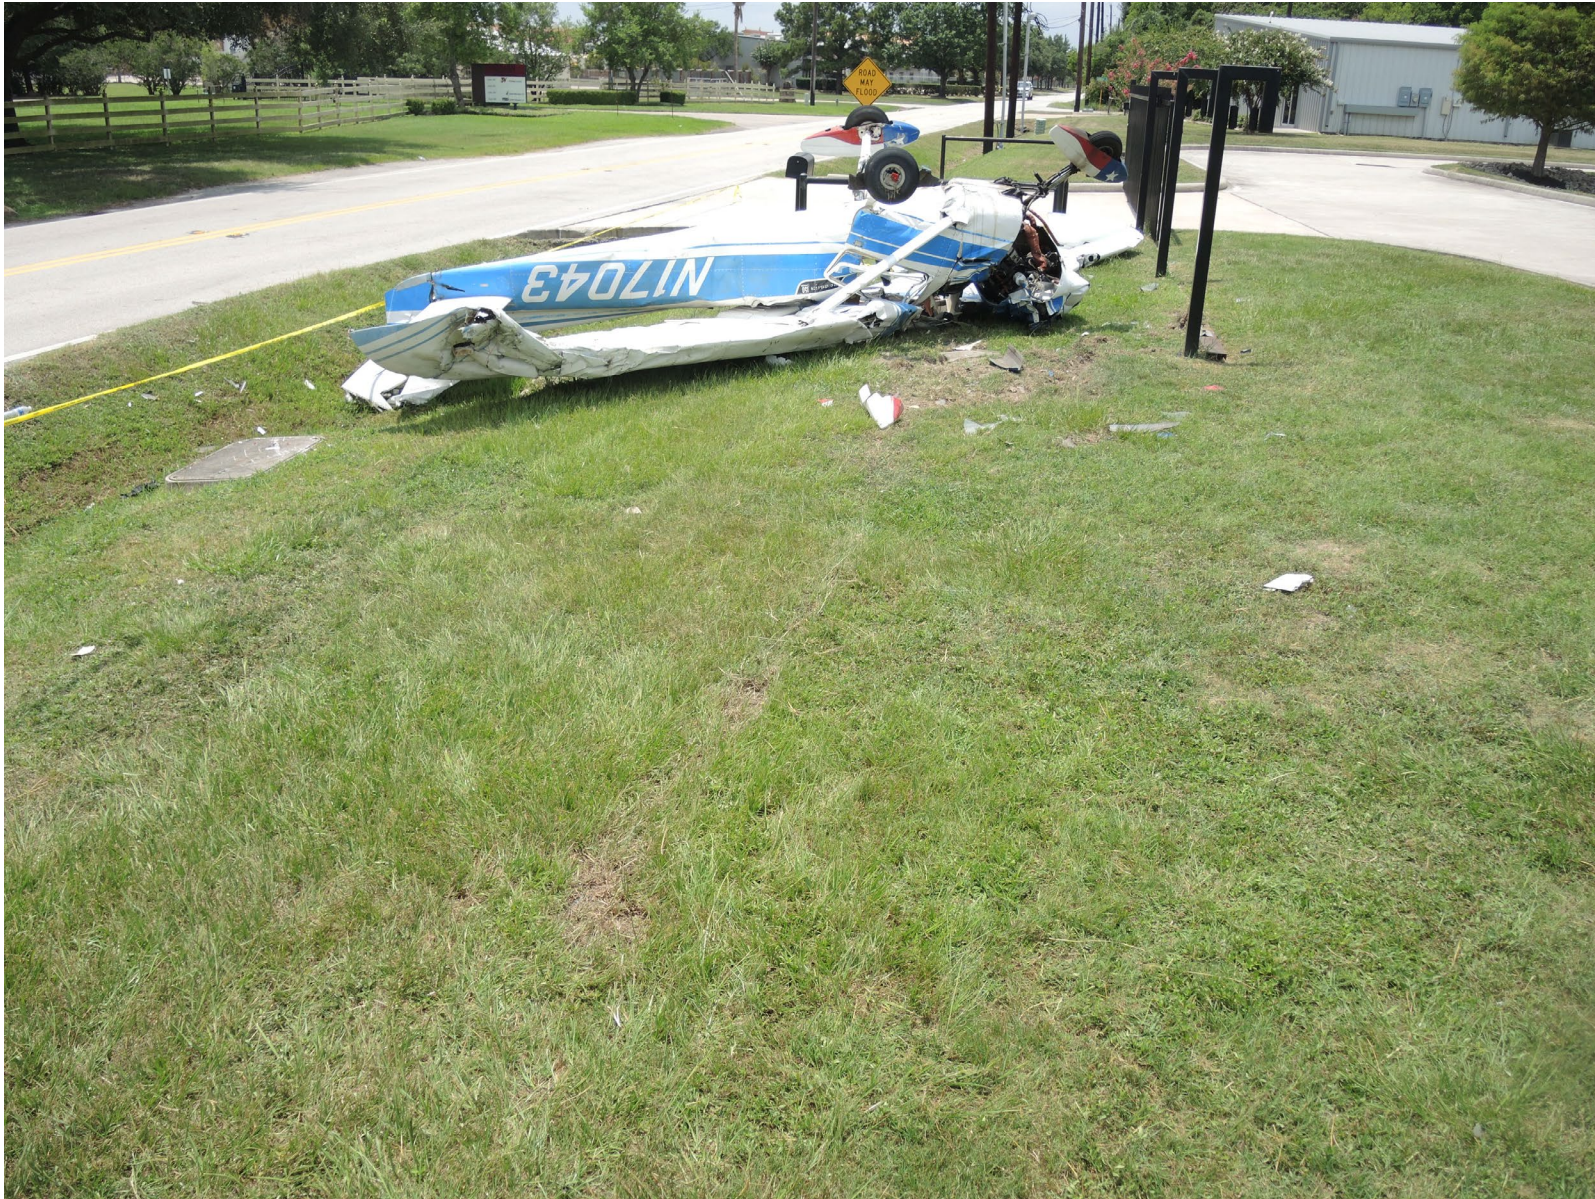
**Photograph 5 - Left side of inverted airplane**

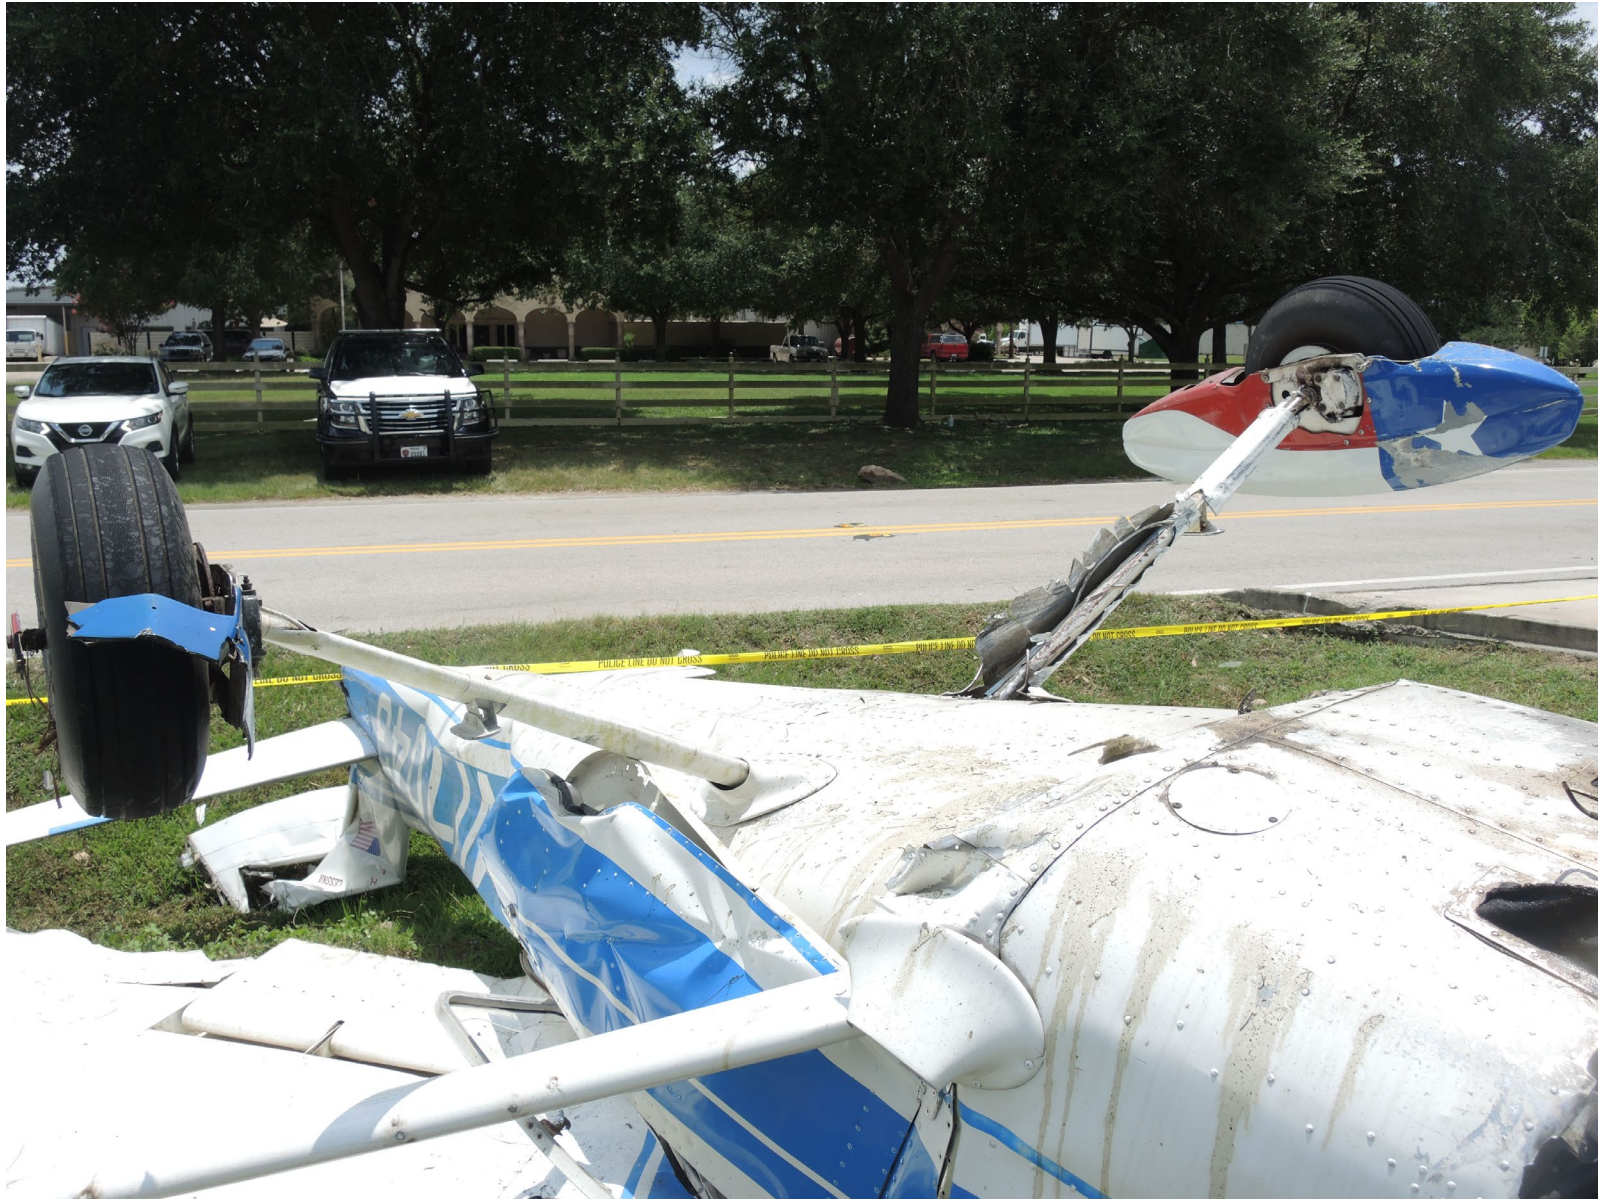
**Photograph 6 - Bottom of fuselage**

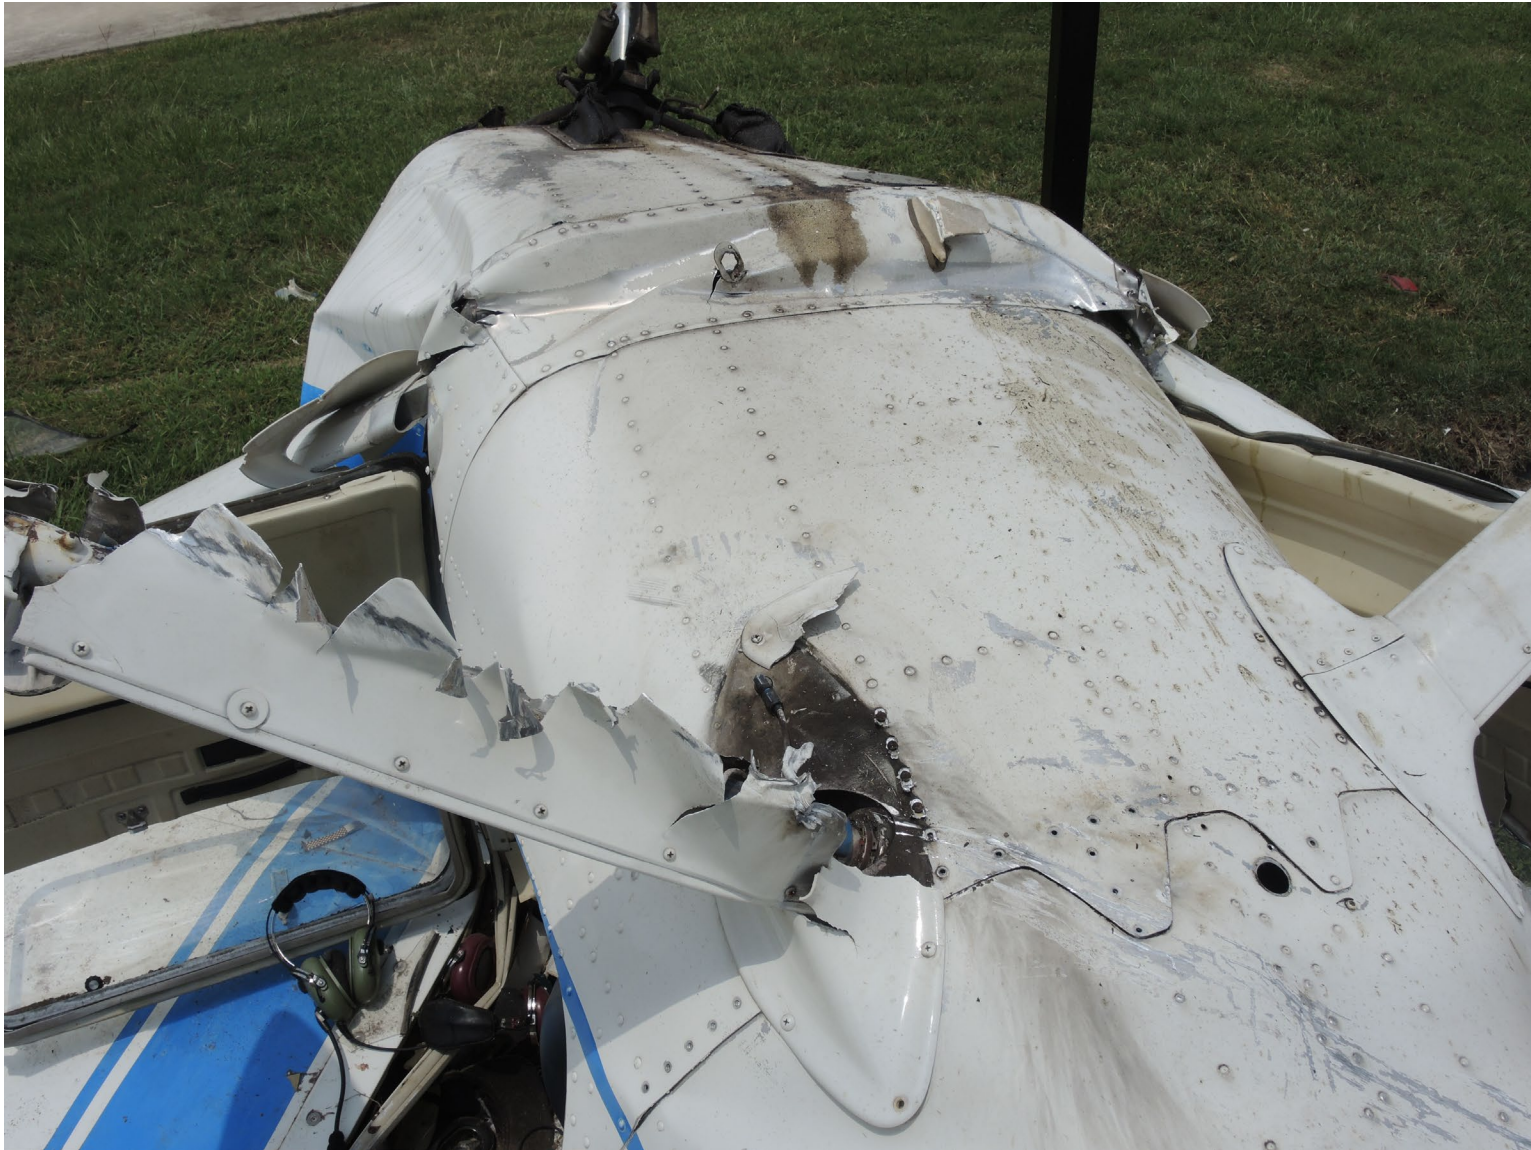
**Photograph 7 - Bottom of fuselage**

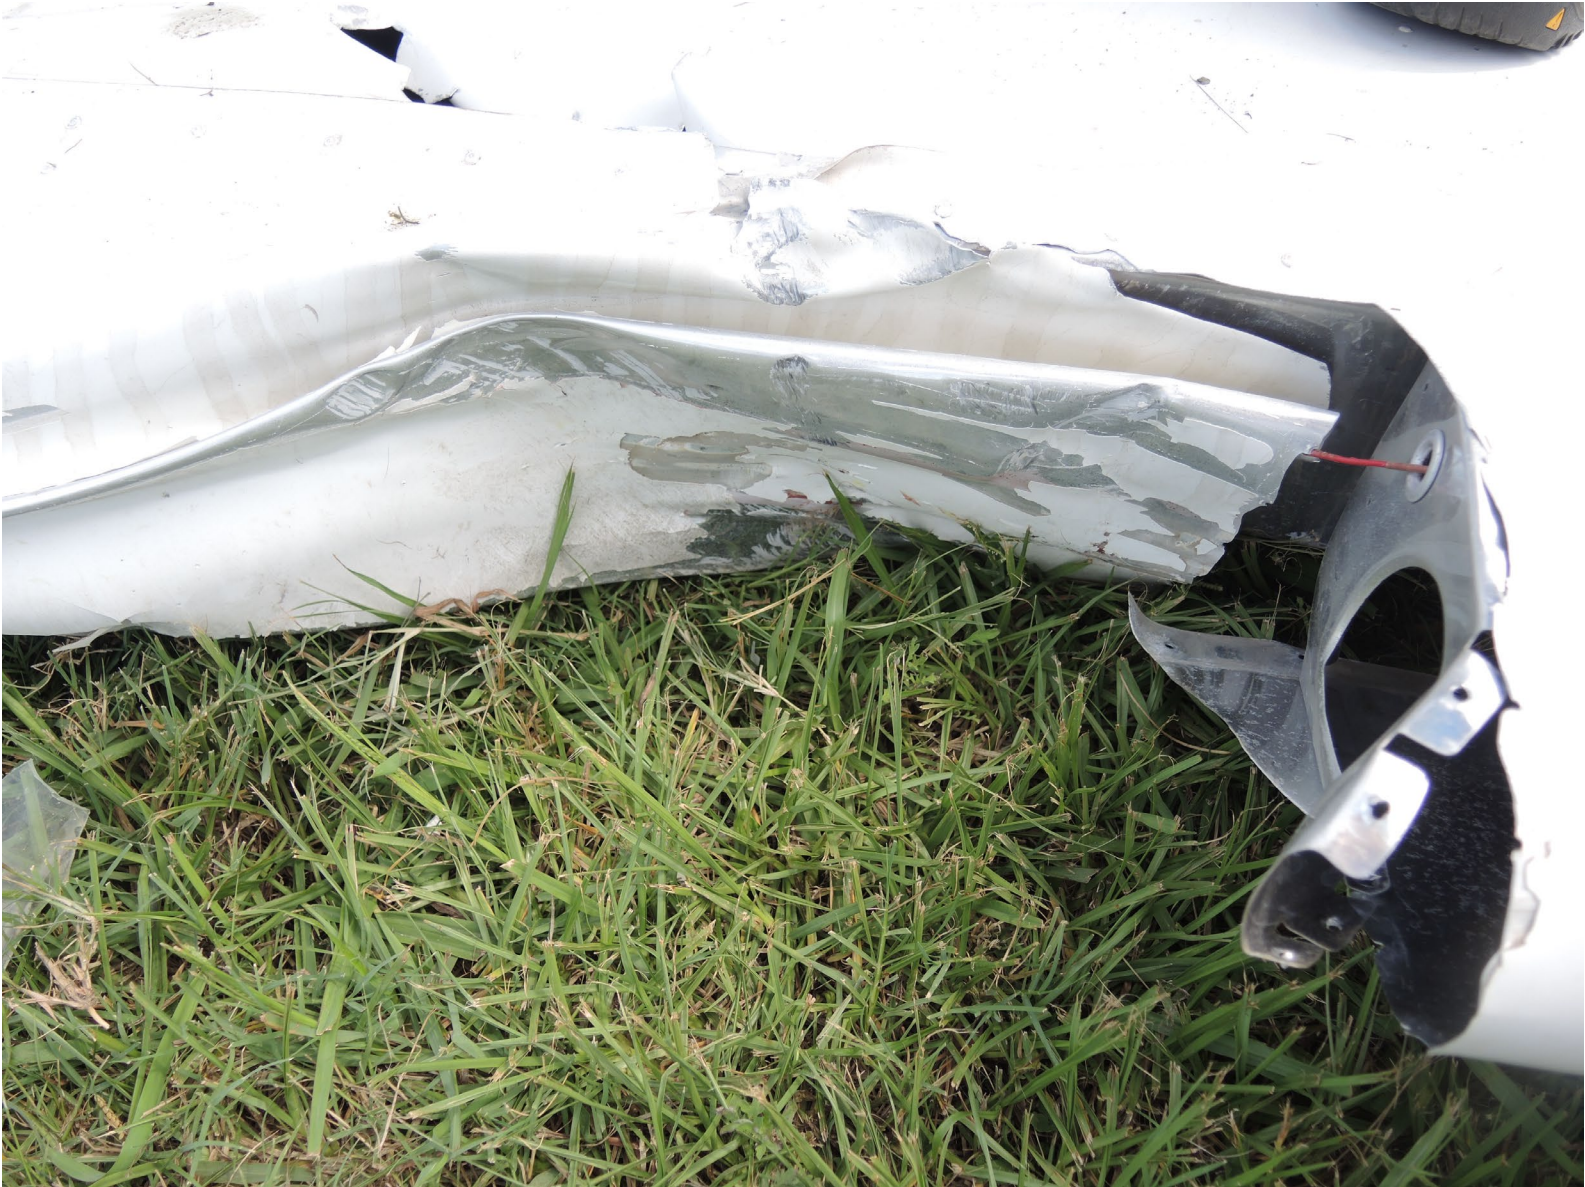
**Photograph 8 - Right wing leading edge damage**

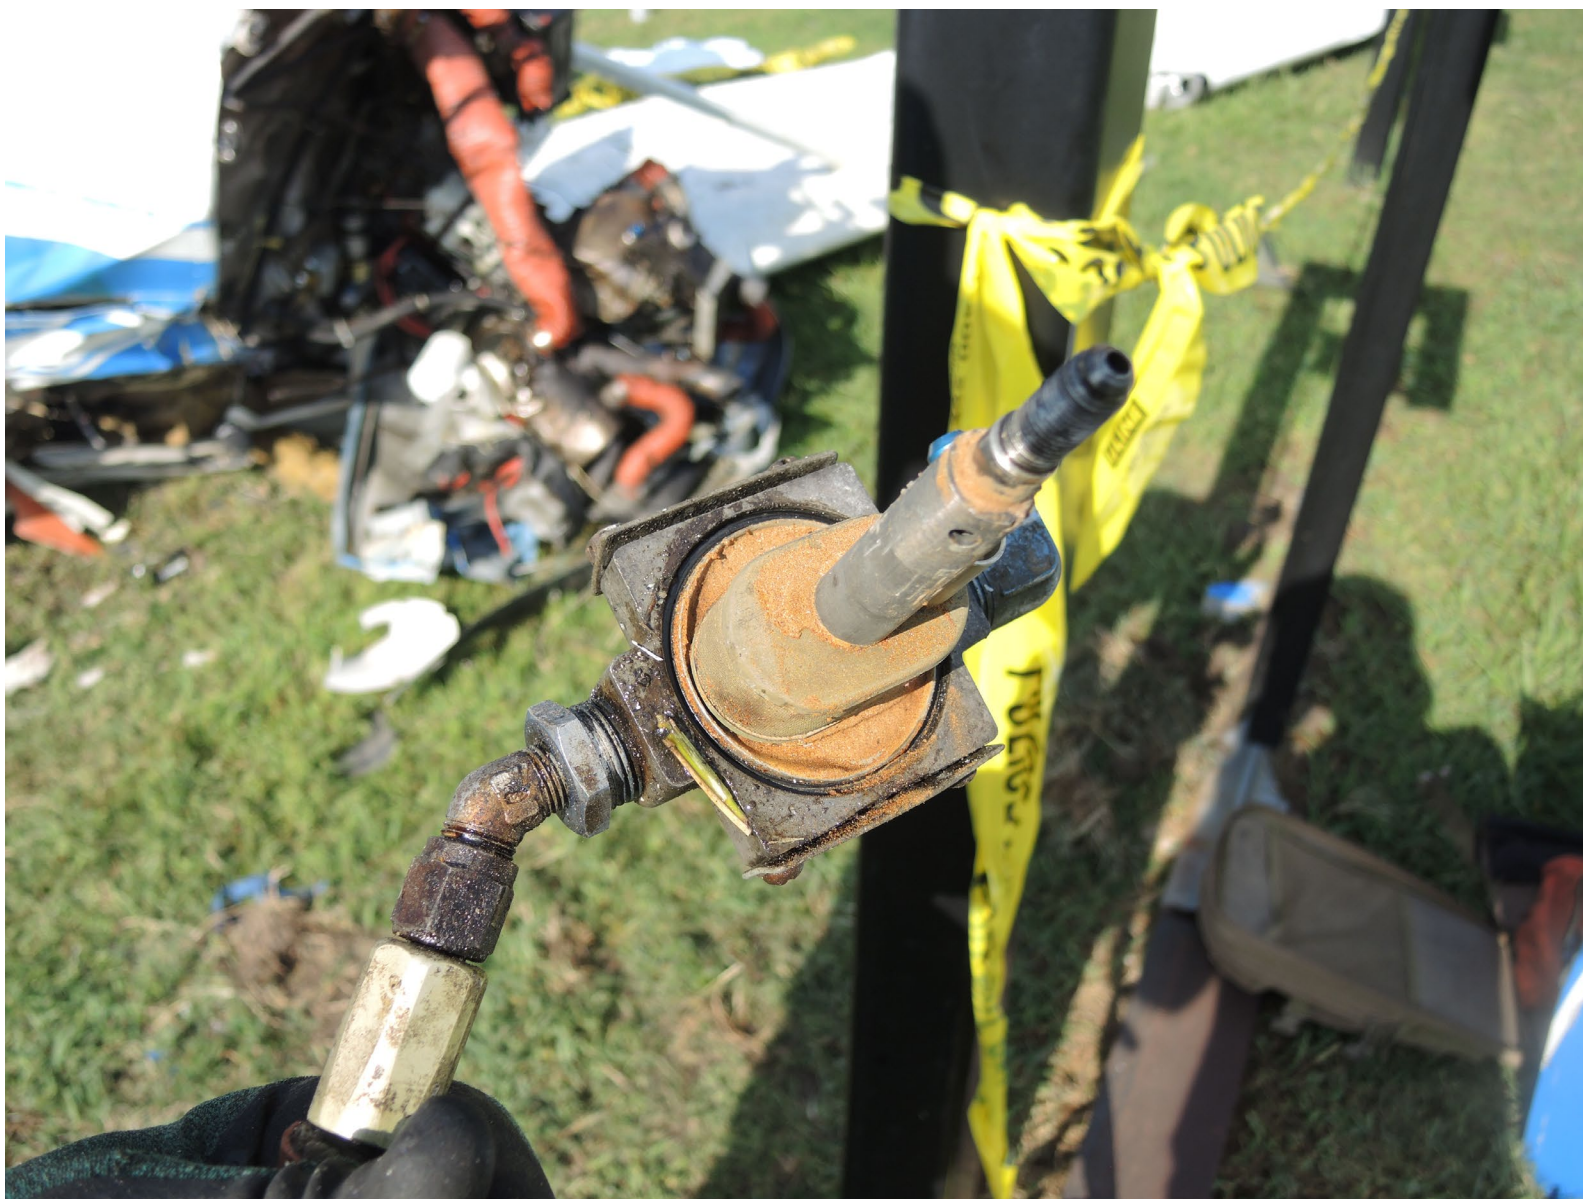
**Photograph 9 - Debris in fuel strainer**

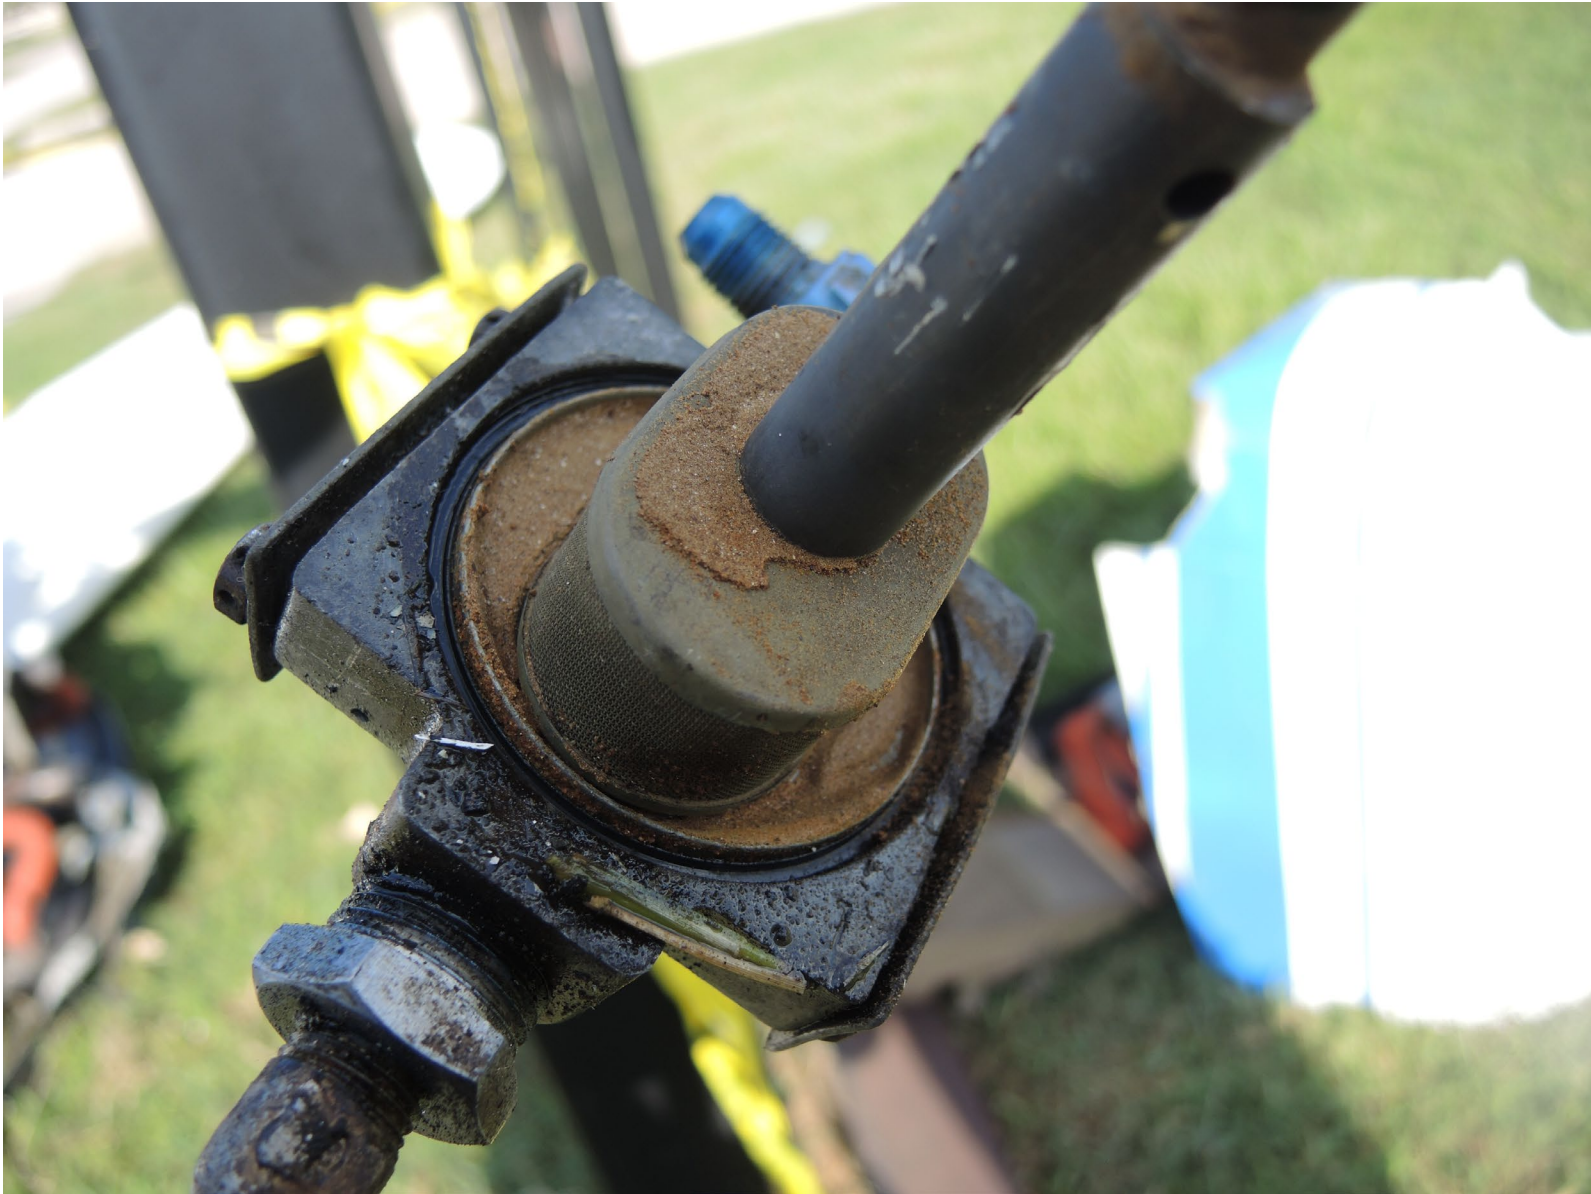
**Photograph 10 - Debris in fuel strainer**

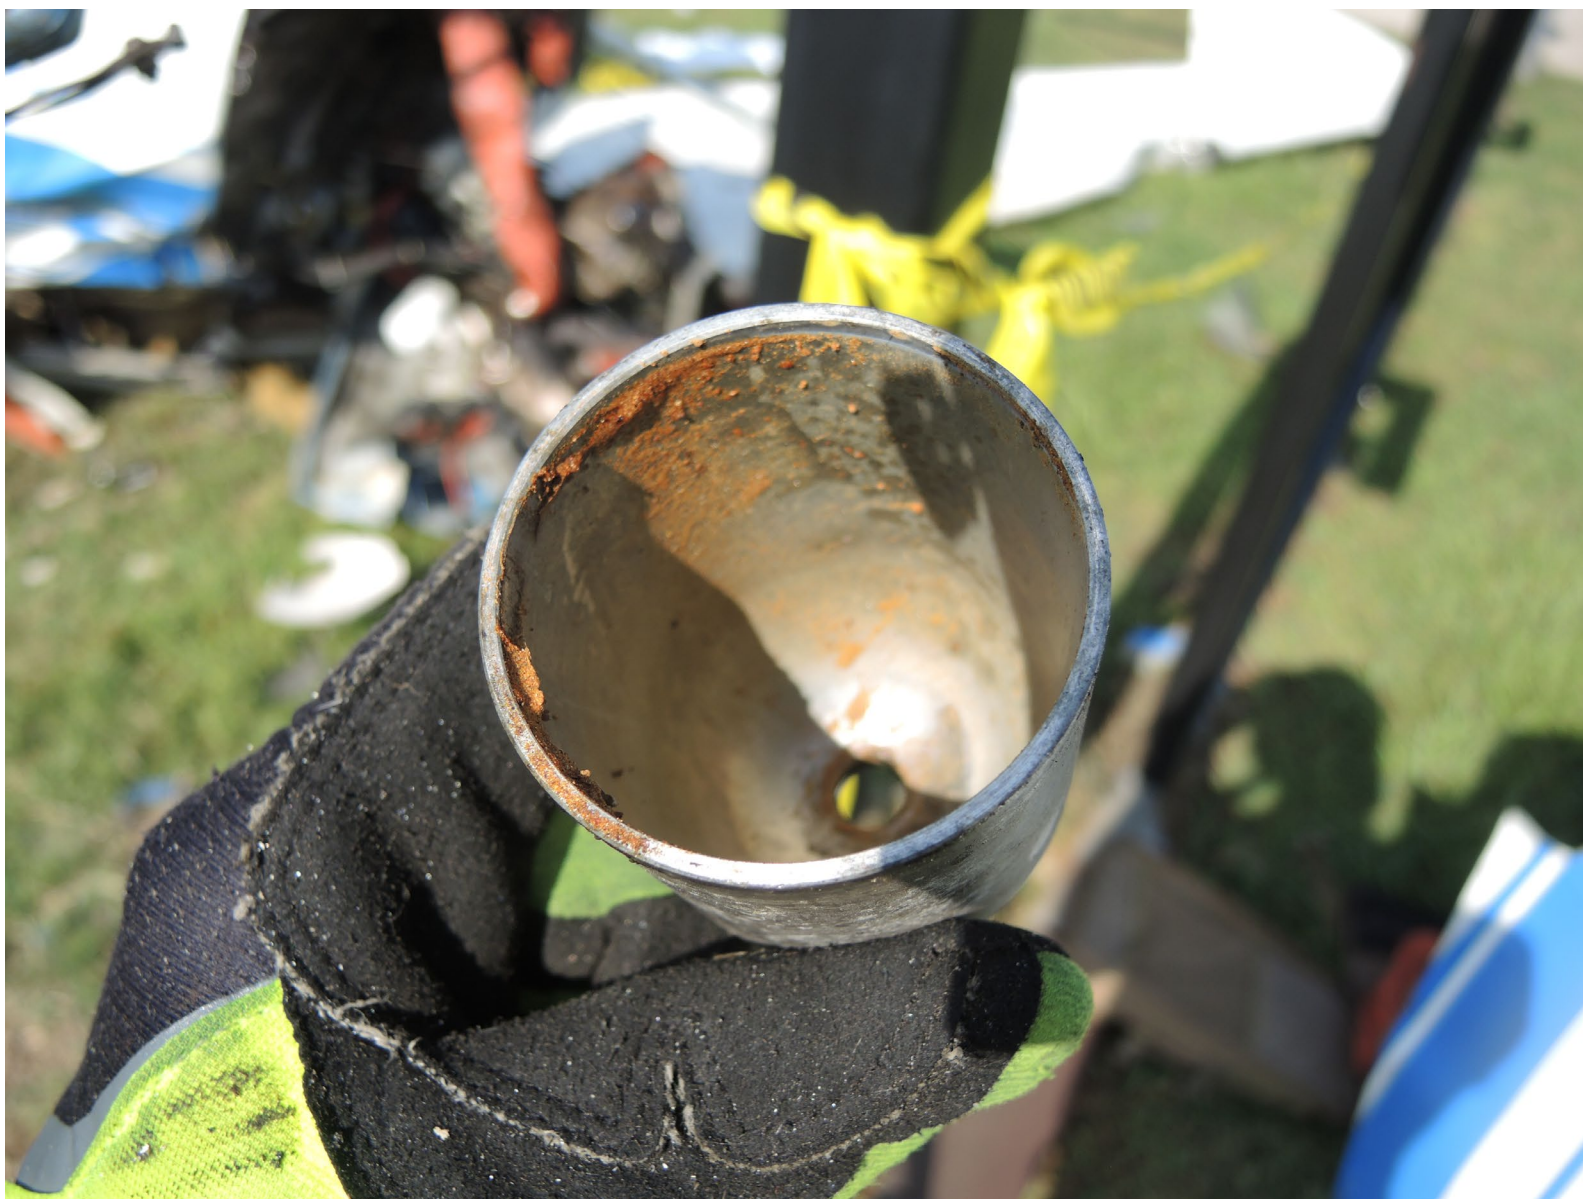
**Photograph 11 - Debris in fuel strainer bowl**

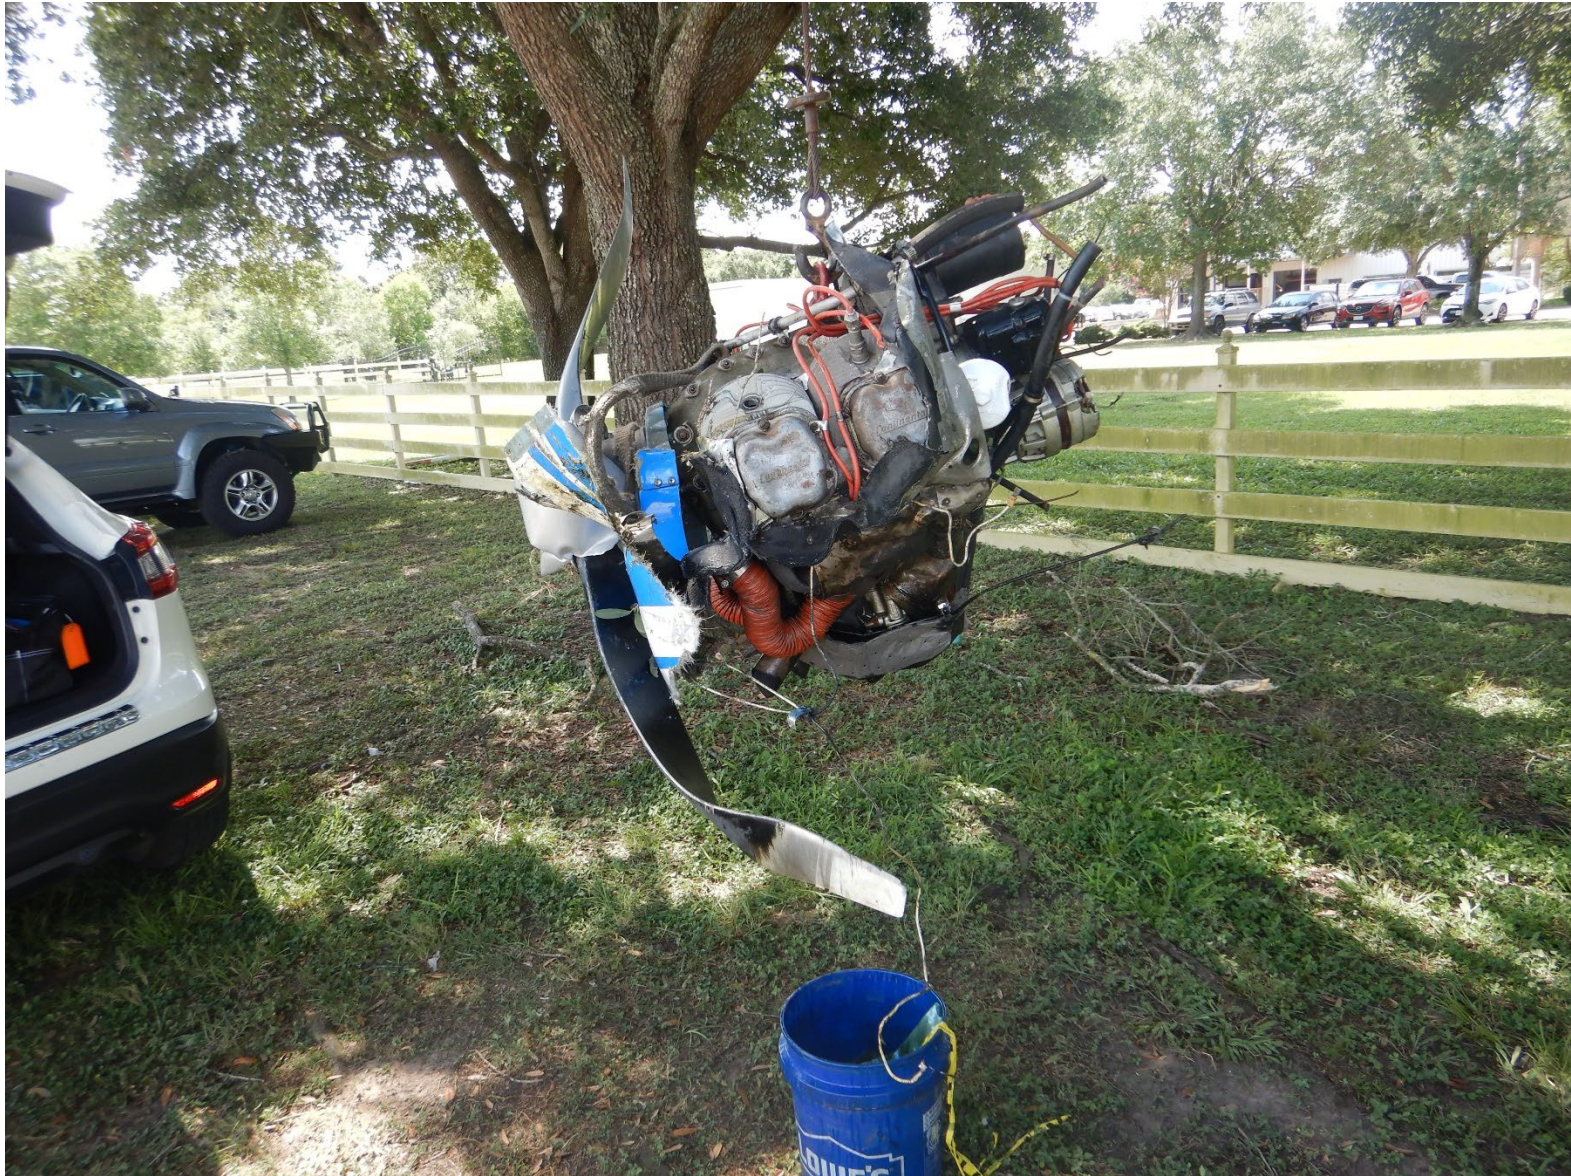
**Photograph 12 - Engine and propeller (Courtesy of Textron Aviation)**
