CEN23FA315

## INVESTIGATION PHOTOGRAPHS

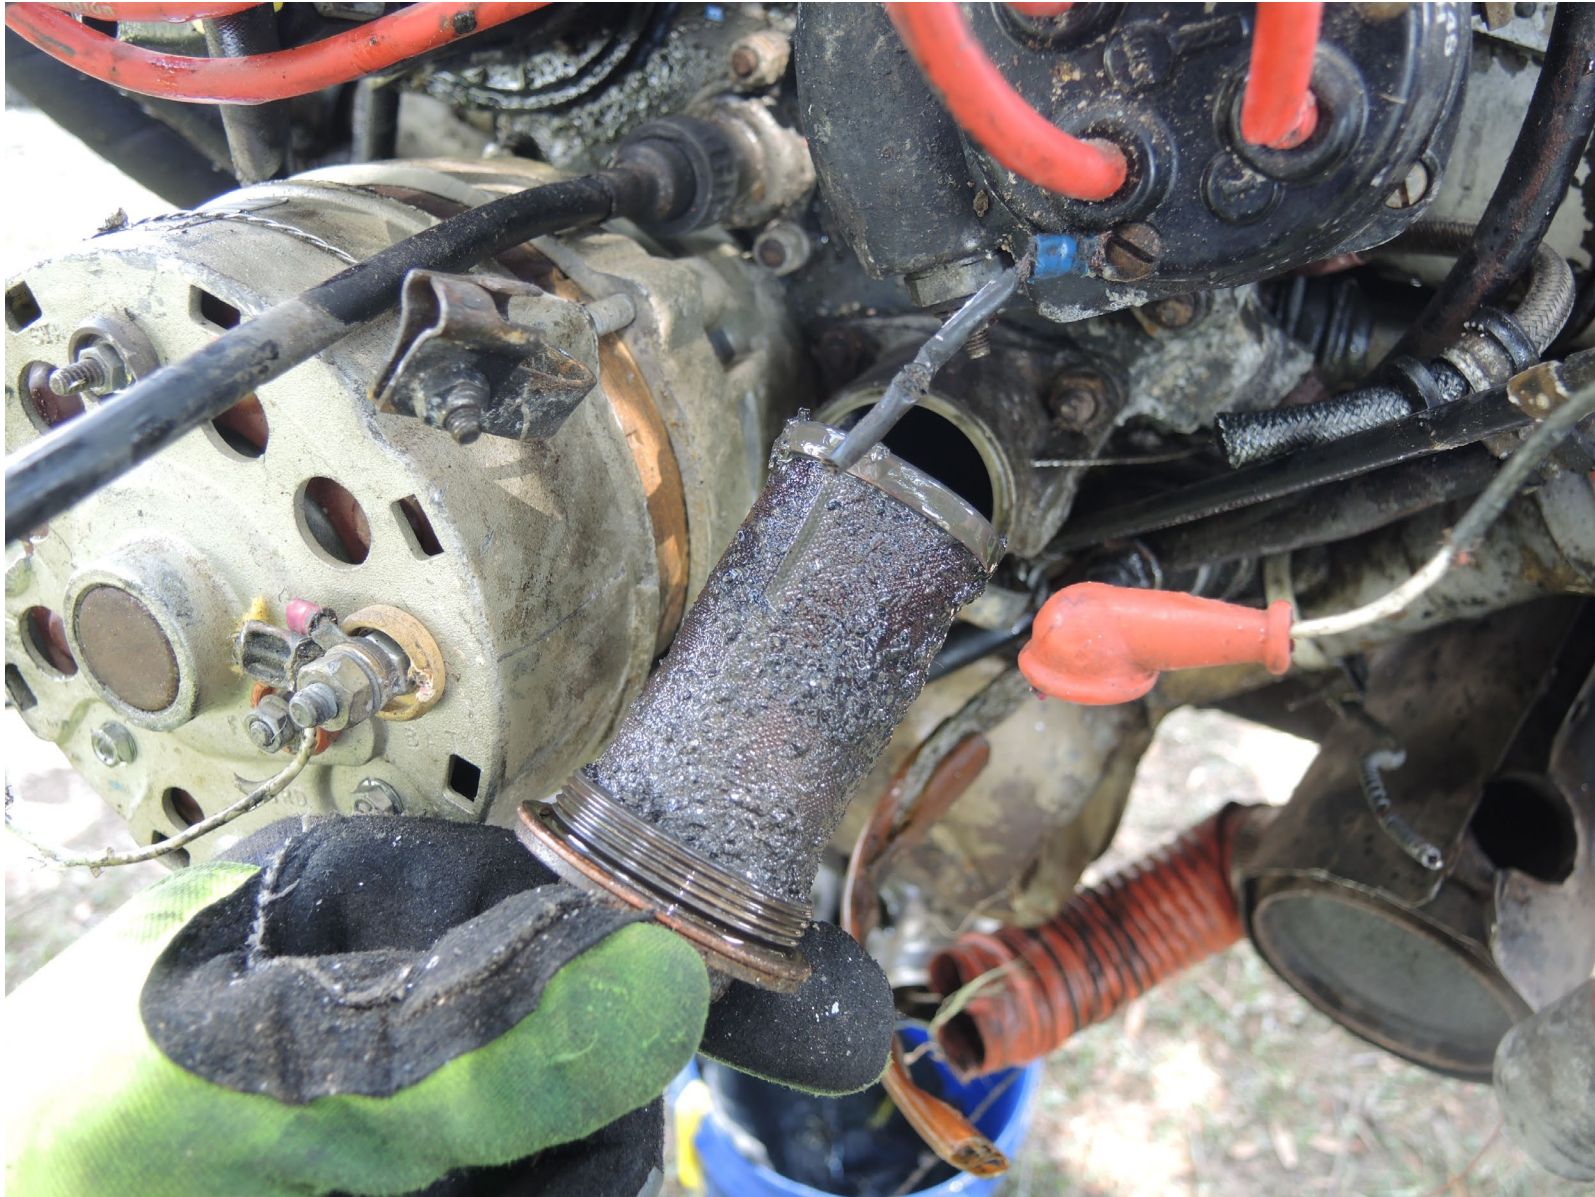
**Photograph 13 - Oil screen**

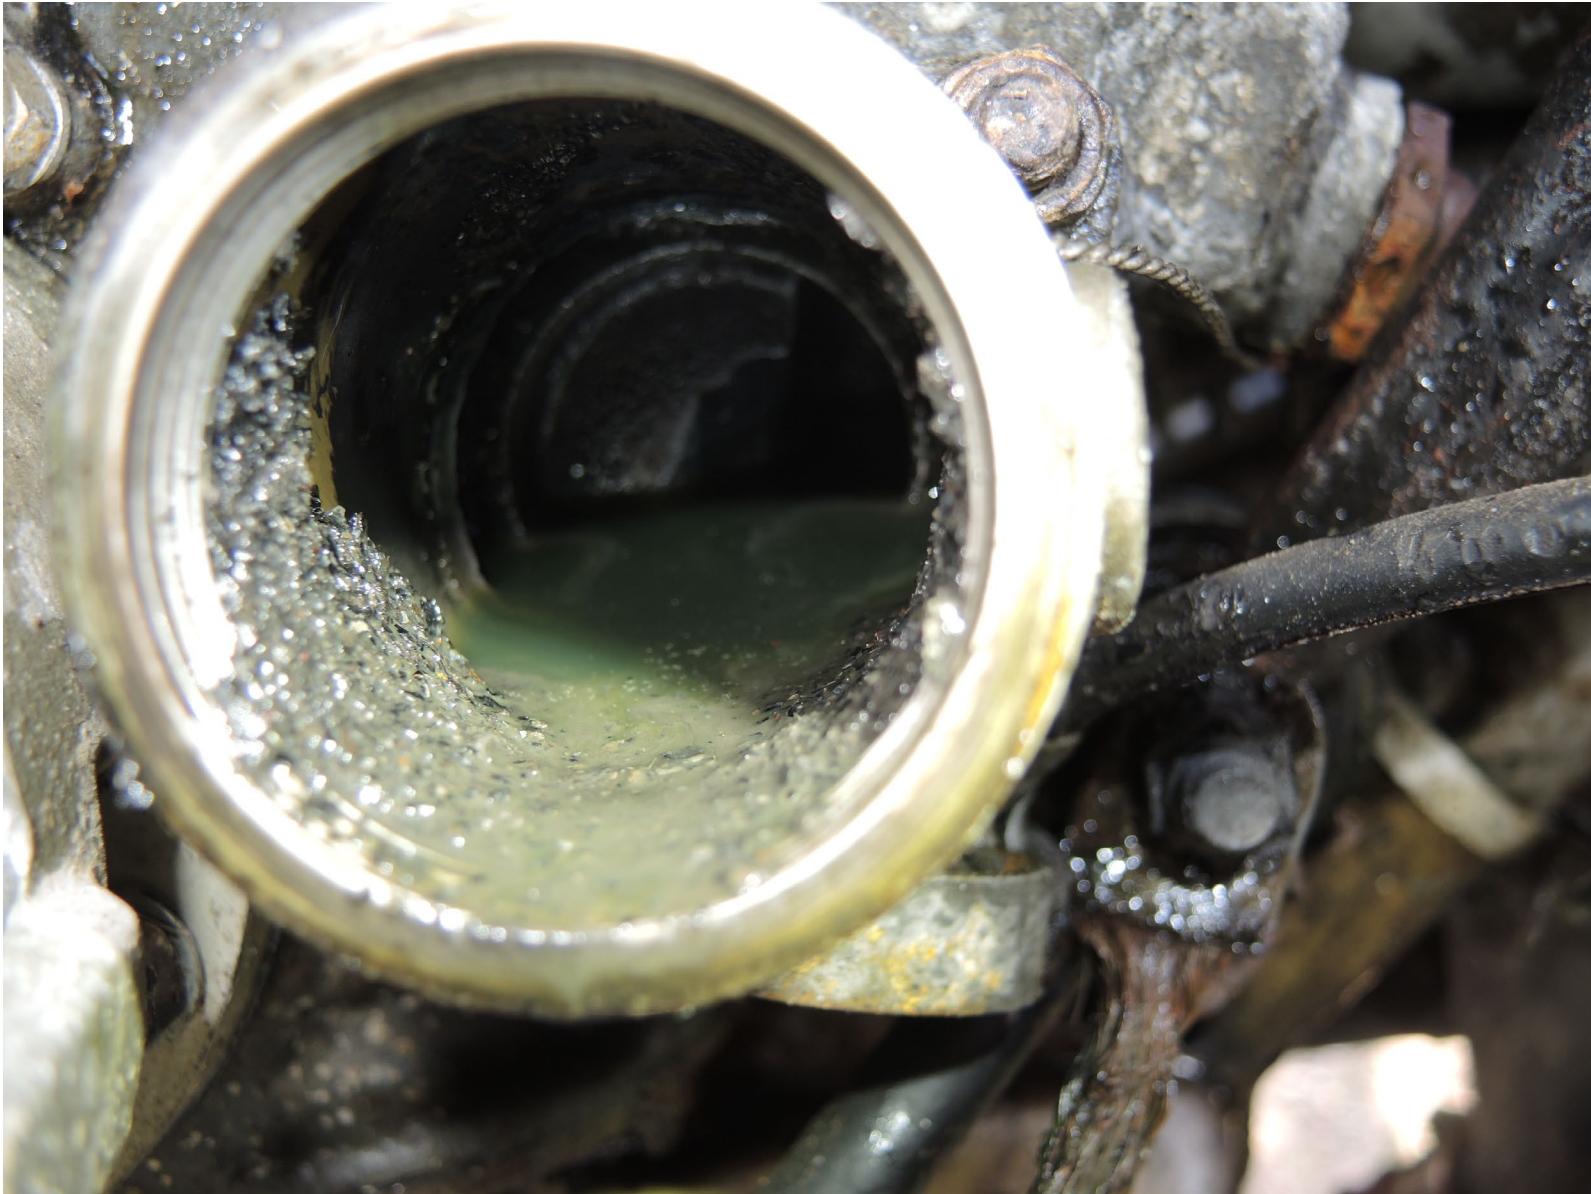
**Photograph 14 - Oil screen housing**

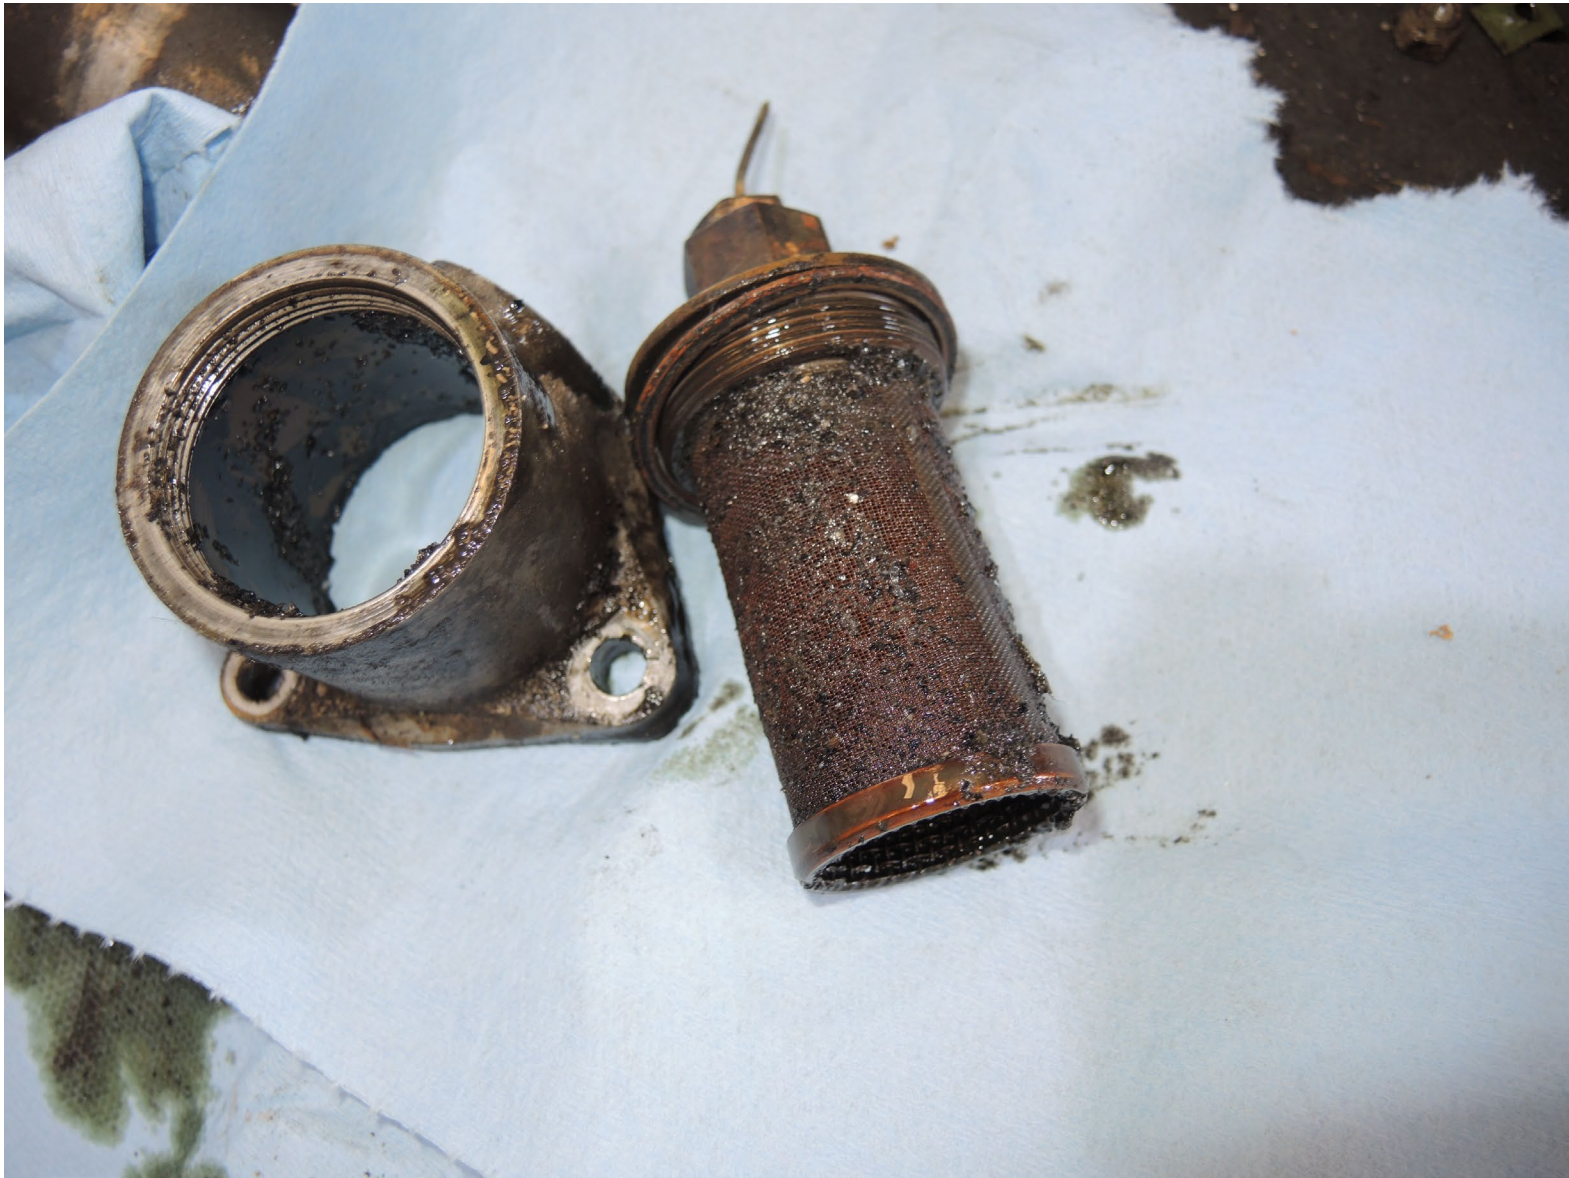
**Photograph 15 - Oil screen**

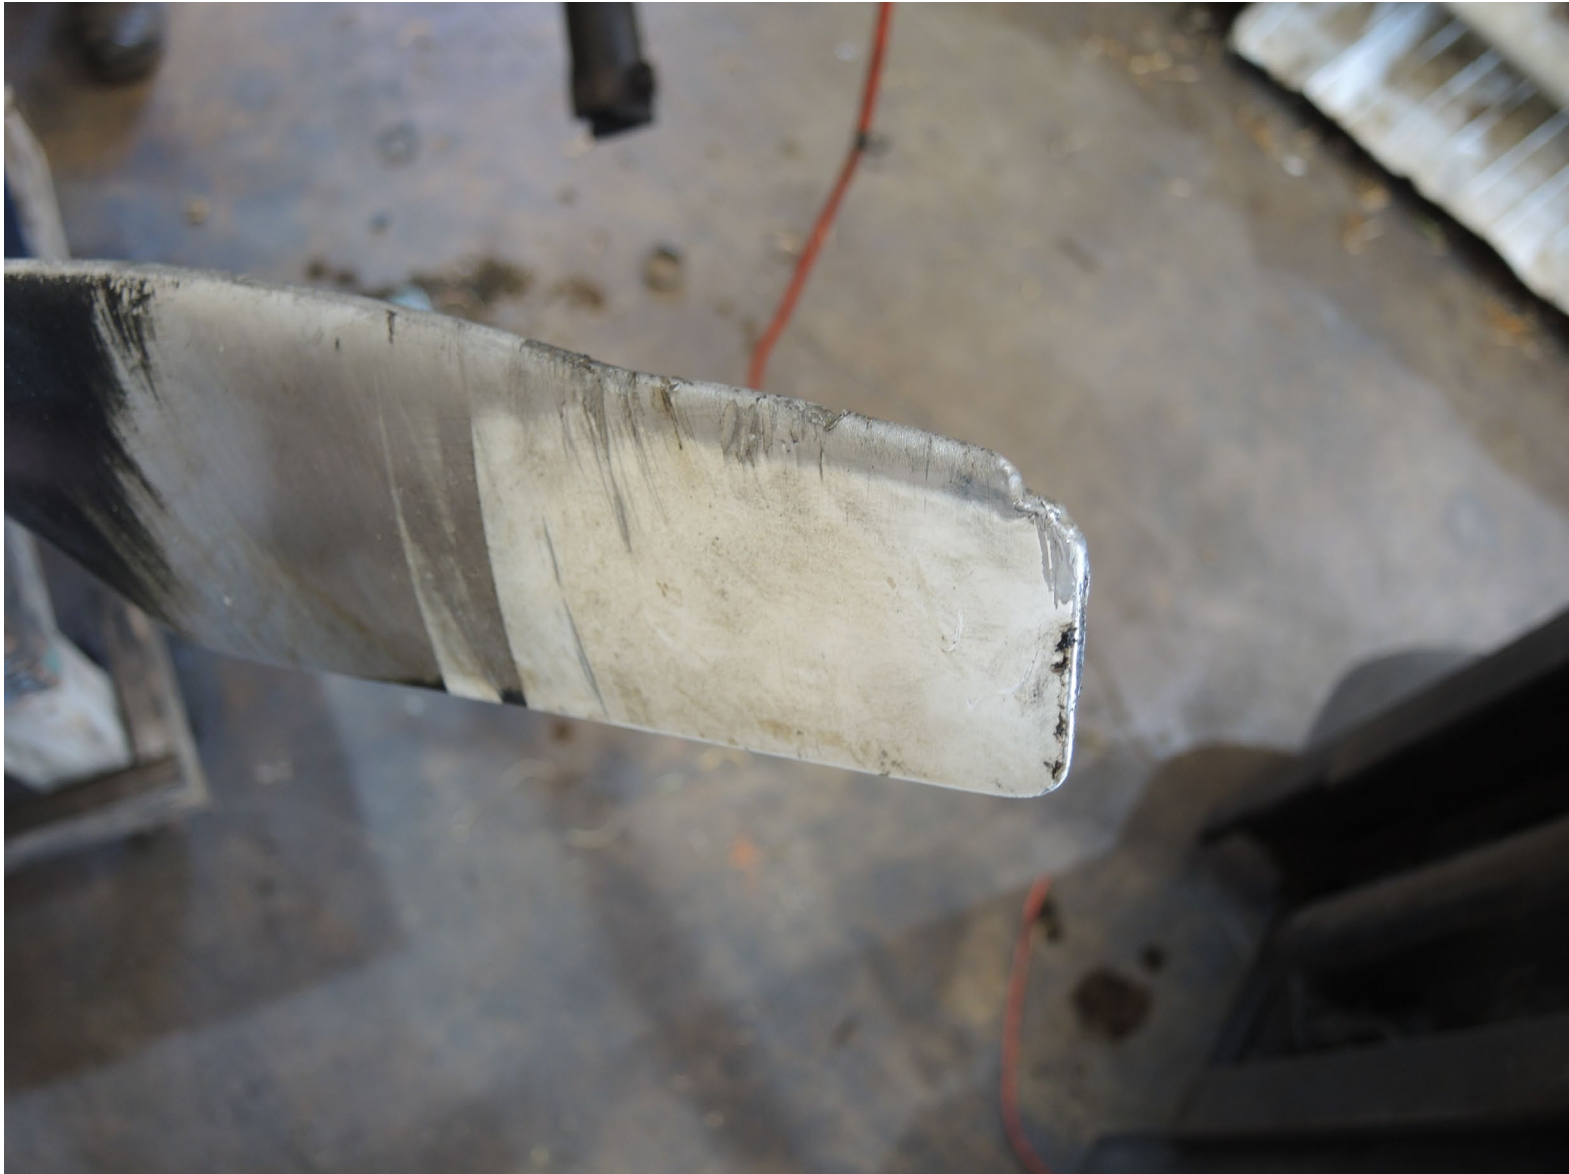
**Photograph 16 - Propeller blade 1 damage**

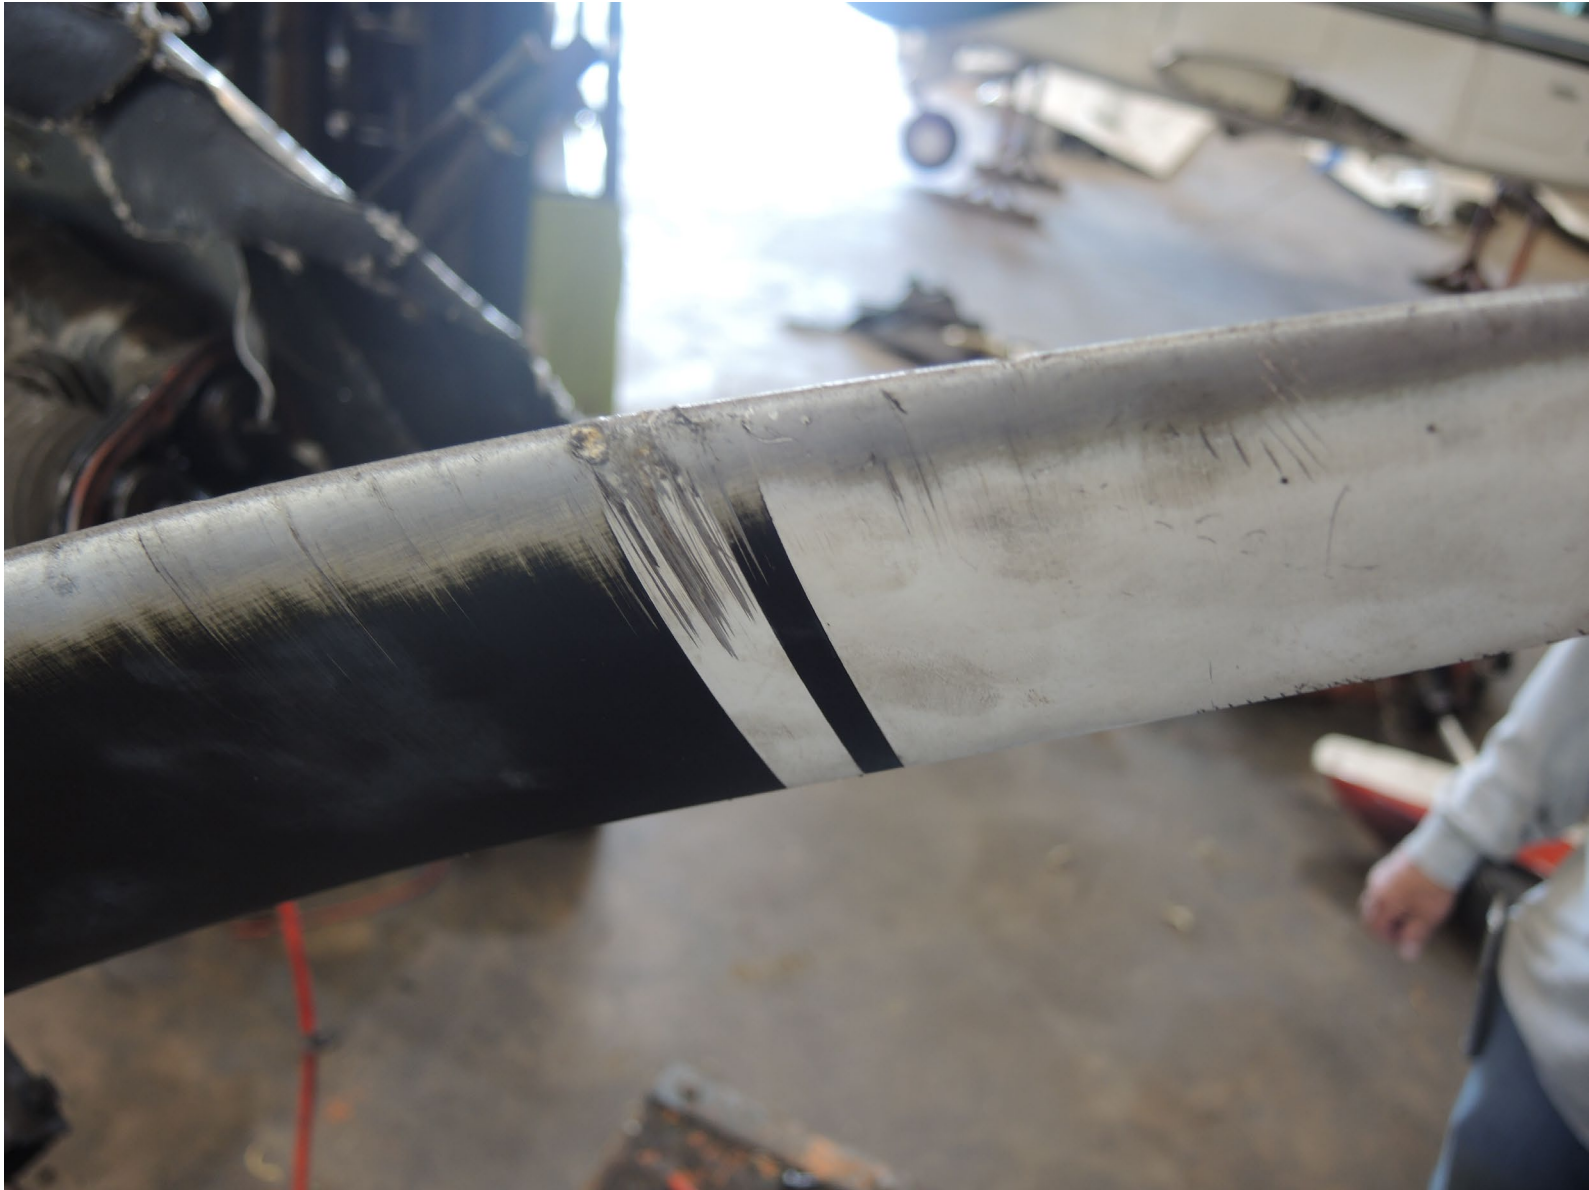
**Photograph 17 - Propeller blade 2 damage**

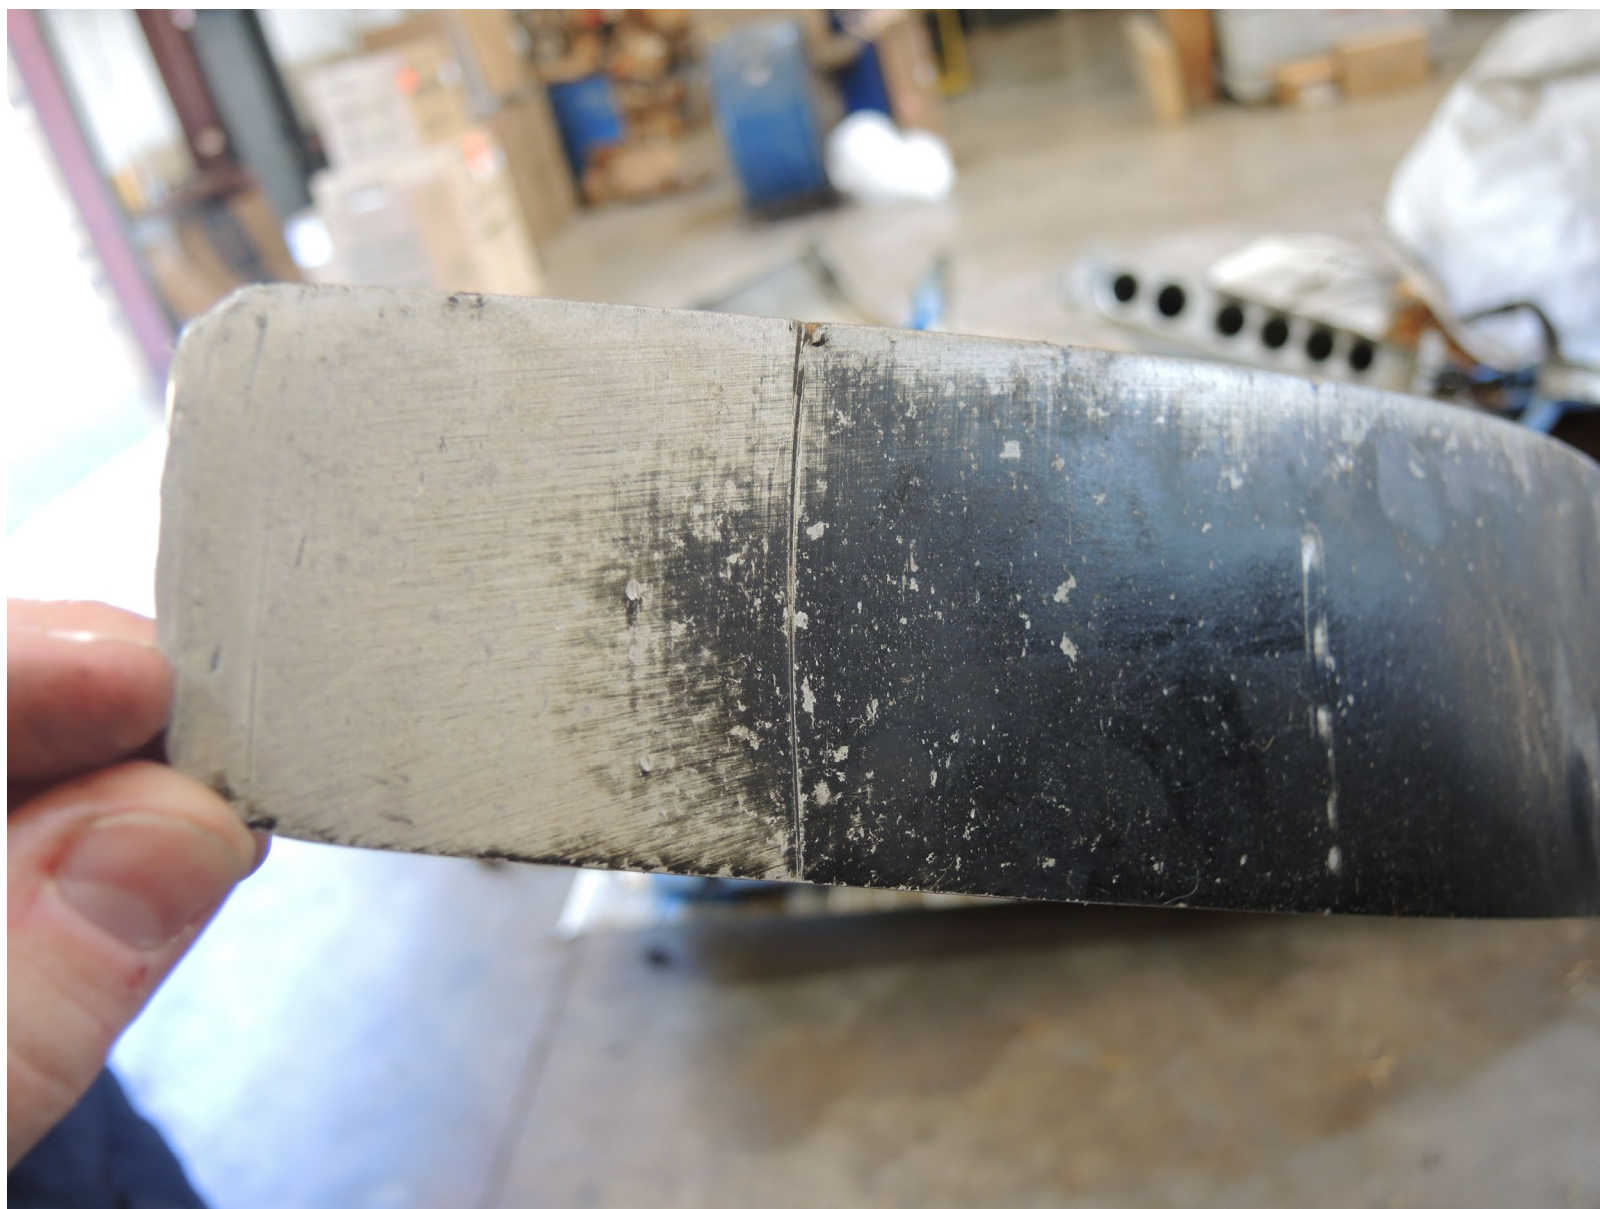
**Photograph 18 - Propeller blade 2 damage, cambered side**

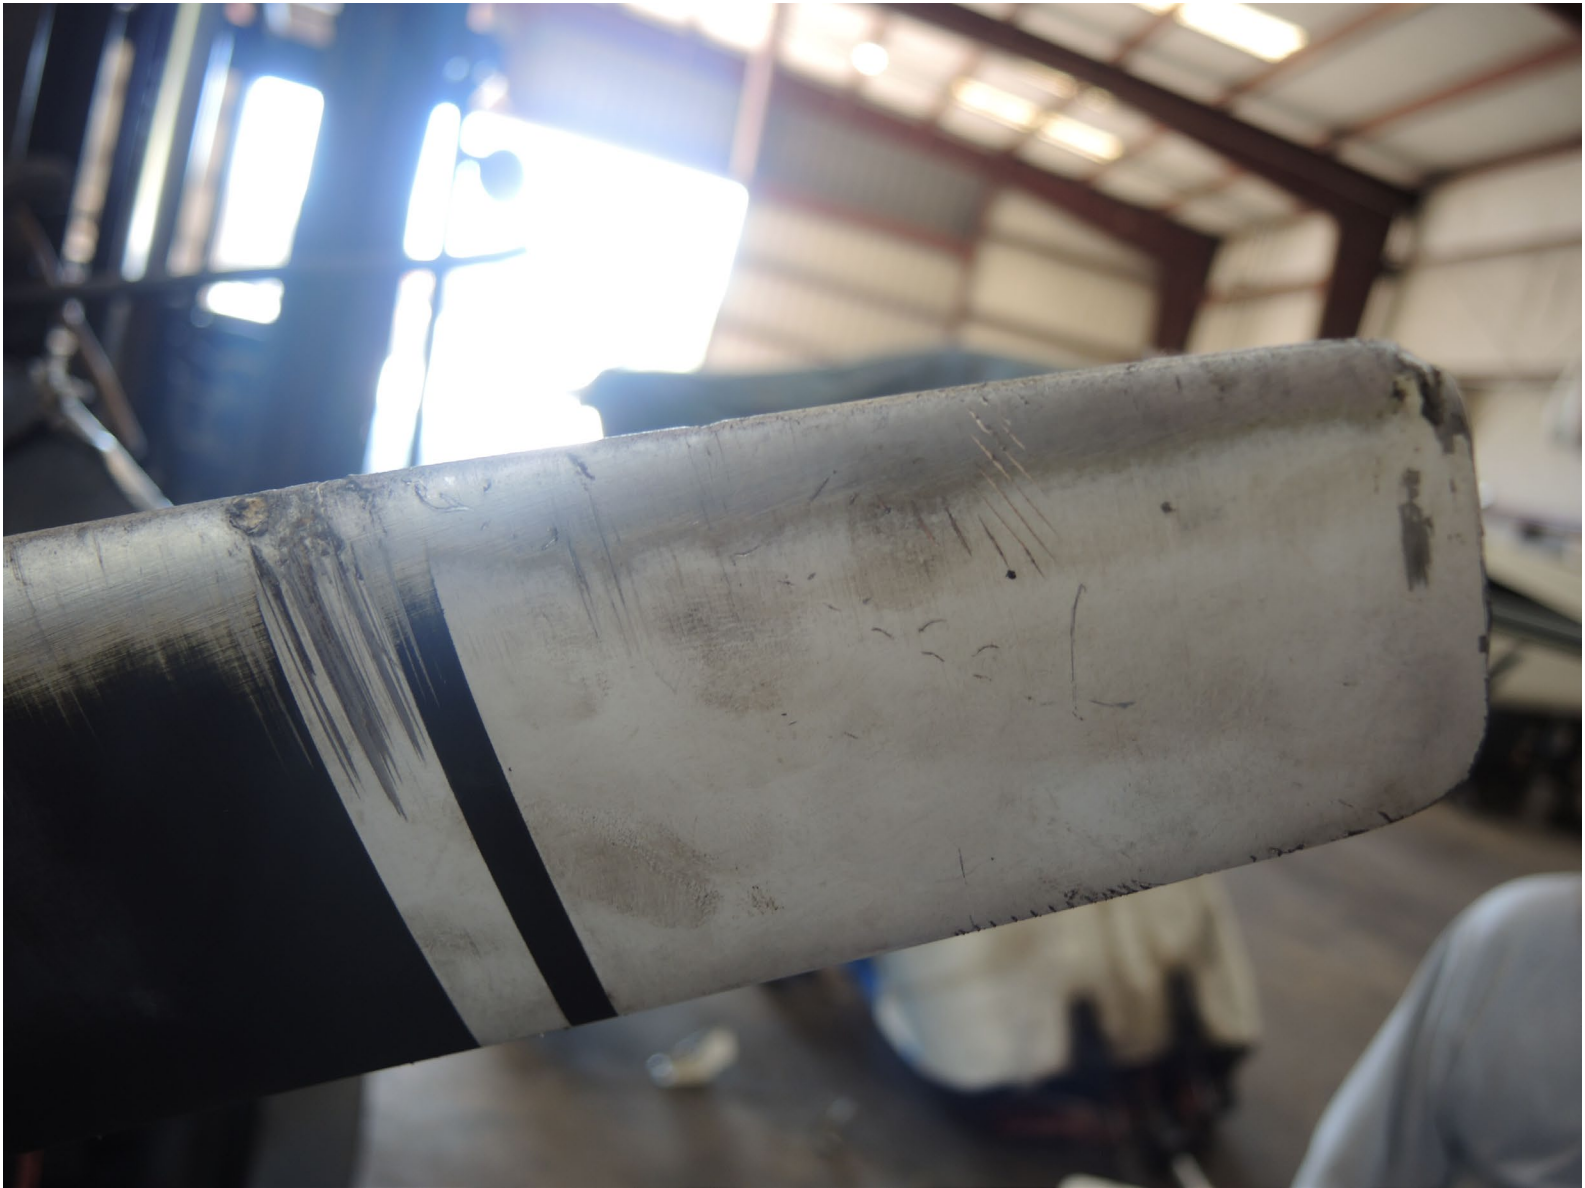
**Photograph 19 - Propeller blade 2 damage**

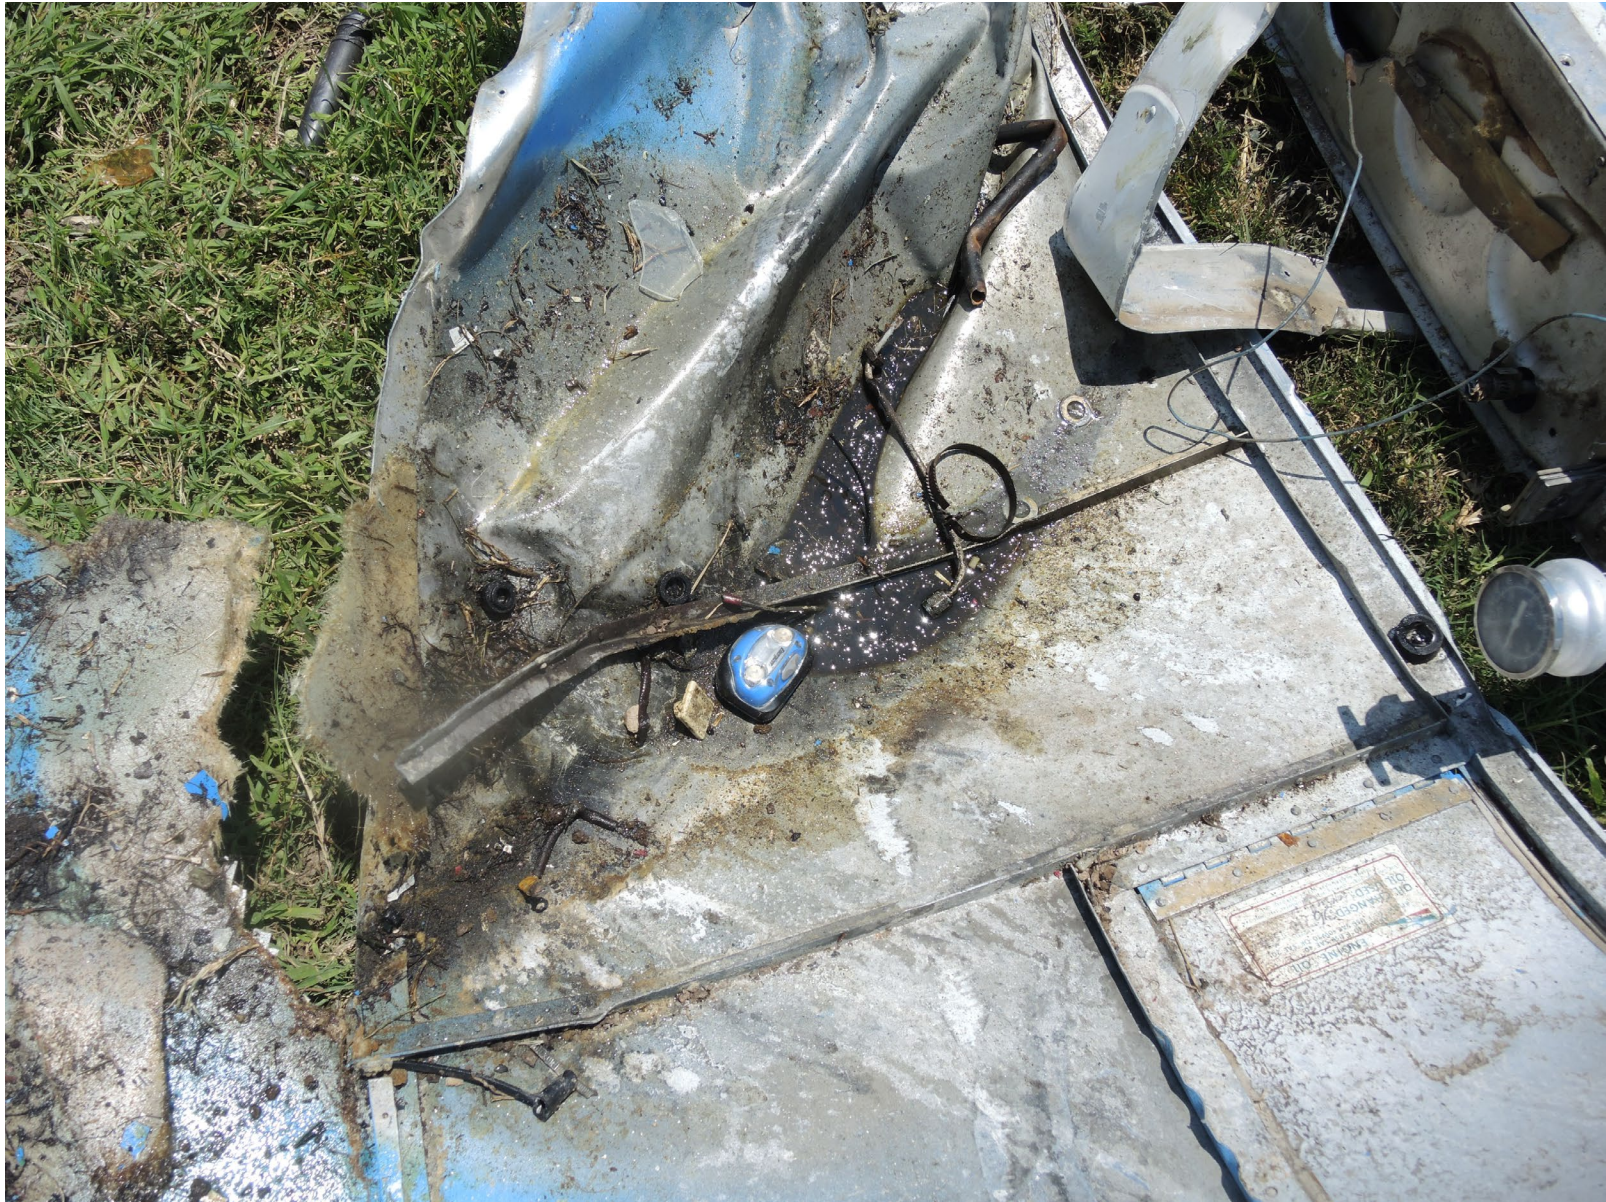
**Photograph 20 - Headlamp in wreckage**

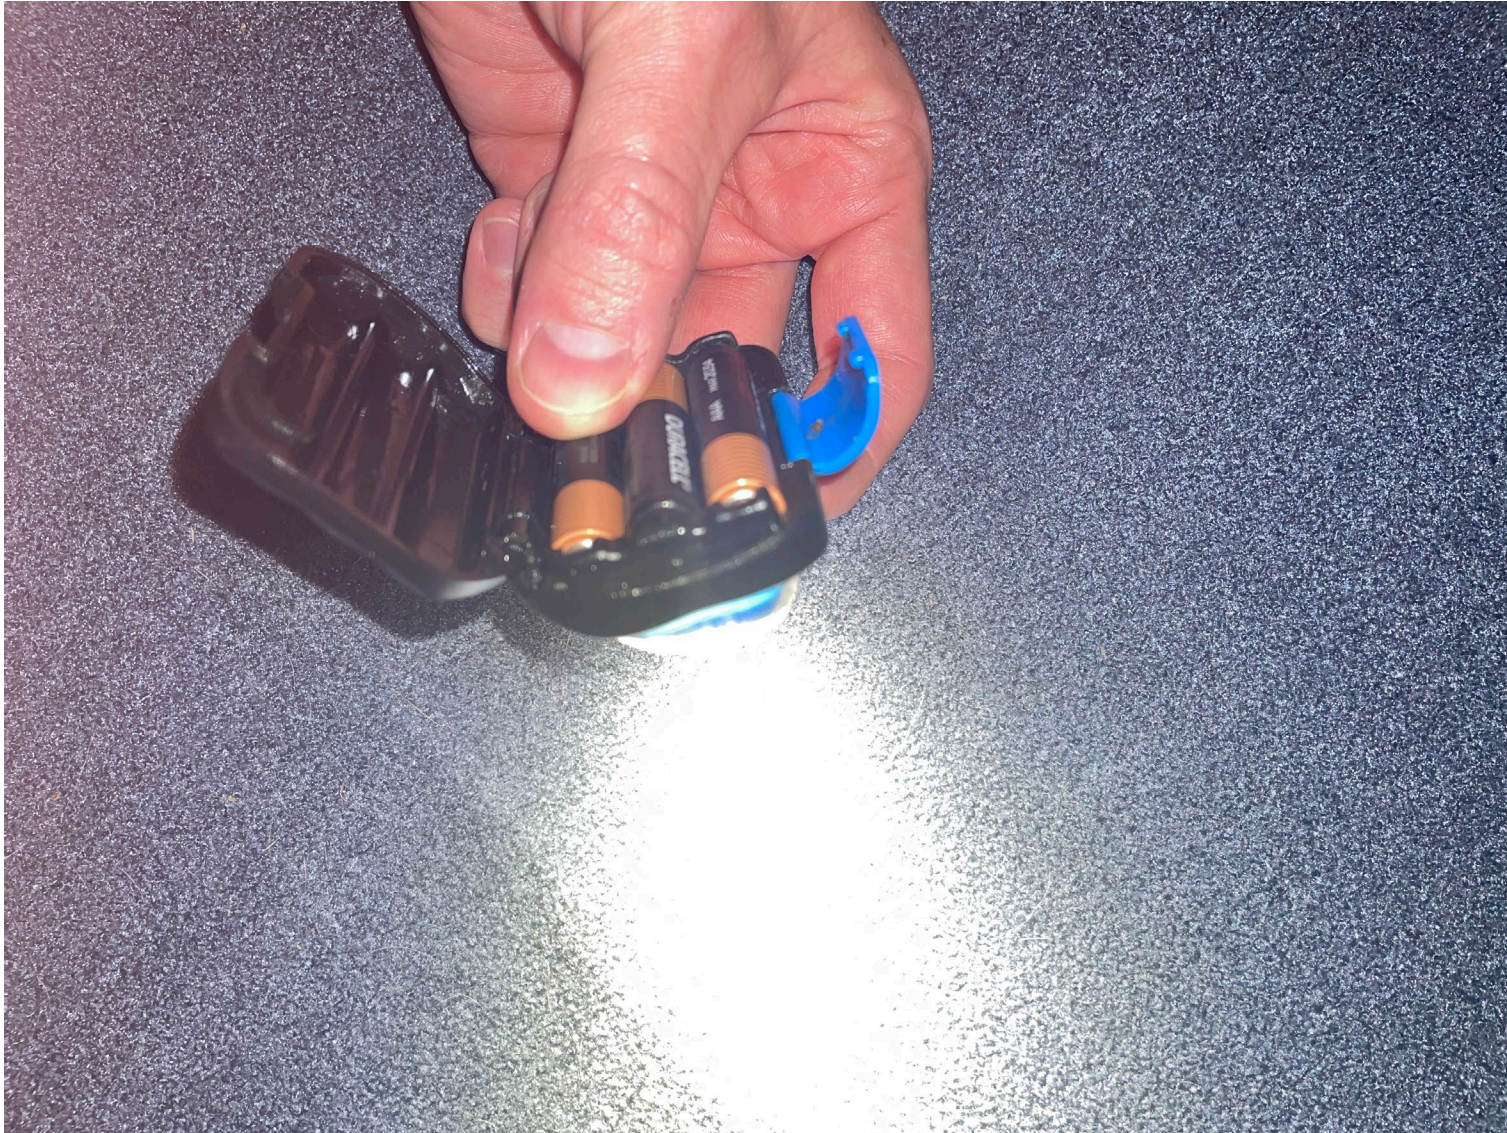
**Photograph 21 - Headlamp light on**
