# National Transportation Safety Board

CEN23FA315

## INVESTIGATION SUMMARY

Location: Houston, Texas  
Date: July 22, 2023  
Time: 2224 central daylight time (CDT)  
0324 coordinated universal time (UTC)  
Airplane: N17043, Cessna 150L

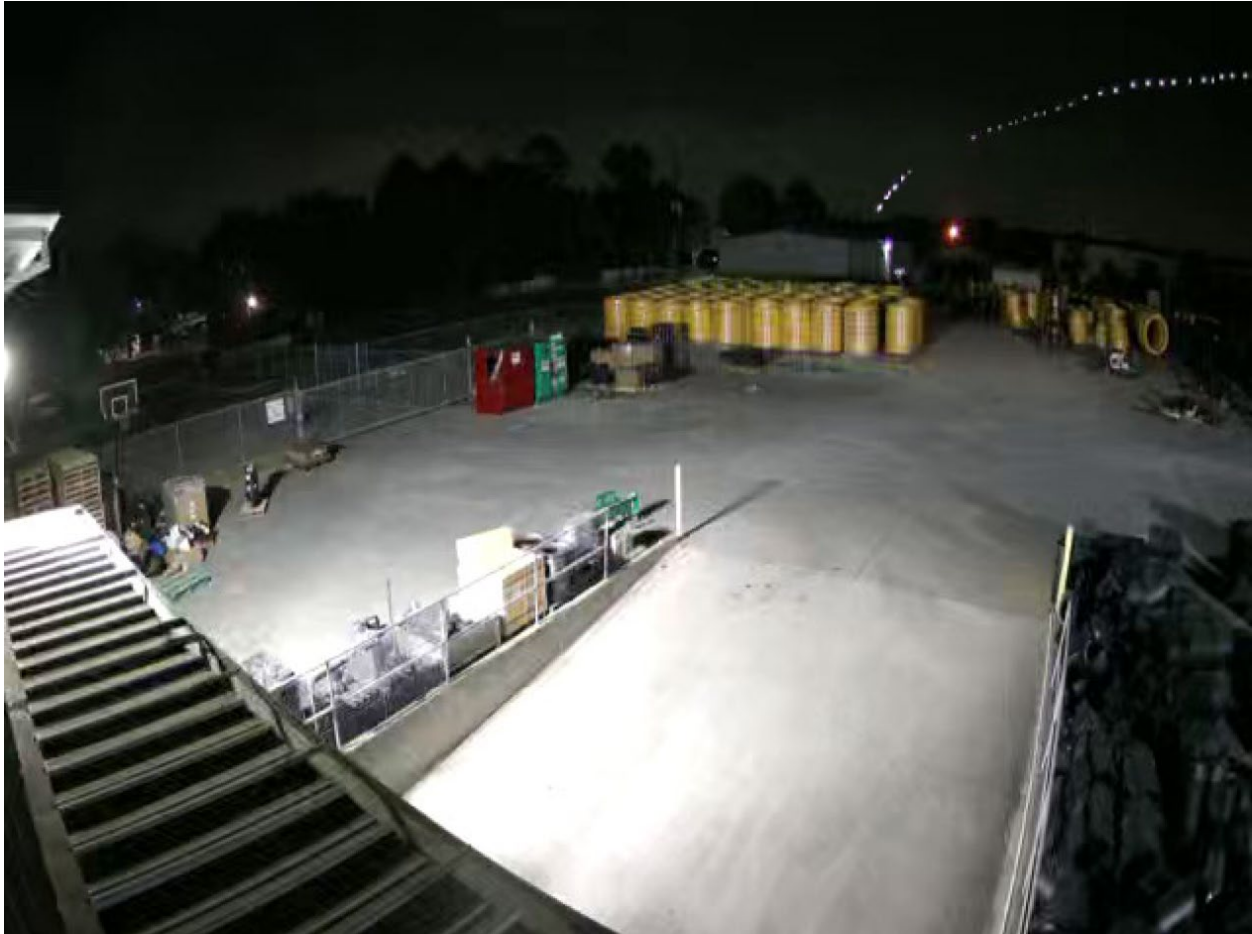
A local business surveillance video showed the airplane flying north, in seemingly level flight, with a lot of lightning flashes in the background. The airplane then quickly descended toward the ground and impacted power lines, which produced a large flash and sparks. The airplane's white landing light was visible during the level flight and descent, but it was briefly not visible for less than 1 second, then it was visible again right before the impact with power lines (Figure 1).

Figure 1. Composite image from surveillance video showing the flight path.

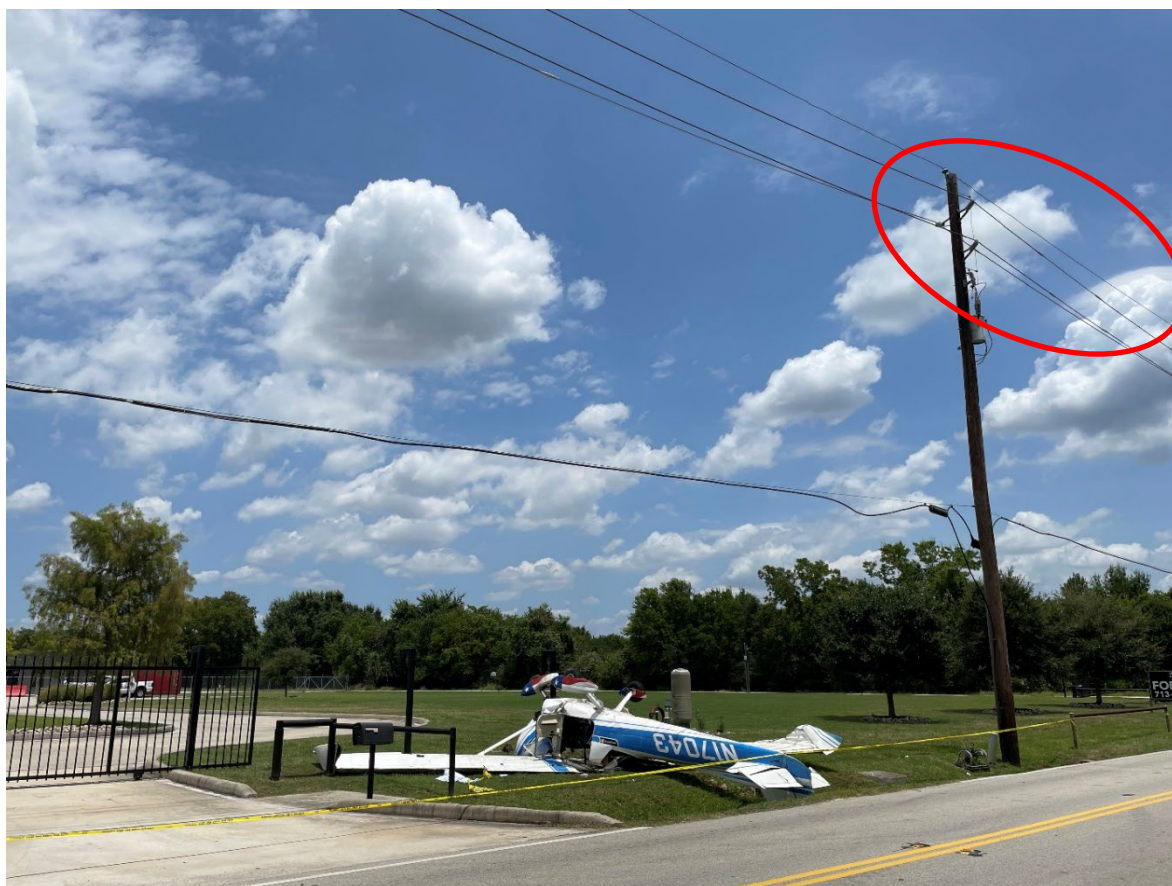
The airplane was located in a grassy drainage ditch, next to a road, and underneath powerlines. The powerlines were downed and one way laying on top of the airplane. The airplane came to rest inverted and oriented about 330° magnetic. The power lines circled in red in Figure 3 are the approximate location of the collision. This photo shows the powerlines after they had been repaired and restrung.

Figure 3. Image of the accident site.

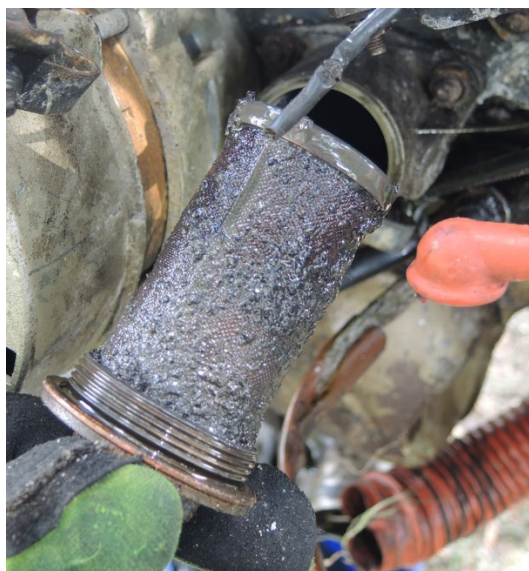
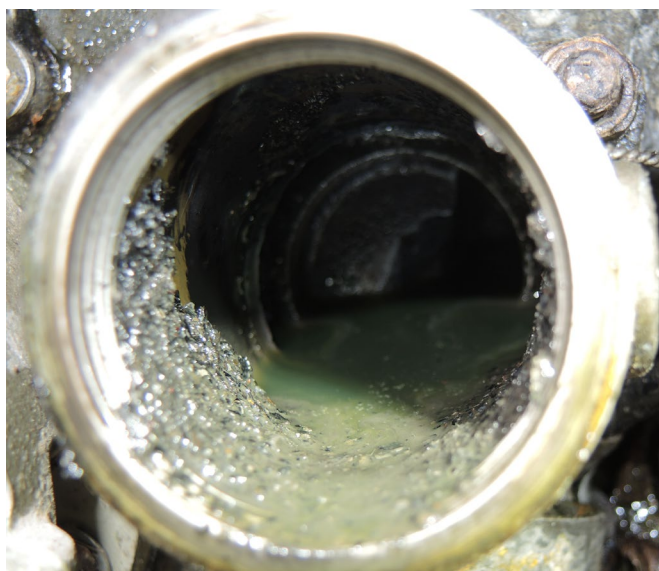
The oil screen was examined and found to have approximately 1 oz. of sludge and carbon fragments surrounding the screen. According to airworthiness records, an STC approved TAF-L spin-on oil filter adapter was installed in 1993. Per the instructions, the oil screen is to be removed from the oil system as part of the adapter installation. The spin on oil filter was cut open and examined. No visible contaminants were observed. The oil that drained from the engine, and in the filter appeared clean like oil that had been recently replaced.

Figures 4/5. Oil screen sludge and debris.
