# National Transportation Safety Board

CEN23FA340

## **AIRWORTHINESS**

Specialist's Factual Report

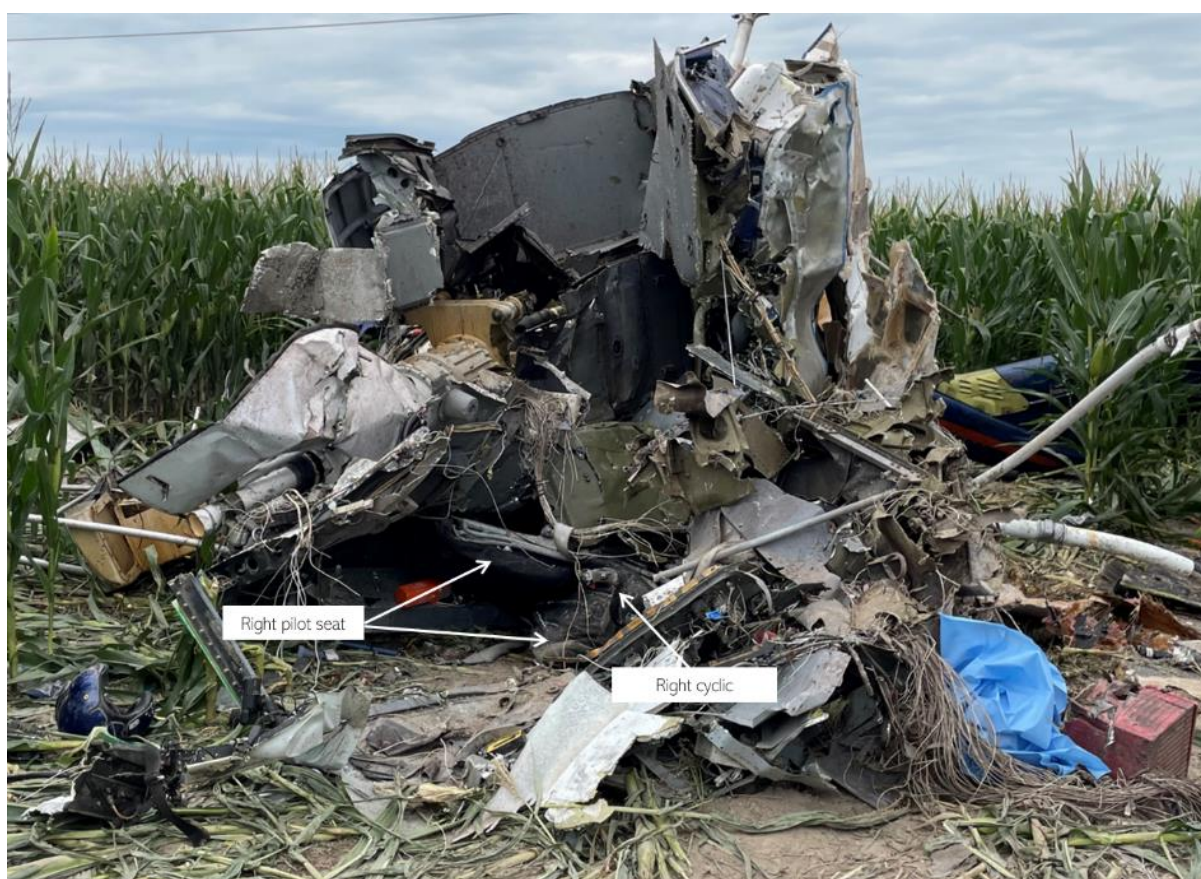
On scene photos of the cockpit show the right pilot seat, characterized by black seat covers, was intermingled with the right cyclic stick, which was still aligned with its associated gimbal assembly, positioned beneath the cockpit floor (Figure 3). The left cockpit seat did not appear to be in the immediate vicinity of the cockpit and the left cyclic stick was located some distance away from the main wreckage. During the wreckage layout, the left seat was located and both seats were set side by side for comparison. The left seat had a sheep skin cover over the cushions and some areas of red stains were observed on the sheep skin cover (Figure 4).

**Figure 3.** Wreckage view of the cockpit area with the right pilot seat and right cyclic stick identified.

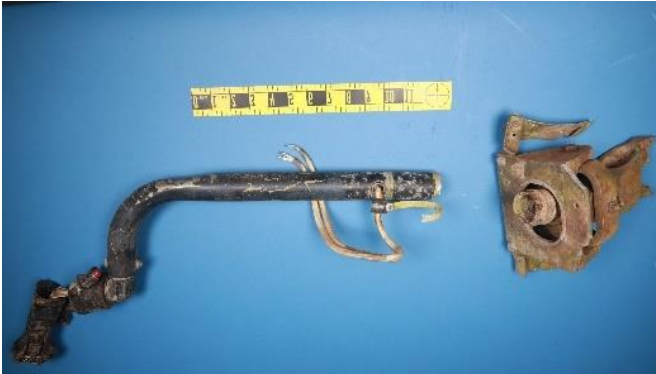
The left and right cyclic controls (Figures 5 and 6) and their respective bases were received by the NTSB Materials Laboratory as shown. Both control sticks were fractured at the lower end just above the gimbal assembly with fracture surfaces on slant angles consistent with ductile overstress fracture. The forward side of the right control stick wall and aft side of the left control stick wall were flattened consistent with heavy contact with the respective sides of the control stick openings in the upper base plates for the gimbals. At the lower end of the gimbal assemblies, the forward lug at the lower end of the right control and both lugs at the lower end of the left control were fractured, and a heavy impact mark was observed on the forward side of the right control gimbal above the fractured lug. The gimbal lower lug fractures on both controls had uniform rough matte gray features consistent with overstress fracture. The floor structure around the base on each control was fractured and crushed, and fractures were on slant angles consistent with overstress fracture. On the left control, the right forward and right aft corners of the upper base plate for the gimbal were fractured, and visible fracture features had rough features consistent with ductile overstress fracture. The handle for the left control was substantially damaged and was fractured where it intersected the upper end of the control stick tube section. The handle fracture had relatively large mirror zones that transitioned to river markings and hackle features consistent with overstress fracture. No

indications of a progressive fracture mechanism or other preexisting damage were observed.

**Figure 5.** Left cyclic stick.

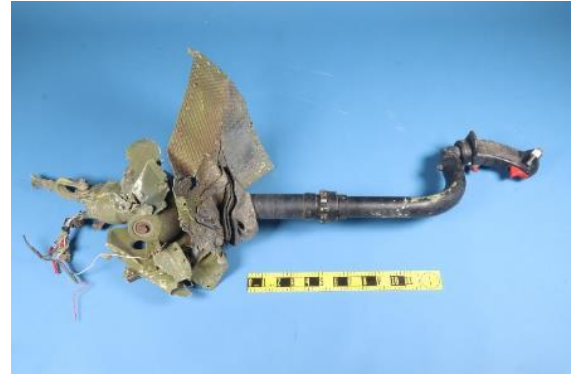
**Figure 6.** Right cyclic stick.

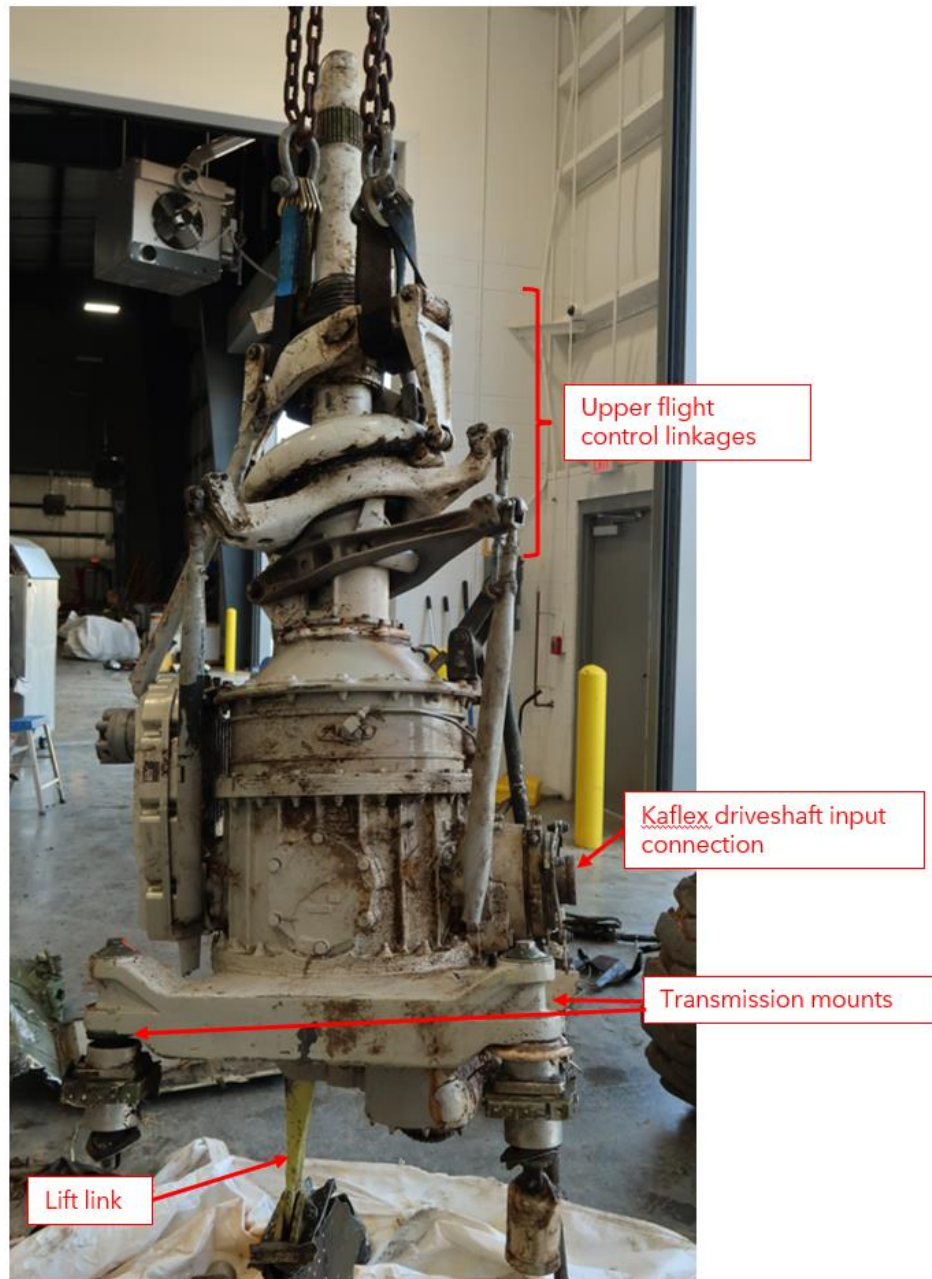
**Figure 7.** Transmission with rotor mast, collective lever, and swashplate assemblies attached.

The helicopter main transmission gear box (Figure 7) had separated from the fuselage by fracturing the lift beam, pulled the isolation mounts off the pylon structure, and the 5<sup>th</sup> mount beam had fractured in half at the 5<sup>th</sup> mount. The isolation mounts exhibited features of over travel and bent flanges, and the attached pylon structure had jagged edges and rivets sheared flush, all characteristics consistent with overload. The lift link remained attached to the lower portion of the transmission gear box and a jagged fragment of the fuselage lift beam was attached to the opposite end. The lower sump, with the tail rotor drive quill still attached, had separated from

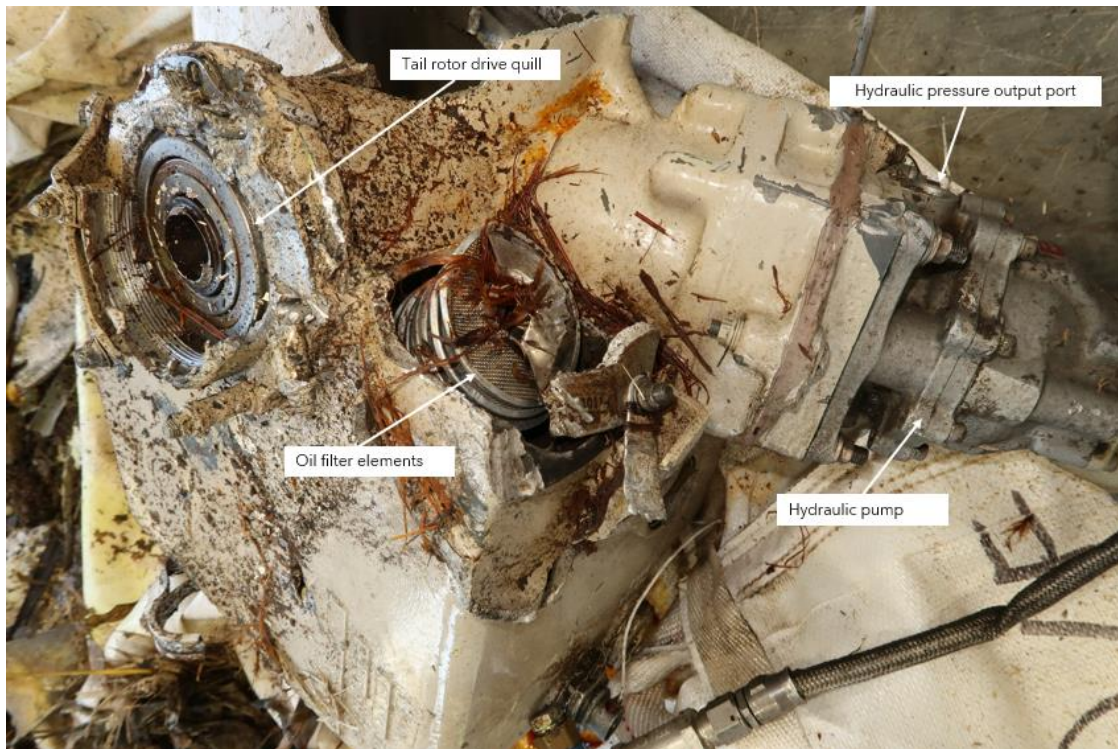
the upper main transmission gearbox. Impact damage fractured the lower transmission case surrounding the oil filter (Figure 8). The interior of the main transmission gearbox was visually examined through the hole in the bottom of the case. The portion of the bull gear teeth that could be seen were undamaged and no metal chips or debris was observed within the case.

**Figure 8.** Transmission sump had separated from the bottom of the main gear box. Evidence of impact damage to the oil filter housing, hydraulic pump output port, and tail rotor drive quill.

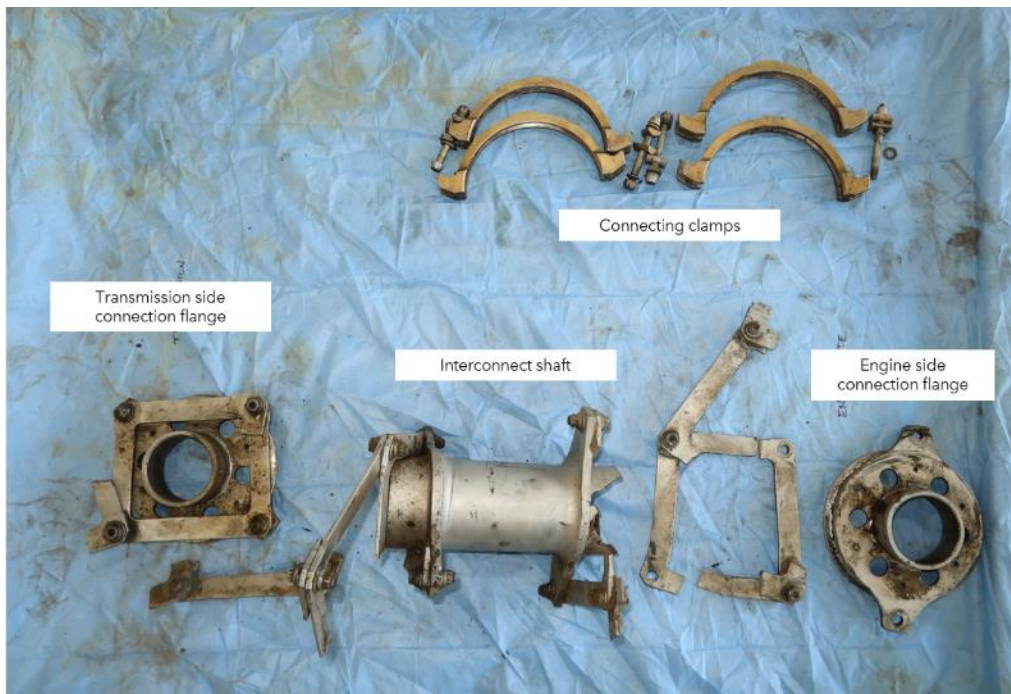
**Figure 10.** KAFlex drive shaft.

The KAFlex inner-connect drive shaft had flex frames attached at both ends and fragments of all frames were accounted for (Figure 10). All 10 bolt connections were identified on the engine side, and 8 bolt connections were identified on the transmission side. There were external rub marks on the engine side of the flange plate cup. The inner-connect had inward deformations the width of a flex frame segment. Both end flange cup portions of each end of the KAFlex retained their round characteristics.

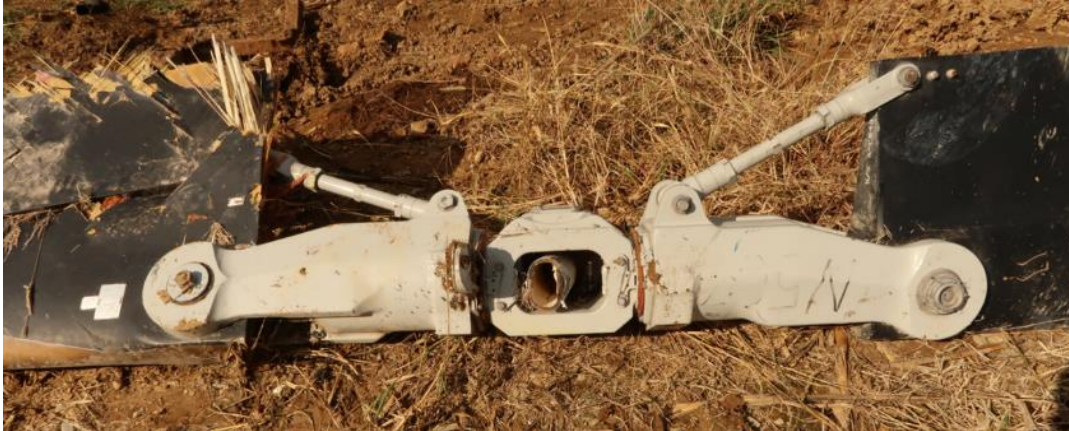
The main rotor head remained intact but had separated from the mast and the fracture surface was consistent with torsion overload. The mast end fracture was oval in shape and exhibited features consistent with torsional shear (Figure 11). The pitch horns on each blade had pulled out of their base. The stabilizer bar had separated from the rotor head, but all control links were attached at their fittings (Figure 11). The pitch links and pitch horns were attached to the stabilizer bar assembly. Both viscous dampers had separated from the rotor mast.

**Figure 11.** Rotor head had separated from the mast. Centered in the rotor head is a portion of the mast that had deformed into an oval shape.

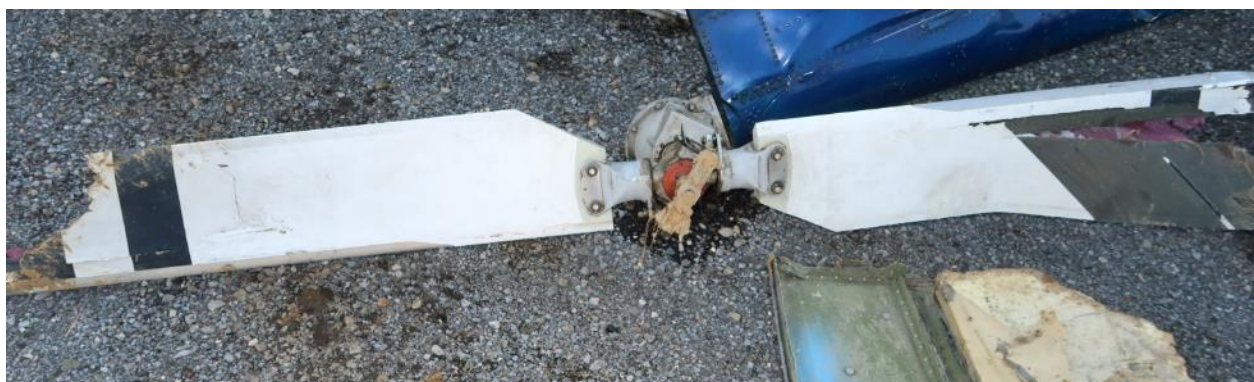
The tail rotor was intact and remained attached to the 90° trail rotor gearbox (Figure 11). The rotor rotated freely in conjunction with rotation of the tail rotor drive shaft. Both tail rotor blades were attached to the rotor head and pitch change beam. Both blades exhibited blade tip damage and skin delamination.

**Figure 13.** Tail rotor hub and blades.

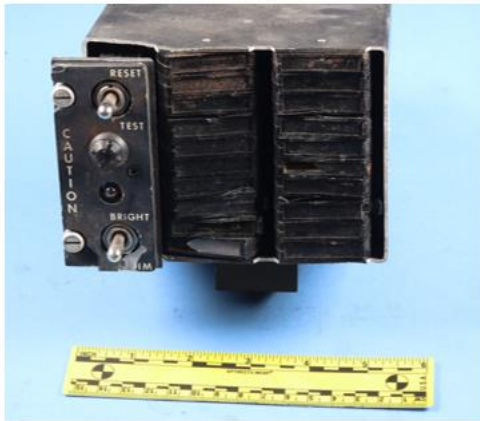
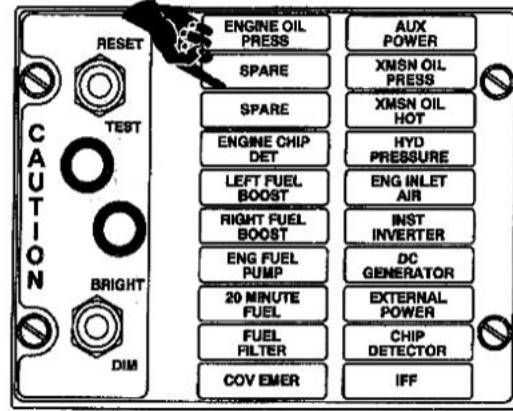
**CAUTION PANEL**

The caution (annunciator) panel from the accident aircraft was submitted to the Materials Laboratory for examination. The annunciator panel consisted of twenty annunciator lights, two columns with ten lights in each column (Figure 14). Each annunciator light contained two incandescent bulbs. The annunciator panel was partially disassembled to allow for visualization of the individual bulbs within the annunciator lights. The annunciator lights were radiographed to determine the filament status of each of the bulbs within the individual annunciator lights (Attachment 2). The layout of the panel with the filament status for each light is depicted in Table 2. The layout of the panel came from the operations manual and was visually verified by the NTSB laboratory. One annunciator labeled GOV EMER according to the manual drawing for the panel was marked as UNKNOWN due to a missing cover on the annunciator. Four annunciator lights ENGINE OIL PRESS, XMSN [transmission] OIL PRESS, HYD PRESSURE and DC GENERATOR, exhibited hot filament stretching in both light bulb filaments. No hot filament stretching was found in any other light bulb filaments in the accident panel.

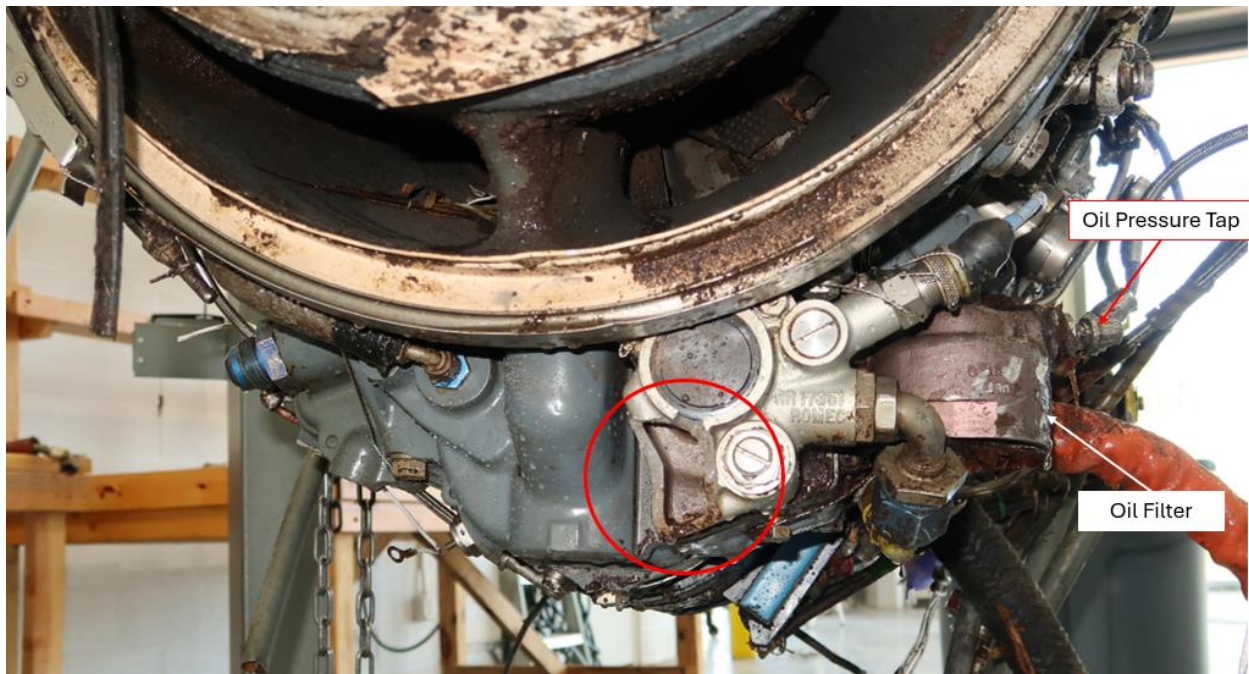
**Figure 17.** View of the lower front of the engine. Damage to the oil pump circled in red.

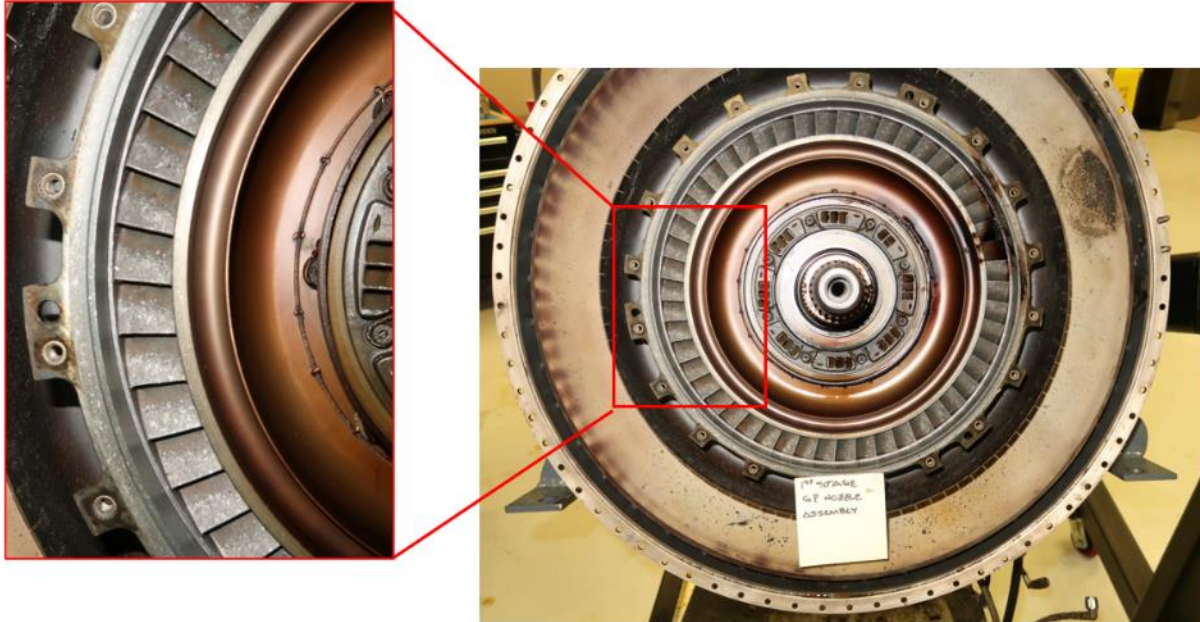
The engine was mounted on an adjustable engine stand (Figure 19). The combustor turbine section was removed. Metal spray was observed on the 2<sup>nd</sup> stage gas producer (GP) rotor assembly and turbine nozzle. Metal and organic debris was found in the 1<sup>st</sup> GP nozzle curl. The debris was probed with a magnet and ferrous material was collected. When the engine was rotated via the engine stand, the GP turbine freed up and could be rotated by hand. The accessory gearbox was removed from the engine case. Drive continuity was confirmed between the compressor drive gear to the accessory gearbox. The accessory gearbox input shaft was turned by hand with some stiffness. The engine oil pump was removed, and external impact damage was observed. The oil pump input drive shaft was very stiff to operate by hand. Once the oil pump was removed, the accessory gearbox gears rotated freely with no binding. All accessory gearbox drive pads (fuel control, start generator, tach generator) had drive continuity. The compressor/GP section rotated freely by hand.

**Figure 19.** 1<sup>st</sup> stage gas producer nozzles exhibiting metal spray collected on the nozzle surfaces.

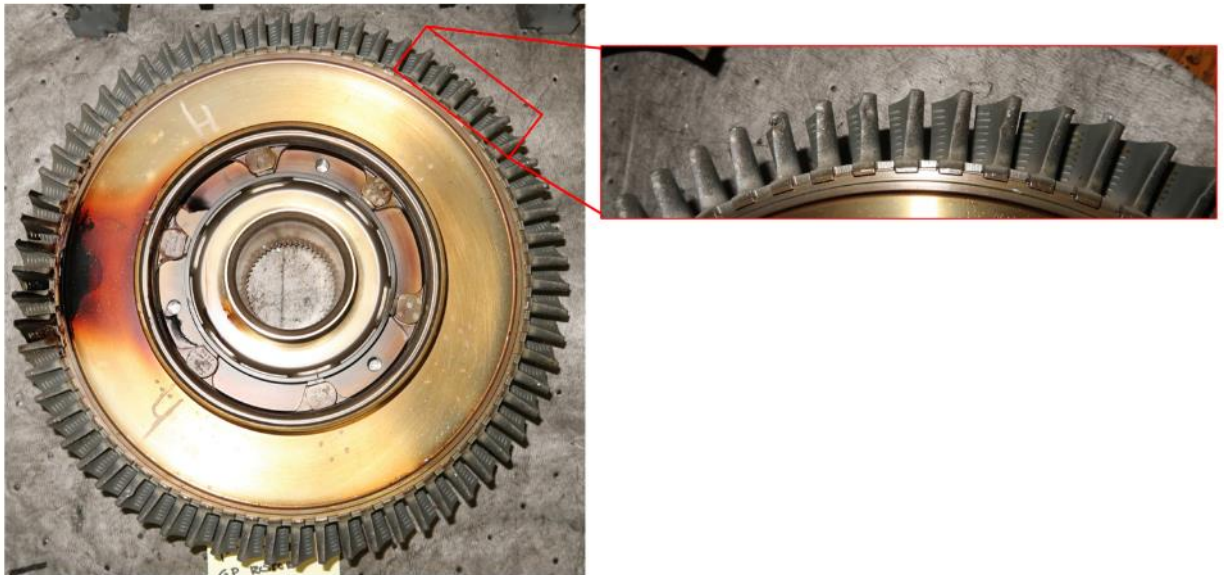
The compressor housing and impeller housing halves were removed, and the compressor stators and all blade stages of the compressor rotor were exposed. There was leading edge tip damage and trailing edge damage observed on most stator nozzles and rotor blades. The impeller had light FOD damage to the leading edges. There was a light impeller rub mark identified on the impeller housing. Light weight debris of a metallic and organic nature was observed between the compressor stages. The 2<sup>nd</sup> stage GP rotor assembly was removed and no FOD damage was observed; however, metal spray was observed on the rotor disk blades leading edge and convex (suction) surfaces. The 2<sup>nd</sup> stage GP nozzle assembly was removed and no FOD damage was evident; however, metal spray was observed on the trailing edge convex surface. One 2<sup>nd</sup> stage nozzle airfoil had been blended. The 1<sup>st</sup> stage GP rotor assembly was removed. No noticeable FOD damage was observed to the leading edge of the nozzle vanes. Extensive metal spray on the back/concave side of the nozzle vanes was observed (Figure 20). Numerous 1<sup>st</sup> stage GP blades had leading edge FOD damage (Figure 21) and the blade concave trailing edges exhibited metal spray. The air deflector was undamaged. The power turbine section rotated freely, no

**Figure 20.** 1<sup>st</sup> stage gas producer rotor exhibiting FOD.
