# National Transportation Safety Board

CEN23FA352

## **MATERIALS LABORATORY**

Factual Report 24-014

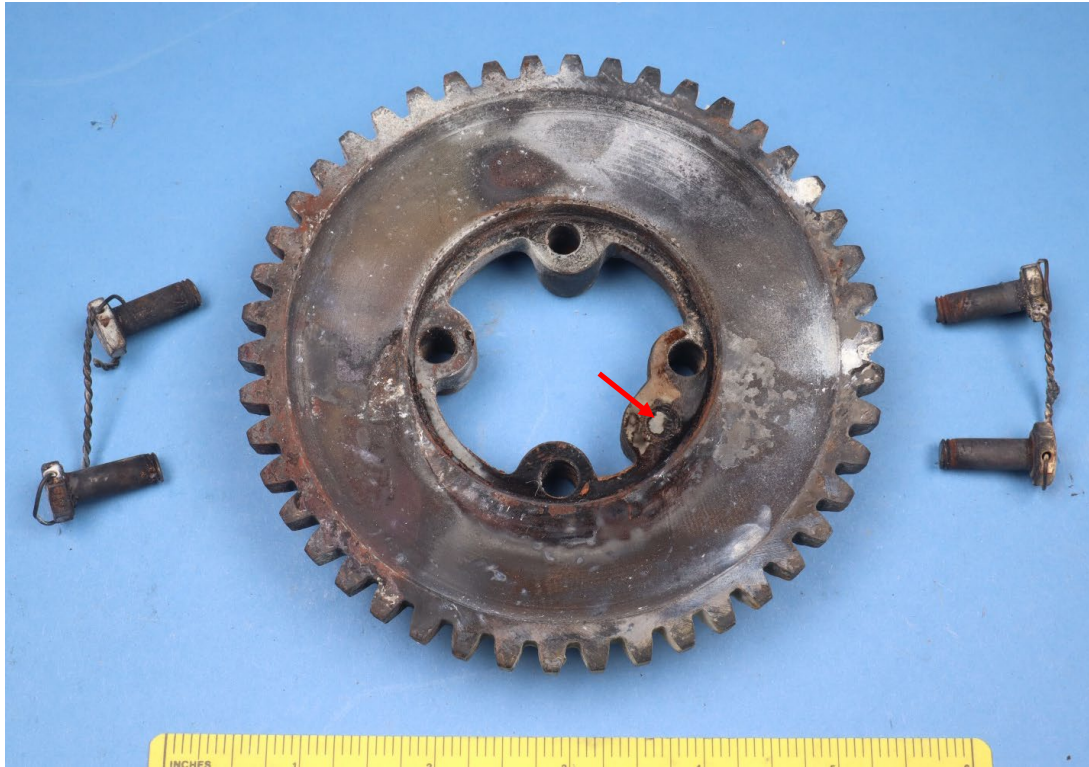
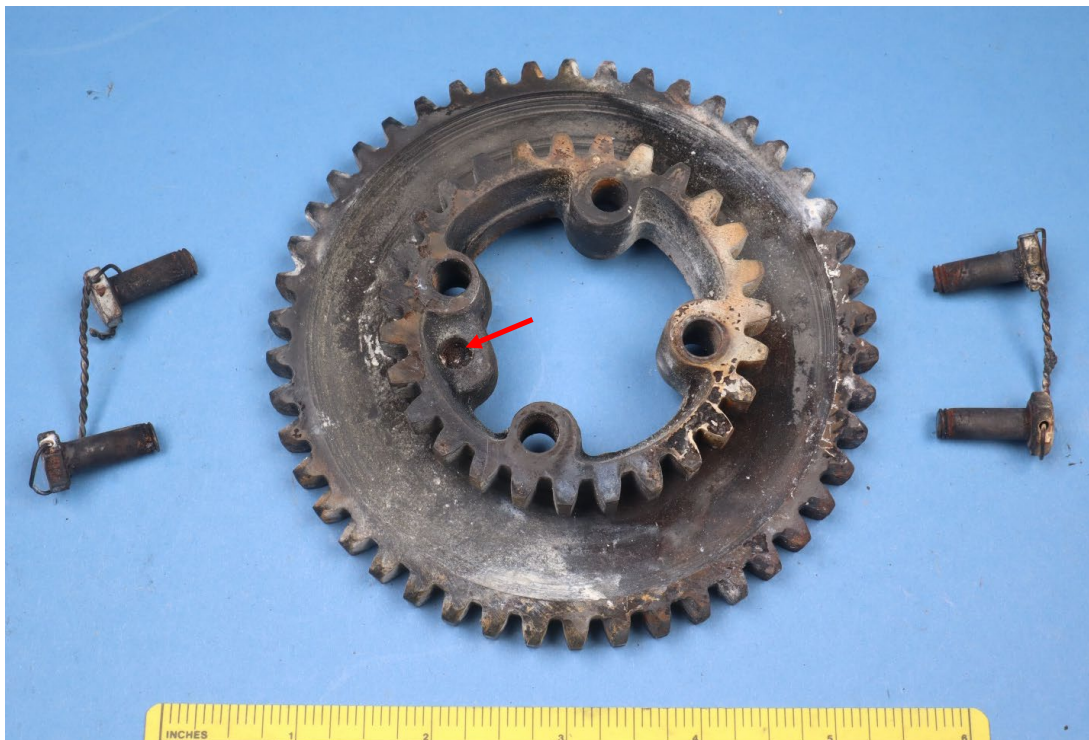
The dowel pin was still assembled inside the crankshaft gear, as indicated by the red arrows in Figure 1. Figure 2 shows a close-up of the fracture surface on the dowel pin. Macro features on the fracture surface were consistent with shear overstress. The dowel pin sheared from circumferential motion of the gear, indicated by the black dotted line. White arrows point to circumferential scrape marks on the surface of the gear surrounding the dowel pin.

**Figure 1.** Macro photos of the submitted crankshaft gear and attachment bolts. The red arrows points to the dowel pin still assembled inside the gear.

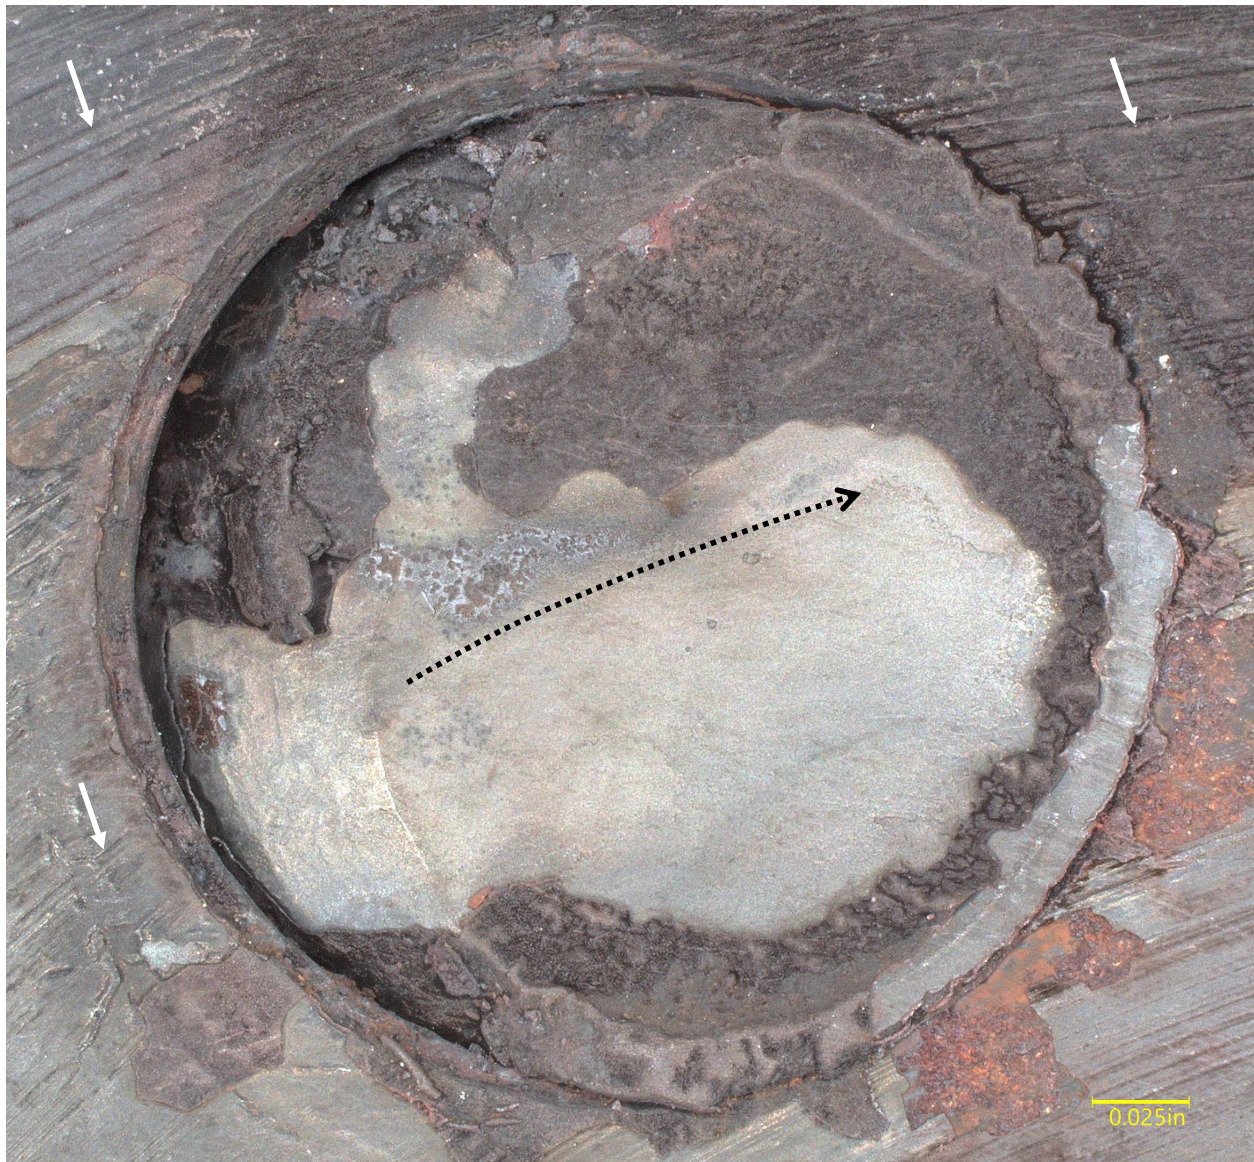
**Figure 2.** Close-up photo of the fracture surface on the dowel pin. The black dotted arrow indicates the direction of shear the fractured the dowel pin. The white arrows point to circumferential scrape marks on the surface of the gear surrounding the dowel pin.

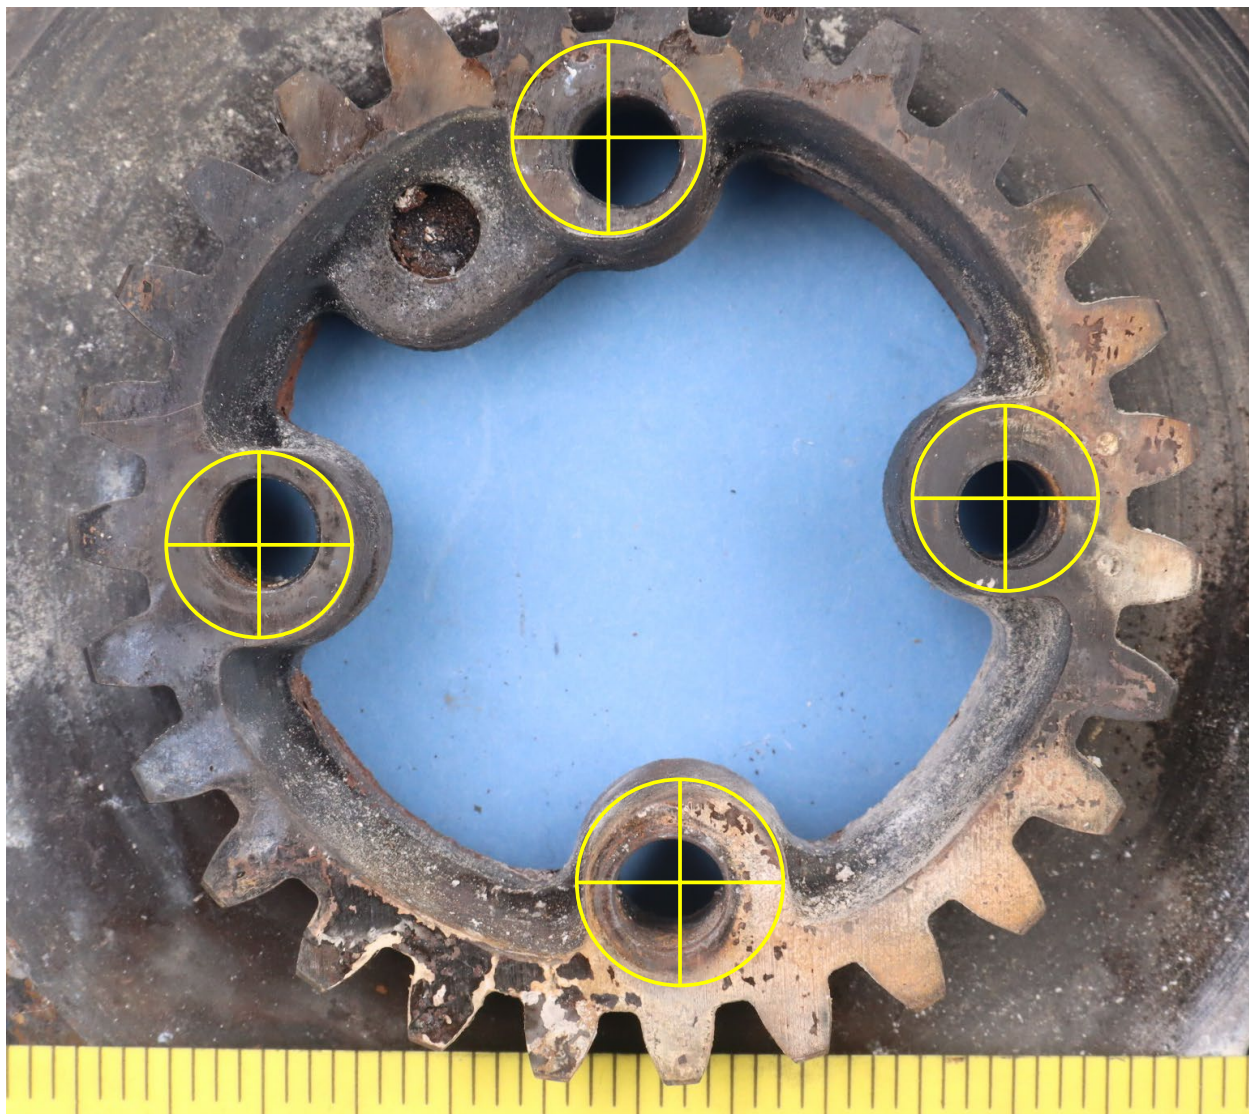
The through holes in the crankshaft gear to which the attaching bolts mated appeared off-center within their respective flanges, as illustrated by the yellow crosshairs in Figure 3. Raised material was observed on one side of each through hole, likely from contact with the mating attachment bolts. One corner was worn on the inboard side of each tooth on the larger diameter gear, as indicated by the black arrows in Figure 4.

**Figure 3.** Close-up photo showing the through holes in the crankshaft gear, with yellow crosshairs illustrating their positions relative to their respective flanges.

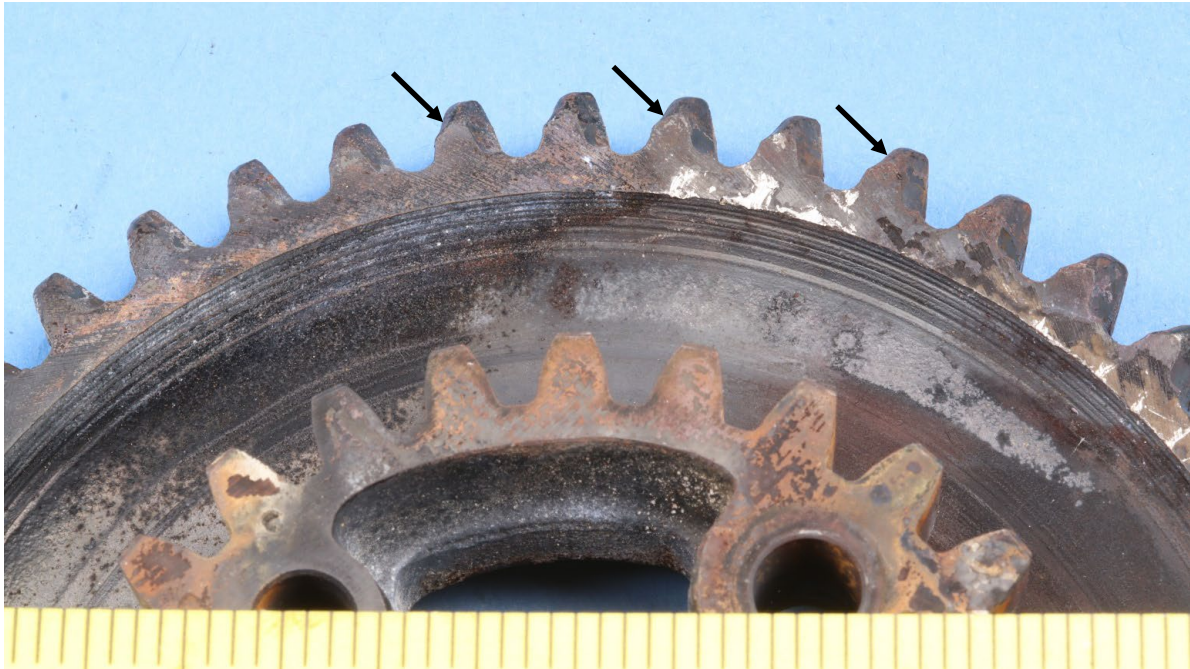
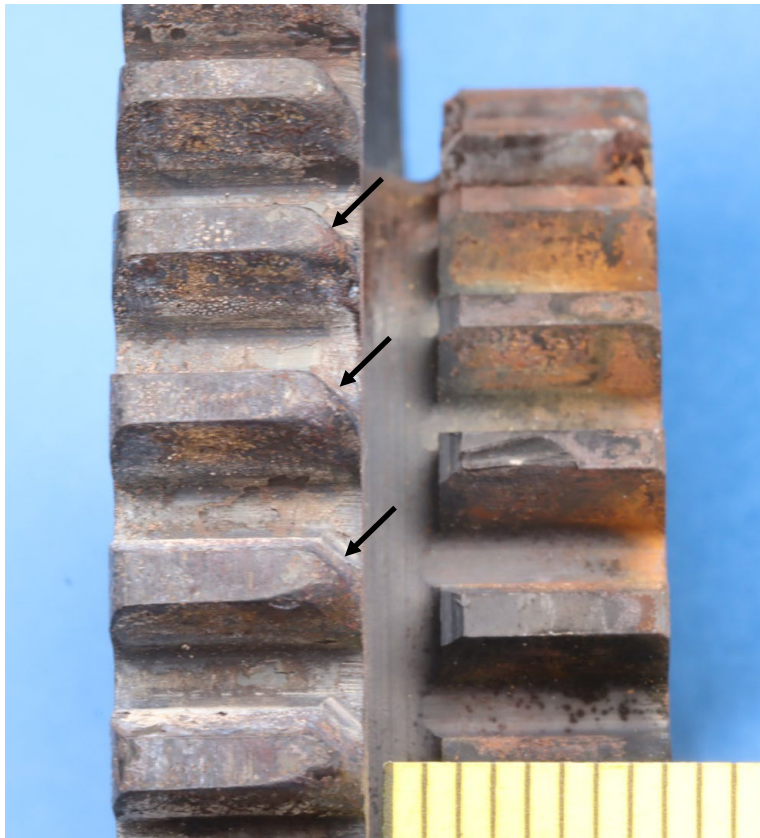
**Figure 4.** Close-up photos of the teeth on the crankshaft gear. The black arrows point to wear on one inboard corner of each tooth on the larger diameter gear.

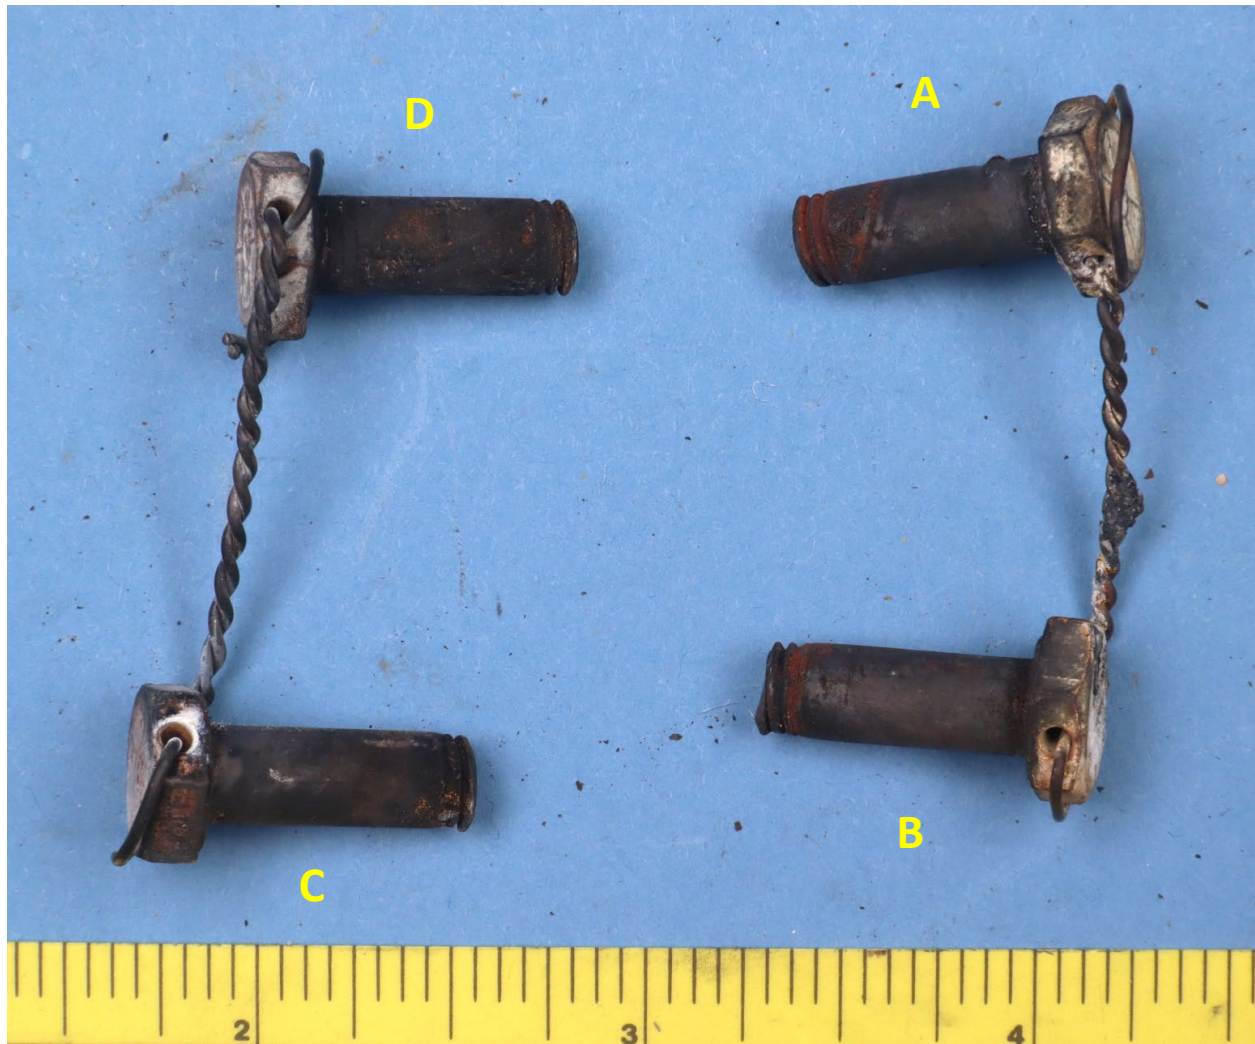
The four separated attachment bolts are shown in Figure 5. All the bolts separated in the threaded region, with three bolts separated at the third thread and one bolt separated at the second thread. Locking wire still connected the heads of the bolts into two pairs. The bolts were labeled A, B, C, and D in the lab for identifying purposes.

**Figure 5.** Macro photo of the fractured attachment bolts.

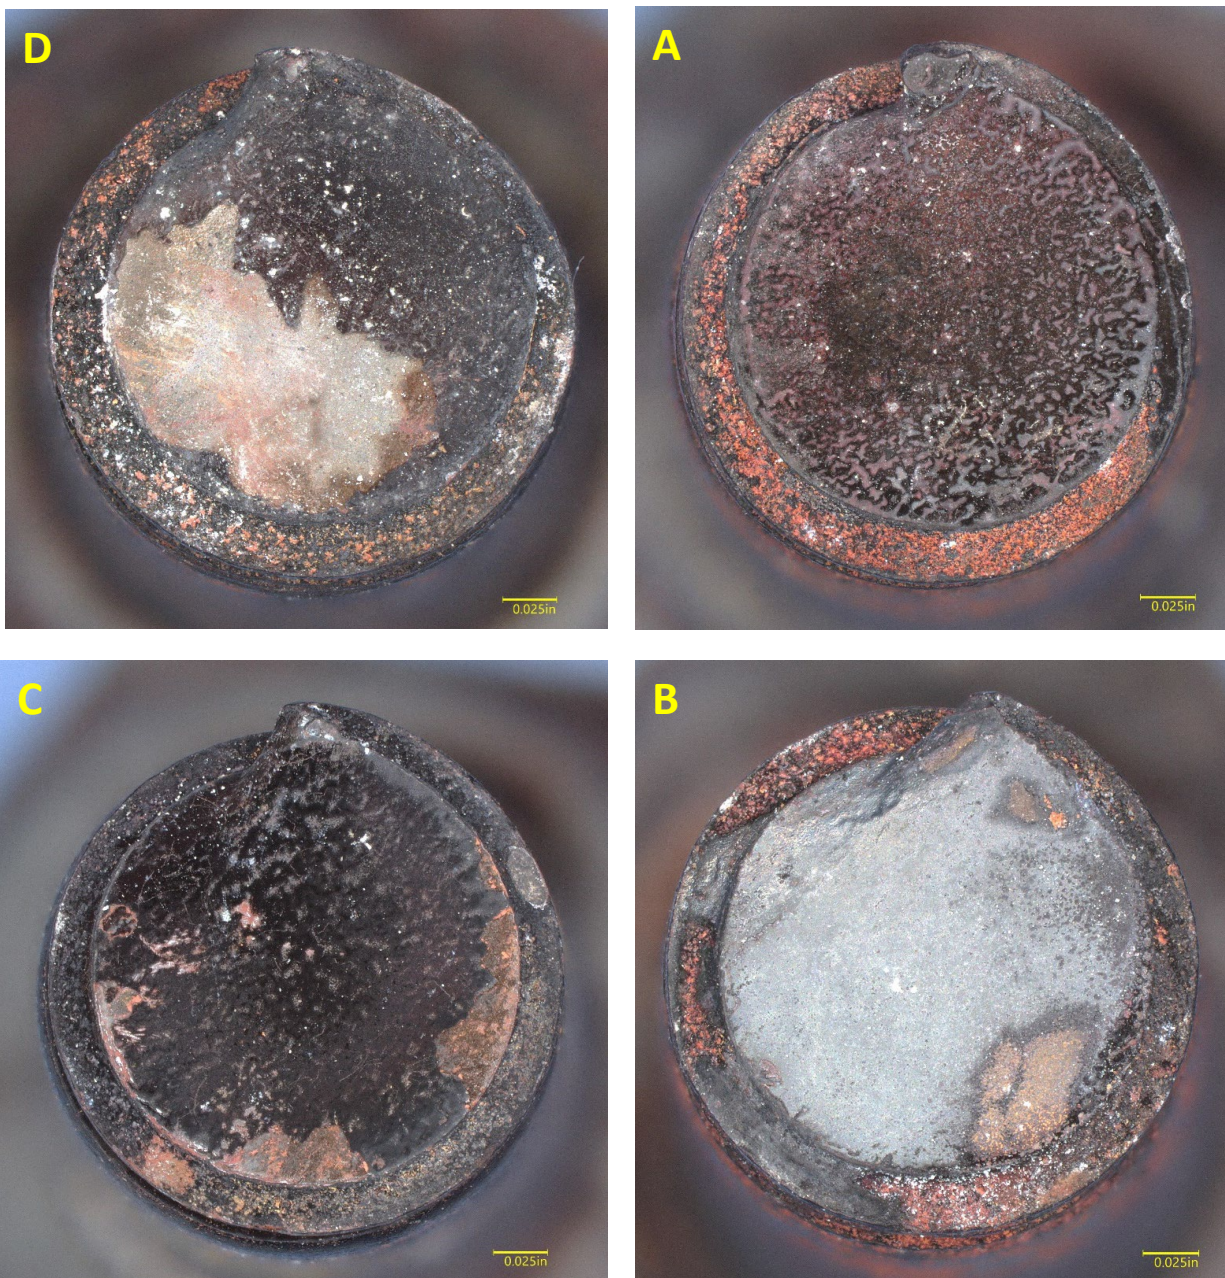
The fracture surfaces of the bolts in the as-received condition are shown in Figure 6. The fracture surfaces were relatively flat, with those on bolts A, C, and D were covered in thick black deposits consistent with burned oil and debris likely from the post-crash fire. Areas without black deposits had flattening from secondary contact after fracture.

**Figure 6.** Digital microscope images of the fracture surfaces on the attachment bolts in the as-received condition.

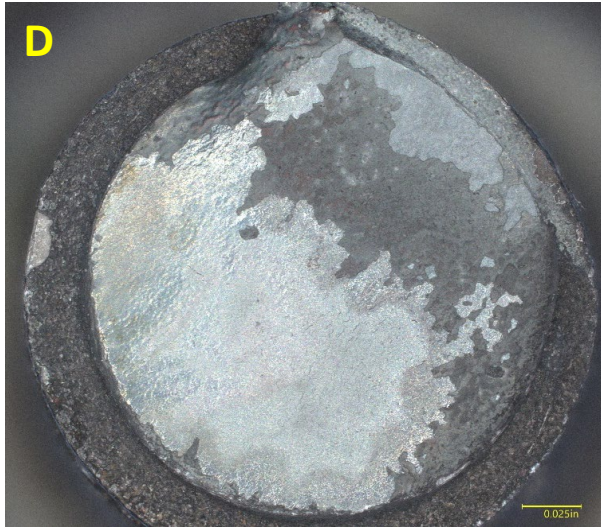
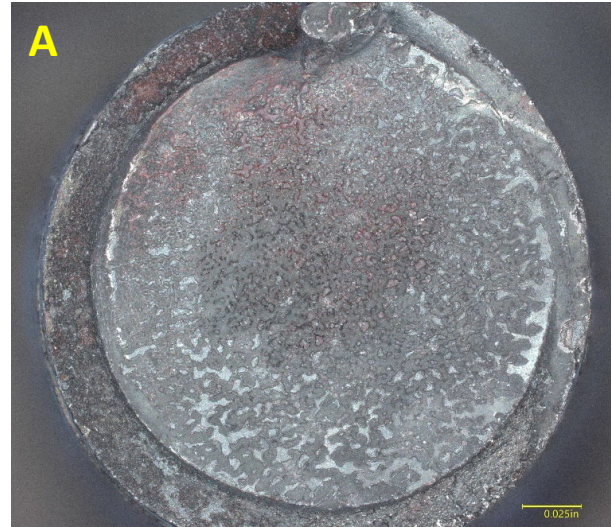
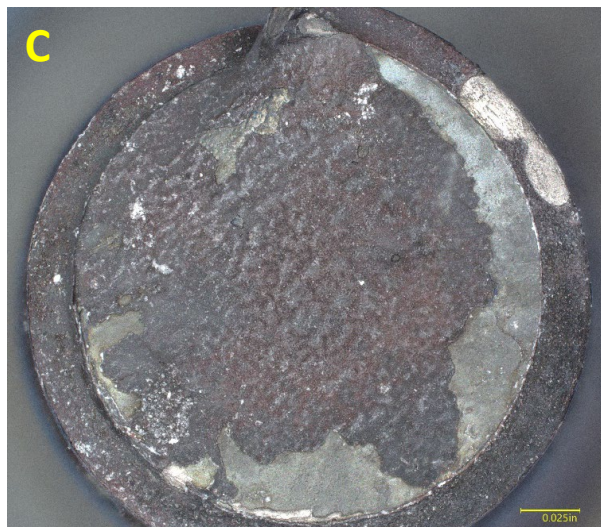
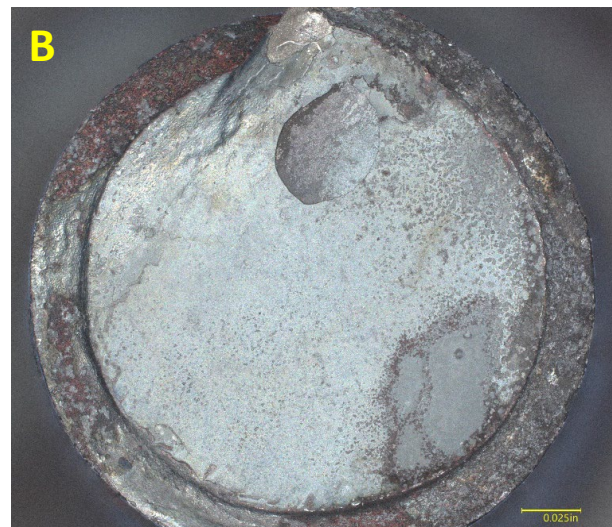
The locking wire was removed and the bolts were iteratively cleaned with mild detergent and a soft bristle brush, followed by an ultrasonic bath of isopropanol, and then soaked in Evapo-Rust® (CRC Industries, Horsham PA) heavy duty rust remover for several hours and rinsed with methanol. Large areas of the fracture surfaces were still covered in the black deposits even after extensive cleaning. The appearance of the fracture surfaces after cleaning are shown in Figure 7. The cleaned fracture surfaces were examined using a scanning electron microscope (SEM). Areas without the black deposits were covered in heavy oxidation products from the post-crash fire.

**Figure 7.** Digital microscope images of the fracture surfaces on the attachment bolts after cleaning.

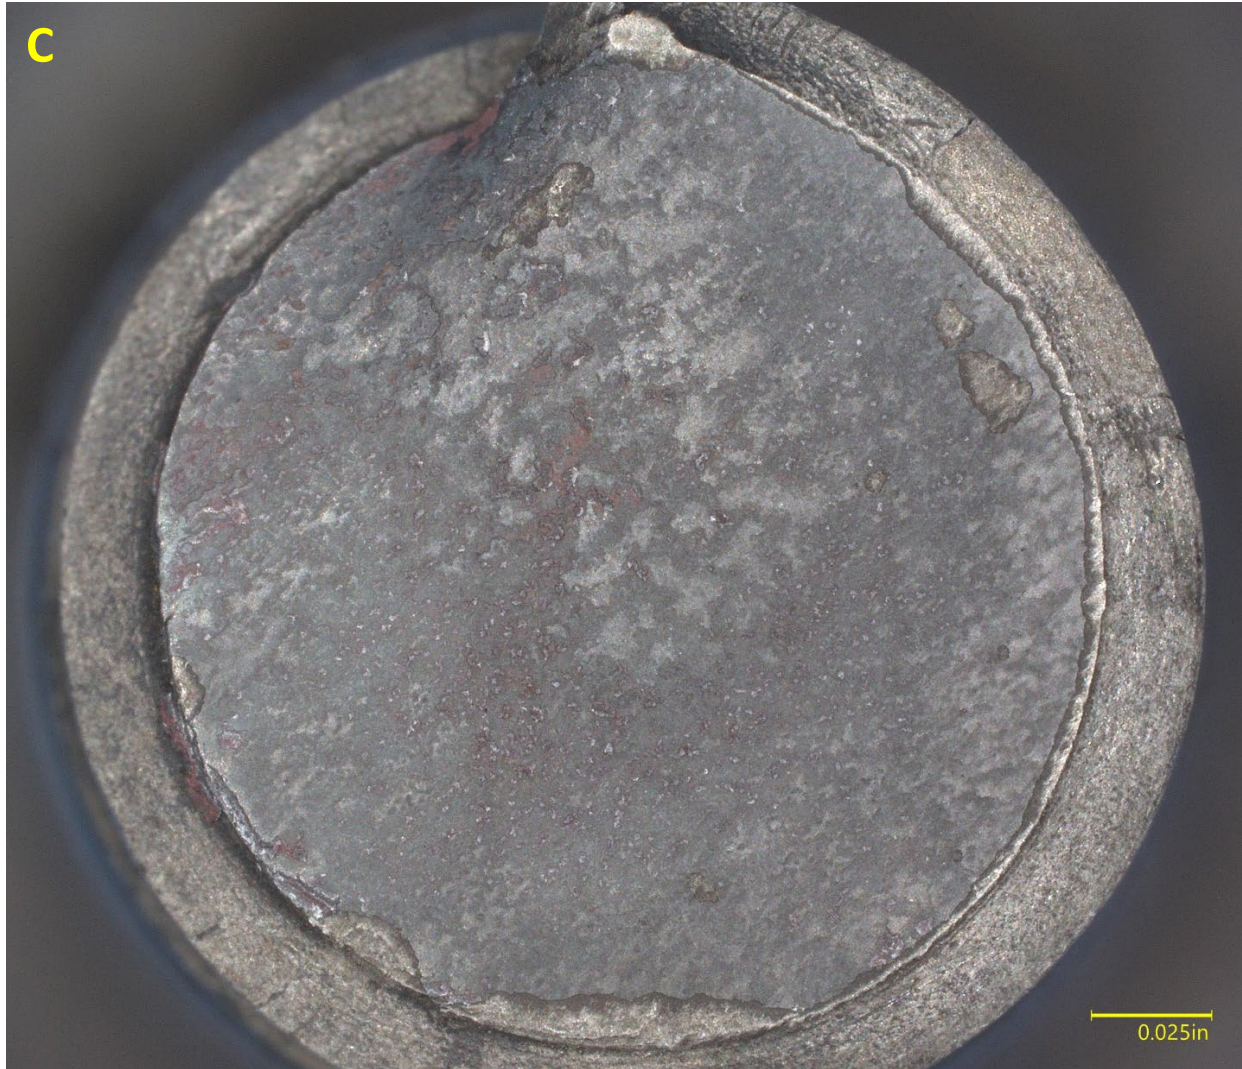
A more aggressive cleaning was attempted on bolt C, which was the bolt with the most promising areas of possible fracture features. Bolt C was soaked in Evapo-Rust® for 8 hours, with periodic removal for surface scrubbing with a soft bristle brush and methanol rinse. The appearance of the fracture surface on bolt C after the more aggressive cleaning is shown in Figure 8. Bolt C was again examined using a SEM, with resulting images shown in Figures 9 and 10. The areas free of black deposits remained heavily oxidized that completely obscured any finer features.

**Figure 8.** Digital microscope image of the fracture surface on attachment bolt C following additional cleaning.

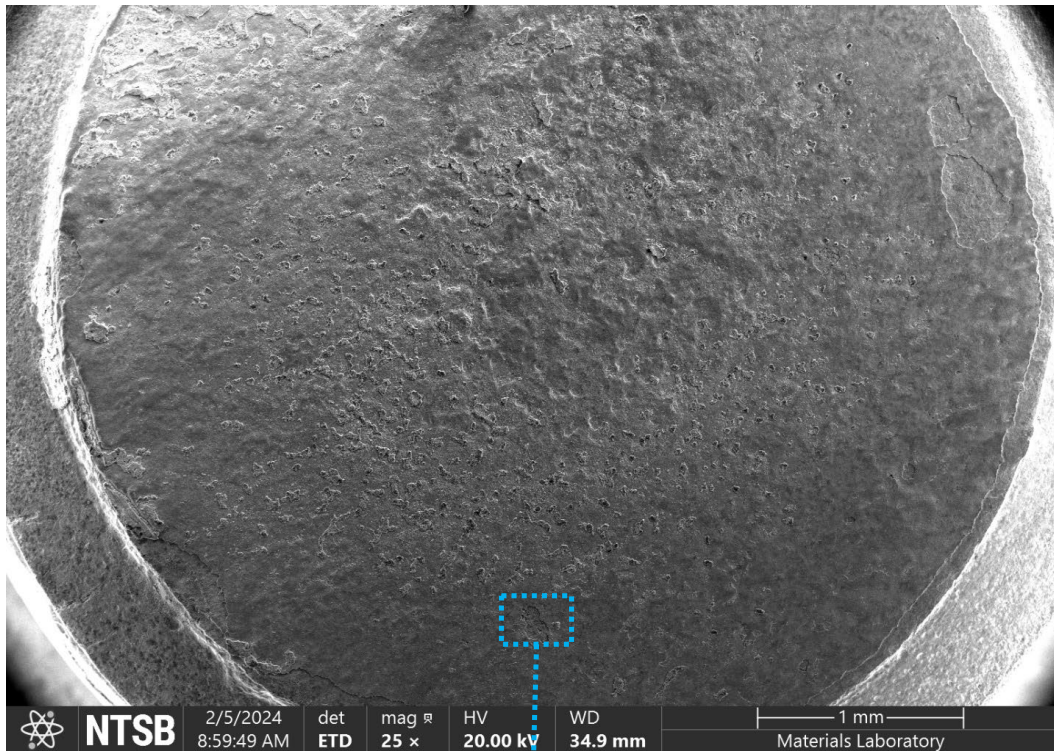
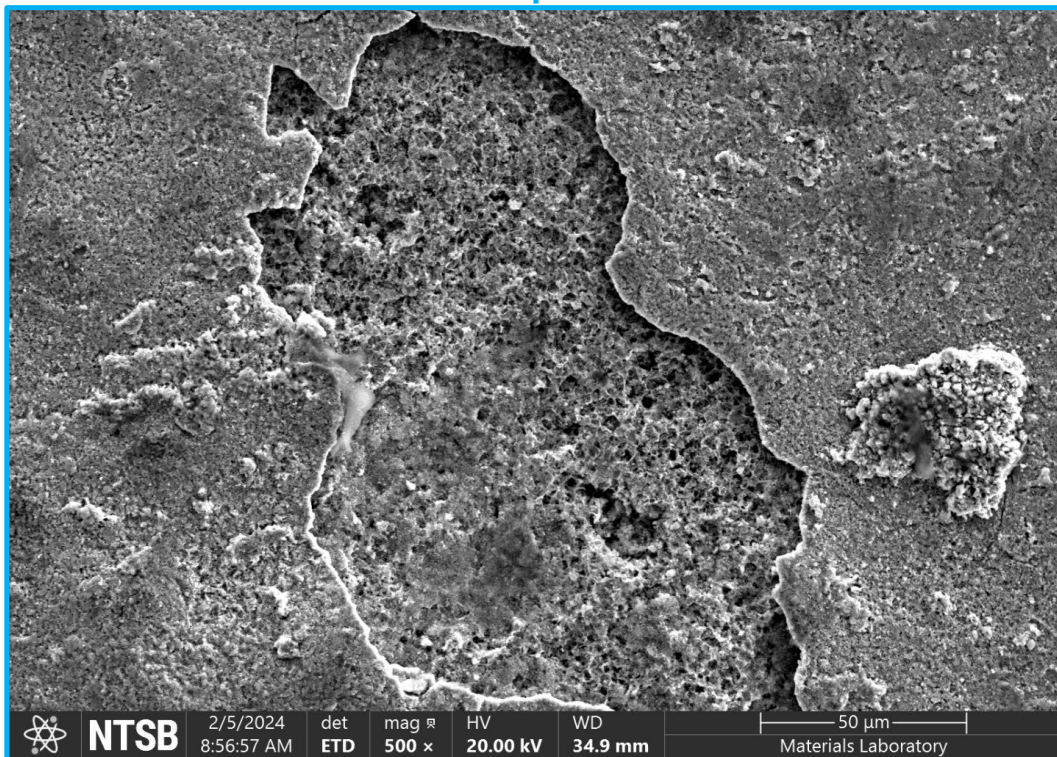
Consequently, the exact fracture mechanism of the bolts could not be determined.

**Figure 9.** SEM images of the fracture surface on attachment bolt C following additional cleaning.

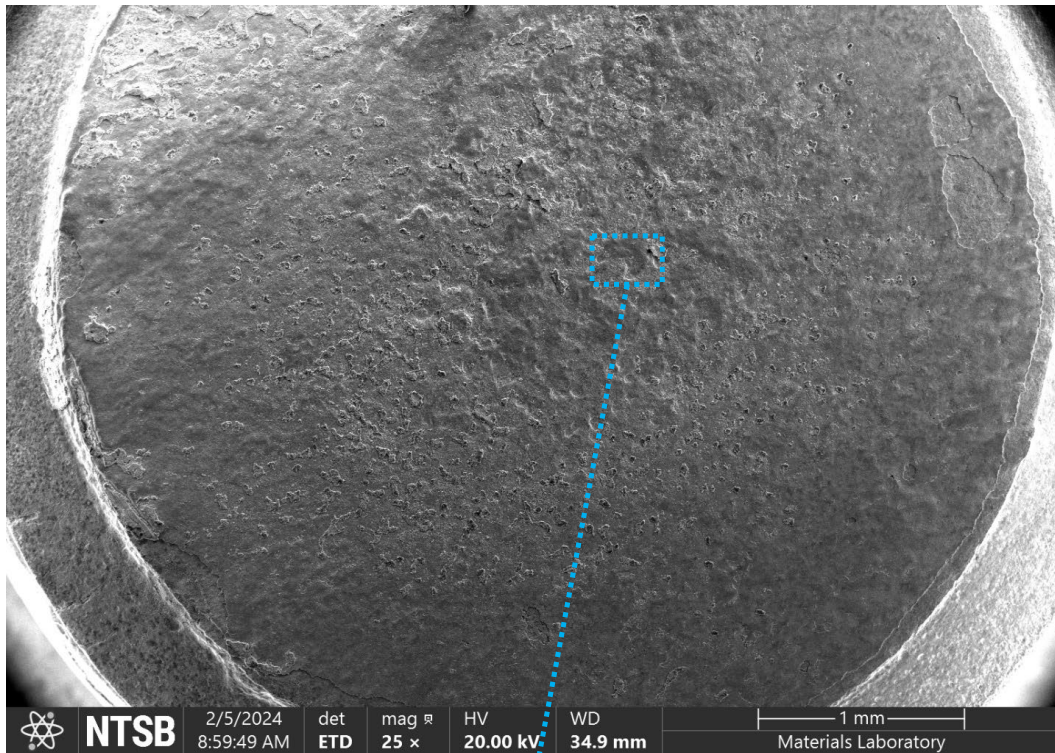
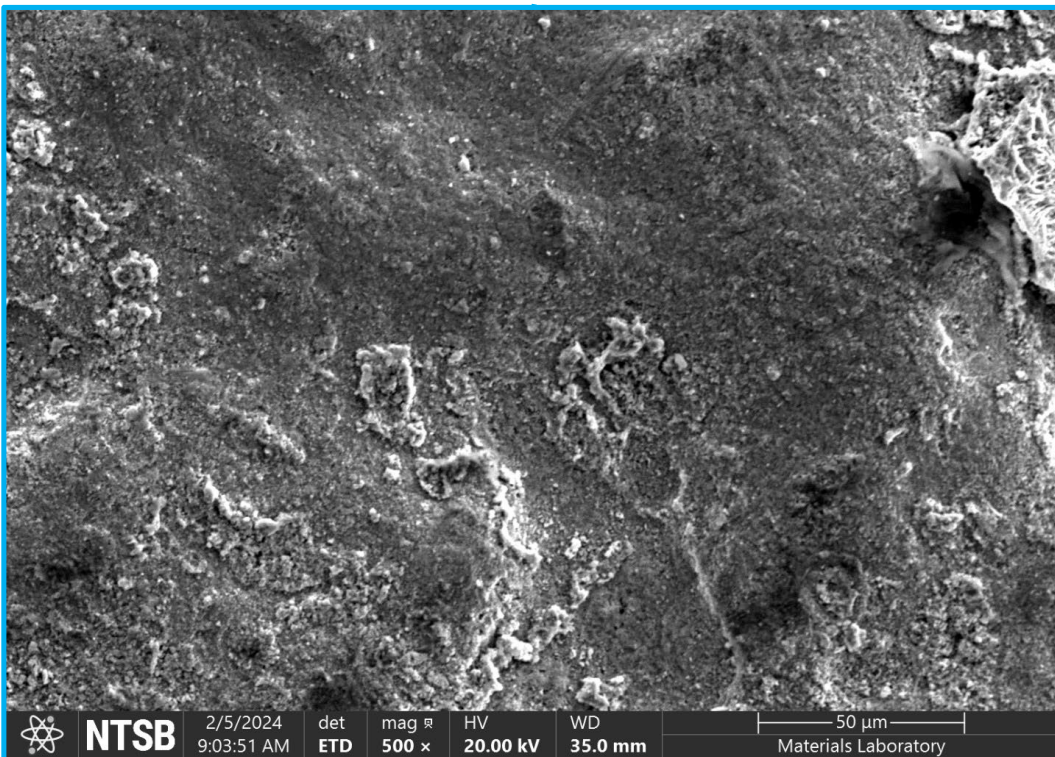
**Figure 10.** SEM images of the fracture surface on attachment bolt C following additional cleaning.
