CEN23FA352

## INVESTIGATION PHOTOGRAPHS

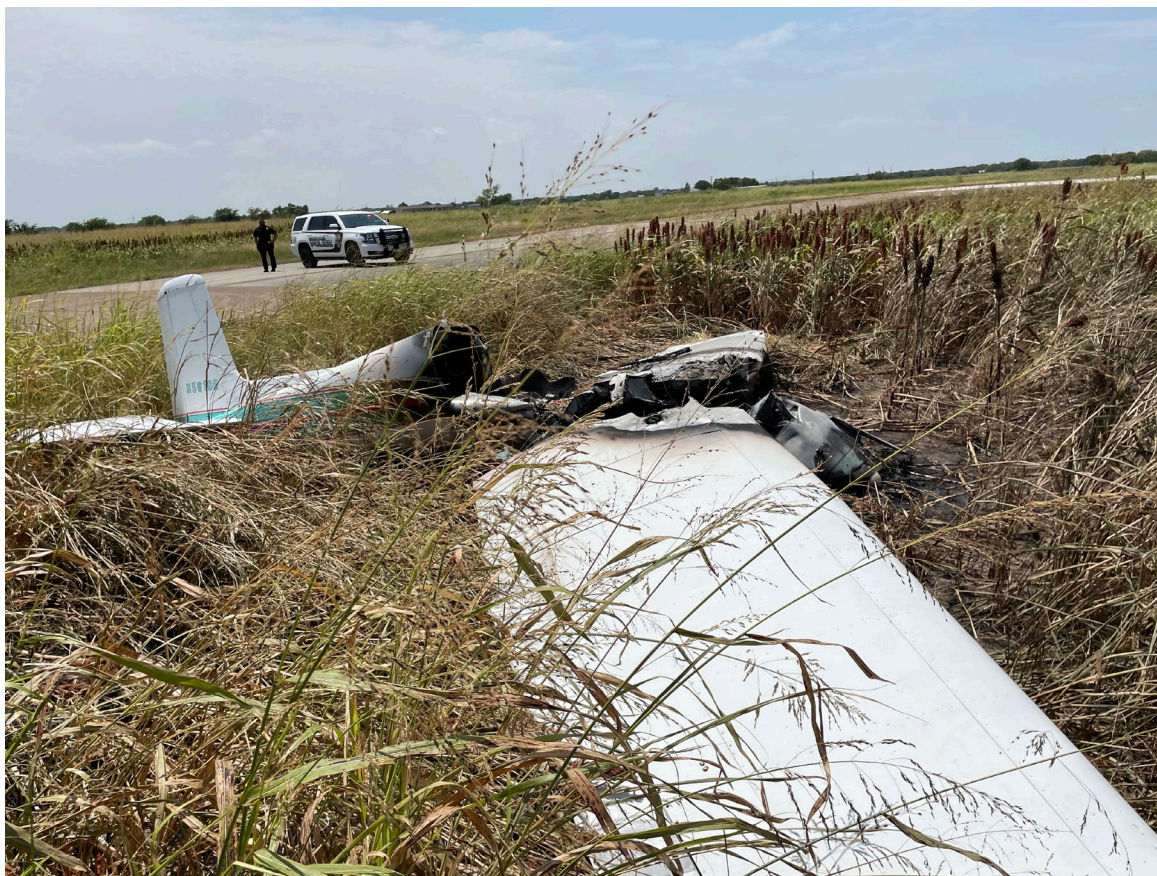
**Photograph 1 - Right side view of wreckage at accident site (NTSB Photo)**

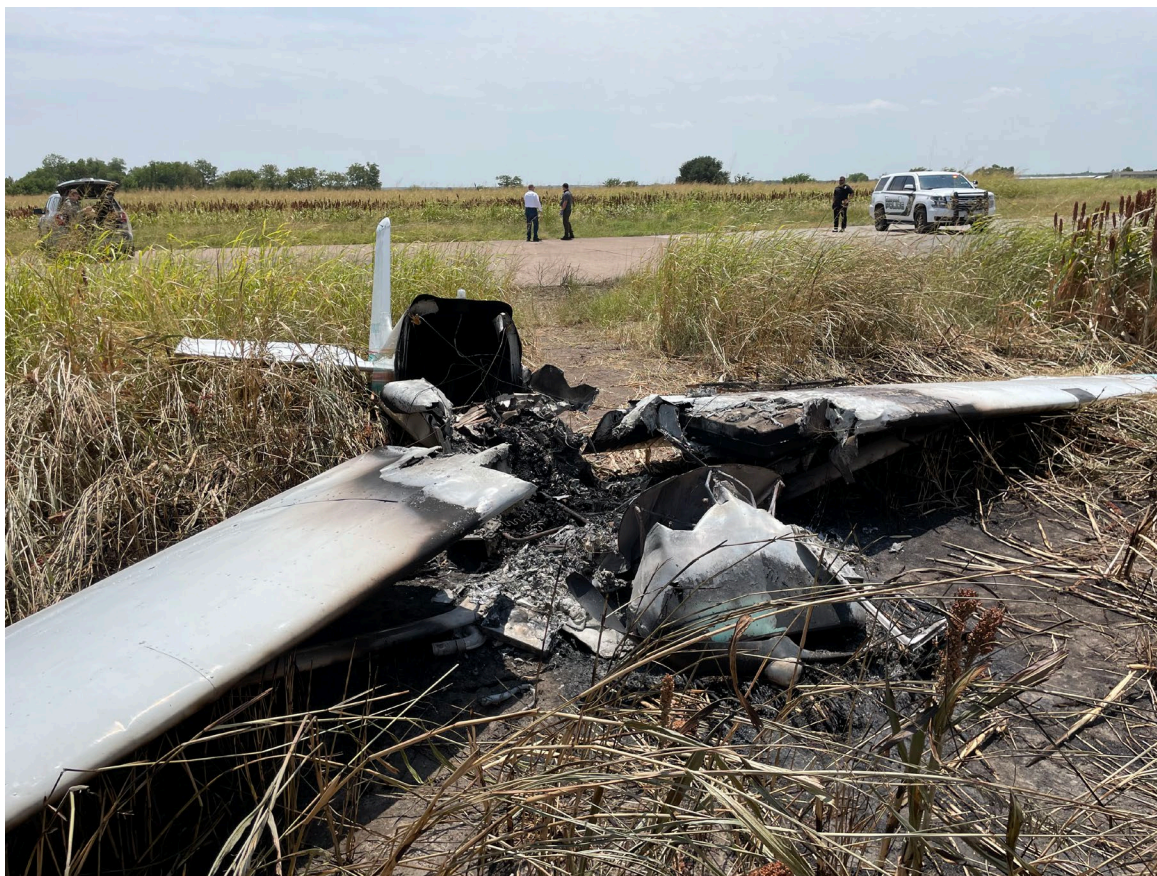
**Photograph 2 - Front view of wreckage at accident site (NTSB Photo)**

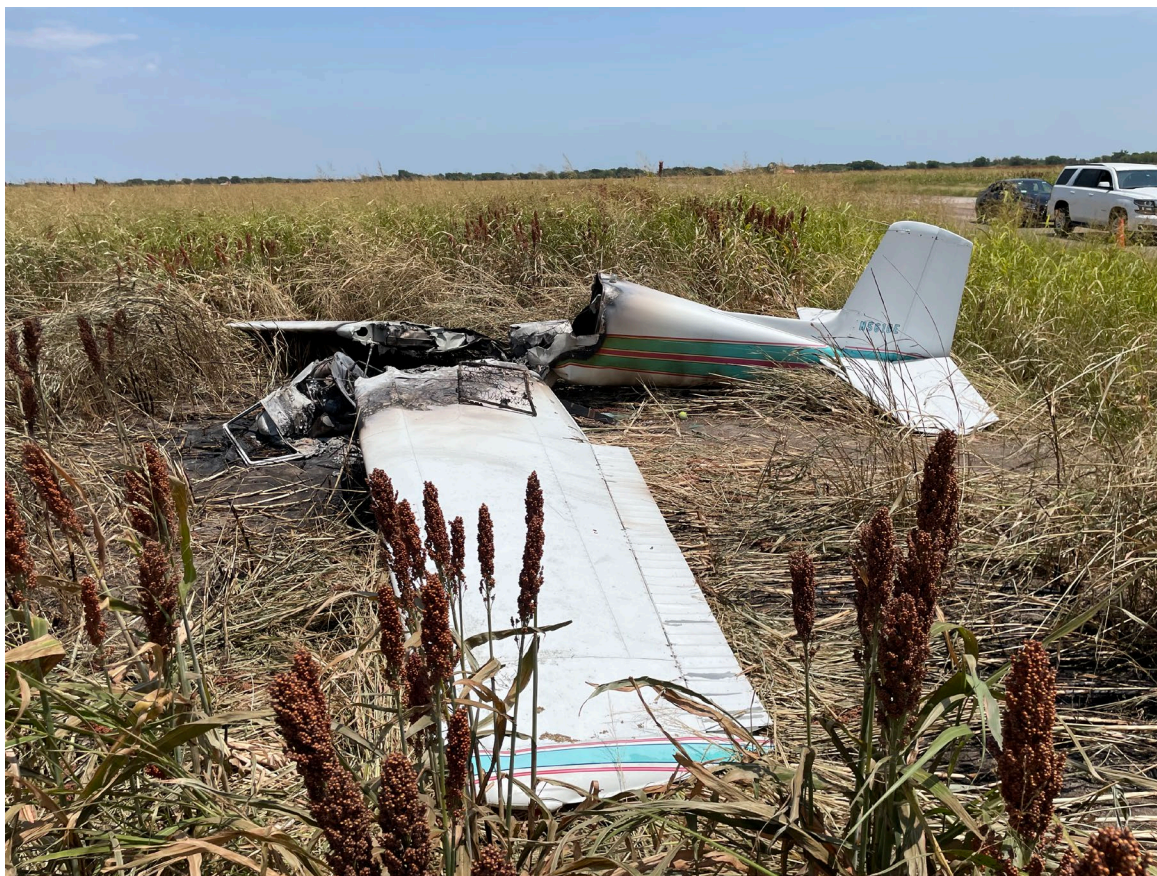
**Photograph 3 - Left side view of wreckage at accident site (NTSB Photo)**

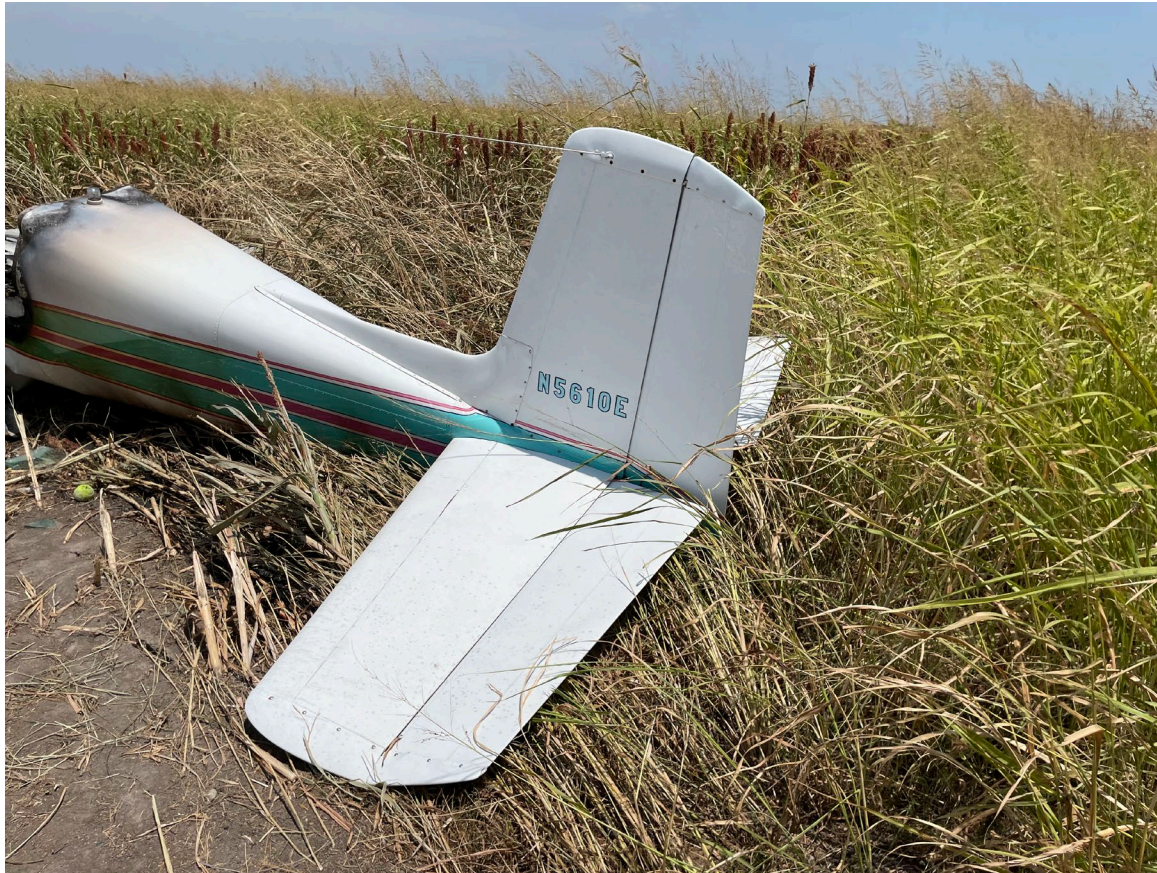
**Photograph 4 - Aft fuselage and tail surfaces at accident site (NTSB Photo)**

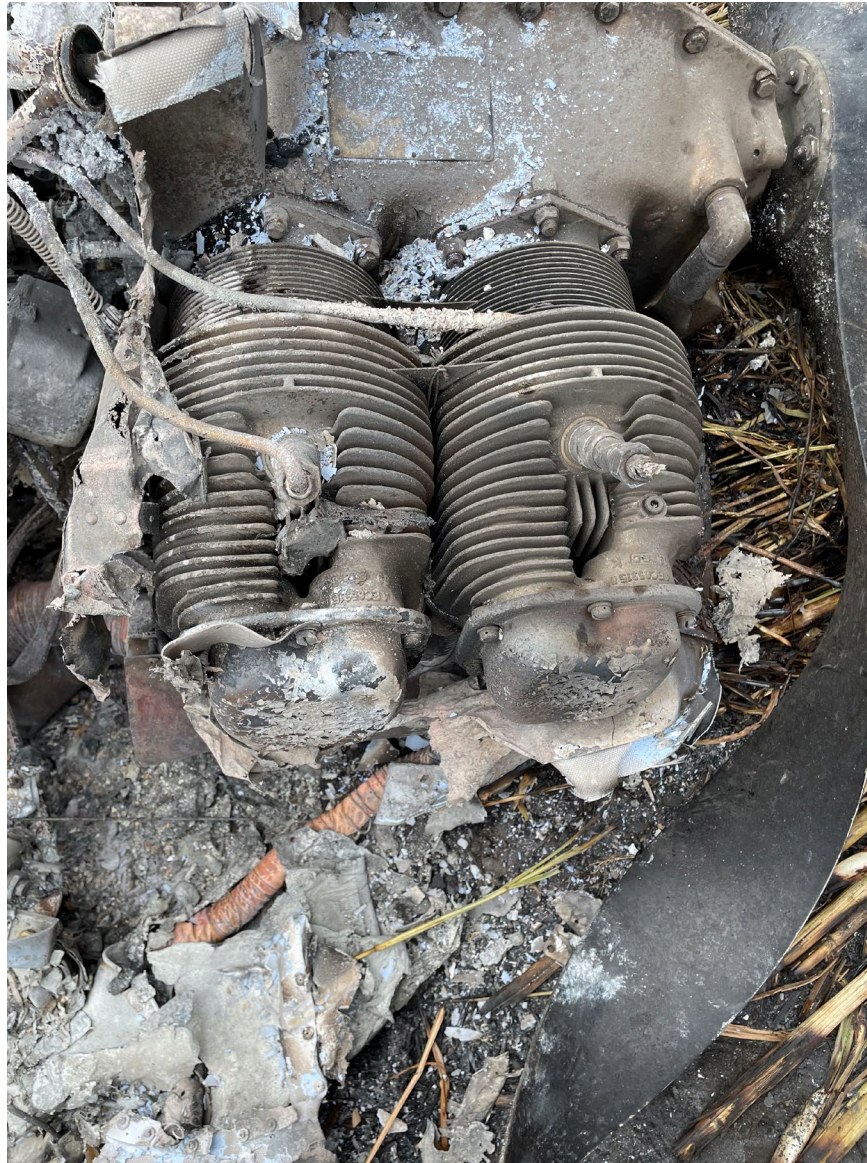
**Photograph 5 - Engine at accident site (NTSB Photo)**

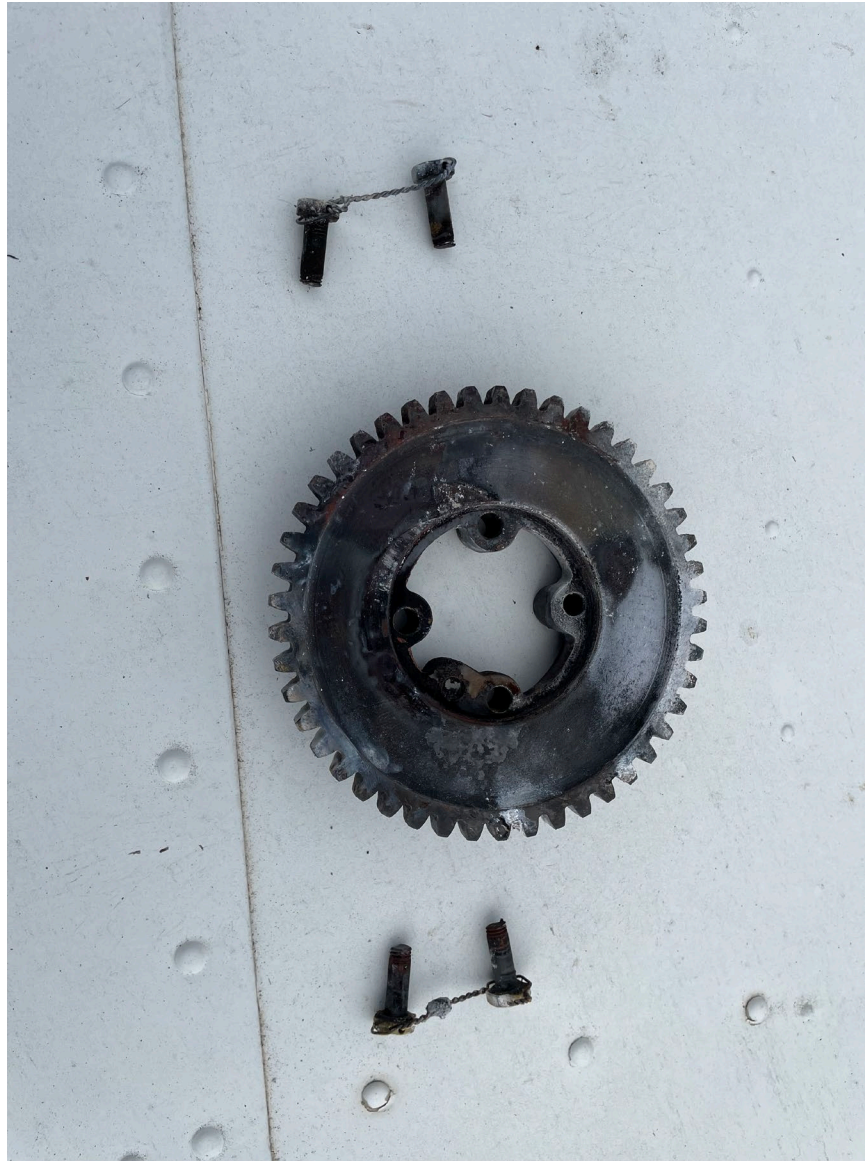
**Photograph 6 - Crankshaft gear after removal from engine at accident site (NTSB Photo)**
