**Air Tractor, Inc.**  
Accident Investigation

**AIRFRAME REPORT**

**CEN23FA353**

**8/8/2023**  
**Gilman City, MO**

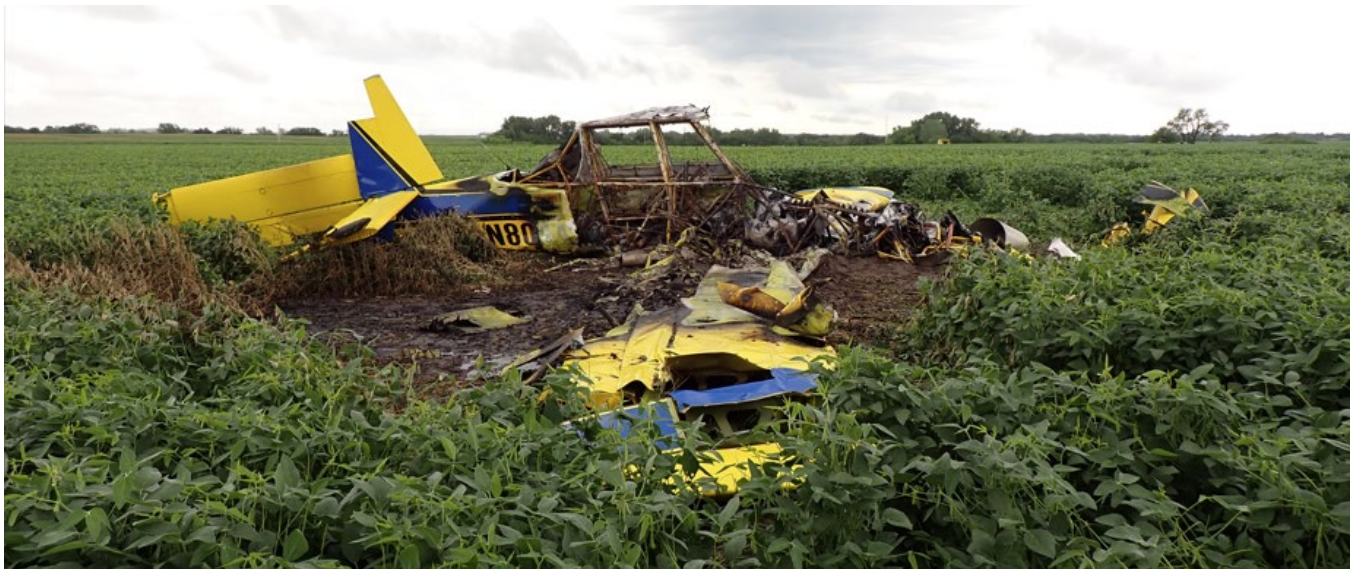
**Wreckage Overview (looking southwest)**

There were no ground scars leading up to the wreckage. All components were located near the main wreckage. The airplane was found upright. The right wing was partially consumed by fire. The fuselage exhibited fire damaged from the engine compartment to the aft end of the cockpit. The smell of fuel was noted at the accident site. The airplane was found on a 280° magnetic heading.

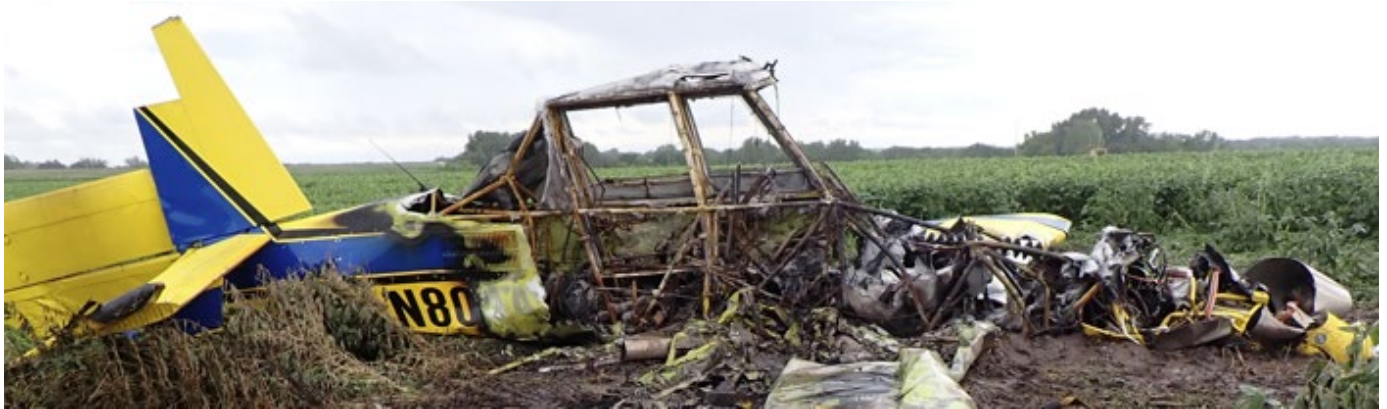
**Fuselage (looking southwest)**

The fuselage was found upright, with fire damage from the firewall to the aft end of the cockpit. There was upward crush damage to the fuselage.

Occupiable space was maintained. The upper inboard seat rail attach plates were found separated from the fuselage frame structure consistent with overstress and remained attached to the seat rails with hardware attached. The upper outboard seat rail attach plates remained attached to the fuselage frame and the hardware holes were found torn out. The seat rails and seat frame were found bent forwards at the upper seat attach brackets. The aft right vertical tube of the seat frame was found separated immediately below the upper seat frame attach bracket consistent with overstress. The pan portion of the seat frame was deflected down approximately 30° relative to the back of the seat.

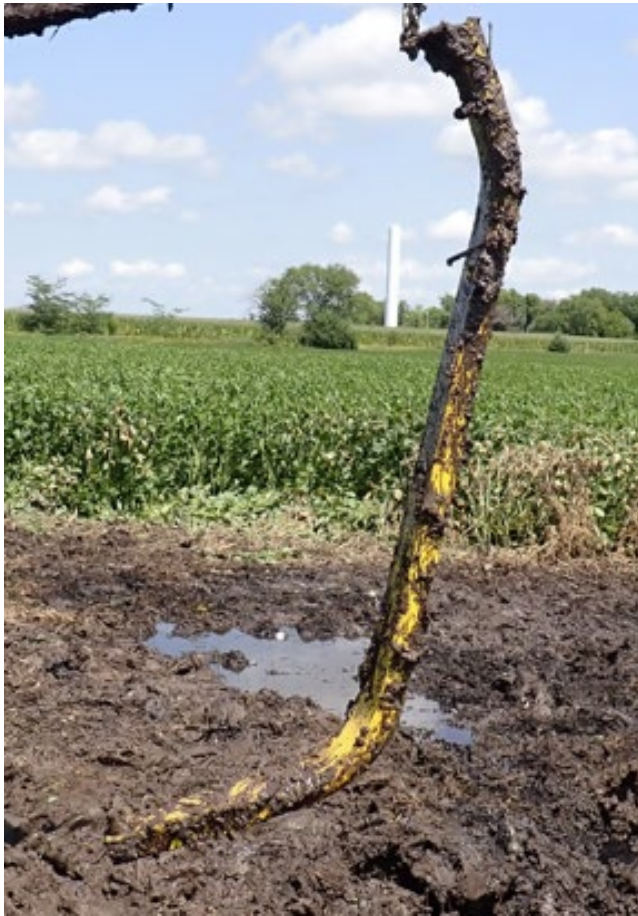
**Left Gear Spring**

The main gear was found embedded in the ground under the fuselage. The left gear spring was found separated from the fuselage. The left wheel was found separated from the left gear spring and was found embedded in the ground under the inboard end of the left wing. The right gear remained attached to the fuselage and the right wheel remained attached to the right gear spring.

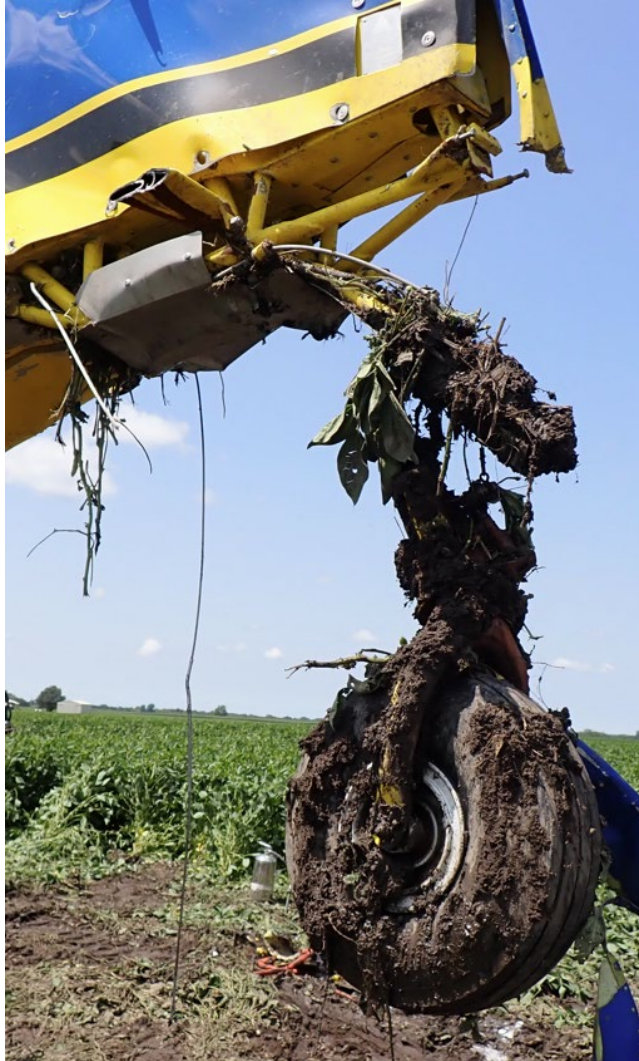
**Tail Gear**

The tail wheel assembly was found separated from the tail gear spring and remained attached to the fuselage by the tail wheel lock cable.

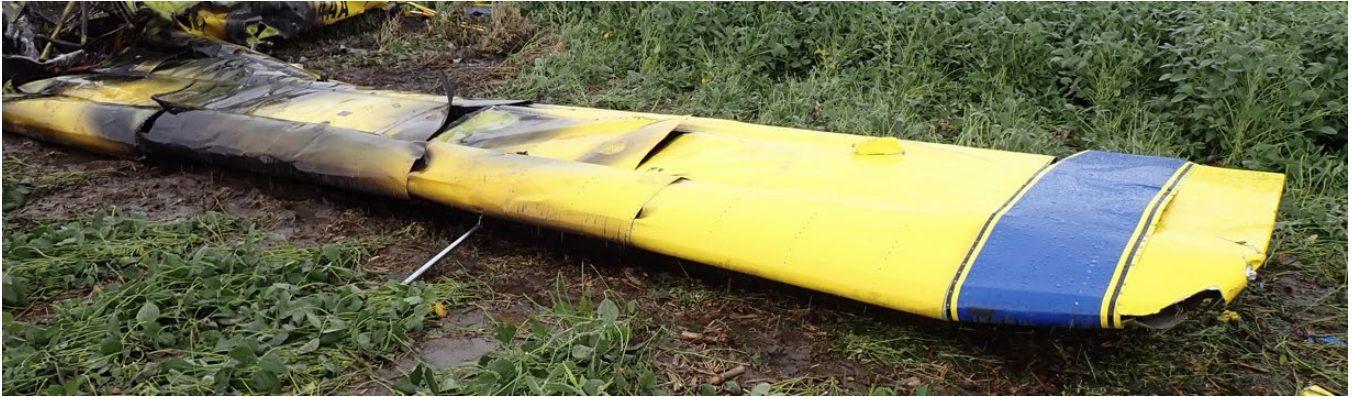
**Left Wing**

The left wing was found with crush damage in the up and aft directions to the leading edge. The left aileron and flap were found attached to the wing. Fire damage was found on the left wing.

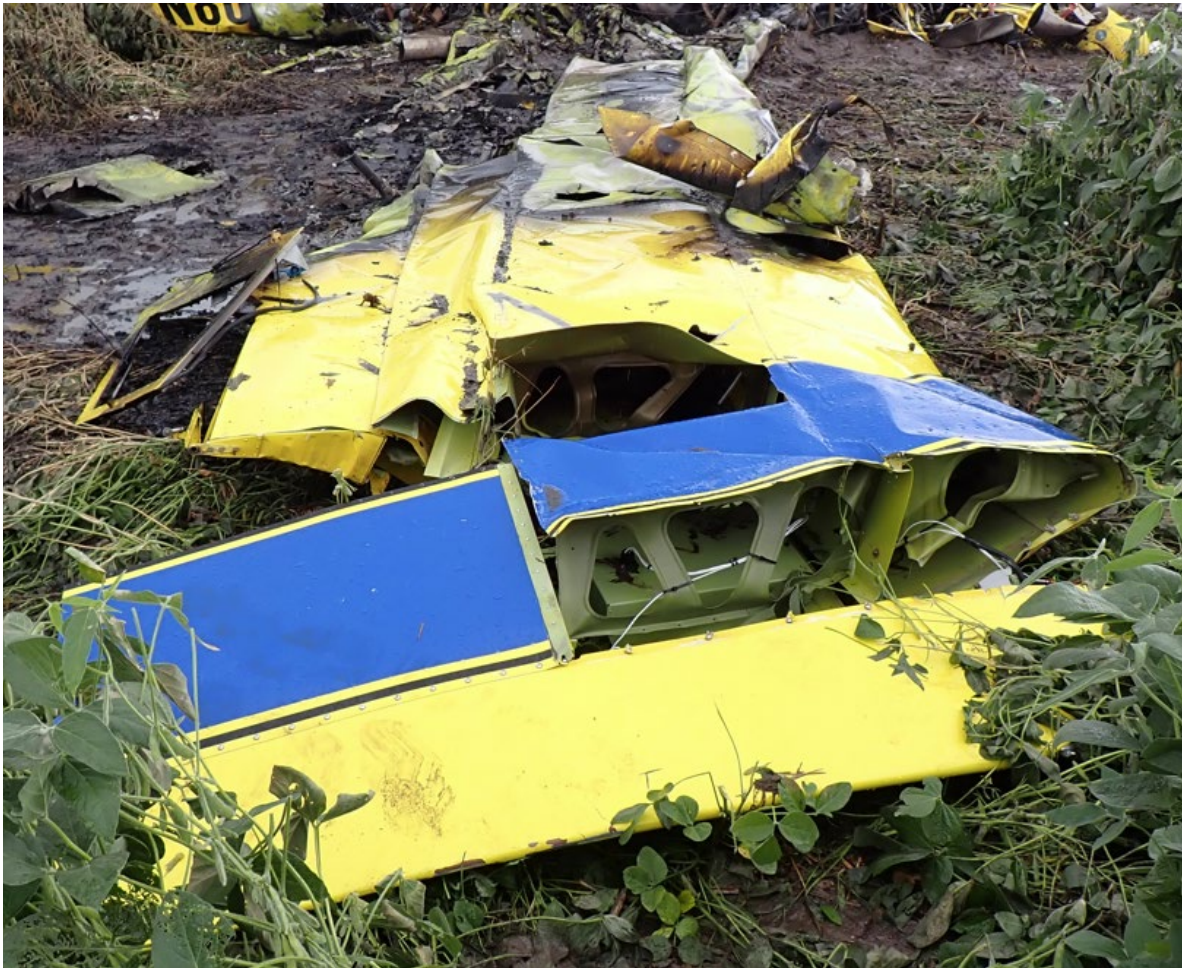
**Right Wing**

The right wing was found with crush damage in the up and aft directions to the leading edge. The right wing was found with heavy fire damage. The right aileron was attached to the wing and exhibited fire damage at the inboard end. The right flap was mostly consumed by fire. The right flap hinges were found attached to the wing.

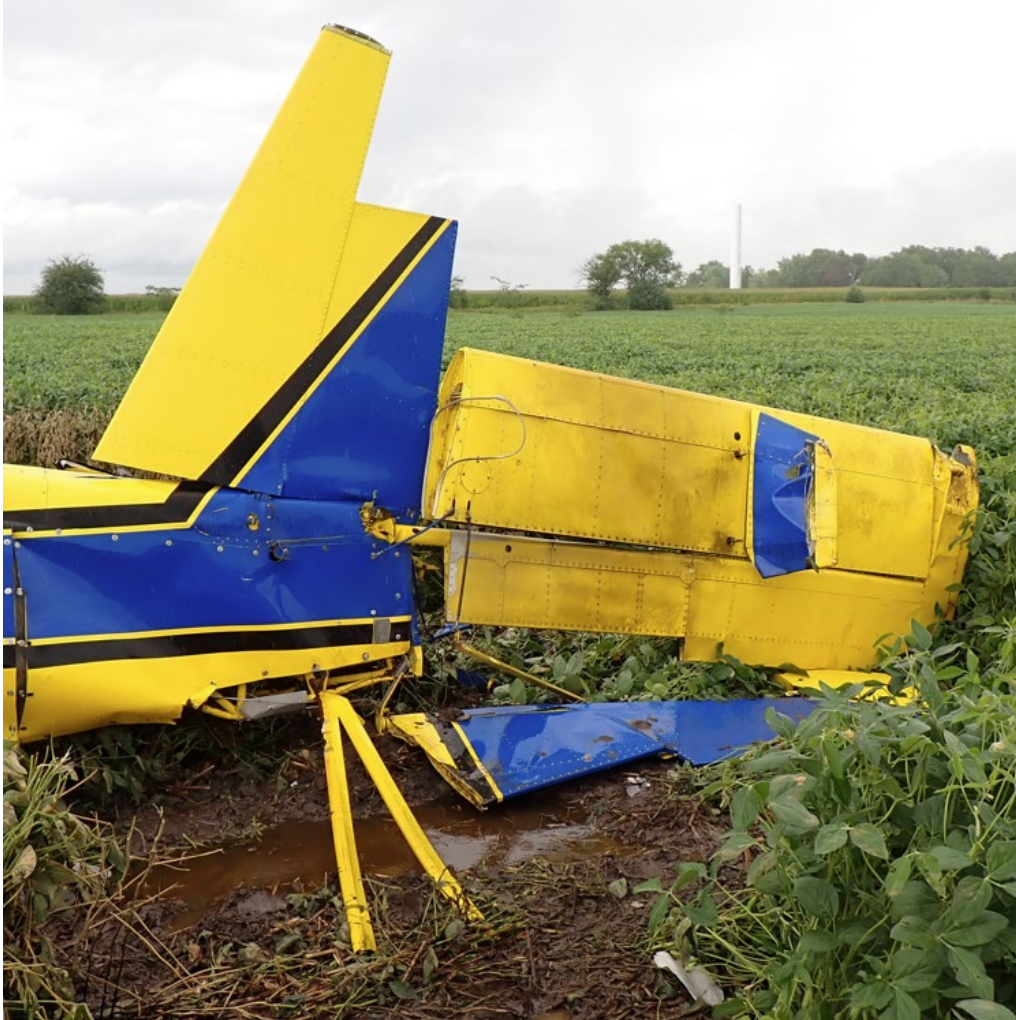
The left horizontal stabilizer was separated from the fuselage. The forward fuselage-side attach point was found separated through the solid section of the lug portion consistent with tension overstress. The aft fuselage-side attach point was found torn out. The hardware remained installed in the horizontal stabilizer. The left auxiliary fin remained attached to the stabilizer and was found with impact damage in the upward direction. The left elevator remained attached the stabilizer. The forward and aft v-strut attachments were found separated from the horizontal stabilizer at the clevises consistent with overstress. Both clevises remained attached to the stabilizer. The v-strut remained attached to the fuselage attach point.

**Left Horizontal Stabilizer and Elevator, Vertical Fin, and Rudder (rudder on ground)**

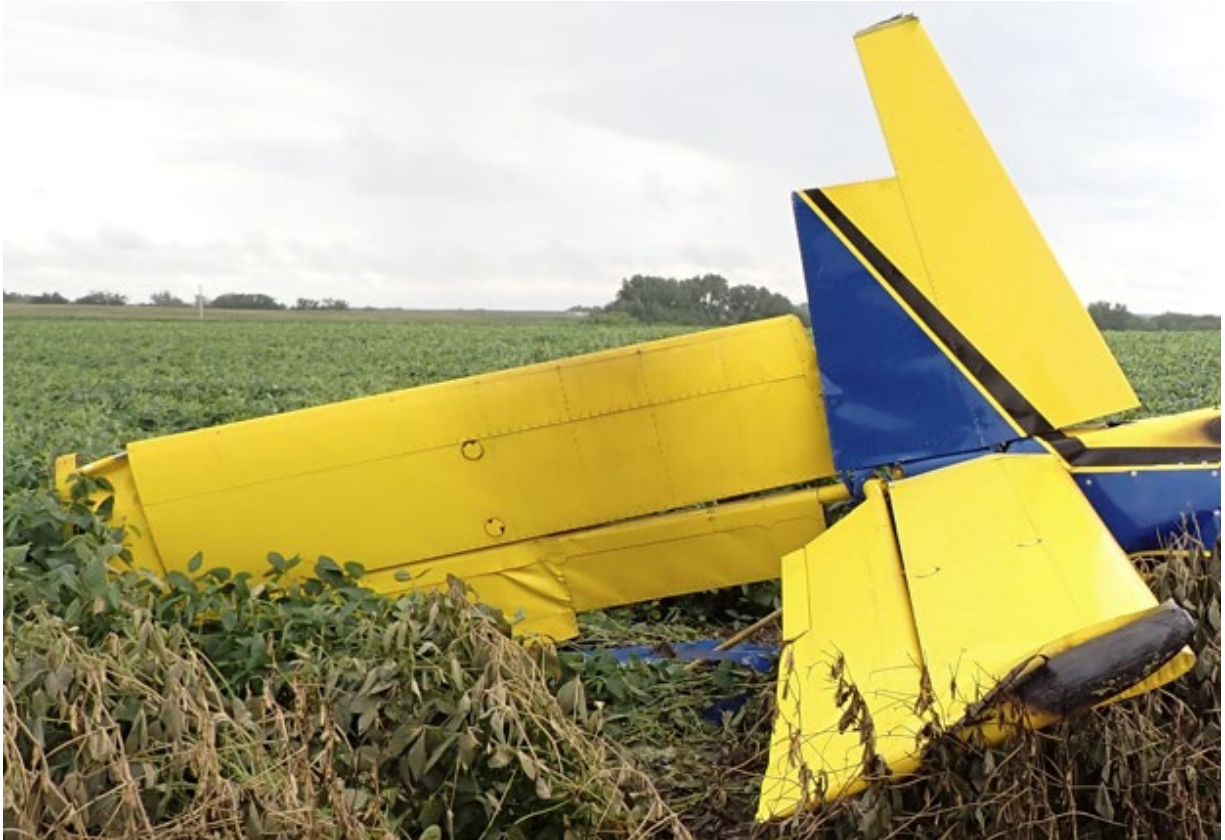
**Empennage (rudder on ground)**

The vertical fin was attached to the fuselage. The upper aft fuselage skin was damaged consistent with rapid deceleration in the forward direction which would cause the lower forward portion of the vertical stabilizer to crush against the top of the fuselage. The rudder was separated from the vertical fin and was found near the aft end of the fuselage. The separations were consistent with overstress. The rudder remained attached to the fuselage through the rudder cables.

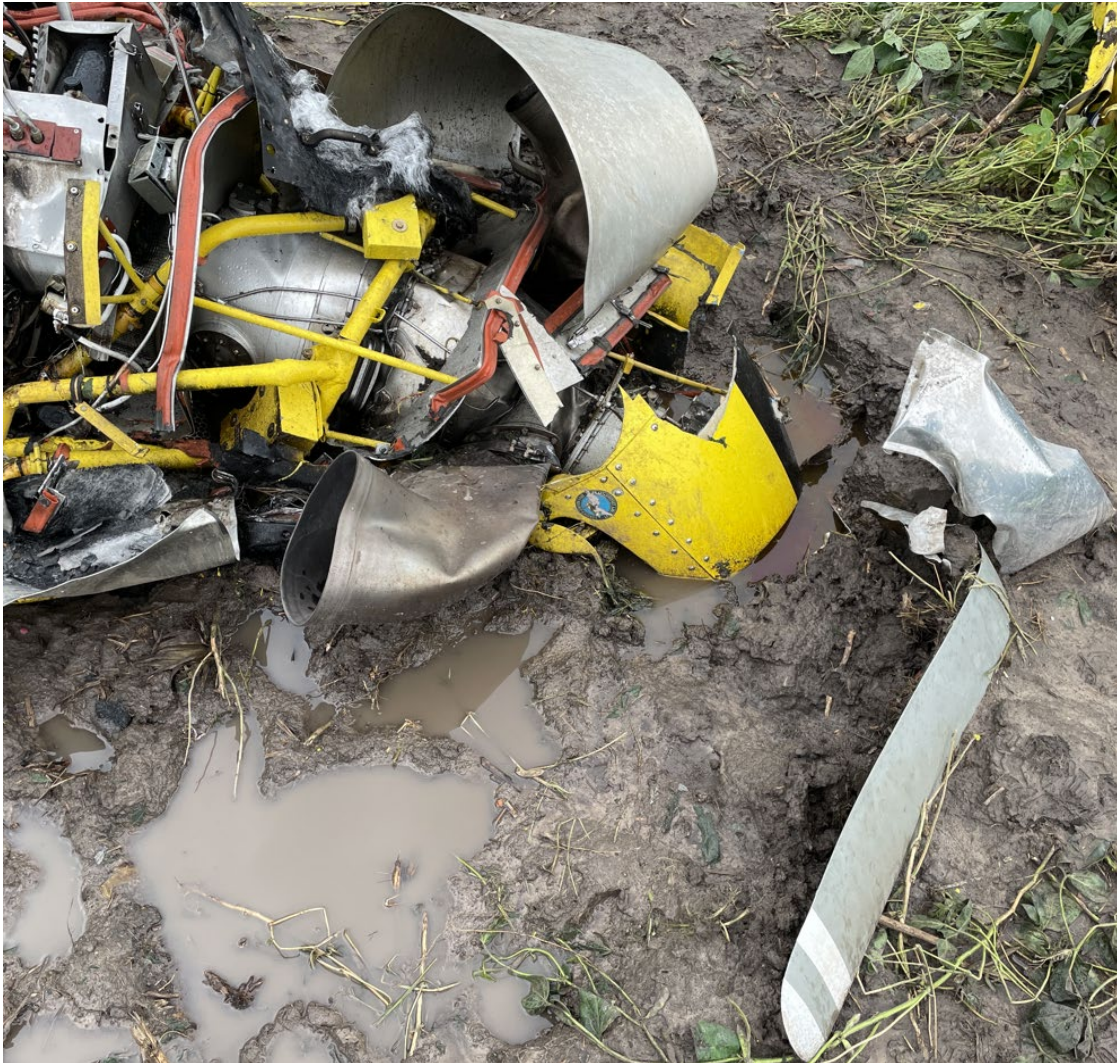
**Engine and Propeller**

The engine remained attached to the engine mount. The engine mount ring was fractured above the upper right engine attach point consistent with bending overstress. All engine mount tubes were bent consistent with impact damage. The fixed balance weights remained loosely attached to the engine mount with hardware attached. The engine mounted remained attached to the fuselage.

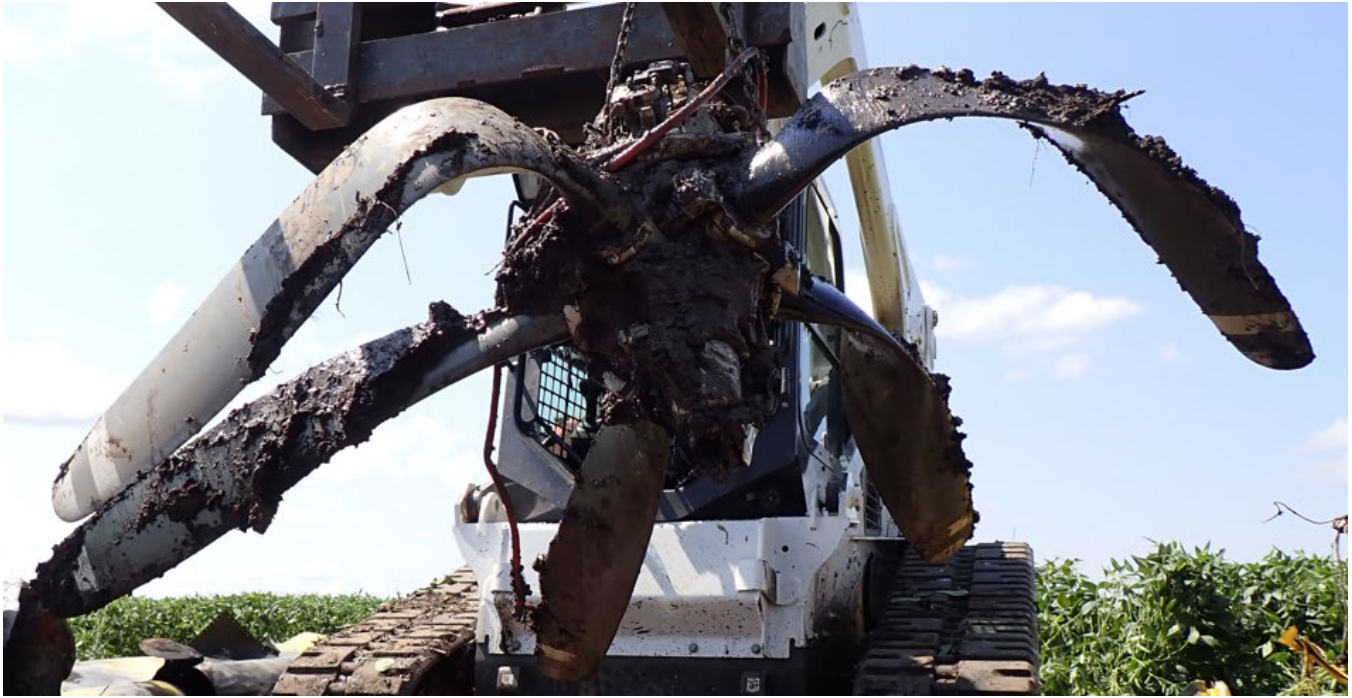
**Propeller**

The engine was equipped with five-bladed constant speed, fully reversible propeller. The propeller was embedded in the ground with one blade visible above the ground. Two blades exhibited bending towards the camber side, one blade remained mostly unbent, and two blades exhibited bending towards the face side. The propeller damage was reported by the propeller manufacturer to be consistent with producing thrust at impact with sudden rotational deceleration. Each of the blades was found attached to the propeller hub. The propeller hub was found attached to the reduction gearbox. The reduction gearbox was found partially separated from the engine.

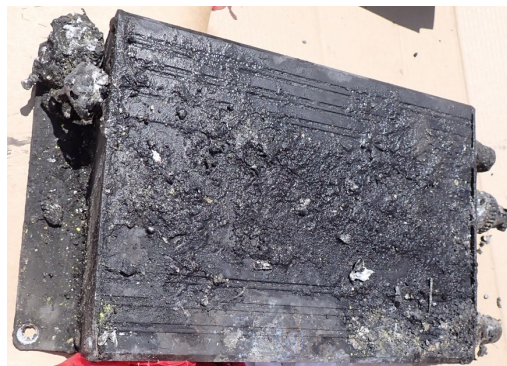
No portion of the wreckage was removed by Air Tractor personnel during our involvement in this accident investigation, except for the removal of a Satloc agricultural GPS unit that was provided to the NTSB on scene. The model and serial number of the unit were unknown due to fire damage.

**Satloc GPS unit (after removal from wreckage)**
