# National Transportation Safety Board

CEN23FA353

## **ON-SCENE INVESTIGATION SUMMARY**

Location: Gilman City, Missouri  
Date: August 8, 2023  
Time: 1150 CDT  
Airplane: Air Tractor AT-802, N804AA

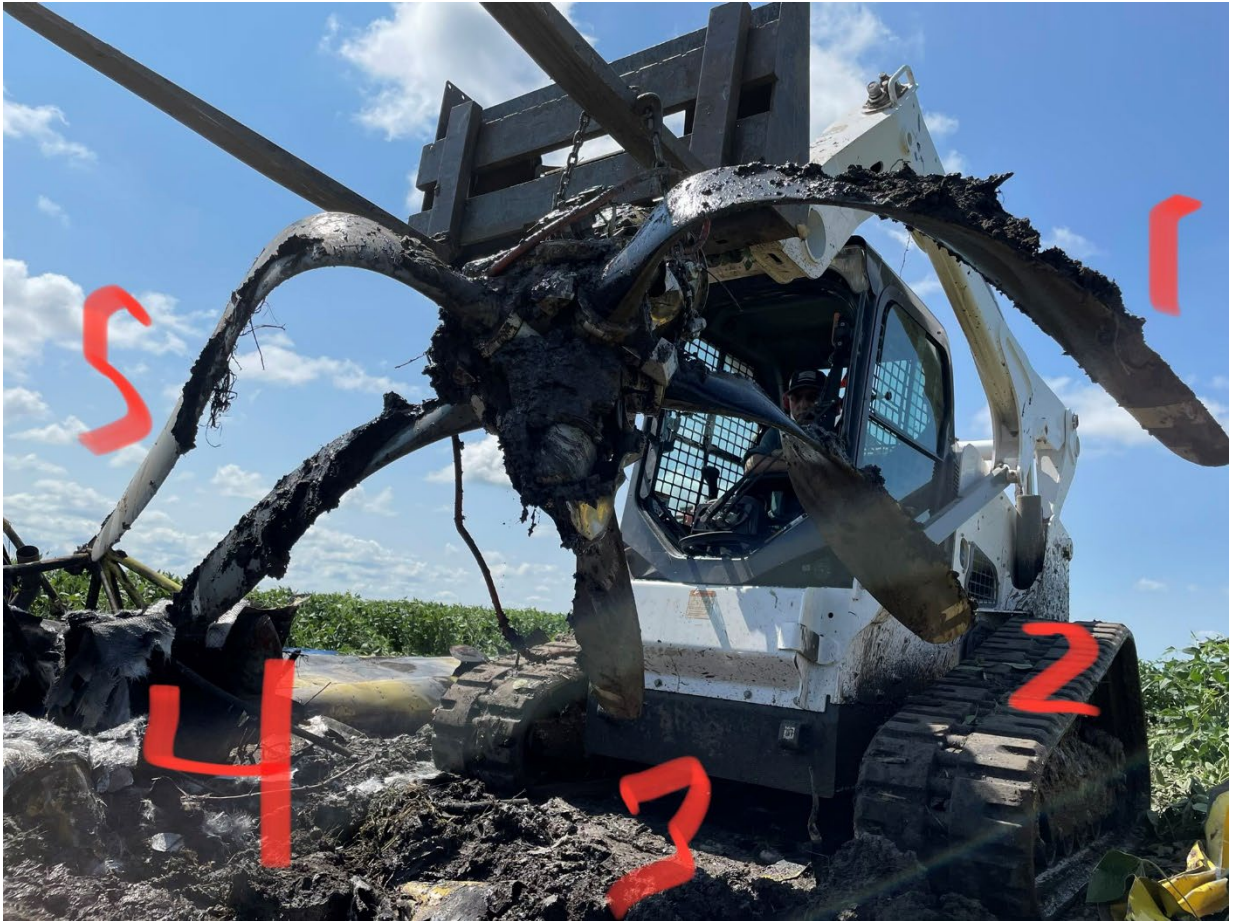
The propeller assembly was completely embedded in the ground. A chain was attached to the reduction gear box and lifted from the impact crater. All 5 blades remained attached to the propeller hub. The blades exhibited compound bend and twist progression from forward to aft in the sequence of rotation consistent with producing thrust at initial impact. The RGB second stage planet gear carrier impact separated from the propeller shafter between the carrier web slots. Material deformation on the propeller shaft tabs was consistent with shear/torque production. The propeller was retained for further examination.

Figure 2. Propeller after it was removed from the impact crater.
