# National Transportation Safety Board

CEN23FA353

## EXAMINATION SUMMARY

Location: Gilman City, Missouri  
Date: August 8, 2023  
Time: 1150 CDT  
Airplane: Air Tractor AT-802, N804AA

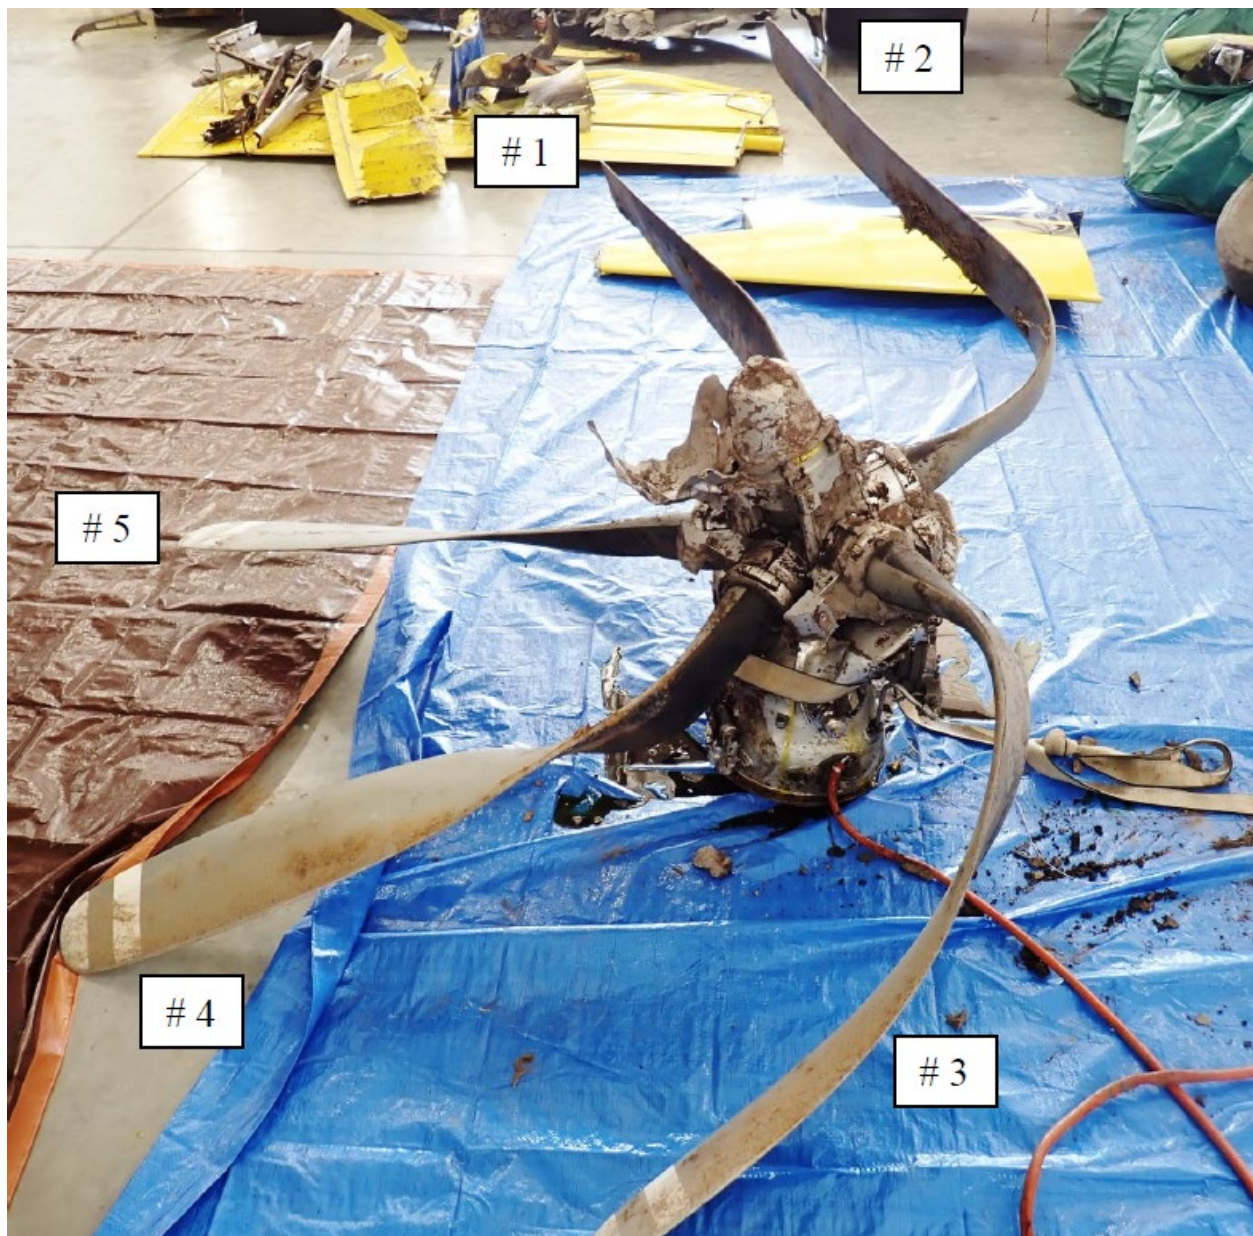
The propeller was presented for examination as shown in Figure 1. The propeller remained partially attached to the propeller shaft flange. The engine RGB impact-separated from the engine. The spinner dome was crushed and torn with only

fragments remaining jammed in the propeller assembly. The spinner aft bulkhead remained attached and was bent aft. The propeller assembly was packed with dry, hard, rock-free soil. All five blades remained attached to their respective clamps. There were no discernable slip indicators, so it was undetermined if the blades slipped in the clamps. The piston was displaced approximately 1.7" forward of the beta guide collar. All link arms remained attached at the piston link pin. Only one link arm (blade No. 5) remained attached at the clamp link screw, all others were detached at the clamp link screw. Blade No. 5 was in a normal blade angle range, all other clamps/blades appeared to be near feather.

Figure 1. Propeller as presented.

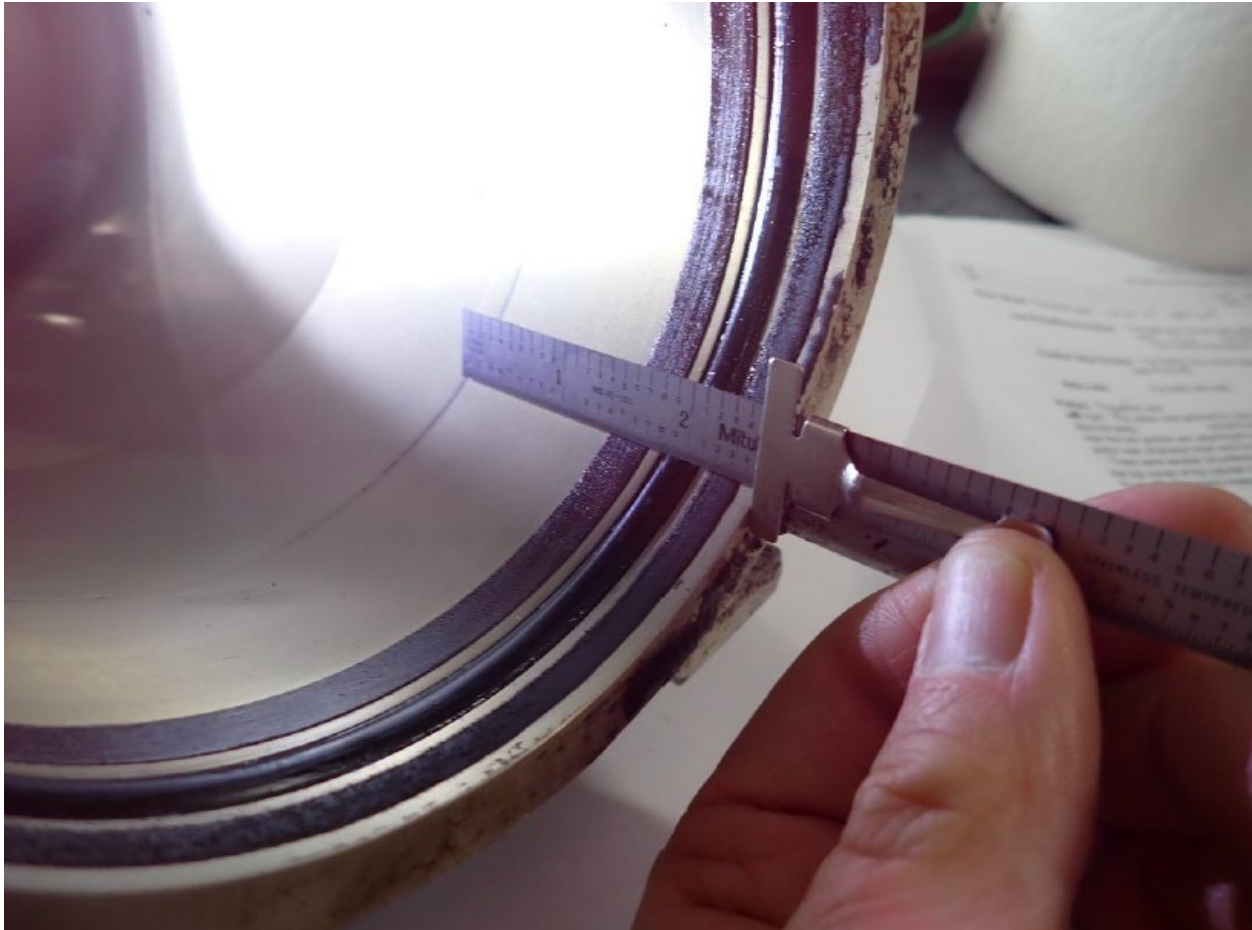
Blade Nos. 3, 4 and 5 were bent in the forward/thrust direction and blade Nos. 1 and 2 were bent in the aft direction. The piston was removed, and a circumferential impact mark was present at approximately 2.45" from the bottom edge (Figure 2). This distance translates to a blade angle of approximately 22 degrees, in the normal range of operation.

Figure 2. Piston ID impact signature.

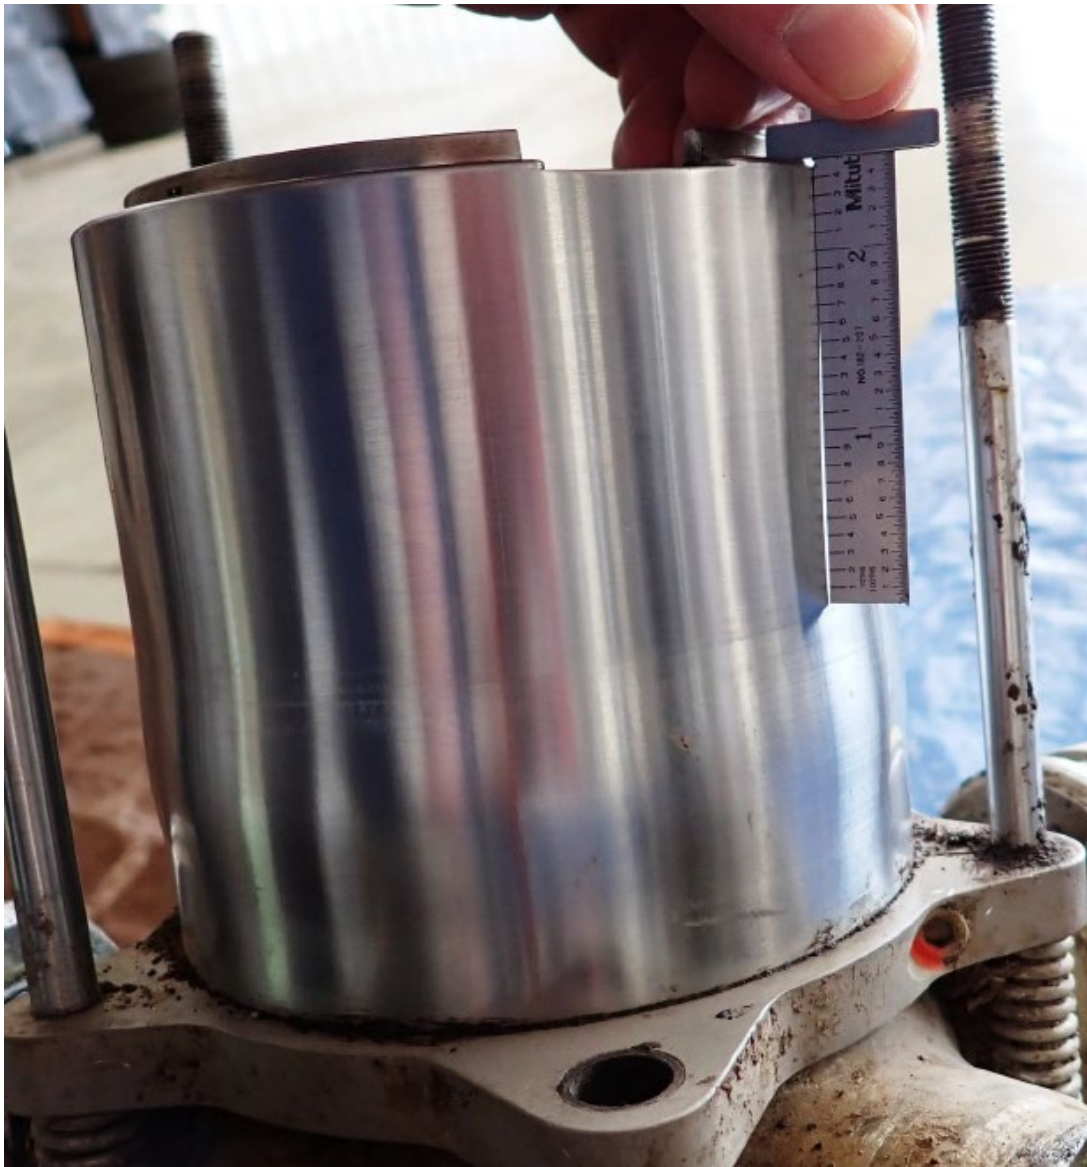
The cylinder exhibited a bulge and crease at approximately 2.5" from the top corner, consistent with the internal mark on the piston (Figure 3). The link arms were removed and compared to a full-sized drawing. Link arms Nos. 1-4 exhibited stretch, consistent with forceful blade rotation towards high pitch (Figure 4). The link screws on the corresponding clamps exhibited bending opposite high pitch. All five blade clamps remained attached with all bolts secure. The link screws on clamps Nos. 1-4 were bent opposite high pitch with link screws Nos. 2-4 partially fractured at the cotter pin holes. All counterweight arms and slugs remained attached and secure. Except for the No. 4 pilot tube, there were no visible fractures or cracks of the hub spider. The feathering spring was removed and was intact and undamaged. The pitch change rod appeared to be in the feathered position. The blades were removed from the assembly. The pilot tube for blade No. 4 was fractured and a portion remained

Figure 3. Cylinder bulge at 2.5" below top corner

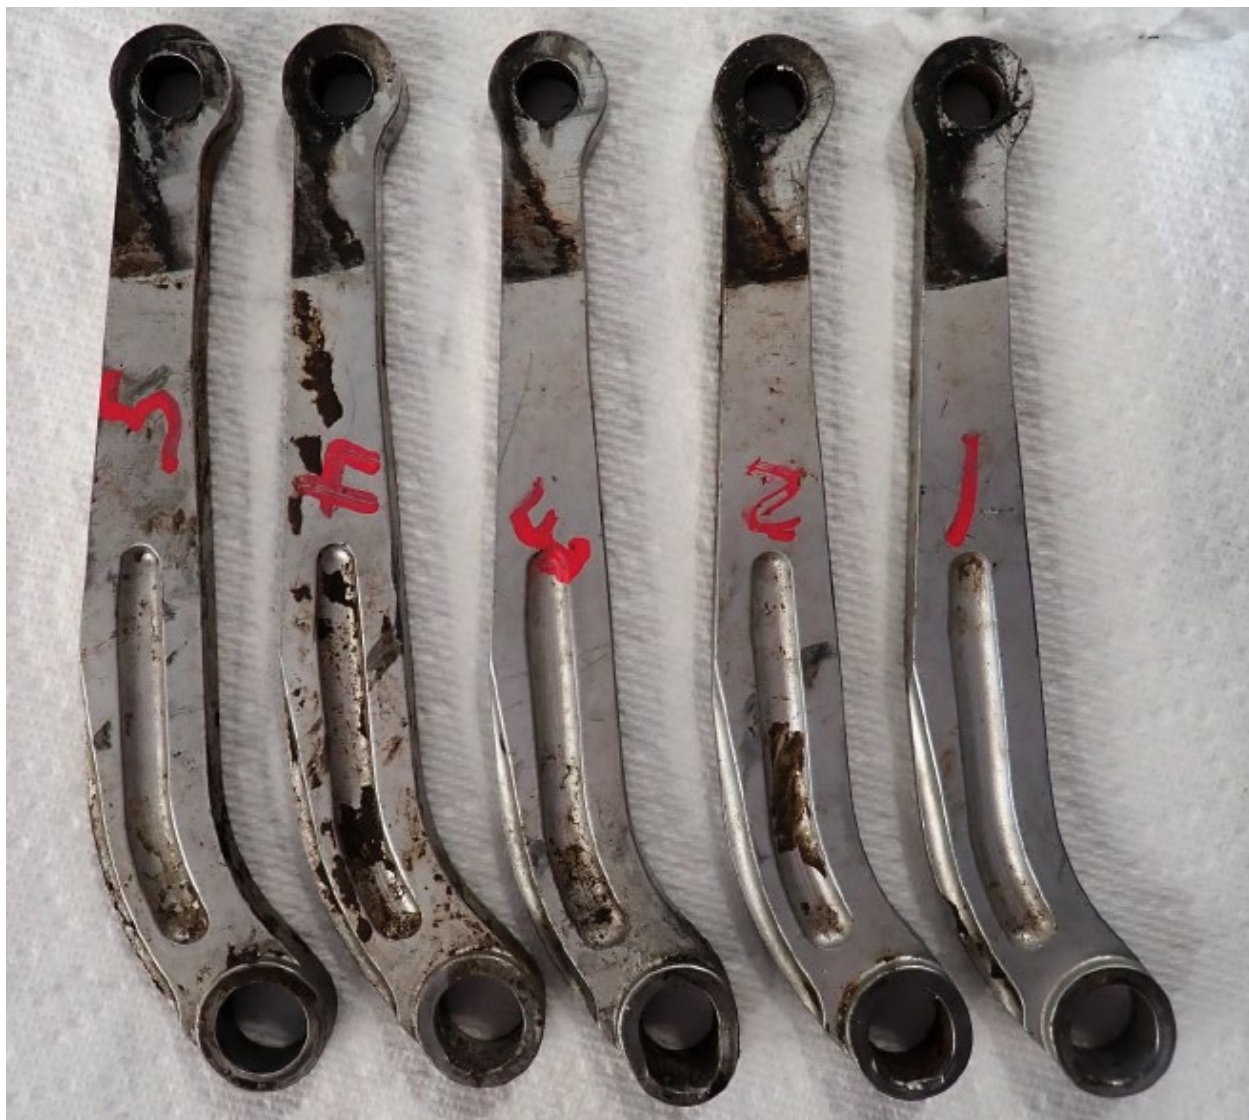
Figure 4. Link arm comparison showing stretch on No. 1-4

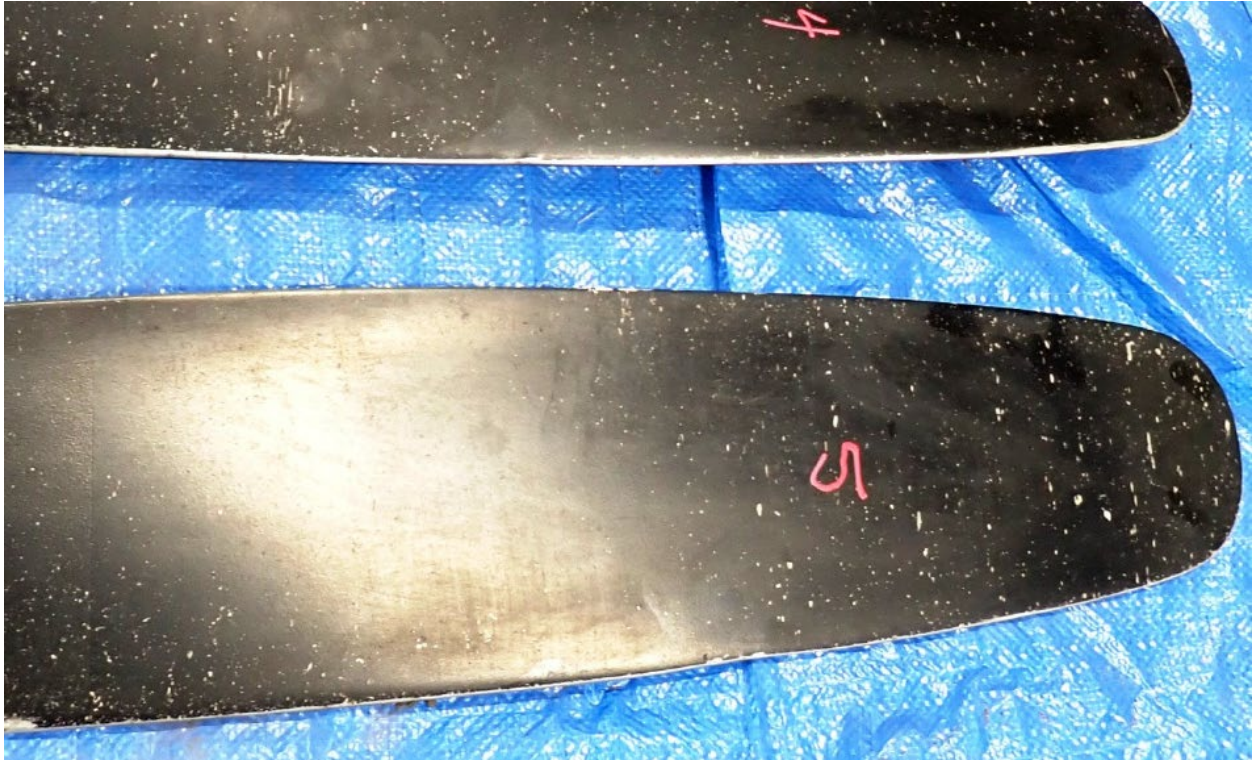
jammed in the blade bore. All five blades had pilot tube shoulder impact impressions in the blade butt. Blade Nos. 2, 4 and 5 had blade-to-hub impact crescent impressions. There was no remarkable leading-edge gouging or deep chordwise/rotational scoring on any blade, consistent with impact into soft, rock-free, moist/wet farm field soil. There was light, chordwise/rotational abrasion on the face side of each blade, primarily isolated to the leading edge and trailing edge areas (Figure 5). The blades exhibited bending and twisting damage consistent with impact while rotating at moderate-to-high power and producing thrust at initial impact; blade Nos. 3-5 bent forward in the forward, thrust direction and forceful rotation towards high pitch. Figure 6 shows the progressive bending pattern in the blades.

Figure 5. Light, face-side abrasion on blade No. 5, similar on all blades

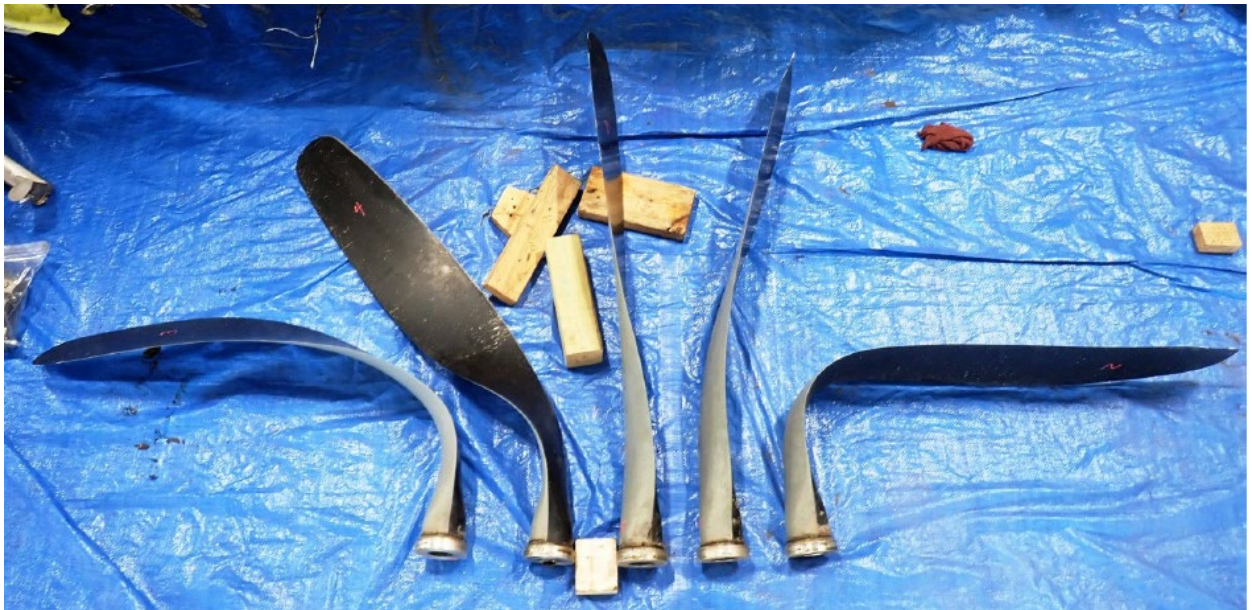
Figure 6. Propeller blades trailing edge view 3-4-5-1-2 left-to-right.

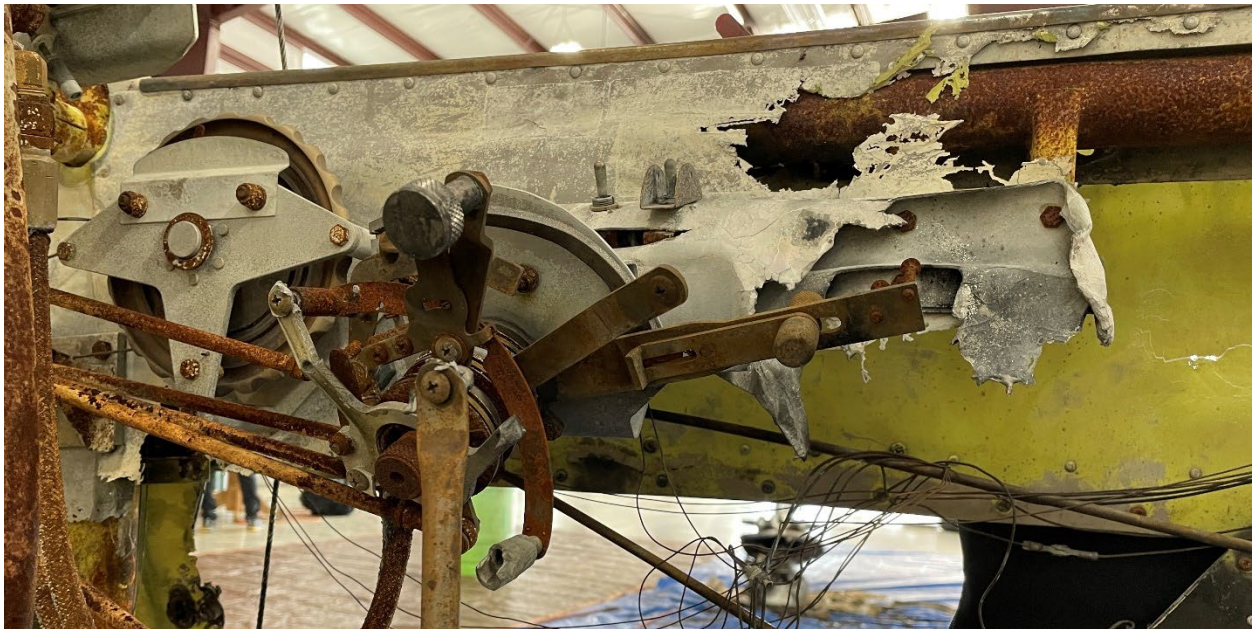
Air Tractor provided an email assessment of the power quadrant lever positions as found on-scene, which were:

Fuel Condition Lever: ground idle

Prop: medium-high to high rpm

Power: high power

Figure 7. The power quadrant lever positions during the examination.
