# National Transportation Safety Board

CEN23FA359

## **ON-BOARD RECORDING DEVICE STUDY**

Aircraft Performance Study

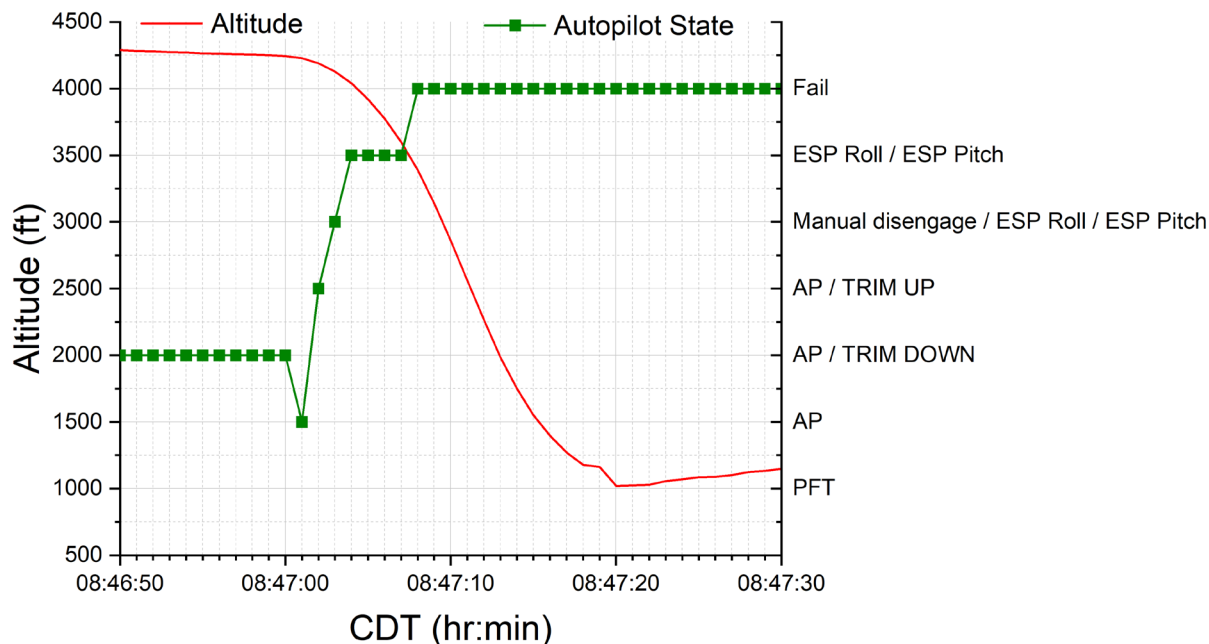
At 08:46:30, as the airplane approached the town of Virden, Illinois, it climbed from 4,100 ft to 4,200 ft while slowing from 168 kts of indicated airspeed to 160 kts by 08:47. At 08:47:00, the autopilot, which had been in the "AP/TRIM DOWN" setting moved through "AP" then "AP/TRIM UP" to "Manual disengage/ESP Roll/ESP Pitch" then to "ESP Roll/ESP Pitch" where it remained for four seconds before recording "Fail" for the rest of the recording.

**Figure 5.** Garmin recorded altitude and autopilot setting for the end of flight.

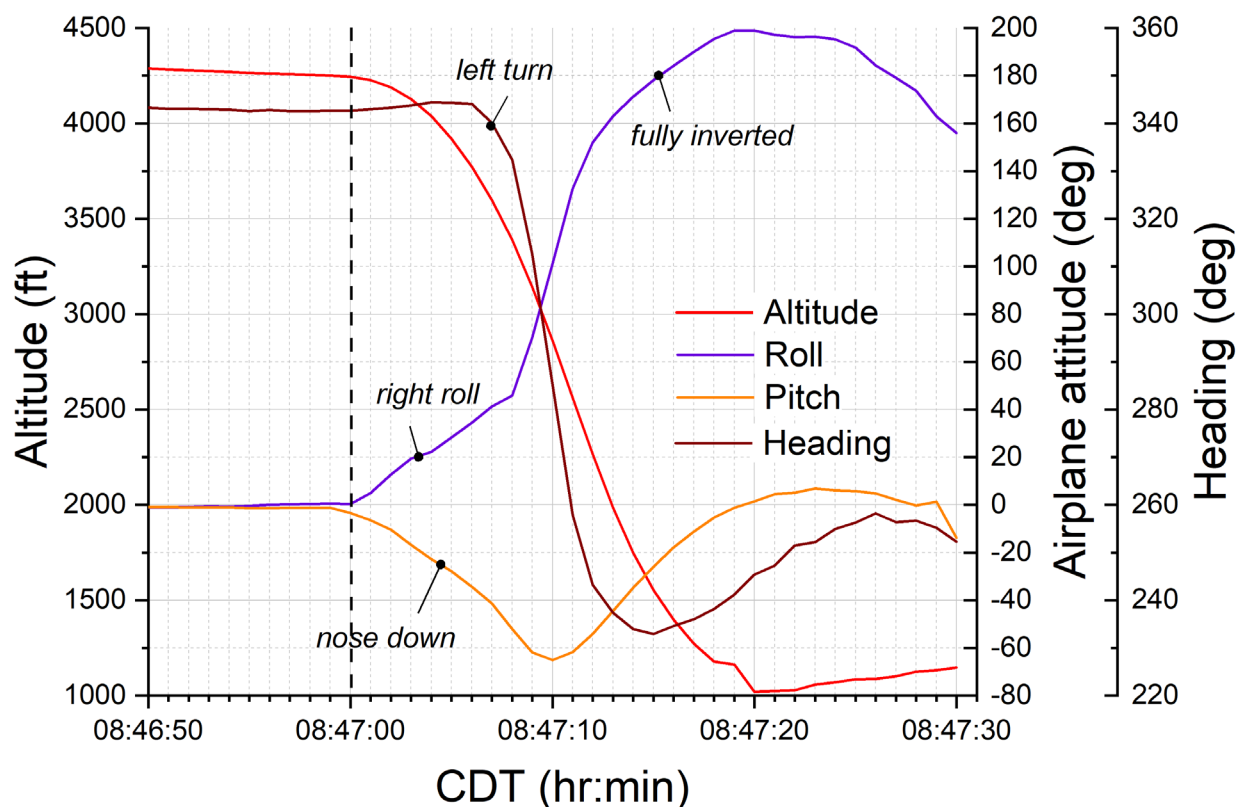
Simultaneous with the release from AP/TRIM DOWN the airplane began rolling right while pitching down rapidly. By 08:47:06 the airplane was 35° right wing down and 34° nose down. The airplane had descended 470 ft, but the heading remained straight until 08:47:07 when the recorded heading began to shift left followed by the track angle at 08:47:09.

**Figure 6.** Garmin recorded altitude, roll, pitch, and heading.

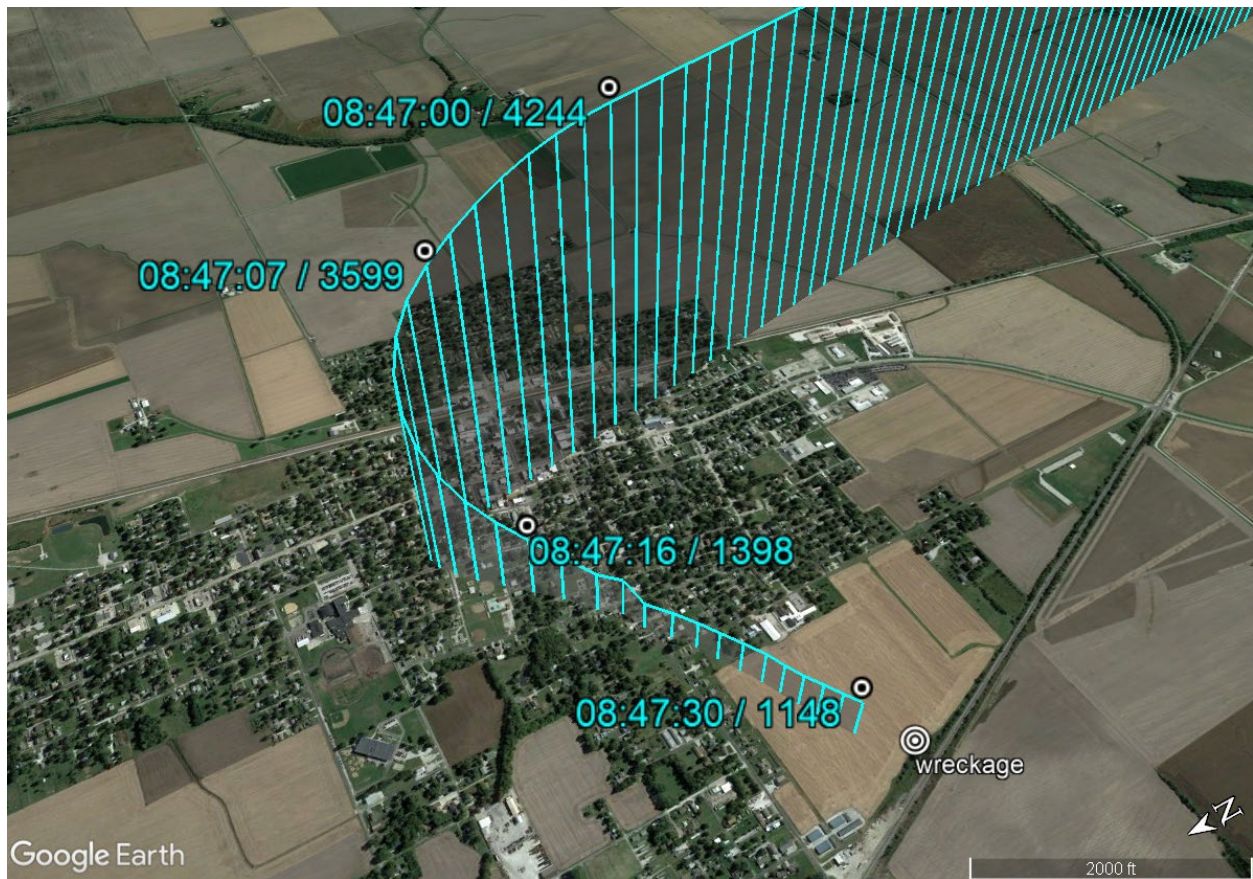
By 08:47:16 the airplane had descended to 1,400 ft MSL (~ 700 ft AGL). The airplane by this time was near level, but inverted. The airplane stayed inverted until the

end of data at 08:47:30, 460 ft from the final wreckage location. Witnesses in the town of Virden confirmed that the airplane was inverted as it overflowed homes.

**Figure 7.** Garmin recorded flight path with times and altitudes noted.

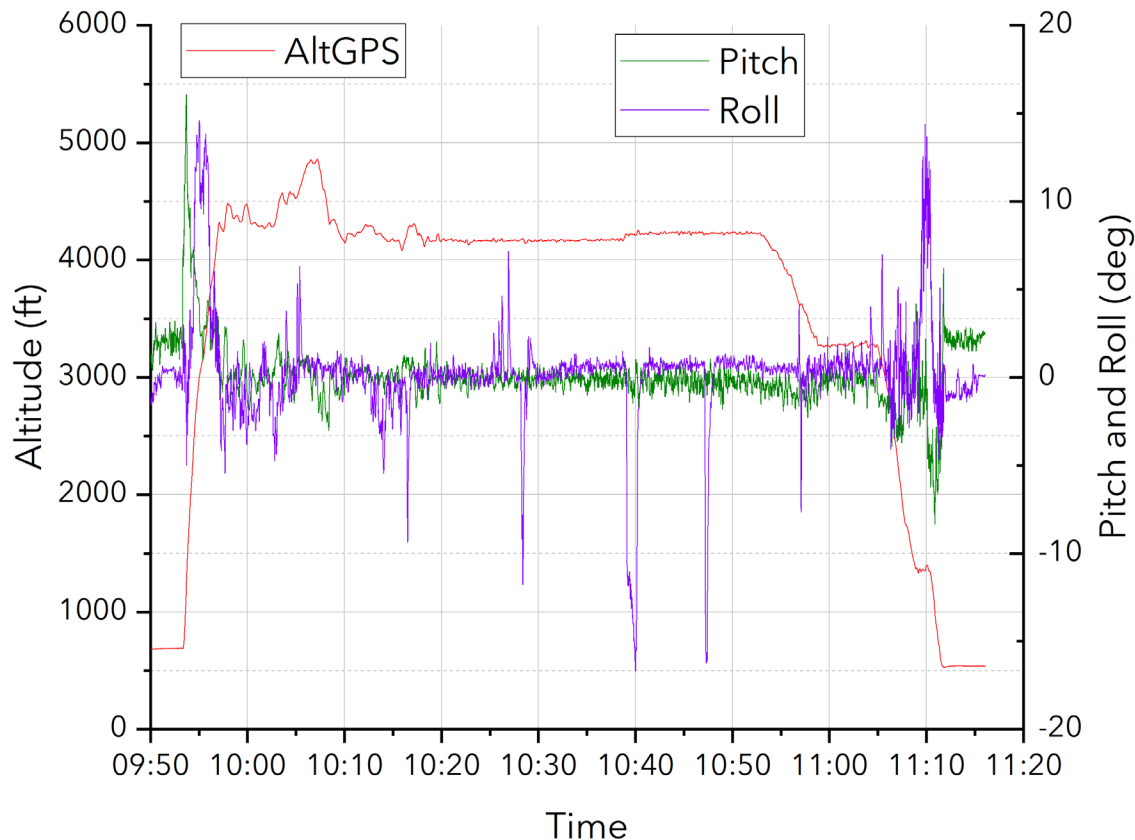
Of interest were the pilot's previous flights. The onboard device had records starting in November of 2022. Twenty-nine of these flights were investigated to see if the pilot participated in aerobatic maneuvers. One flight had a single maneuver that resulted in a bank angle of greater than 40°. The banks angles for all other flights rarely exceeded 30°. None of the flights had a nose down pitch greater than 10° or a nose up pitch greater than 10° after takeoff. There was no evidence in the recorded data of the pilot performing any aerobatic maneuvers.

**Figure 8.** Garmin recorded altitude and airplane pitch and roll for an earlier exemplar flight.
