# National Transportation Safety Board

CEN23FA359

## **ELECTRONIC DEVICES**

Location: Virden, Illinois  
Date: August 12, 2023  
Time: 08:48 central daylight time (CDT)  
Aircraft: Bierman/Van's RV-14A, N6161

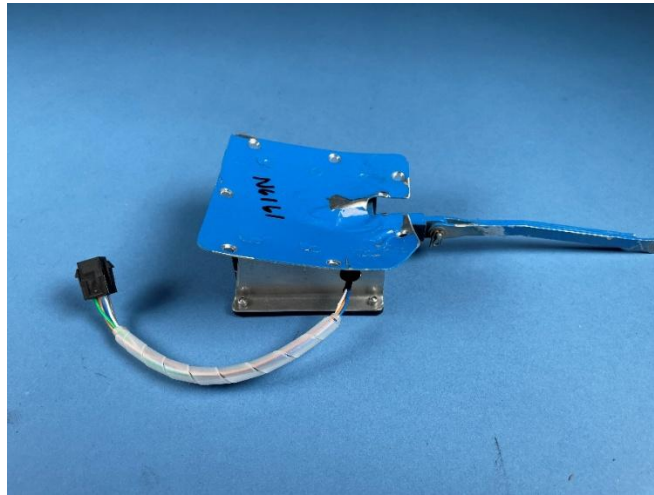
The trim servo was found installed in the wreckage per the Van's aircraft installation instructions. The trim servo was removed during the wreckage exam and is pictured in figure 1. The trim servo appeared to utilize an unmodified Elevator Trim Pushrod (E-01401A, assembly) provided by the airframe manufacturer. No obvious anomalies were present in the construction.

**Figure 1.** The Ray Allen T3-12A pitch trim motor.

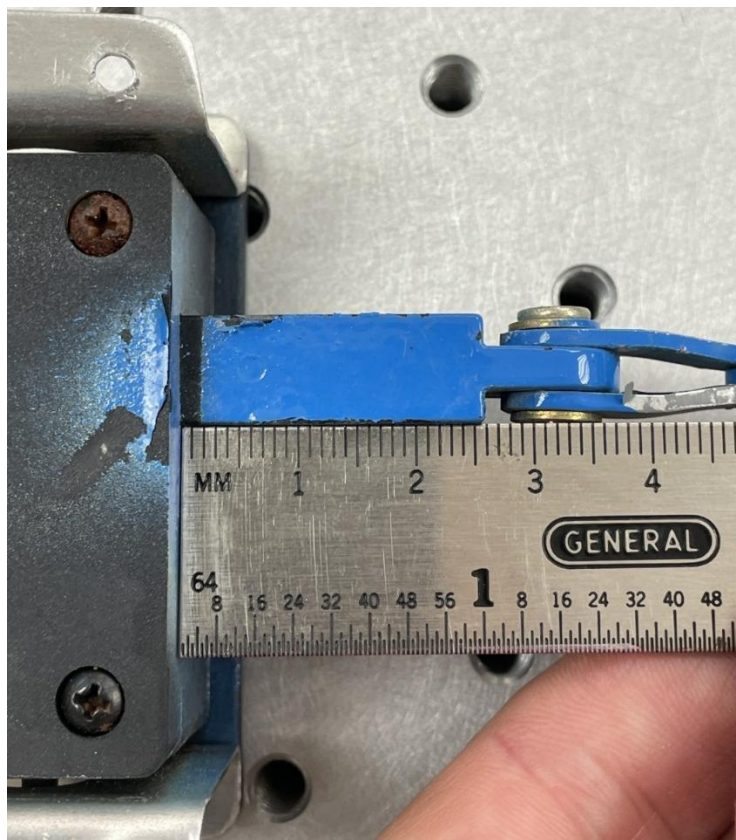
The trim servo arm was measured to be 1 inch extended as recovered. The trim motor was tested and determined to be functional and moved freely along the

shaft screw despite paint overspray on the shaft. Figure 2 is a photo of the measurement taken in the lab.

**Figure 2.** The Ray Allen T3-12A pitch trim motor final trim setting of around 25.5 mm or about 1 inch.

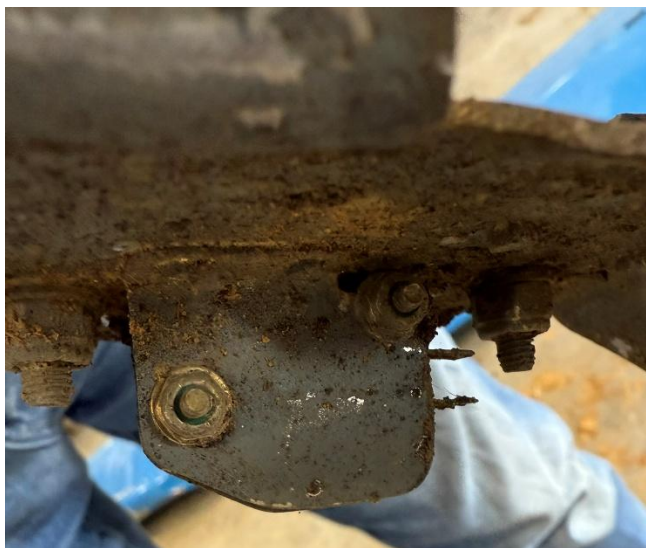
The canopy latch micro switch was installed in the location prescribed by the plans. The switch was tested with a multimeter and was functional. The associated canopy latch pin was inserted into the canopy frame. The canopy latch pin traveled 0.46 inches until the microswitch changed state. The canopy latch pin traveled 0.53 inches until it could no longer be inserted while the switch remained in an engaged state.

The canopy latch micro switch is pictured as recovered in figure 3. The canopy latch microswitch appeared to be installed as per the airframe manufacturer's instructions and was installed such that the microswitch was adjusted to the adjustment point closest to the roll bar (toward the aft of the aircraft).

The recorded canopy latch condition, as recorded by the Garmin EFIS, is discussed in the G3X section of this report. The canopy latch state did not appear to indicate a canopy position configuration type on the ground until the 25<sup>th</sup> recorded flight session.

**Figure 3.** The canopy latch micro switch as recovered, installed in the location defined in the aircraft's plans.

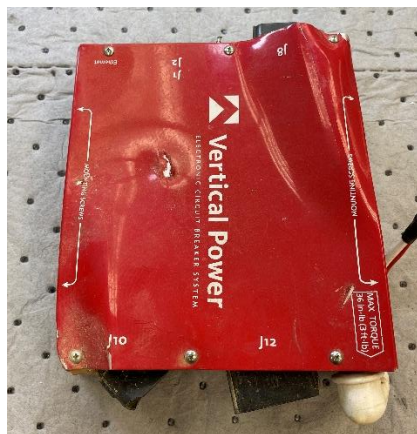
The Vertical Power VP-X Pro is pictured in figure 4. The VP-X sustained some impact damage. The manufacturer of the VP-X unit was contacted and provided a configuration that was uploaded by the builder. Vertical Power reported that they were not able to determine the date of the configuration upload. Figure 5 is the relevant portion of the configuration file that deals with the aircraft's trim system, as

**Figure 4.** The condition of the VP-X Pro Unit.

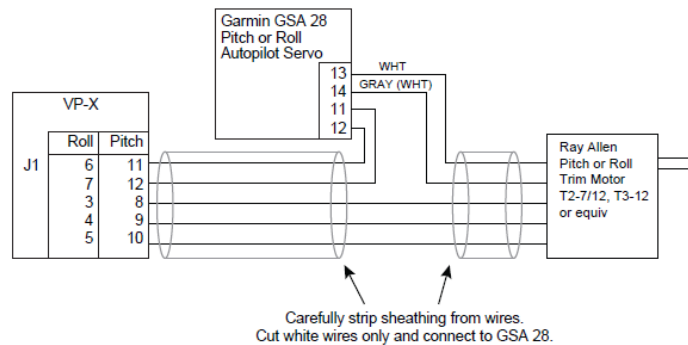
*Wiring GSA 28 Servos to the VP-X.*

Turn off variable speed trim on VP-X.  
Details for non-white wires in VP-X Install Manual.  
Orientation of white/gray (or white/white) wires does not matter to VP-X, and can be changed using the configurator.  
Consult Garmin manual for correct orientation of white wires between GSA 28 and trim motor.

Refer to notes from the wreckage examination, in the public docket for this accident. In summary, the Van's C411J fuselage connector was examined and found connected to the WH-0057 fuselage wiring harness. Specifically, C1037 and C1036 wires were present. Due to damage to the aircraft wreckage, further wiring interfaces to either the Garmin equipment or the Vertical Power equipment, could not be verified.

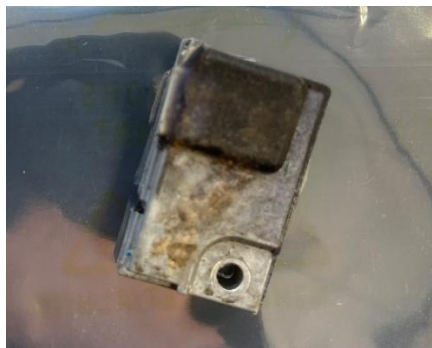
- Most servo gain settings were set to 1.00, which is known to be a starting point for gain values when configuring Vans RV-7/8 aircraft.
- Maximum torque values were set at 45% for both pitch and roll.

- ESP limits were set for 45 degrees for bank and 10 degrees for pitch. The minimum airspeed for ESP engaging was set to 100 knots.
- ESP was set to enable upon power up. Garmin noted that this setting, in conjunction with a minimum ESP enable airspeed of 100 knots, would result in ESP providing stick forces during critical phases of flight, such as after takeoff and before landing, when not below the AGL height threshold that inhibits ESP.

**Figure 7.** The recovered Garmin configuration module.

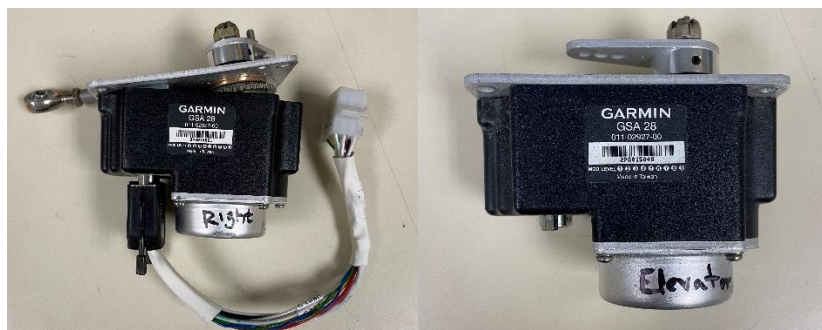
**Figure 8.** The roll servo recovered (left) and the pitch servo (right). Note that the servos had been removed by the salvager, and the condition is not necessarily representative of the installed state.

Garmin Service Bulletin 23038 Rev A was issued in part due to an NTSB investigation (ENG22LA004<sup>1</sup>) into a November 2021 inflight upset involving a Beech F33, where sulphuration caused electrical degradation in a GSA 28 pitch servo, leading to erroneous signals from the pitch trim servo and full nose-down pitch trim command upon autopilot engagement. Garmin noted the sulphuration issues in the ENG22LA004 investigation differed from a previously issued service bulletin (SB 2063) in which sulphuration caused premature failures that were absent of any erroneous signaling.

The service bulletin called for the replacement of the servos installed in the RV-14 aircraft, but neither were complied with by the accident pilot.

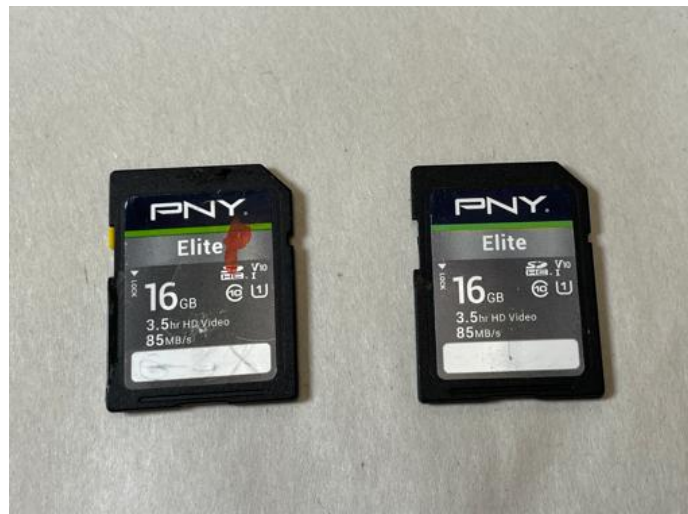
Two Garmin G3X Touch displays were recovered from the accident site. Each display contained an SD memory card capable of recording flight data. The displays are pictured in Figure 9. The SD card from the pilot side (herein referred to as the PFD) was recovered and read out normally. The section below covers information from the SD card associated with the PFD only.

**Figure 9.** The recovered SD card from the pilot's side G3X display (left) and the passenger side G3X Touch display (right).

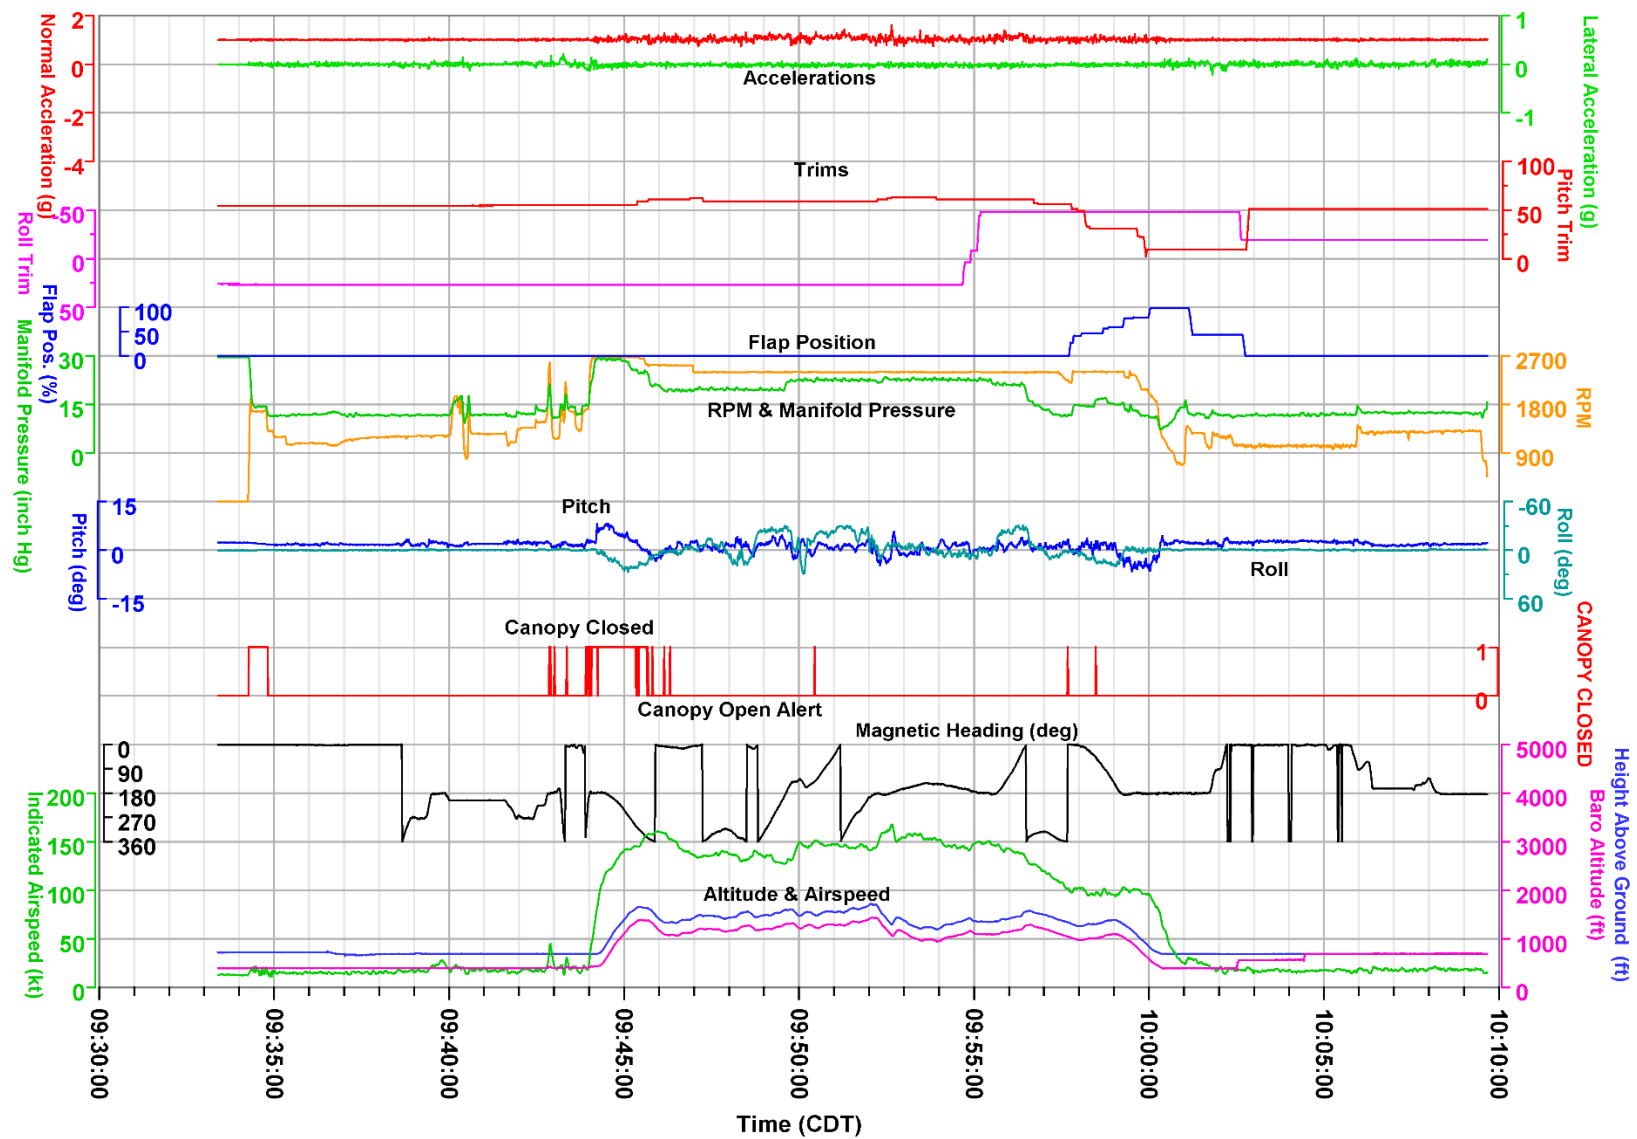
The recording began at 9:33:24 CDT. The flight conducted on May 14, 2023, was local to Litchfield Municipal Airport (3LF), Litchfield, IL, and contained no autopilot use. The EFIS warning for a canopy open condition was present upon the start of the EFIS recording, and at various positions on the ground prior to the flight. The canopy open warning alerted while the aircraft was on takeoff roll, but was no longer present as the aircraft continued its takeoff roll. Around 9:45 CDT, the EFIS warning began triggering intermittently while the aircraft was at 155 KIAS and 1380 feet MSL. By 9:46:40 CDT, the canopy warning was recorded as 'Canopy Open' for the remainder of the flight. The aircraft continued to fly with the canopy warning present until the aircraft landed at 3LF. The maximum airspeed achieved on this flight was 167.5 KIAS which was recorded at 9:52:40.

Figure 10 is a plot of basic parameters during the flight conducted on May 14, 2023, and contains the conditions of the canopy warning status parameter.

**Figure 10.** A plot of basic parameters during flight 27, which was conducted on May 14, 2023, showing canopy status.

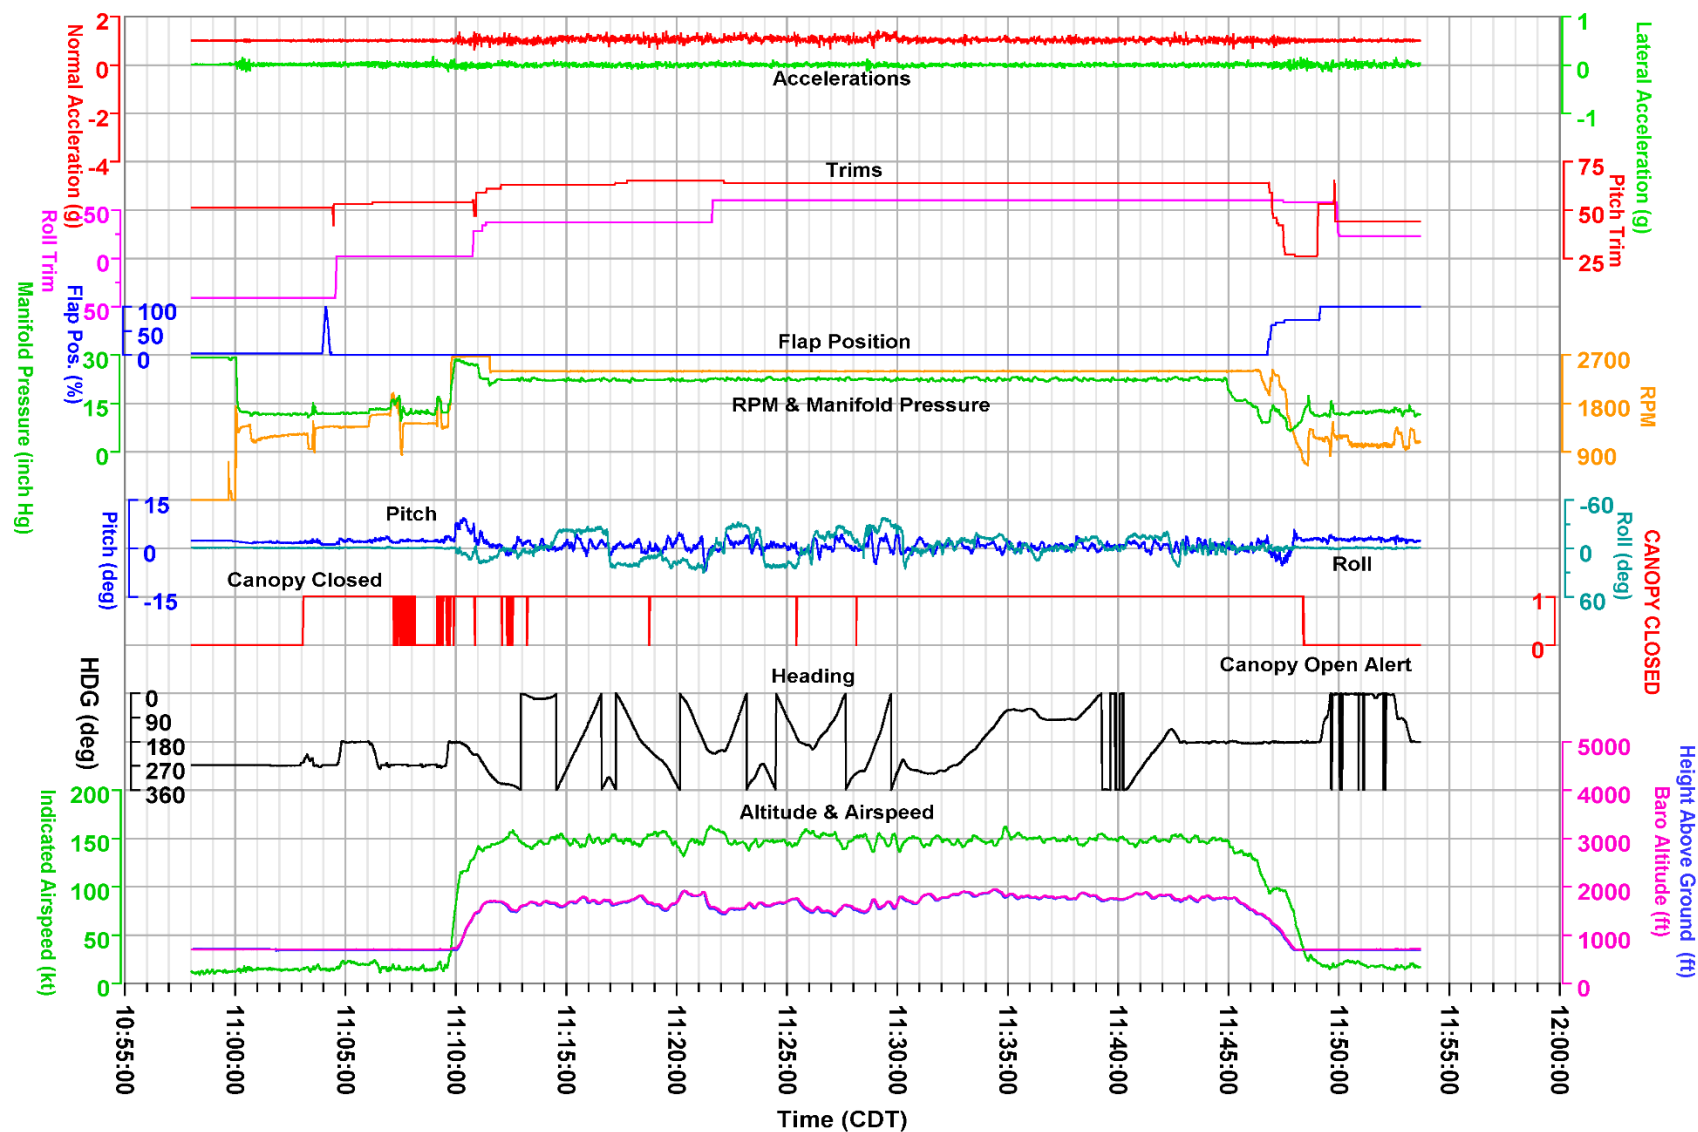
The recording started at 10:58:02 CDT. The flight conducted on August 6, 2023, was local to 3LF and contained no autopilot use. The EFIS warning for a canopy open condition was present upon the start of the EFIS recording<sup>2</sup>. By 11:03 CDT, the canopy warning ceased, and the aircraft was near the ramp and hangars of 3LF. Around 11:07:30 CDT, the canopy warning was recorded intermittently while the aircraft was on a taxiway. The canopy warning continued to trigger intermittently until around 11:10 CDT while the aircraft was on takeoff roll. The canopy warning ceased as the aircraft departed 3LF. The canopy warning triggered intermittently during the early phase of the flight. The aircraft landed at 3LF around 11:48 CDT.

Figure 22 is a plot of basic parameters during the flight conducted on August 6, 2023, and contains the conditions of the canopy warning status parameter.

**Figure 22.** A plot of basic parameters during flight 39 which was conducted on August 6, 2023, showing canopy status.

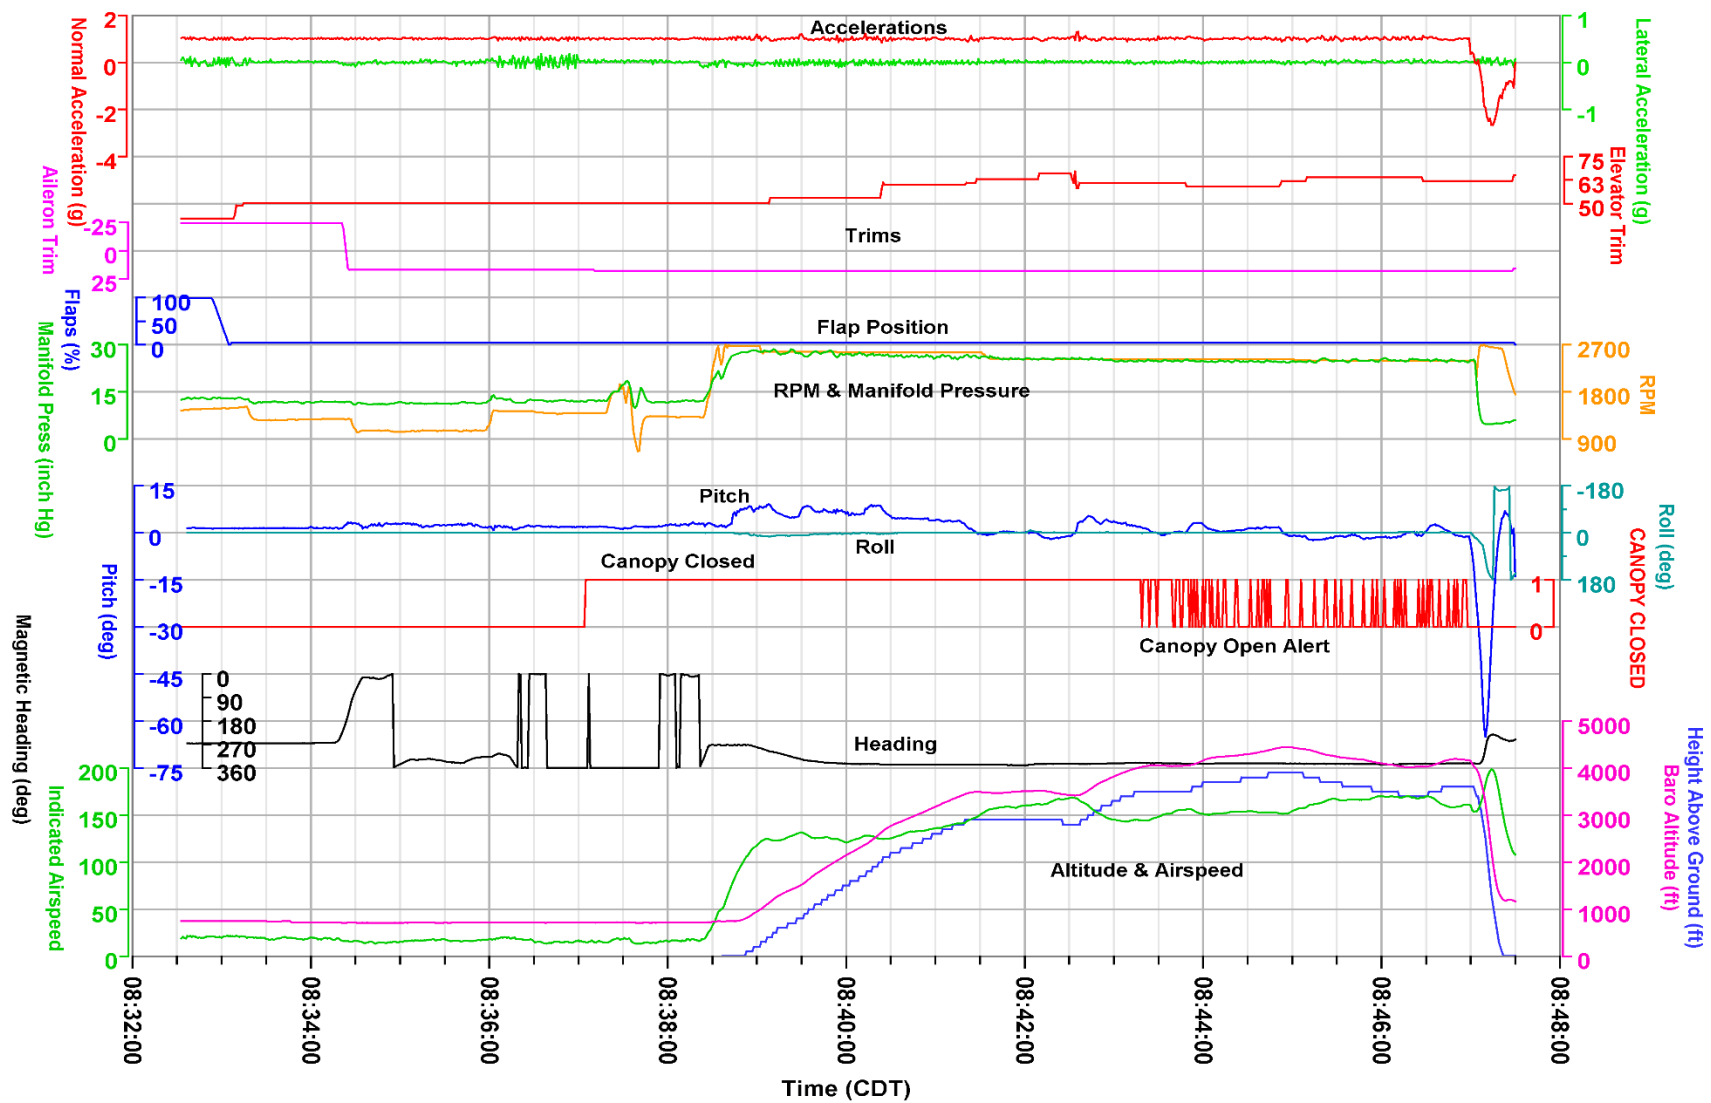
Figure 23 is a plot of basic parameters during the accident flight on August 12, 2023, and contains the conditions of the canopy warning status parameter.

**Figure 23.** A plot of basic flight and engine parameters for the entire accident flight (flight 40).

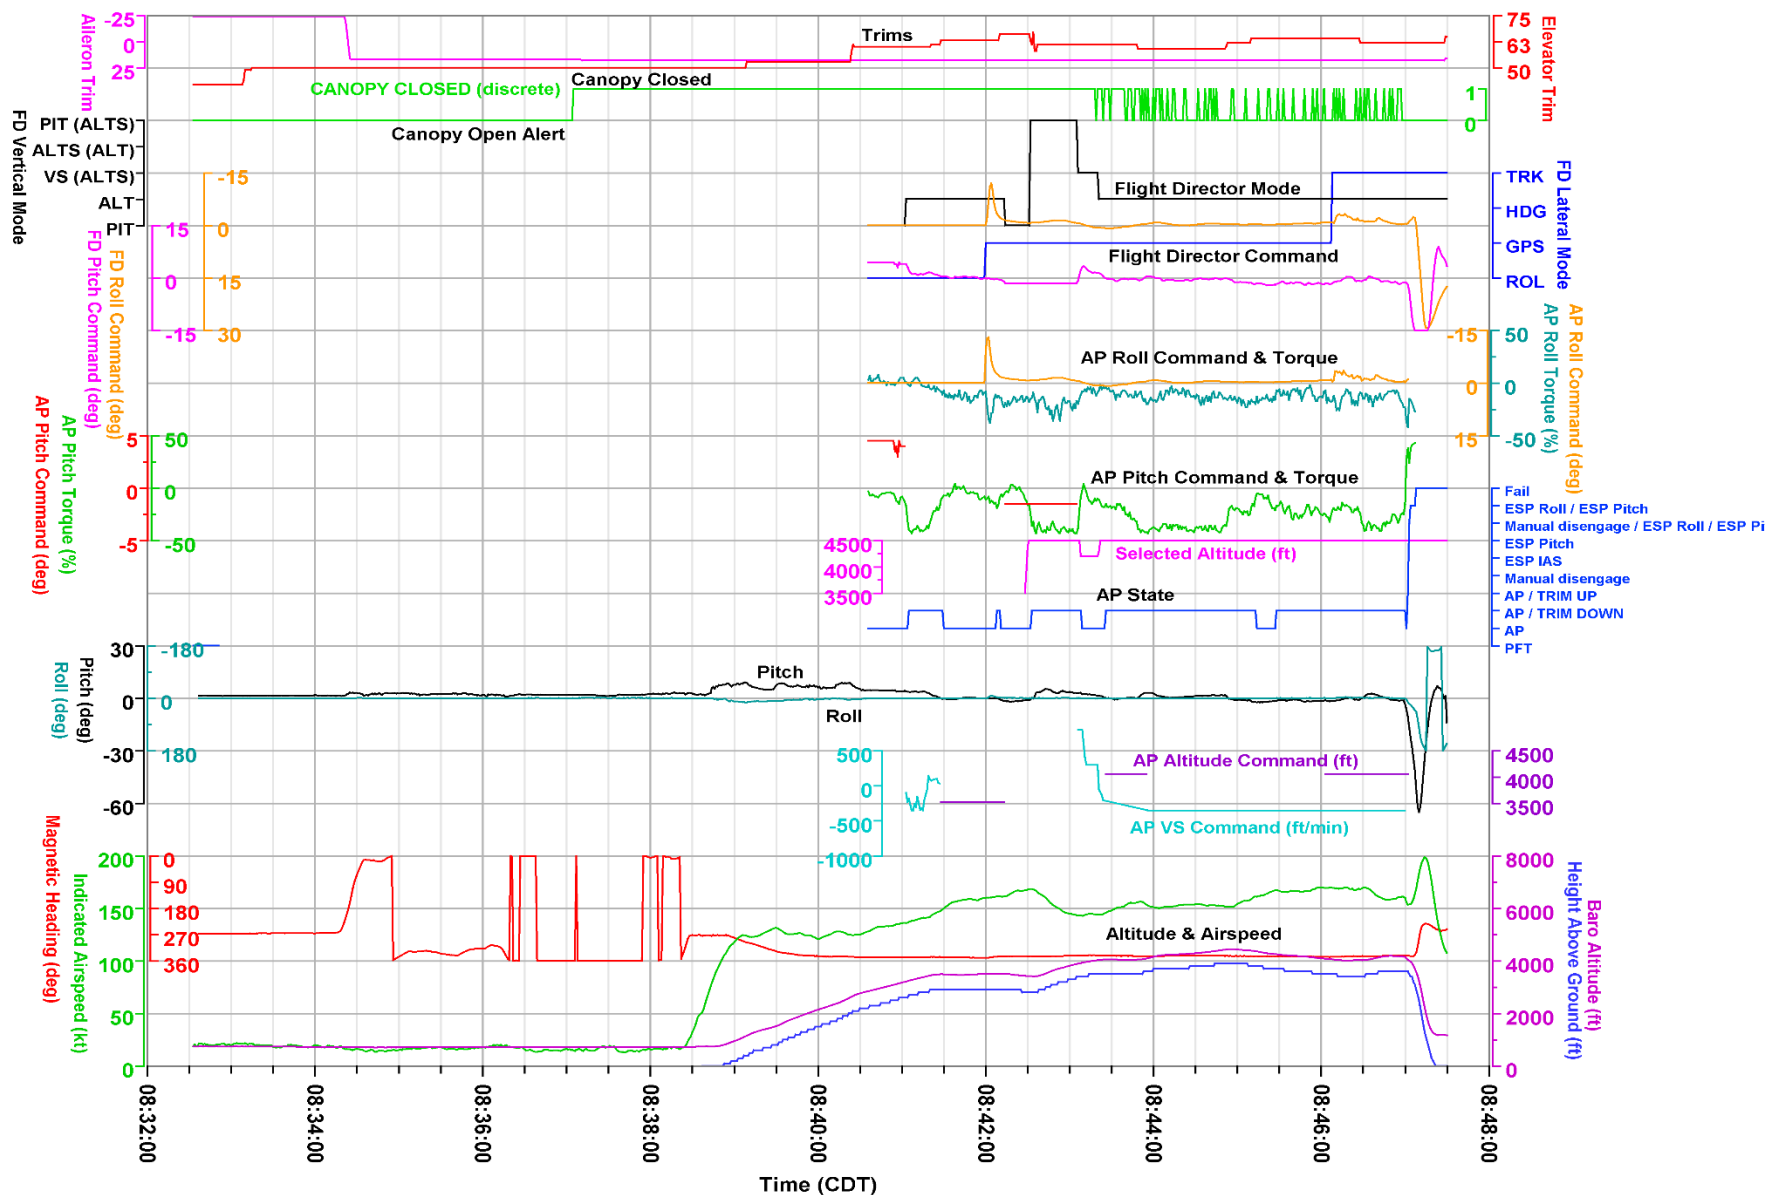
Figure 29 is a plot of basic parameters and numerous autopilot-related parameters during the accident flight on August 12, 2023. The plot contains the condition of the canopy warning status parameter. Note that the values for AP Pitch Torque % differ from previously plotted flights in which autopilot usage was engaged.

**Figure 29.** A plot of autopilot related parameters for the entire accident flight.

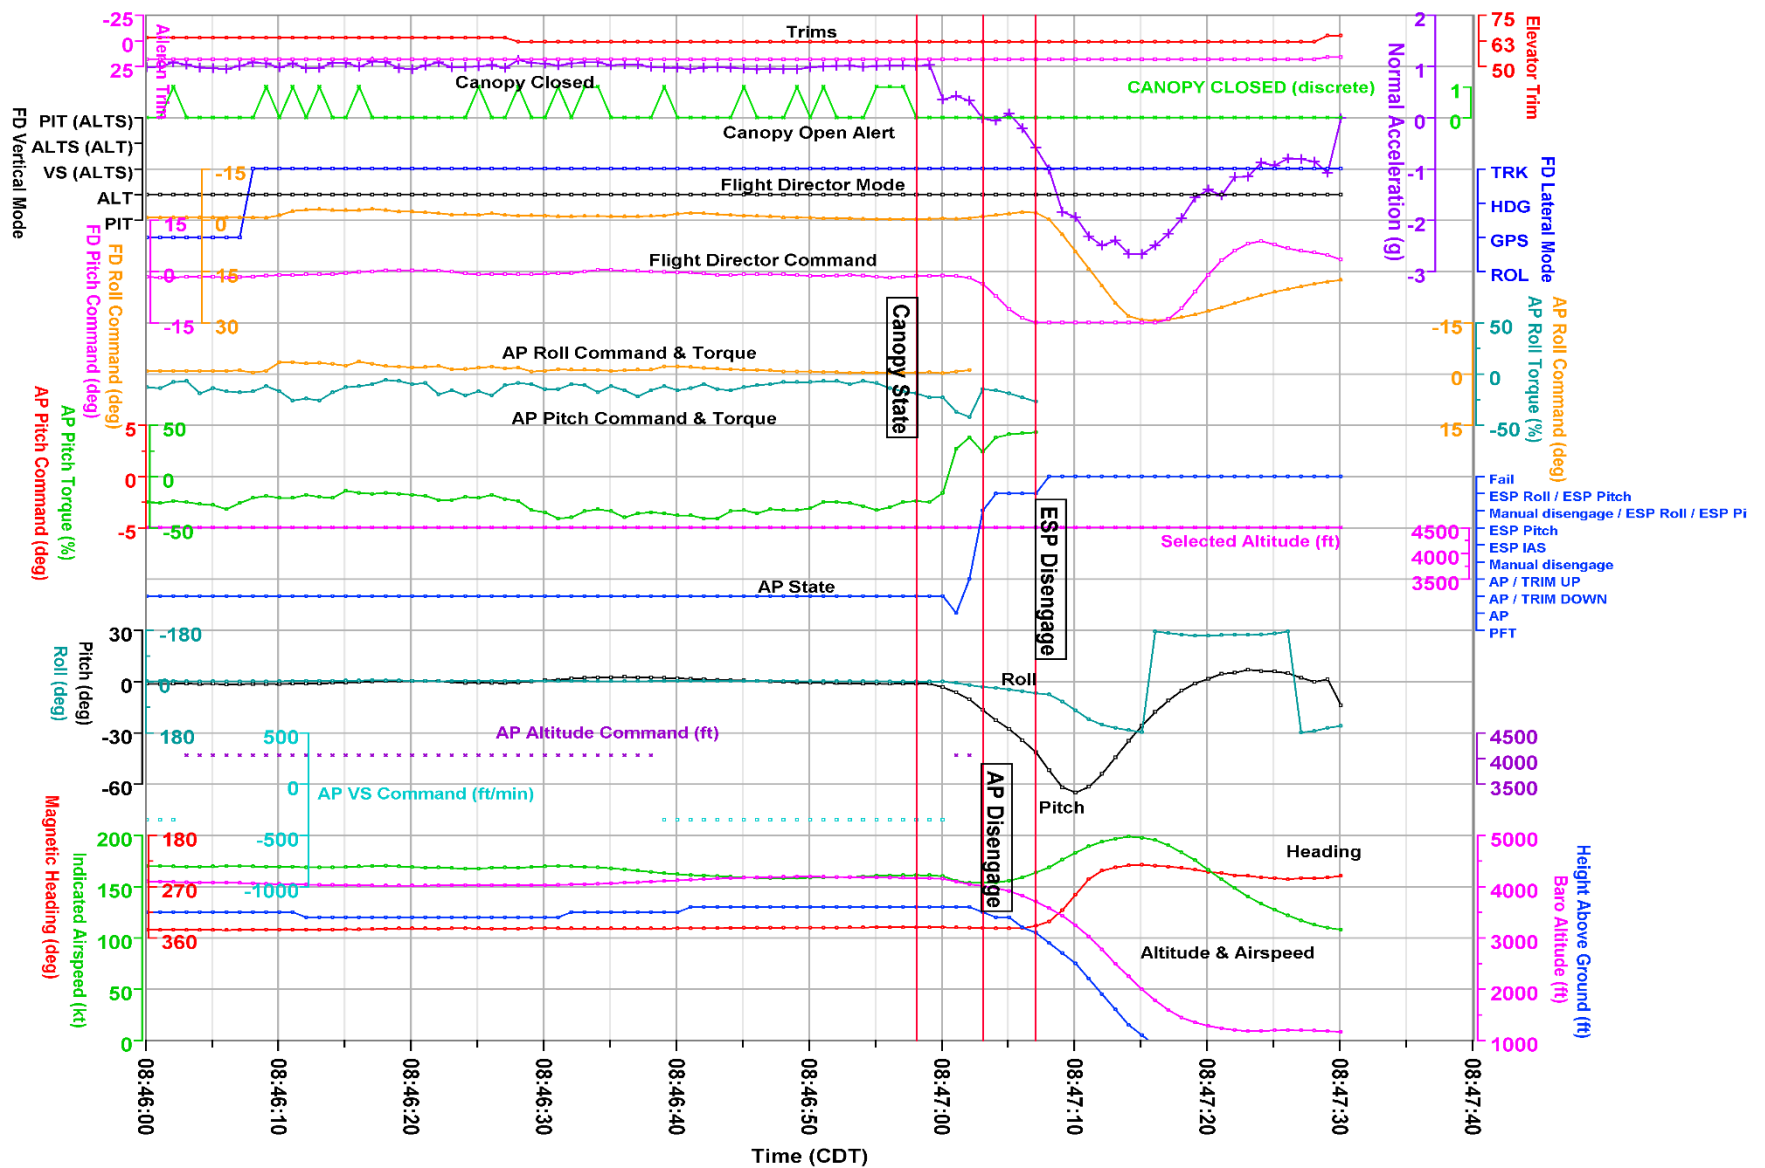
By 8:47:08, the AP State was recorded as "Fail" and information provided by Garmin's download of the configuration module showed that the autopilot was outside of engagement limits at this time. Pitch was 52 degrees nose low and about 46 degrees right roll. Indicated Airspeed continued to increase rapidly, and altitude continued to decrease rapidly. Normal Acceleration (Z) was around -1g at this time.

Figure 32 is an expanded time scale plot of basic parameters and numerous autopilot-related parameters during the accident flight on August 12, 2023. The plot contains the condition of the canopy warning status parameter. The plot shows the last approximate 100 seconds of flight. Canopy warning state change, the time the

**Figure 32.** A plot of autopilot related parameters for the last 100 seconds of flight. The values for Normal Acceleration (Z Accel.) have been added to this plot.
