# National Transportation Safety Board

CEN23FA359

## **AIRFRAME EXAMINATION**

Location: Virden, IL  
Date: August 12, 2023  
Time: 0848 central daylight time  
1347 UTC  
Airplane: Van's RV-14A

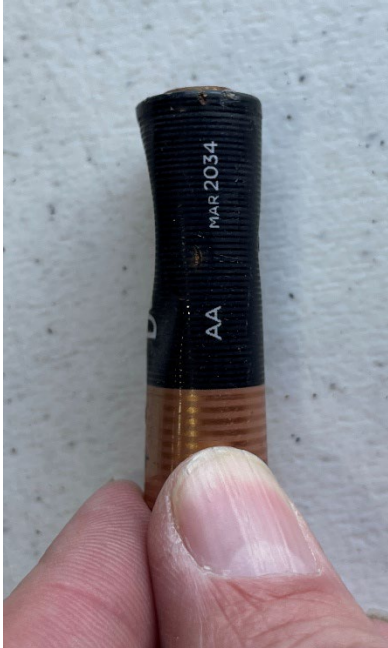
Figure 1. AA battery

When cutting and manipulating the lower fuselage skin open, a AA battery with a best by date of March 2034 fell out (see figure 1). There was a semi-circular dent on one side of the battery (see figure 2) and a small dent on the other side near the same diameter as a rivet (see figure 3).

The area where the battery was found would have been sealed during assembly of the airplane. It could not be determined when the battery would have been introduced to that area.

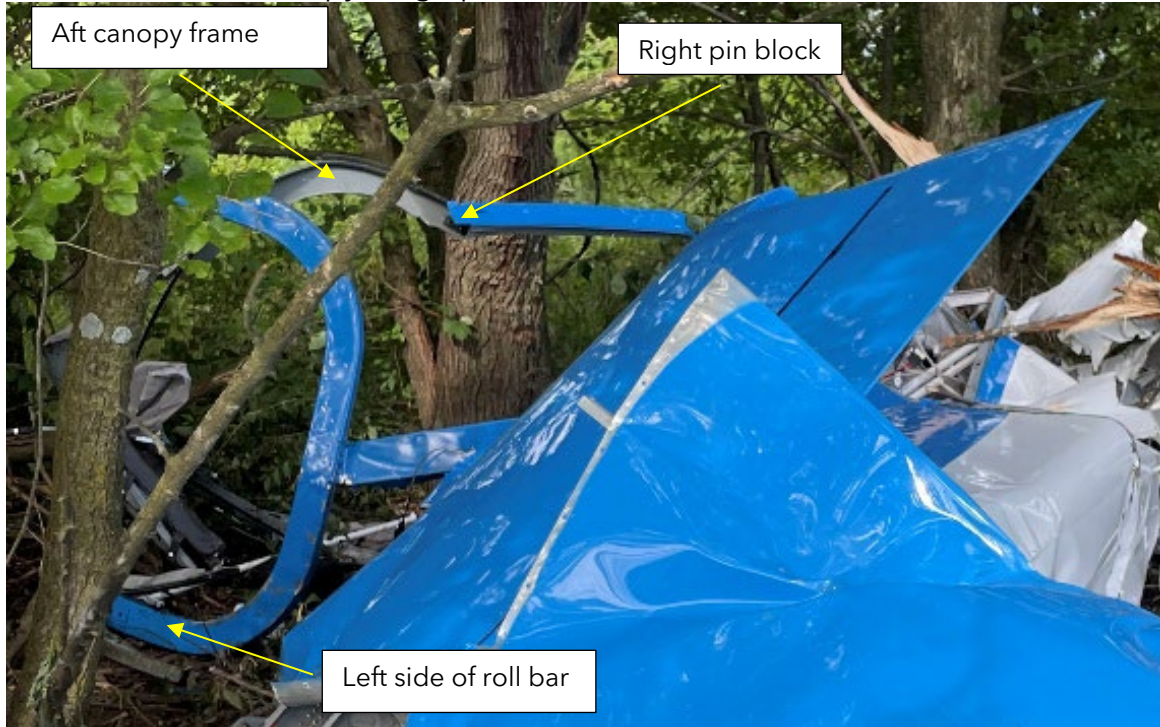
Figure 6. Canopy components

The airplane was equipped with a tip-up style canopy. Examination of the airplane's canopy found that it was impact damaged and fractured in multiple locations. The roll bar was separated from the primary structure. The canopy hinge plates remained attached to the forward canopy frame. The canopy release pins were inserted into the canopy hinge plate.

The canopy release handle remained attached to the jettison system and the release pins were engaged in a non-jettison position. The canopy release handle remained attached to the jettison system. The builder shortened the jettison t-handle, and due to impact forces, was located behind the instrument panel; it is likely due to handle sitting on top of the radio stacks during impact.

The canopy hinge plate hinge (p/n C-01412) was buckled laterally beneath the forward top skin (p/n F-01471). The canopy latch pushrod was found fractured. Both the left and right latch bellcranks were deformed and jammed. The canopy latch torque tube was fractured, and the latches were found partially disengaged.

The canopy latch micro switch remained attached to the frame (see section 2.4). The canopy frame was buckled outward on both sides. The canopy acrylic had shattered during impact and fragments were found scattered around the accident site.

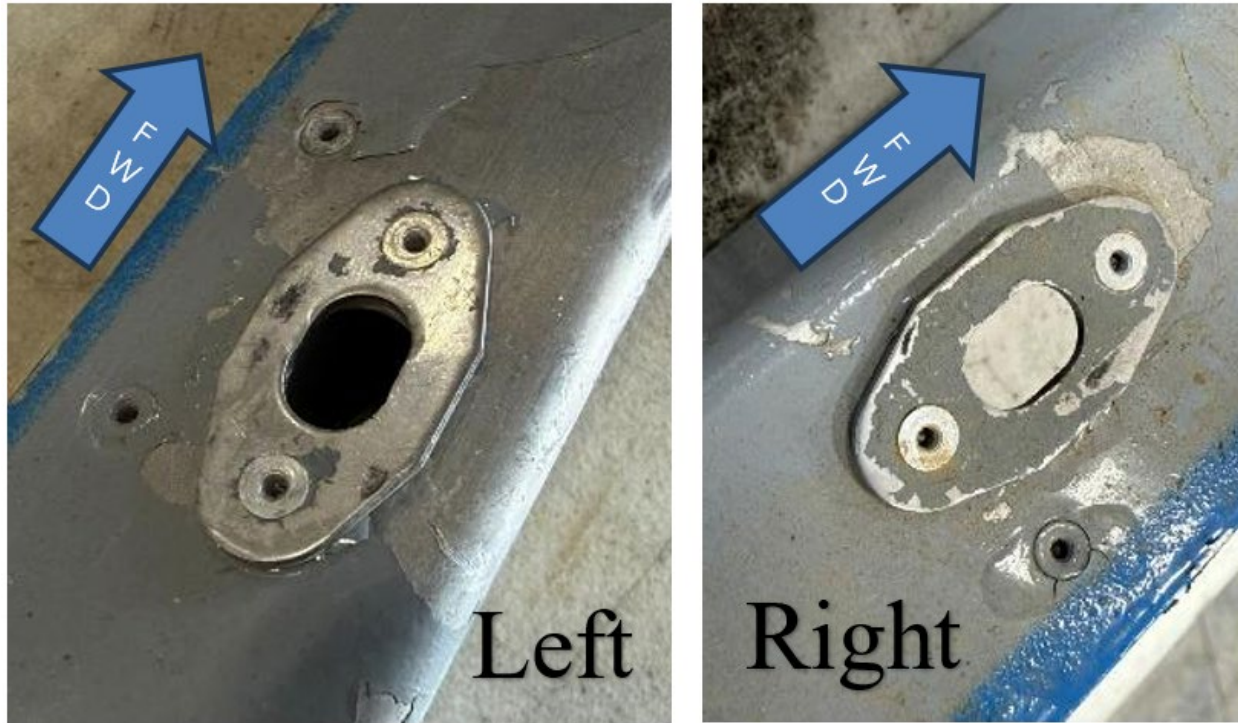
Figure 7. Guide plates

Both guide plates were p/n C-01451 and installed on either side of the canopy deck. The left guide plate had minor scuffing consistent with normal wear. The right guide plate had scoring around its circumference.

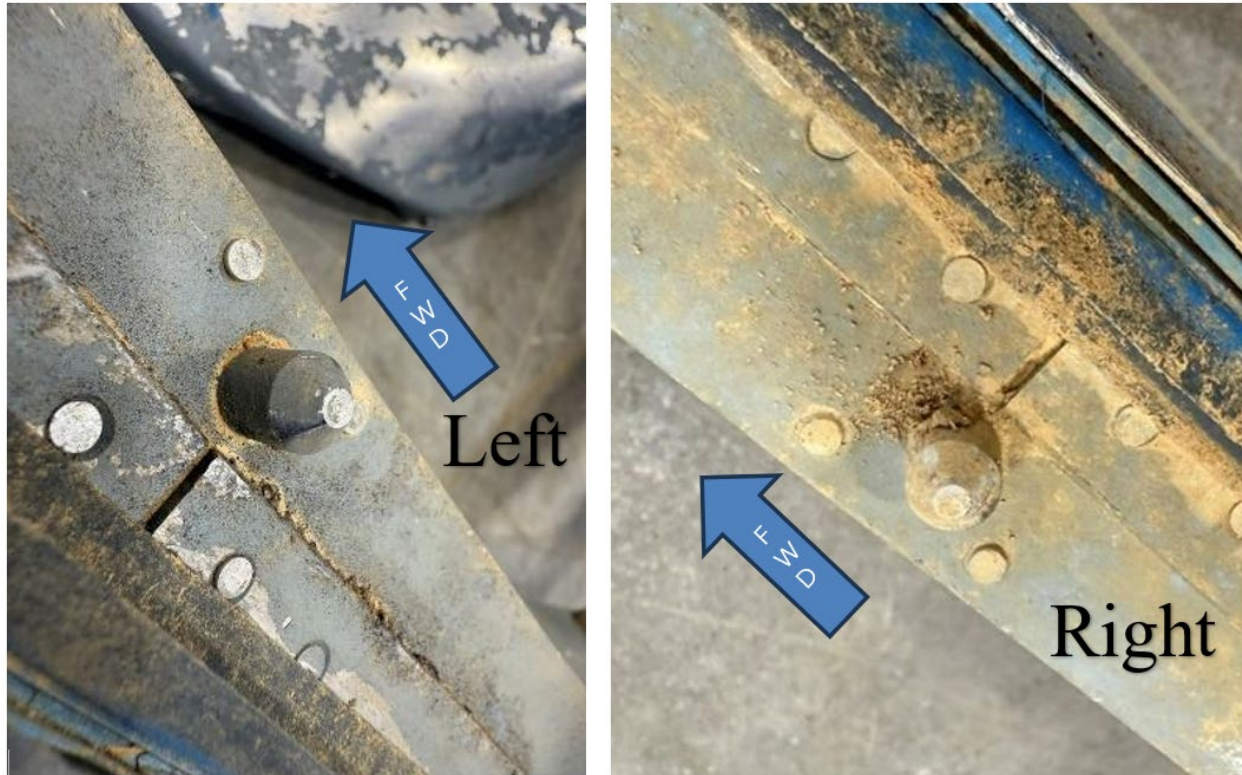
Figure 8. Guide pins (photos provided by Van's Aircraft)

Both guide pins were p/n C-01453 and installed on either side of the tip-up canopy. The guide pins seat into the guide plates when the canopy is closed. The left pin guide had minor scuffing consistent with normal wear. The guide pin had scoring around its circumference.

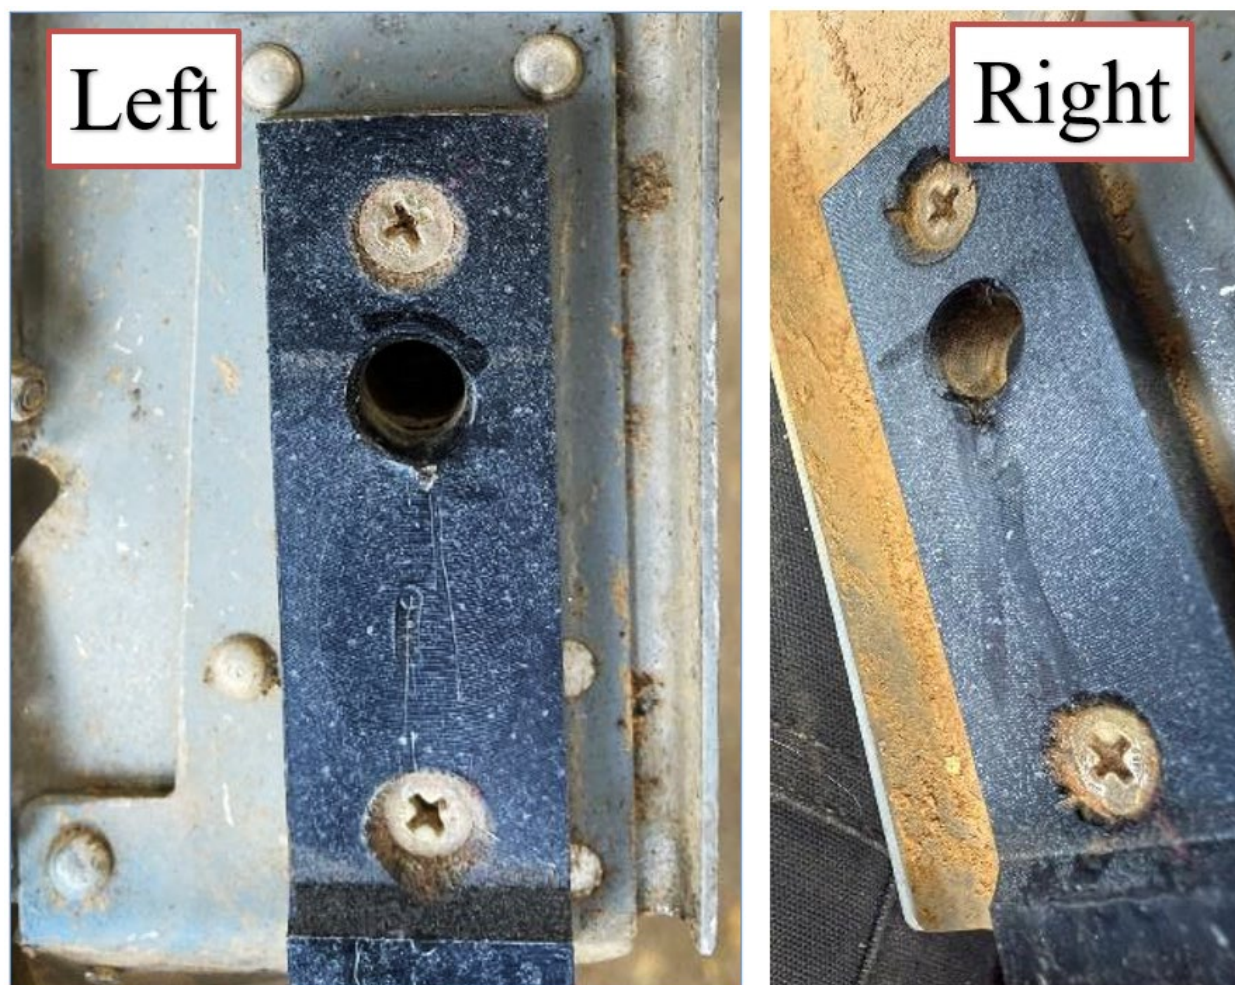
Figure 9. Pin blocks (right photo provided by Van's Aircraft)

The back of the left side pin block was covered in earthen debris. Once cleaned it revealed a score mark near the 5 o'clock position with about one-inch-long gouge trailing below it. Additionally, a vertical gouge mark started about mid-block downwards towards the 6 o'clock position. The bottom of the pin block had divots consistent with the canopy having rested previously on the latch pin.

The back of the right side pin block had a score mark near the 7 o'clock position, with about one-inch-long gouge trailing below it. The bottom of the pin block had divots consistent with the canopy having rested previously on the latch pin.

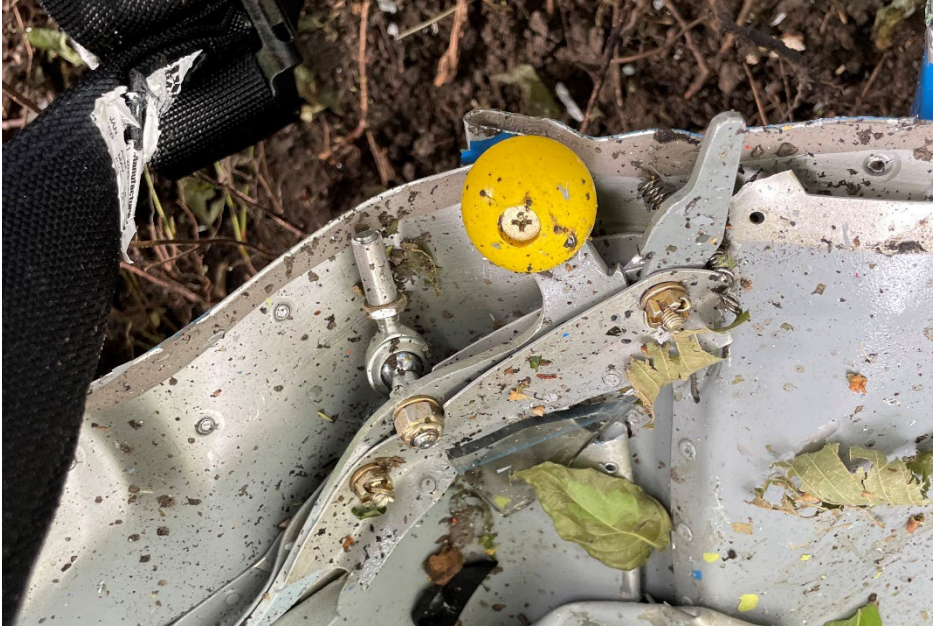
Figure 10. Canopy latch handle and canopy latch

The Van's provided knob (VA-104-01A) was mounted to the latch handle (p/n C-607-1) and installed on the left side of the cockpit. The latch handle was found in the closed position, and the canopy latch had shifted forward. Preimpact positions could not be determined.

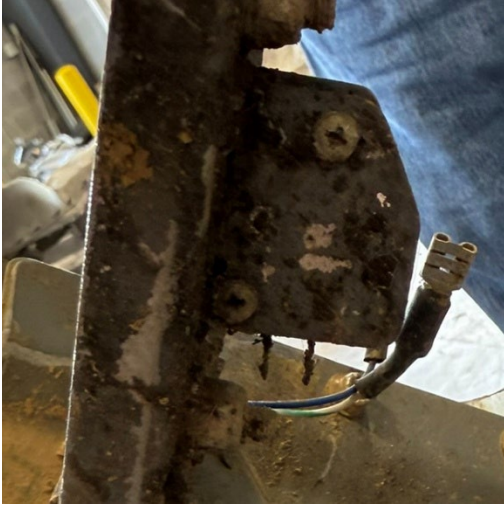
Figure 12. Canopy latch micro switch (photo by Van's Aircraft)

After micro switch installation, the builder should set the micro switch's position in an assembled bracket so that left canopy pin only begins to depresses the micro switch's plunger when the pin is fully seated and the canopy is closed. A check of the micro switch's functionality showed that the switch operated within tolerances. The canopy latch micro switch was found in the aft-most position setting. This setting could allow for the micro switch to signal that the canopy is closed when additional canopy pin travel is needed for the canopy to be fully closed.
