# National Transportation Safety Board

CEN23FA361

## POWERPLANTS

Specialist's Factual Report

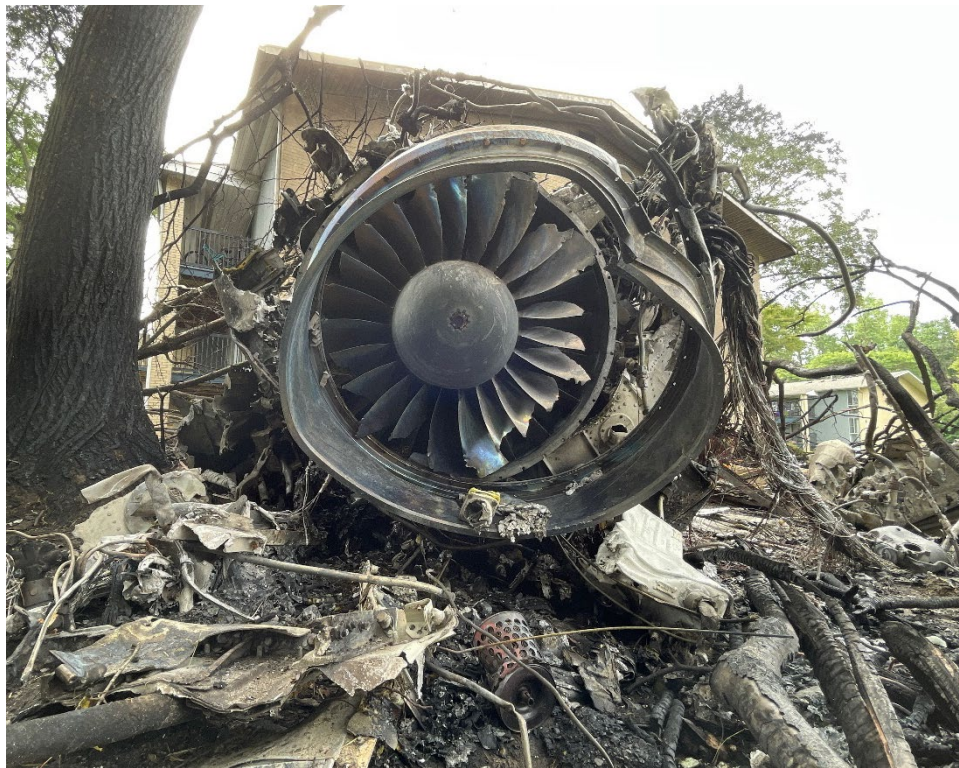
The fan blades exhibited multiple hard body impacts on the leading edges, multiple blade tip fractures on different blades around the circumference (i.e. not localized), and circumferential scoring and rub marks on the spinner dome, all suggesting the engine was rotating under power at the time of impact. However, based on this visual evidence it is not possible to estimate an exact power level. This seems to corroborate the pilot's statement that the engine was operating and producing some level of thrust during the incident flight.
