# National Transportation Safety Board

CEN23FA391

## EXAMINATION SUMMARY

Location: Wellington, Colorado  
Date: August 31, 2023  
Time: 1358 MDT  
1958 UTC  
Airplane: Alexander Scheicher - ASH 26E - N50FU

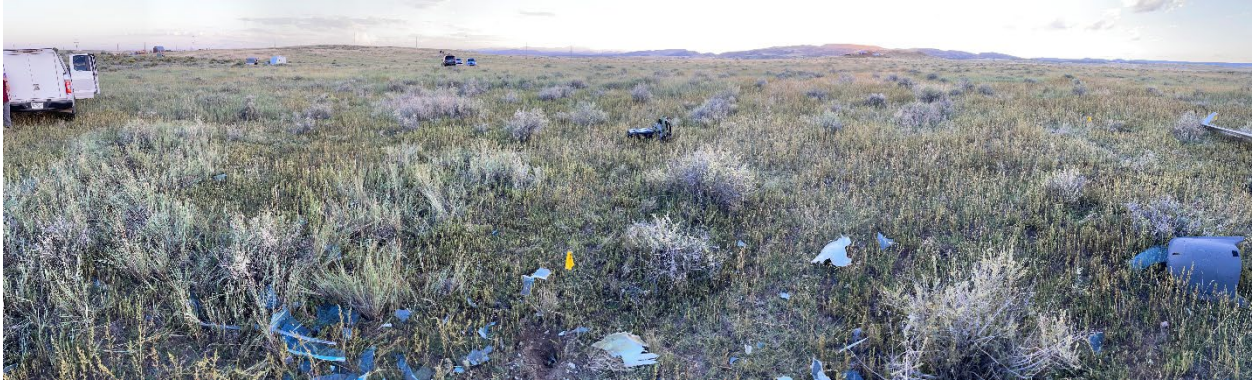
Figure 1. Ground Impression

The glider impacted terrain (Lat/Long: +40.868942° / -105.082558°) in a field about 6 nautical miles northwest of the Owl Canyon Gliderport (4CO2). The glider came to rest facing about 213° about 15 ft rearward of the initial impact site. The entire glider was located at the accident site with no post-crash fire. The debris field included the main impact point out to radius of about 60 ft. A ground scar imprint of both wing leading edges was present in the terrain that equaled the wingspan distance of 59 ft. Location of the leading-

edge impression is consistent with the airplane in a nose down near vertical-to-vertical orientation at impact. The initial impact point consisted of a shallow circular ground impression surrounded by forward fuselage fragments. (See Figure 1.

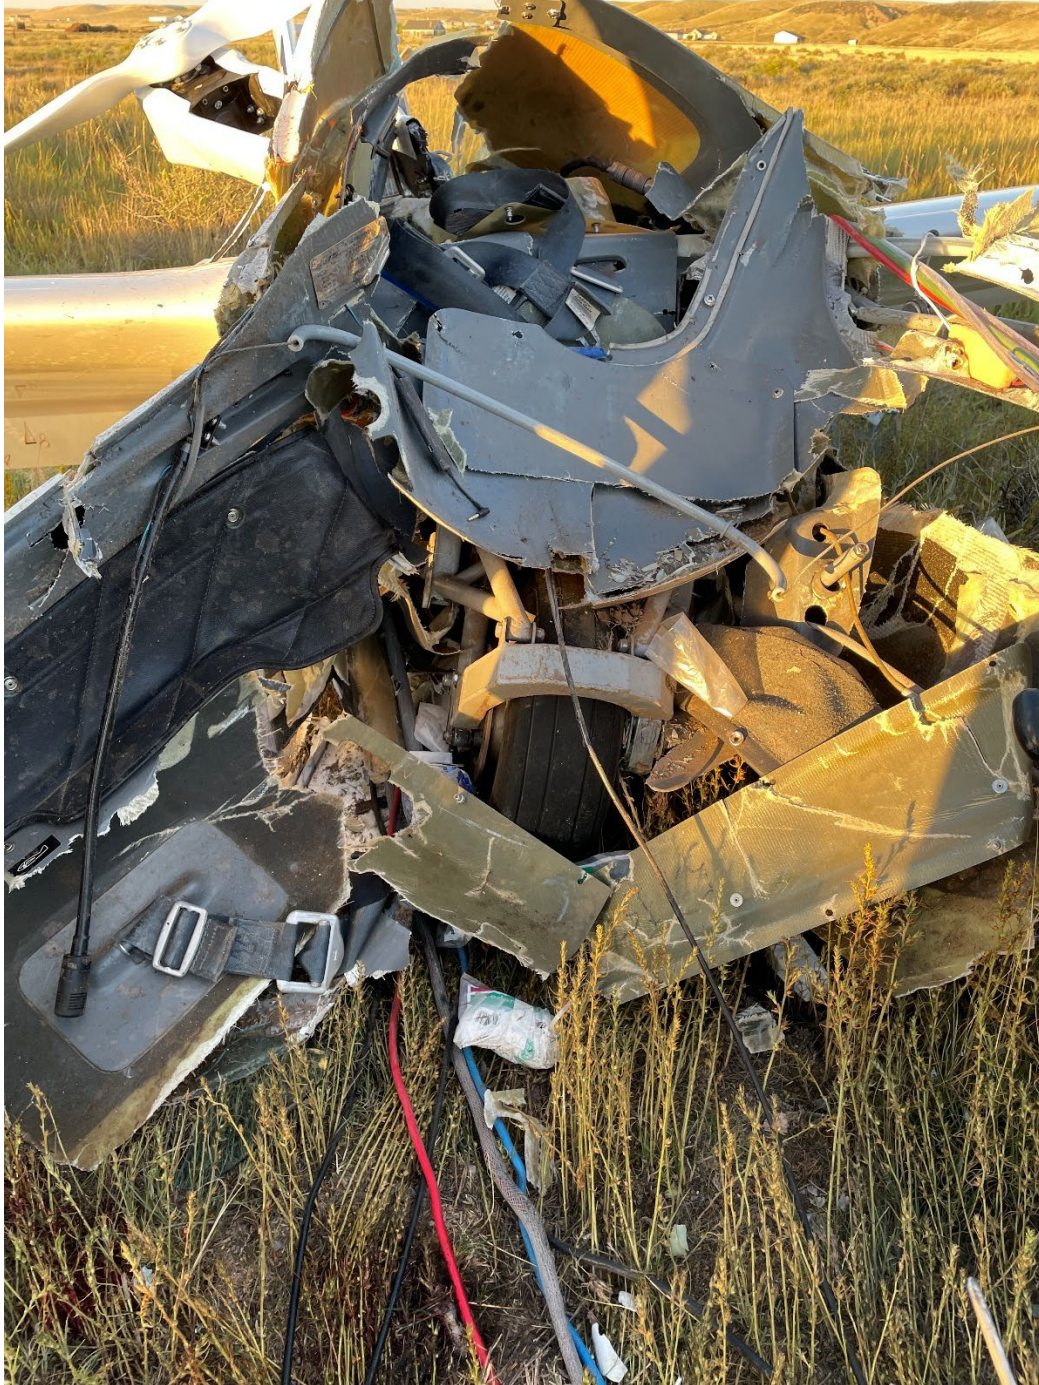
Figure 2. Fuselage

The fuselage came to rest upright with crush damage from the nose to the rear cockpit bulkhead. The forward fuselage was heavily fragmented consistent with a high energy near vertical impact. Various composite debris from the forward fuselage were found in the surrounding field. The pilot seat lap belt was found unlatched and underneath the pilot and the shoulder harnesses were found unlatched and stowed in the cockpit shelf behind the pilot seat. (See Figure 2)

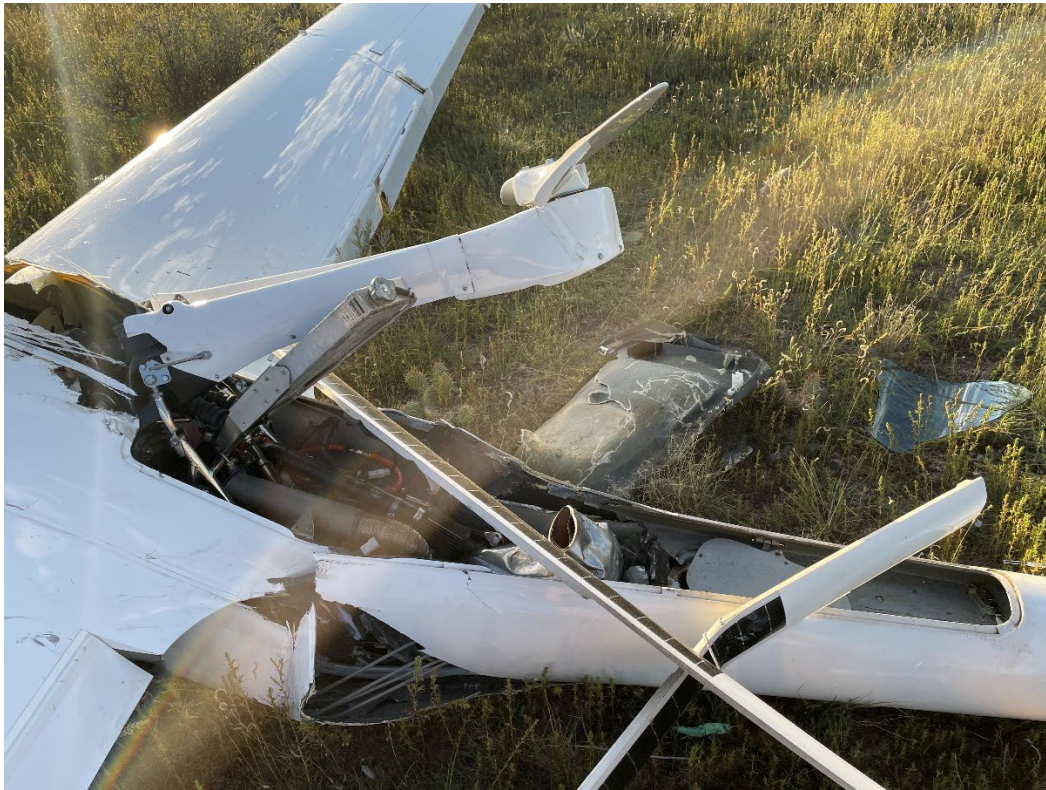
Figure 3. Engine and Empennage

The empennage came to rest still attached to the fuselage with crush damage on the first 2 ft of the tail boom. The stowable propeller assembly was in the unstowed and in the EXTENDED COOL DOWN position. Both engine bay doors were separated at their respective hinges and between the engine

and tail boom. (See Figure 3) The horizontal and vertical stabilizer had only cosmetic damage. Flight control continuity was established from the elevator and rudder to the fuselage cockpit rear bulkhead. Continuity from the bulkhead to the control stick and rudder pedals was not able to be determined due to crush damage and fragmentation of the forward fuselage.

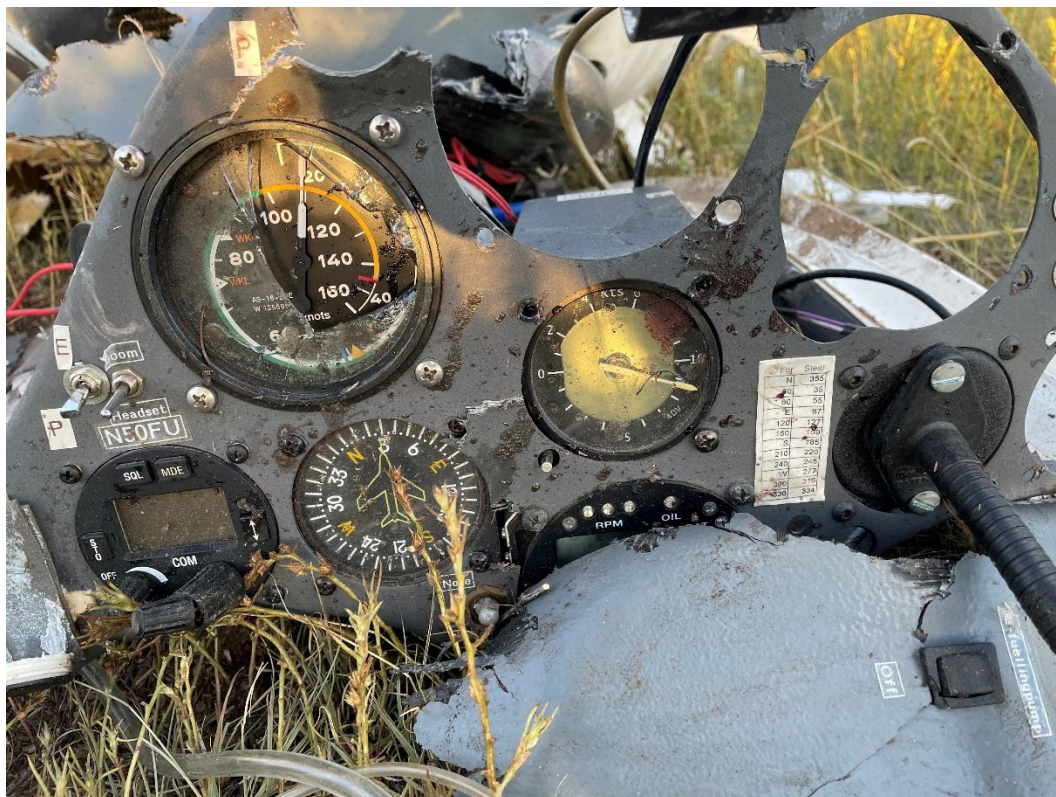
Figure 4. Cockpit Instrument Panel

The cockpit was fragmented along with the forward fuselage from impact related damage. The engine controls were found in the RUN position with the throttle at SHUT. The master switch position could not be determined due to impact damage to the switch. All cockpit instruments were located with impact related damage. The LXNAV Variometer, S/N 05708, was recovered and shipped to the Recorders Lab for data download. The altimeter was located in the debris field with a selector altimeter setting of 29.91. The pilot lap seatbelt was found unlatched and underneath the pilot and the shoulder harness was found unlatched and stowed in the cockpit shelf behind the pilot seat. The handheld LXNAV Nano 3 Flight Recorder mounted on the glareshield was not located. The mount and attachment hardware was located in the debris field. However, the transmitted FLARM data was recovered by the soaring club. (See Figure 4)

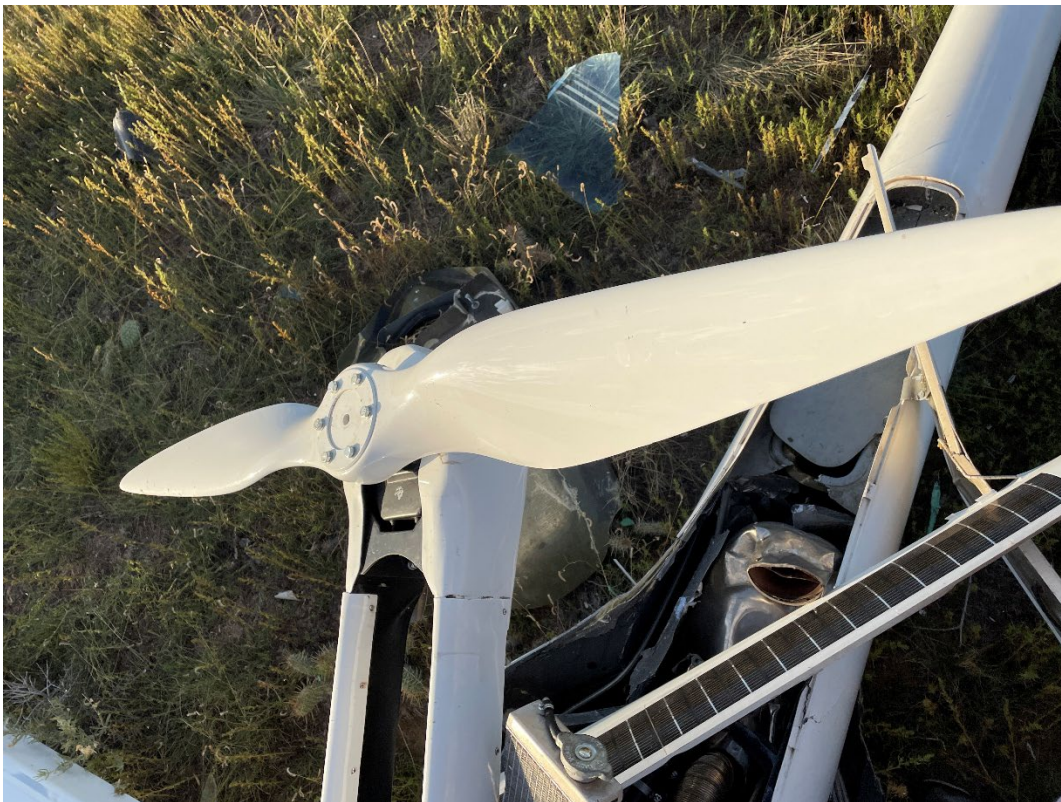
Figure 5. Propeller

The propeller was found in the unstowed horizontal position. Both blades had no impact or rotational damage or witness marks. No mechanical failures or malfunctions could be found that would have precluded normal operation. (See Figure 5)
