# National Transportation Safety Board

CEN23FA401

## **WRECKAGE EXAMINATION SUMMARY**

Location: Huntsville, Texas  
Date: September 6, 2023  
Time: 1148 central daylight time (1648 UTC)  
Airplane: Cessna 150K, Registration No. N6059G

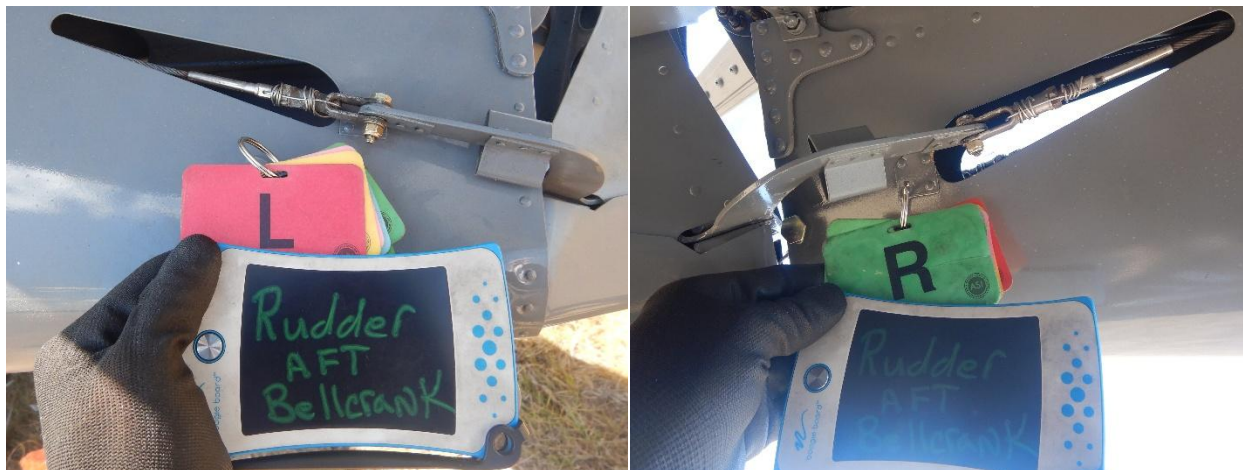
**Figure 3.** Postaccident rudder bellcrank connections (left and right)

On the morning of the accident, the flight instructor asked an aviation mechanic at Conroe/North Houston Regional Airport (CXO), Conroe, Texas, to examine the rudder cable connections at the rudder horn. According to the mechanic, a self-locking nut was found loose (backed off) almost completely from one of the two bolts that secured the rudder cables to the rudder horn. The mechanic and flight instructor discussed this and other discrepancies that the flight instructor had recently seen since the airplane was returned to service following it being painted during the prior month (August 2023). The mechanic recommended not flying the airplane until a thorough inspection of the airplane was completed. A review of the airframe logbook did not reveal a log entry detailing the rudder cable connection discrepancy or how it was resolved. However, based on the postaccident examination, all rudder horn and rudder control cables hardware were present and remained connected, as shown in figure 3.

The cockpit control column assembly exhibited impact related damage. The aileron control chain remained intact and partially attached to each control column sprocket. The aileron forward bellcrank/arm assembly remained attached to the control column with attached cables. The aileron balance cable remained continuous between the aileron bellcranks. The elevator control tube remained attached to the cockpit control column. The aft end of the elevator control tube was displaced aft about 6 inches and separated from the elevator forward bellcrank, which fractured into two halves with attached cables; the fracture exhibited signatures consistent with an overstress separation due to impact related damage. The rudder cables were continuous from the cockpit pedals to the rudder control horn, where all hardware was present and connected, as previously shown in figure 3.

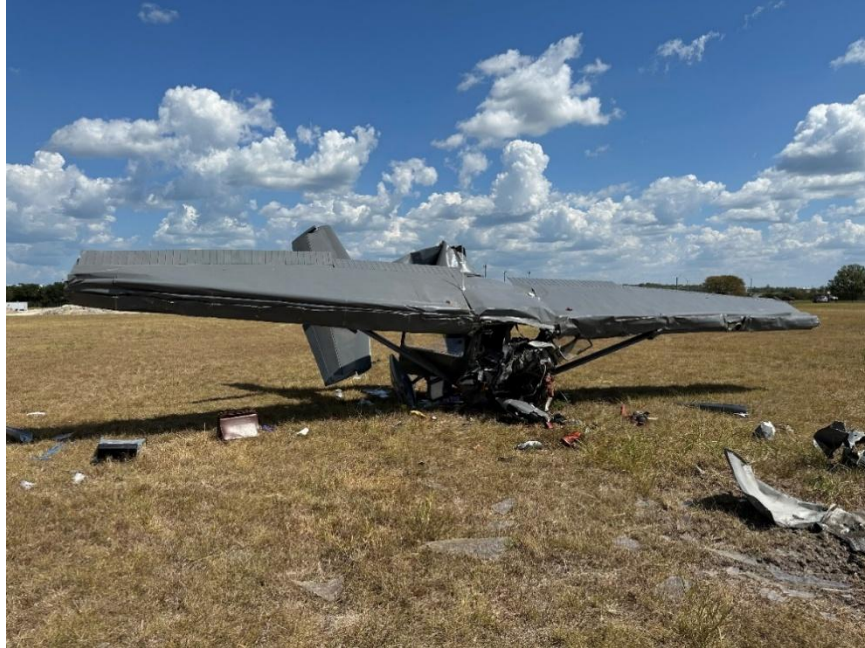
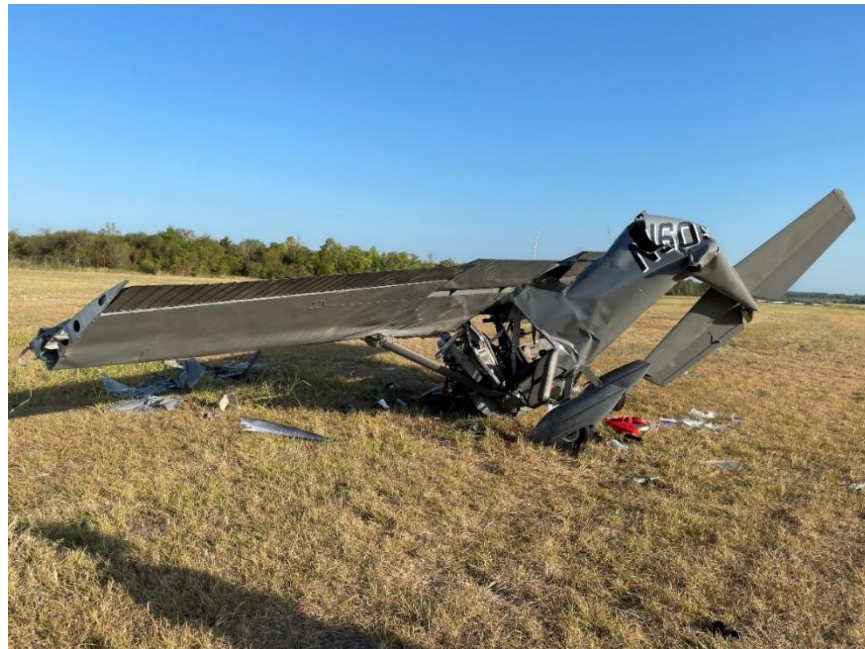
The airplane crashed into an open grass area at Huntsville Municipal Airport (UTS), Huntsville, Texas. The airplane came to rest nose down at 30.738928° north latitude, 95.587989° west longitude, at 362 ft msl. An on-scene survey revealed that the main wreckage was about 407 ft south of the end of runway 18 and about 40 ft east of the extended runway centerline. The aircraft wreckage was found about 15 ft east of the initial ground impact point. The airplane came to rest upright and nose down on a west heading, as shown in figures 4 and 5.

All structural components and flight control surfaces were located at the accident site. The main landing gear remained attached to the fuselage. The nose landing gear partially separated from its attachment points and was found to the right of the engine.

The left and right wings and their wing struts remained attached to their attachment points. The leading edge of both wings were crushed aft to their respective main

spars. The tail was canted forward and to the right beginning about 3 ft aft of the rear cabin window. The empennage was relatively undamaged with minimal impact damage.

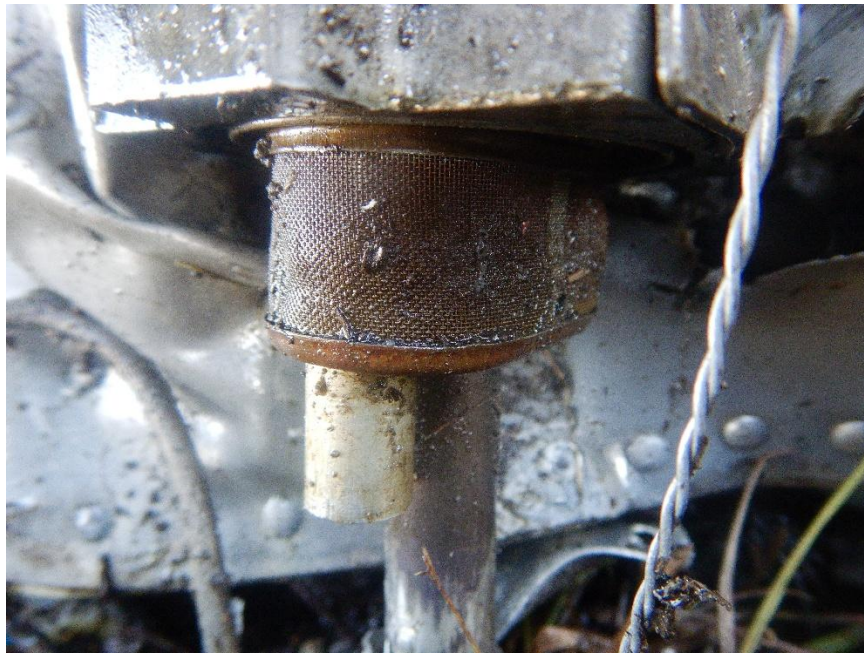
**Figure 6.** Fuel strainer screen filter

shutoff valve assembly remained intact. The fuel lines from each wing fuel tank combined through a Y-shaped fuel fitting upstream of the fuel shutoff valve, as previously shown in figure 1. The fuel line from the fuel shutoff valve assembly to the fuel strainer assembly was impact separated about 2 inches forward of the fuel shutoff valve assembly. The fuel strainer assembly was displaced aft through the firewall into the cockpit floor area. The filter bowl was separated from the fuel strainer assembly and was impact damaged. The fuel strainer screen filter remained attached to the fuel strainer and exhibited debris, as shown in figure 6. The fuel line from the fuel strainer assembly to the carburetor was separated and not observed.

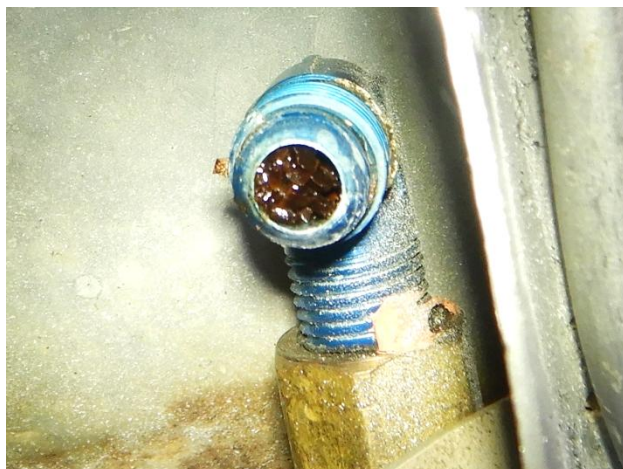
**Figure 7.** Inlet to fuel shutoff valve

The fuel line connected to the inlet port of the fuel shutoff valve was removed to examine the shutoff valve. There was fuel-wetted debris present that obstructed the inlet elbow fuel fitting, as shown in figure 7. The fuel shutoff valve outlet port exhibited accumulated debris affixed to its inside diameter, as shown in figure 8. Additional debris was recovered from inside the fuel shutoff valve when tapped on a table, as shown in figure 9.

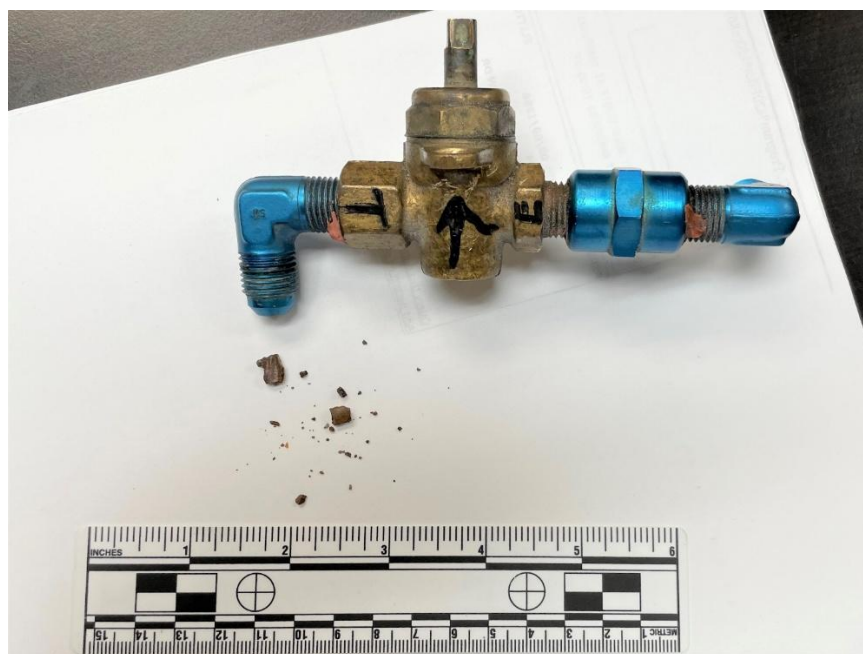
**Figure 9.** Fuel shutoff valve with debris from inlet port

The fuel shutoff valve and the recovered debris from the fuel lines were submitted to the NTSB Materials Laboratory, Washington, DC, for additional examination and testing. According to the x-ray fluorescence analysis, the elemental composition of

the submitted debris consisted mostly of silicon, iron, and lead. Silicon and iron are consistent with soil. The presence of lead was consistent with transfer contact with fuel system components where leaded fuel, such as aviation 100 low-lead fuel, had been present.

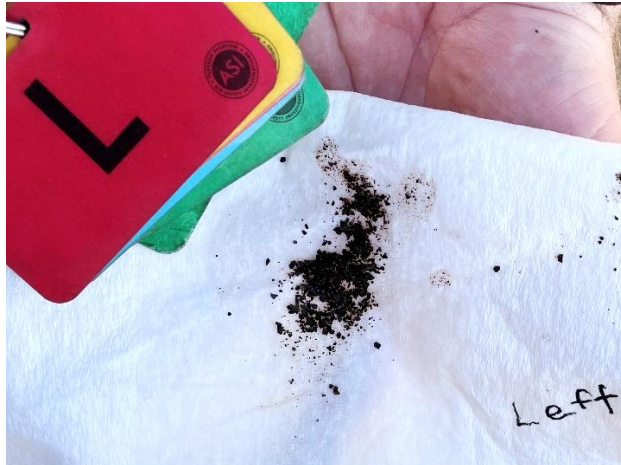
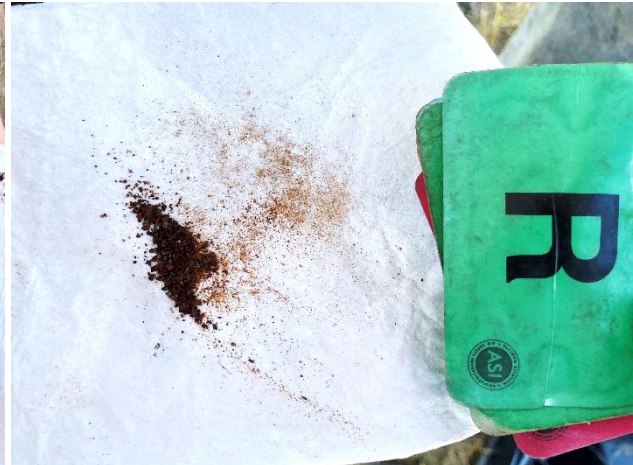
The fuel line from each wing fuel tank was disconnected and air blown through the fuel line to the disconnected line at the fuel shutoff valve. Fuel and traces of debris were extracted from the left and right fuel lines. The recovered debris, as shown in figures 10 and 11, was consistent with the debris found in the inlet/outlet ports of the fuel shutoff valve. Borescope examination of the left- and right-wing fuel tanks revealed additional loose debris inside each fuel tank, as shown in figures 12 and 13.

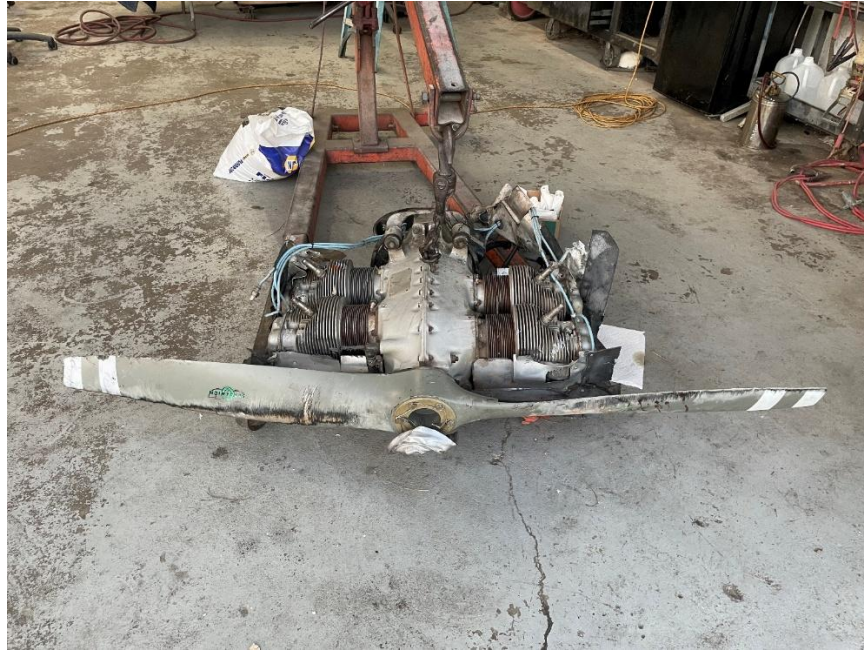
**Figure 13.** Engine with attached propeller

The engine was displaced upwards, compressed aft into the firewall, and was rotated/twisted to the left side of the aircraft. Three of the four engine mounts remained partially attached to the engine and the airframe. The oil pan was crushed up and aft and several push rod shrouds and valve covers were dented. The starter separated from the engine, but the remaining accessories remained attached to the engine. The right exhaust manifold separated from the engine while the left side remained attached but was crushed.

The propeller remained attached to the crankshaft flange, as shown in figure 13. The engine crankshaft did not rotate by hand through the propeller. The crankshaft was displaced aft about 0.5 inches, consistent with damage sustained during a nose down impact. The removal of the rear accessories revealed additional damage to the accessory gears consistent with the entire crankshaft being displaced aft of its normal position.

The engine examination revealed no evidence of a preexisting mechanical malfunction or failure that would have prevented normal operation.

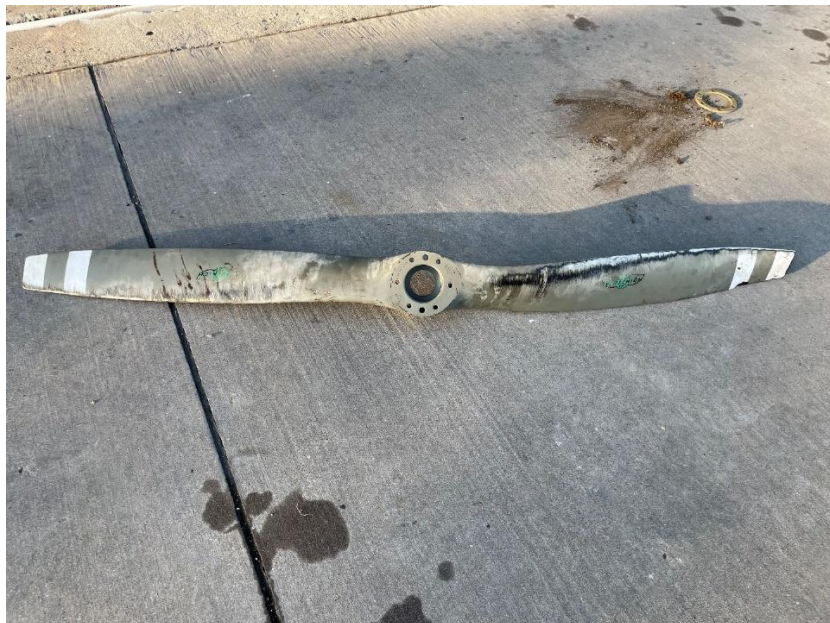
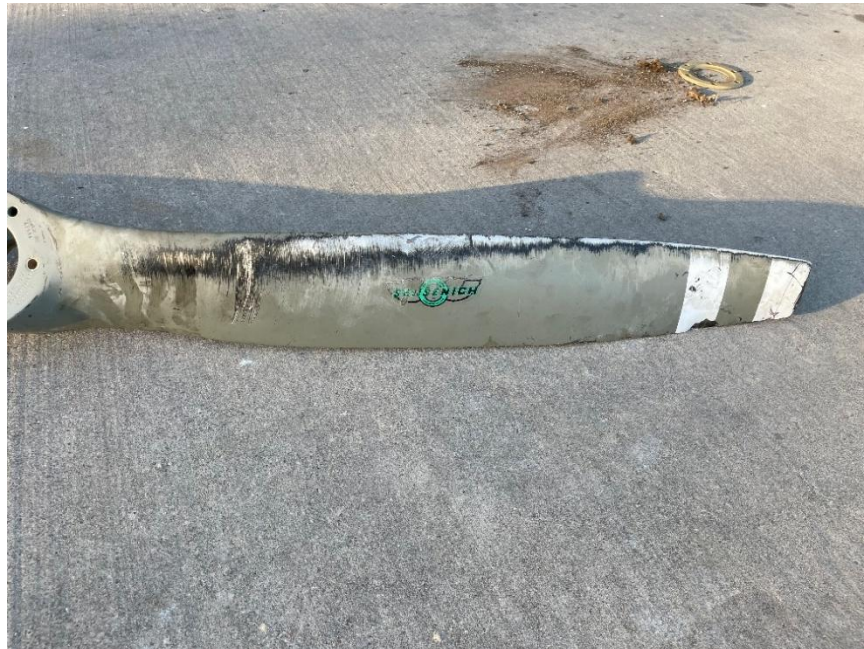
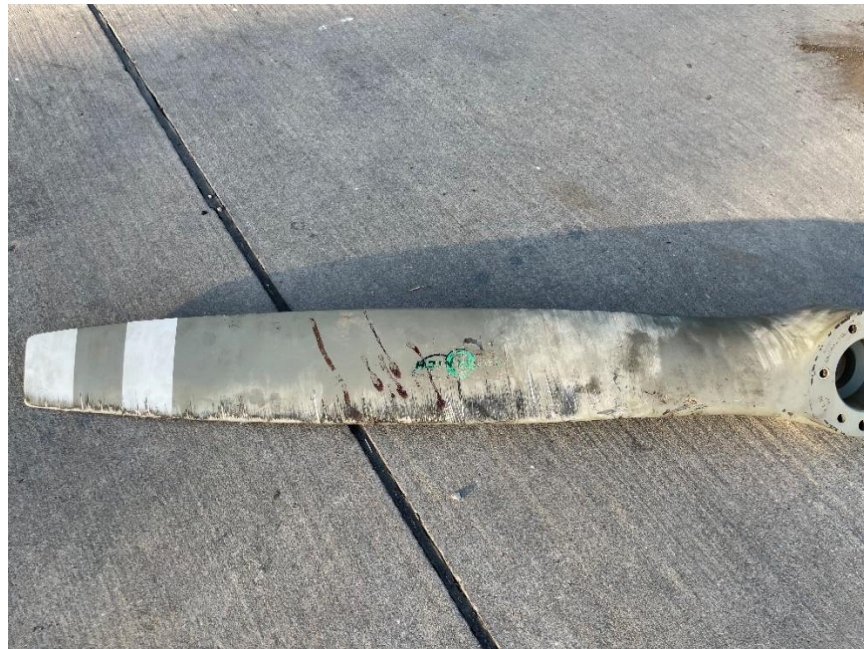
The fixed-pitch 2-blade propeller remained attached to the engine crankshaft flange, as shown in figure 13. Blade "A" exhibited a slight bend aft and in direction of blade rotation, and chordwise rotational scoring along the leading edge on the camber side, as shown in figures 14 and 15. The blade tip trailing edge exhibited gouge marks. Blade "B" did not exhibit any remarkable bend/twist but had chordwise rotational scoring along the leading edge on the camber side, as shown in figure 16.
