# National Transportation Safety Board

CEN23FA412

## **ELECTRONIC DEVICE REPORT**

Location: New Rockford, North Dakota  
Date: September 19, 2023  
Time: 1232 central daylight time (CDT)  
Airplane: Air Tractor AT502B, private operator, N502B

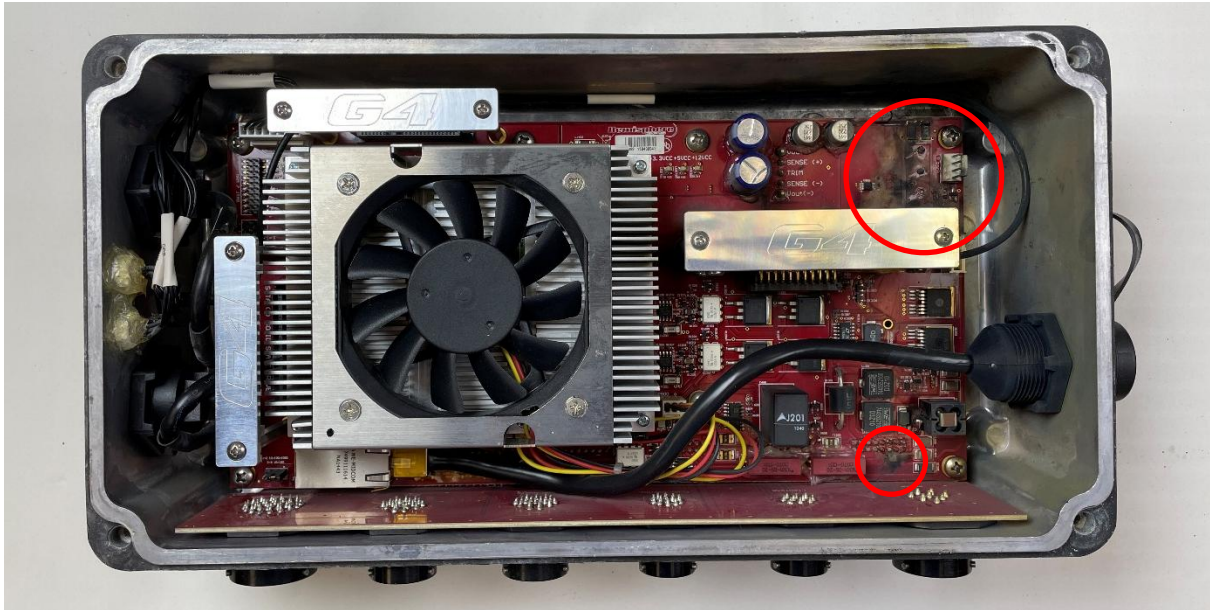
Upon arrival at the Vehicle Recorder Laboratory, an exterior examination revealed the Satloc G4 was in fair condition. An interior examination revealed the unit had thermal damage on the main board. The extent of the damage is shown in Figure 1.

**Figure 1.** Interior photo of Satloc G4 showing thermal damage circled in red.

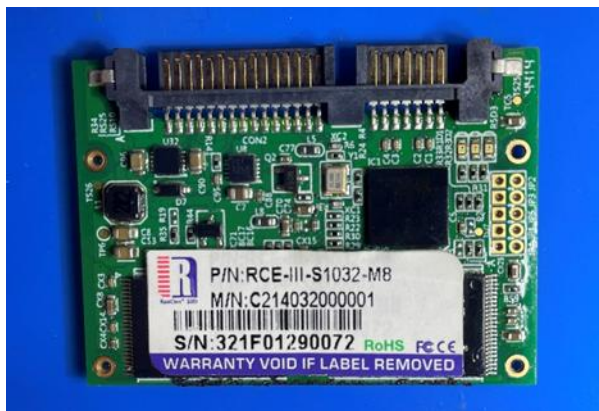
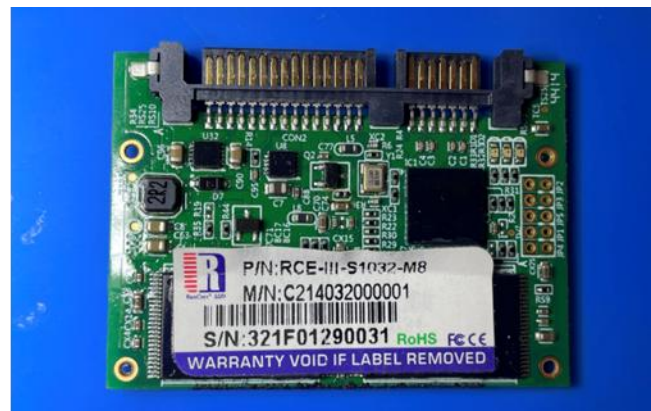
The solid state drive (SSD) memory modules were removed and shown in Figure 2. Both SSD modules appeared undamaged.

**Figure 2.** Photos of both SSDs.

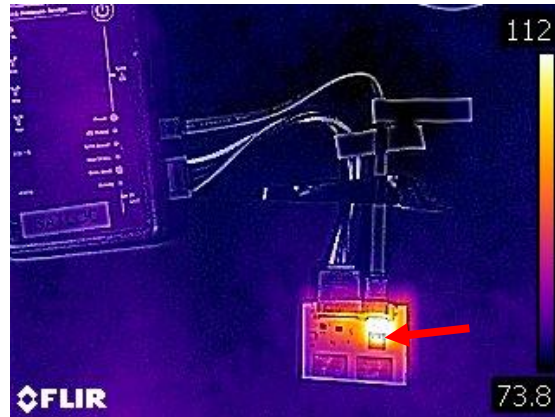
The SSD identified as the module containing historical logs was read using laboratory equipment. These efforts were unsuccessful in detecting the SSD. Thermal imaging revealed a localized hot spot at the controller chip as shown in Figure 3.<sup>1</sup>

**Figure 3.** SSD thermal image showing a hot spot at the controller chip location.

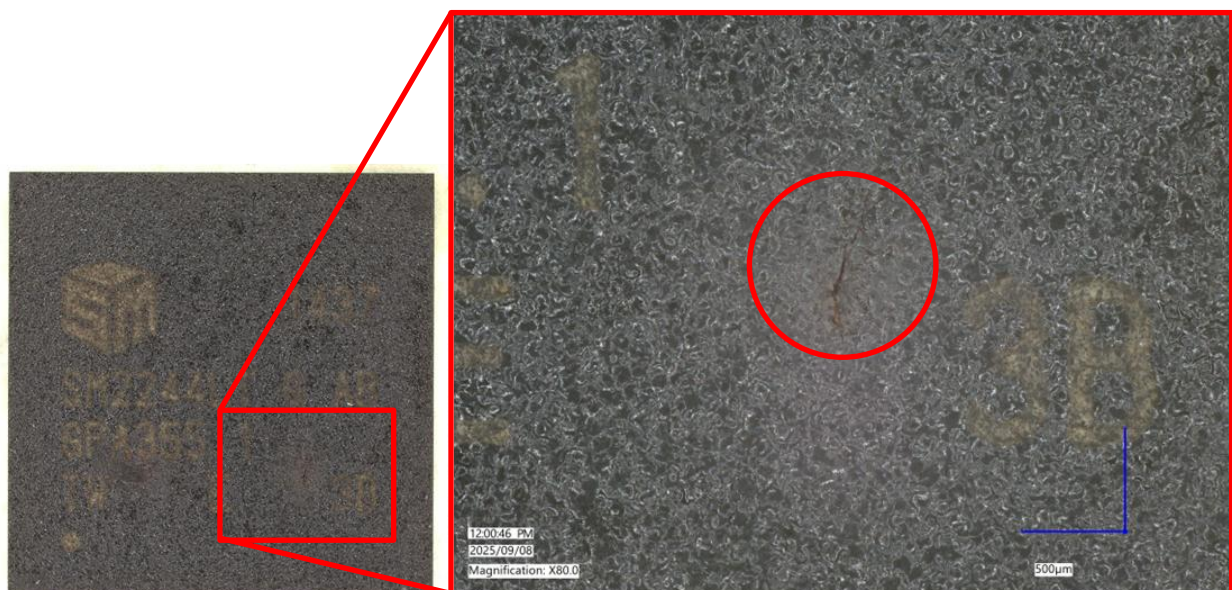
The SSD is capable of storing data in four non-volatile memory (NVM) chips.<sup>2</sup> The four NVM chips and the controller chip on the accident SSD were identified and removed. A binary image was read for each NVM chip and yielded unusable data. The four NVM chips and controller chip were placed on a surrogate SSD board. These efforts were also unsuccessful in detecting the SSD. Additional testing also revealed placing the accident controller chip on the surrogate SSD board resulted in shorting the NVM operating voltage to ground.

Microscope imaging of the accident controller chip revealed localized overheating damage as shown in Figure 4. Therefore, no data pertinent to the accident were recovered.

**Figure 4.** Microscope images of the SSD controller chip (left image) and zoomed in area showing overheating damage (right image).
