CEN23FA412

## INVESTIGATION PHOTOGRAPHS

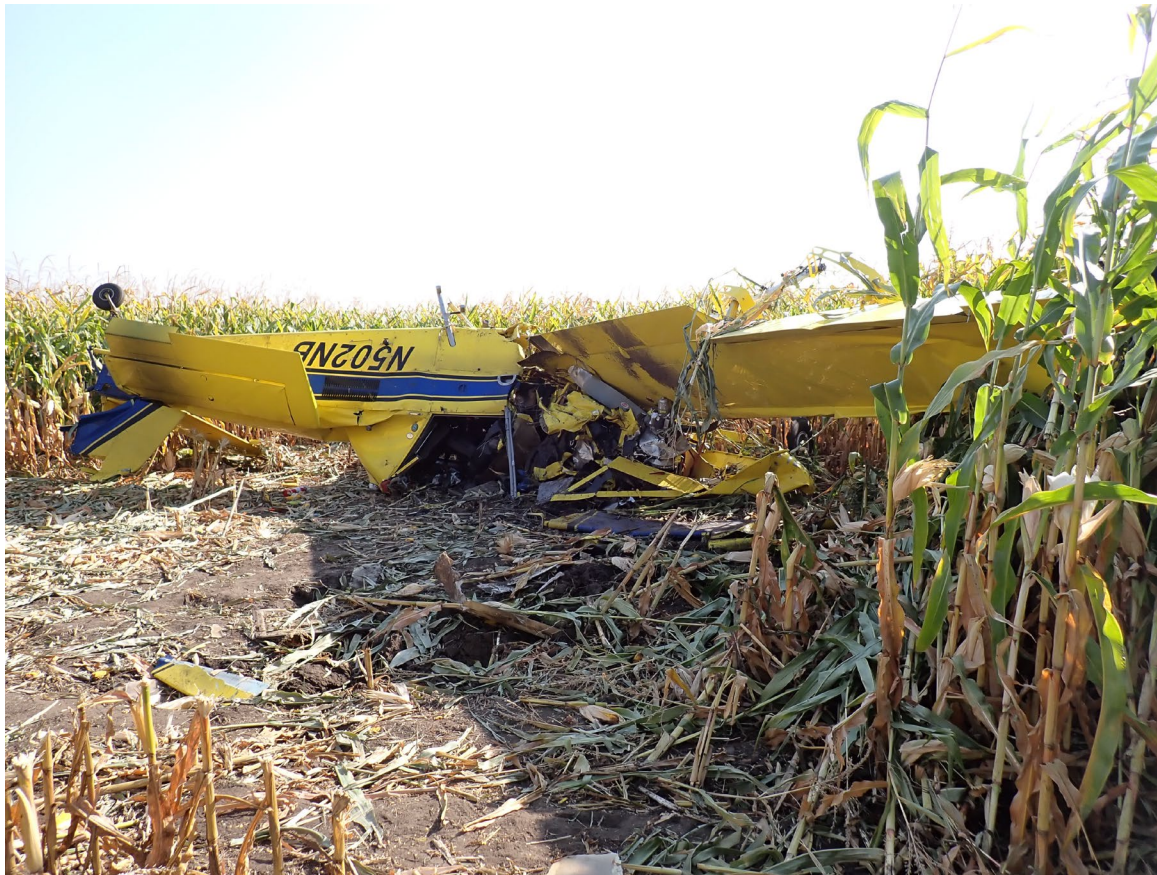
**Photograph 1 - Impact damage noted to fuselage (Courtesy of NTSB)**

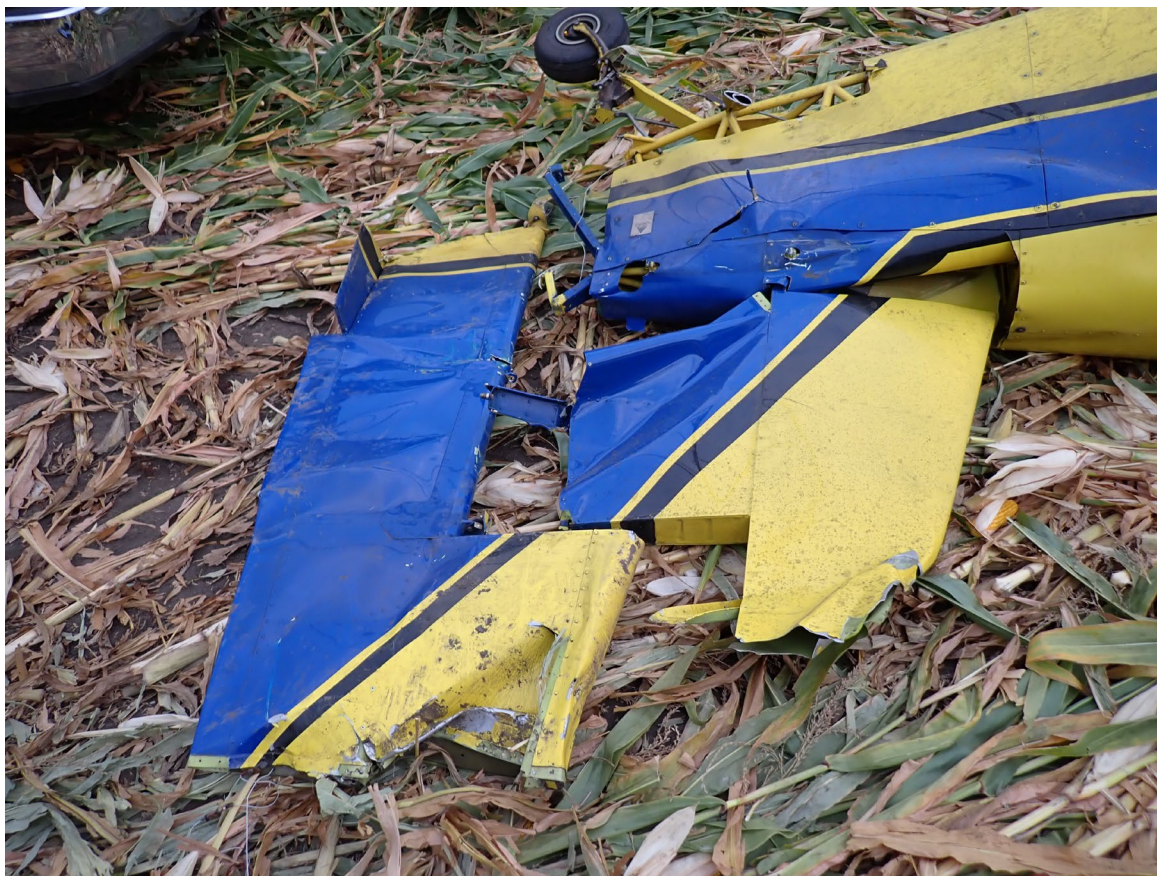
**Photograph 2 - Impact damage and power line impressions (Courtesy of NTSB)**

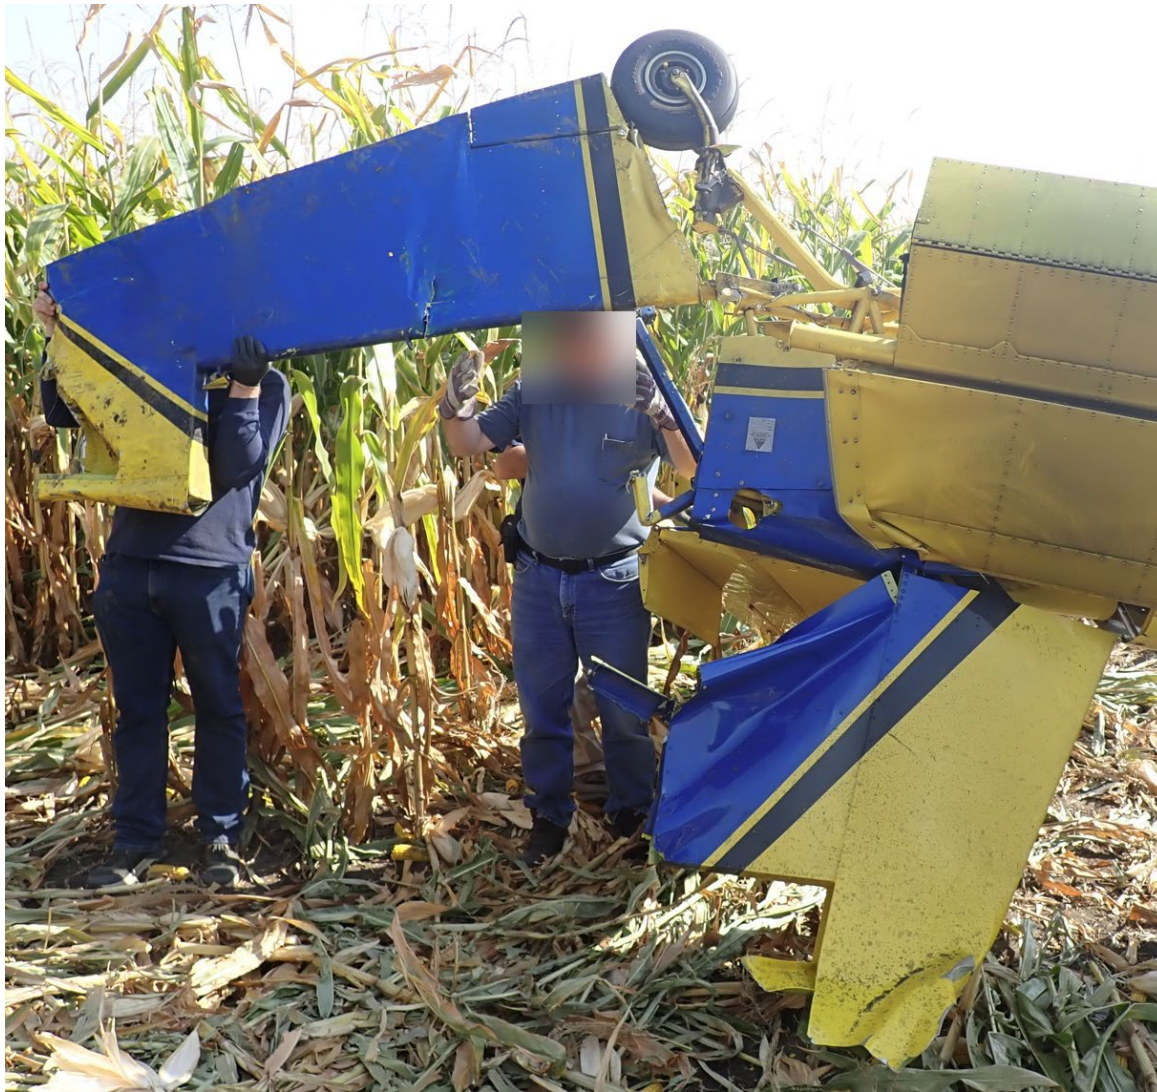
**Photograph 3 - Deformation noted to bottom of rudder (Courtesy of Air Tractor)**

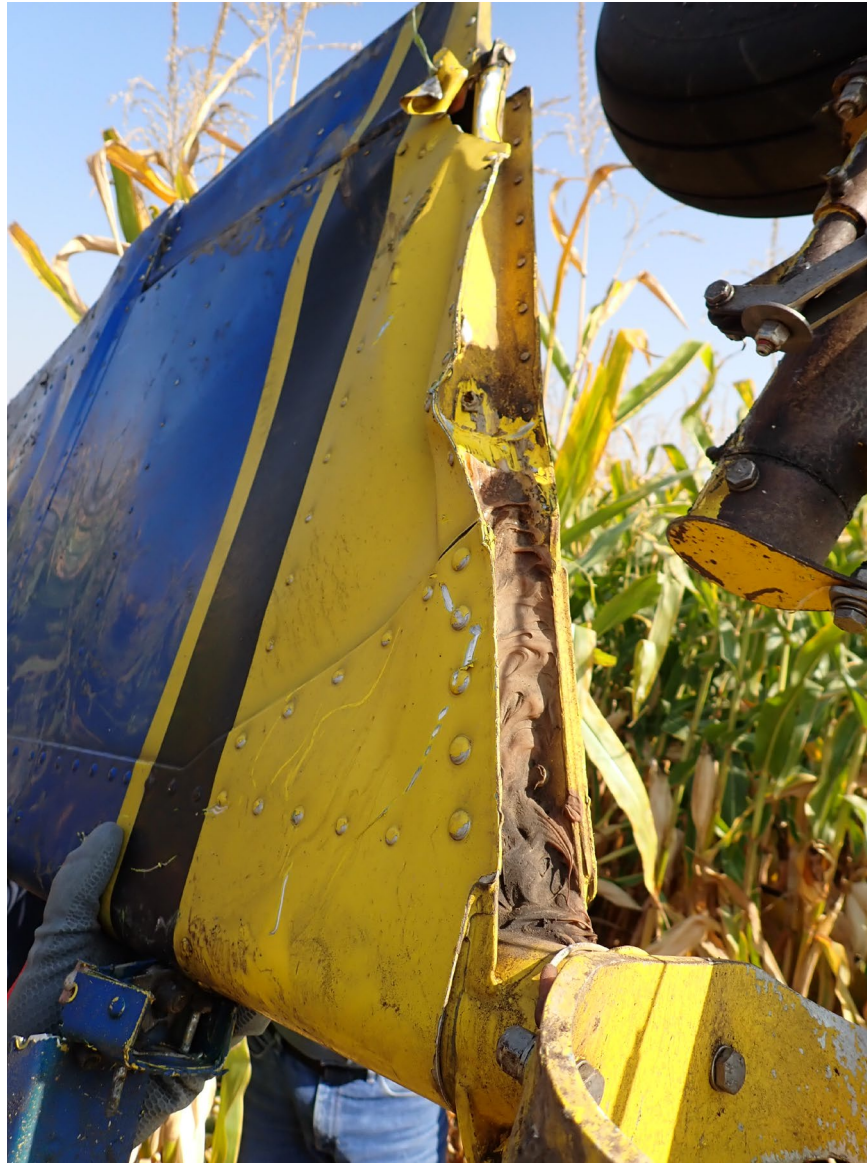
**Photograph 4 - Deformation to bottom of rudder from tailwheel (Courtesy of NTSB)**

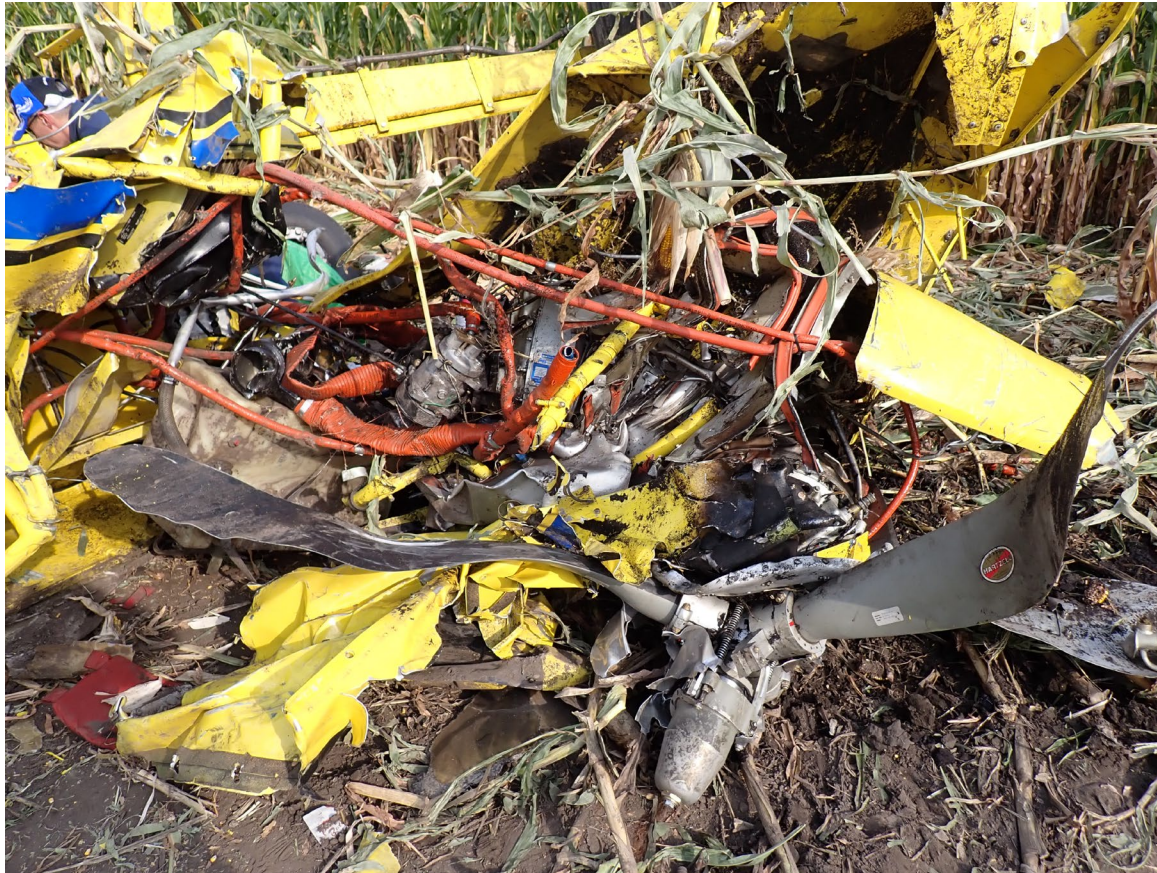
**Photograph 5 - S-type bending noted to propeller blades (Courtesy of NTSB)**

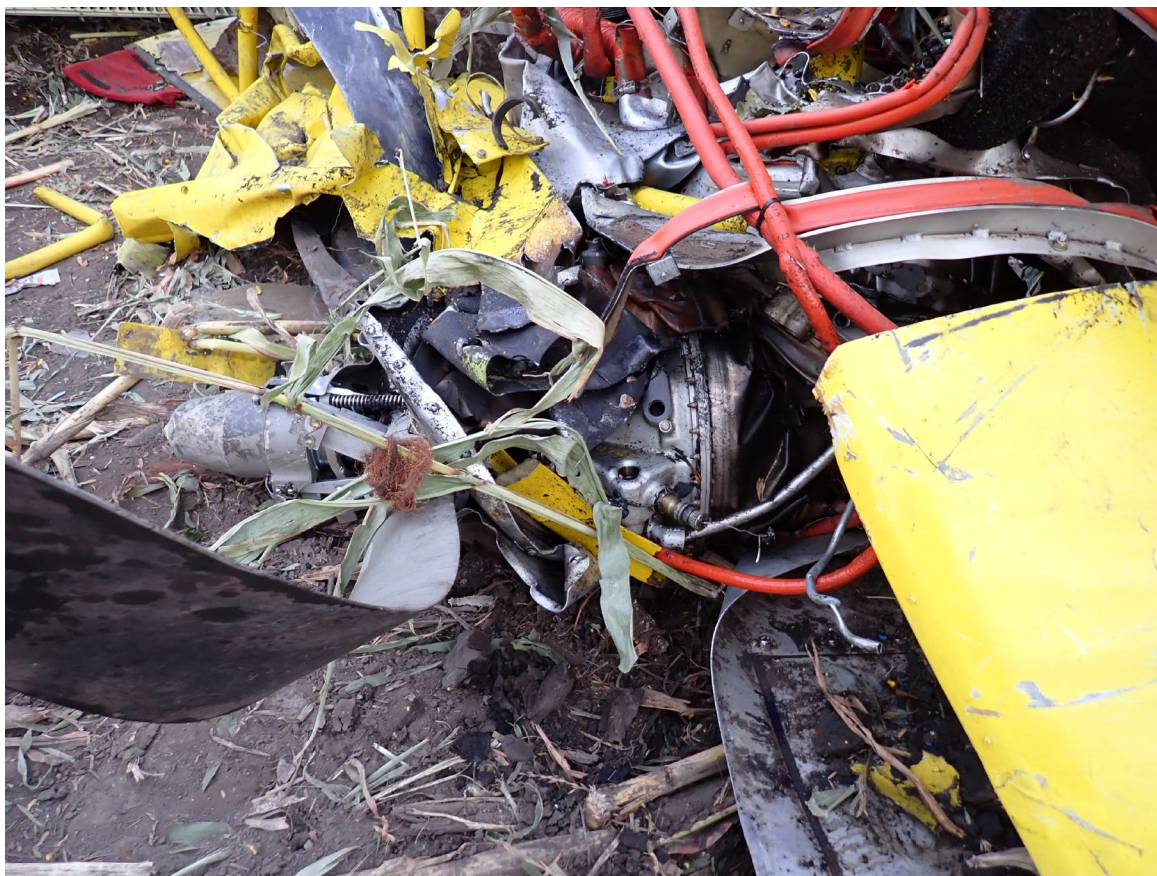
**Photograph 6 - Torsional deformation noted to exhaust duct case (Courtesy of NTSB)**
