Damian Galbraith  
Aviation Accident Investigator  
OAS

**Subject:** CEN23FA412, MOR - Power Line Height and Impact Information

**Contact:** Western Area Power Administration

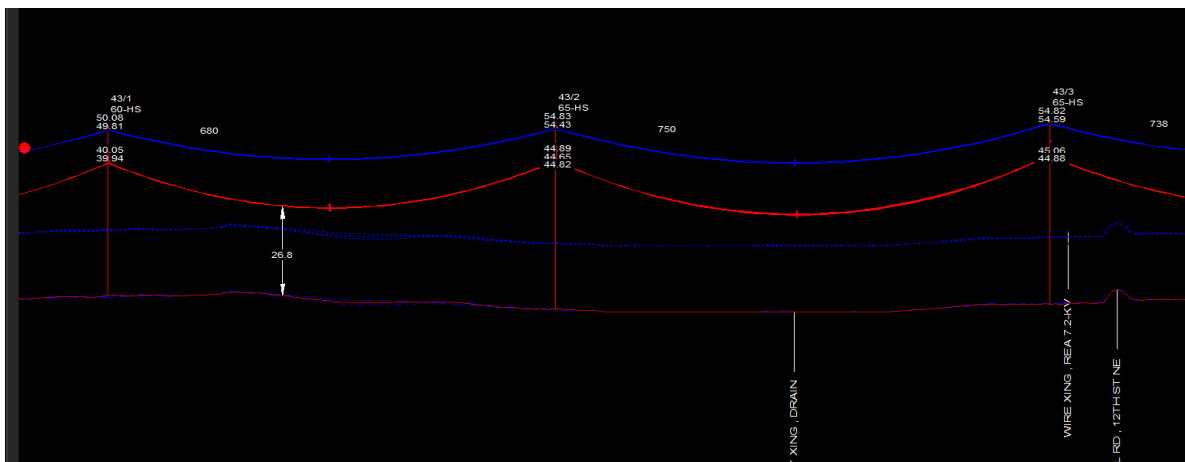
A representative from the Western Area Power Administration reported that, on September 19, 2023, at 1231 central daylight time, their dispatch center received notice that their power line relayed, auto reclosed and relayed again. They left the line open and dispatched personnel to investigate the power line. The inspection revealed no damage to the power line and the power was returned to service. The investigation of the anomaly revealed that the airplane impacted the lower power line and caused the conductors to gallop and contact each other, which triggered the initial relay. The representative further stated that, the numbers provided are accurate with the caveat that the engineer estimated the added temperature due to loading. The conductor would have been at least at the ambient temperature, if there was no load on the line. The most accurate measurement of the line above the ground would be 26.8 ft at 90° Fahrenheit, which was taken directly where the arrow in the image below is (see figure 1).

Figure 1: Photo of the measurement of the power line above the ground (Photo provided by Western Area Power Administration)
