## **NATIONAL TRANSPORTATION SAFETY BOARD**

### **Wreckage Examination Summary**

**CEN23FA412**

Aircraft: N502NB Air Tractor, AT-502B, SN: 502B-2814

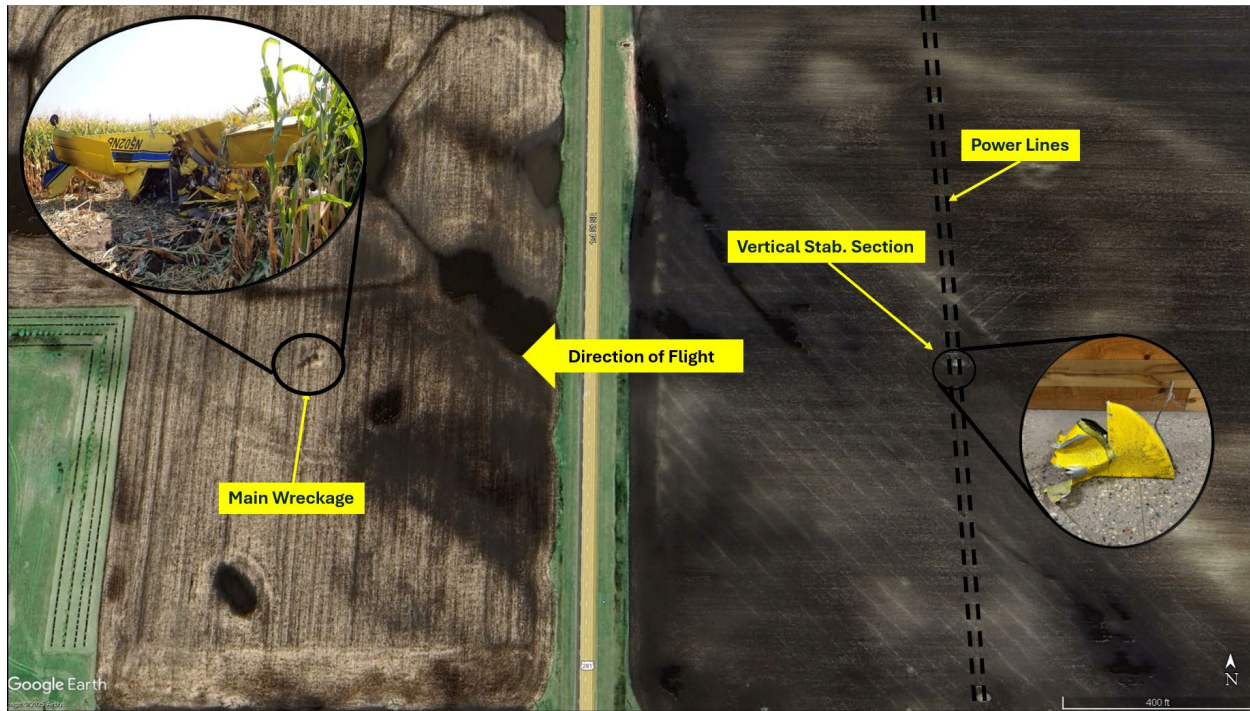
The airplane impacted a powerline during a low-level aerial application pass about 1/4 mile east of the main wreckage. The airplane impacted the ground inverted in about a 45° nose down attitude and came to rest on about a 175° magnetic heading about 15 ft southeast of its ground impact point. A postimpact fire ensued in the accessory case area of the engine which was extinguished by first responders. The accident site was a relatively flat cultivated field with about 8' standing corn (see figure 1). Numerous corn stalks exhibited 45° separations consistent to that of a propeller strike were noted near the initial ground impact area (see figure 2). An odor consistent to that of jet fuel was observed at the main wreckage area. All major component of the airplane were identified and located at the main wreckage area. Majority of the wire deflector cable and a section of the upper vertical stabilizer were separated from the airplane and not observed during the examination. The separated section of the vertical stabilizer, with about an 8-inch section of the wire deflector attached, was later located just east of the stricken powerlines by the landowner in October. About 2 inches of the wire deflector cable remained attached to its

forward attach point; deformation consistent to that of tension overload were noted to this section of the wire deflector cable. The separated end of the wire deflector cable attached to the section of vertical stabilizer exhibited a splayed, broomstrawed appearance, consistent to that of tension overload separation. About 154-inches or 12.83 ft of the wire deflector cable was not recovered.

Figure 1: Annotated photograph of the accident site (Wreckage Photo NTSB & Vertical Stabilizer Photo by FAA)

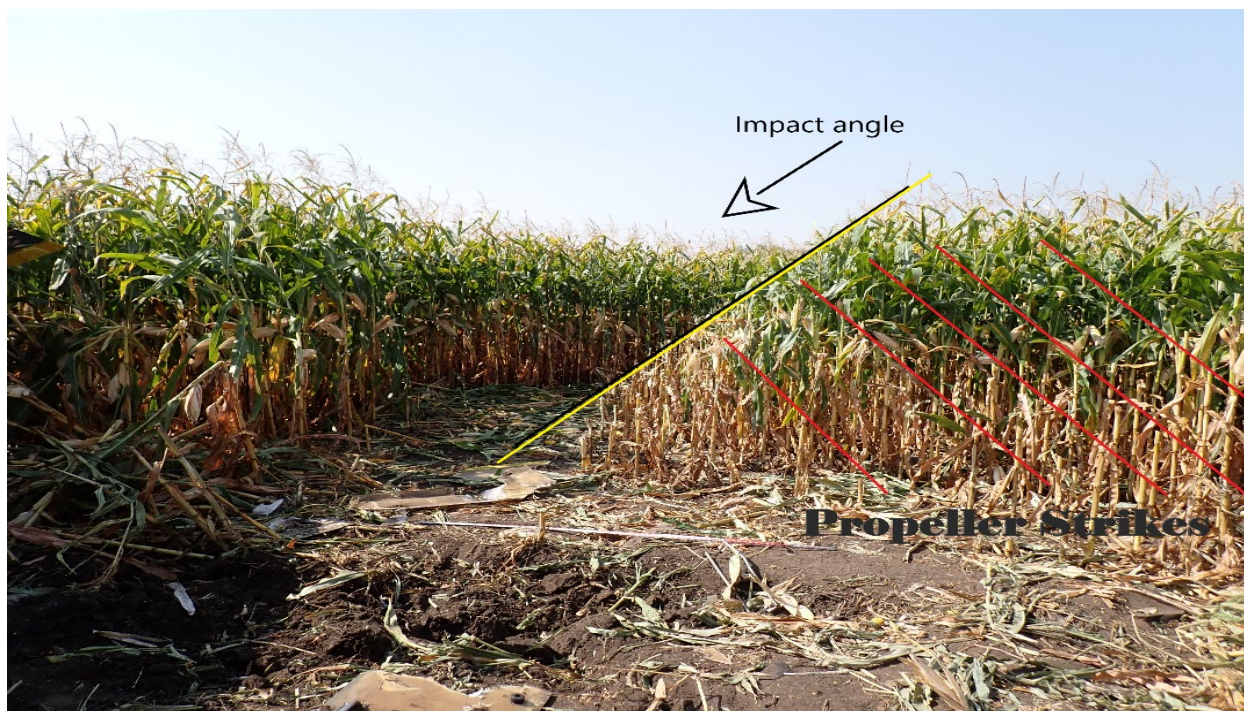
Figure 2: Annotated photo of the impact angle (NTSB Photo)

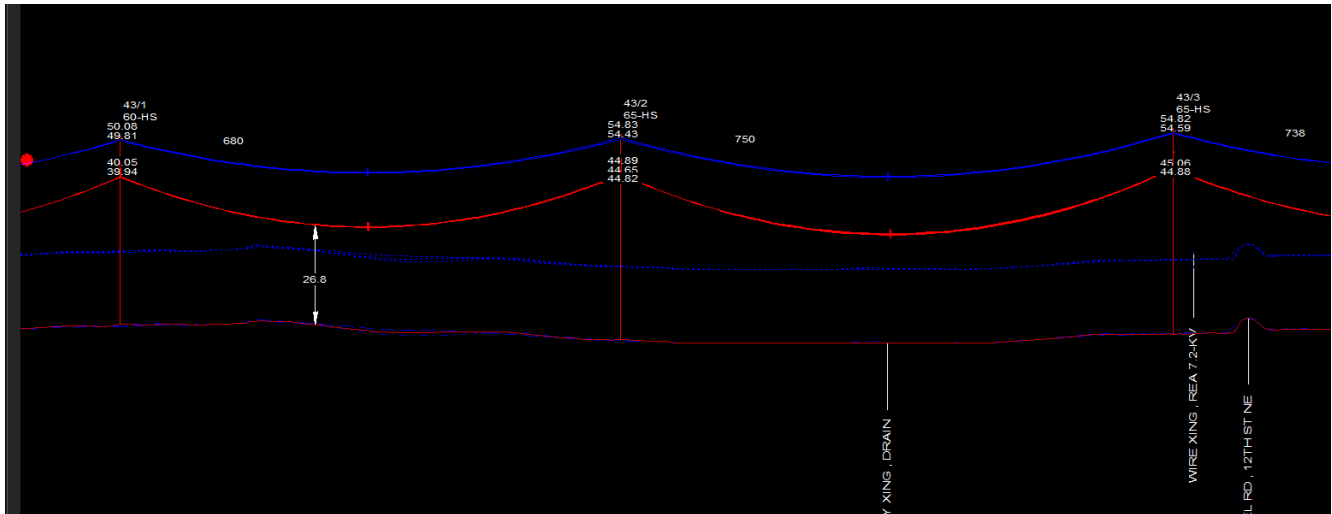
A representative from the Western Area Power Administration reported that, on September 19, 2023, at 1231 central daylight time, their dispatch center received notice that their power line relayed, auto reclosed and relayed again. They left the line open and dispatched personnel to investigate the power line. The inspection revealed no damage to the power line and the power was returned to service. The investigation of the anomaly revealed that the airplane impacted the lower power line and caused the conductors to gallop and contact each other, which triggered the initial relay. The representative further stated that, the numbers provided are accurate with the caveat that the engineer estimated the added temperature due to loading. The conductor would have been at least at the ambient temperature, if there was no load on the line. The most accurate measurement of the line above the ground would be 26.8 ft at 90° Fahrenheit, which was taken directly where the arrow in the image below is (see figure 3).

Figure 3: Photo of the calculated distance between the power line and the ground (Photo provided by Western Area Power Administration)

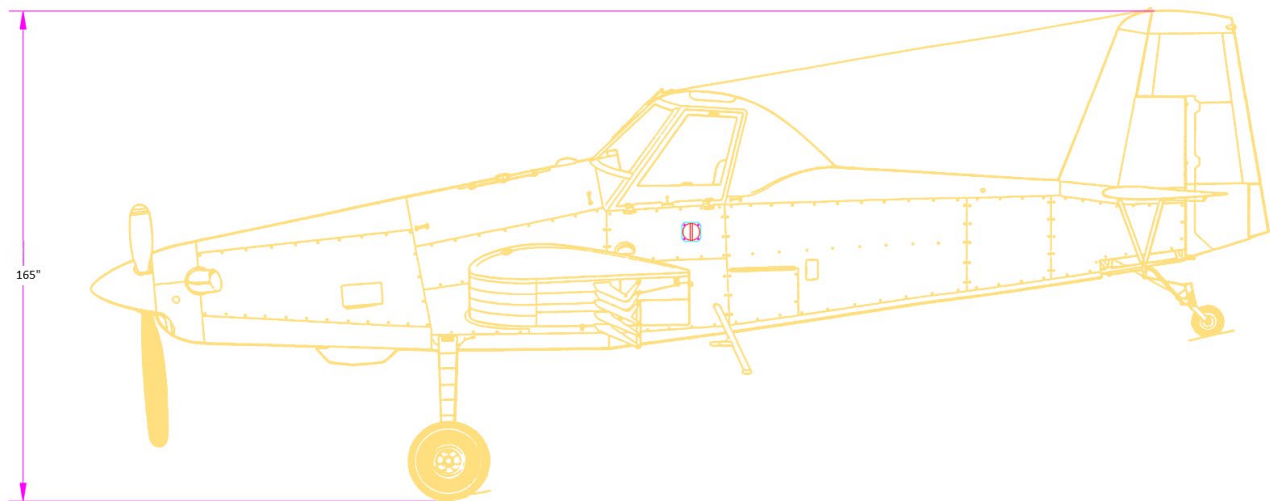
According to Air Tractor, the length of the wire deflector is 164-inches or 13.67 ft and is made of a 5/32-inch diameter MIL-DTL-83420, Type I – non-jacketed wire rope, Composition B – corrosion resistant steel cable, rated to a minimum breaking strength of 2,400 pounds. The Air Tractor model AT-502B has a level flight profile of 165-inches or 13.75 ft (see figure 4).

Figure 4: Air Tractor AT-502B level flight profile (Photo Provided by Air Tractor)
