CEN23LA014

## INVESTIGATION PHOTOGRAPHS

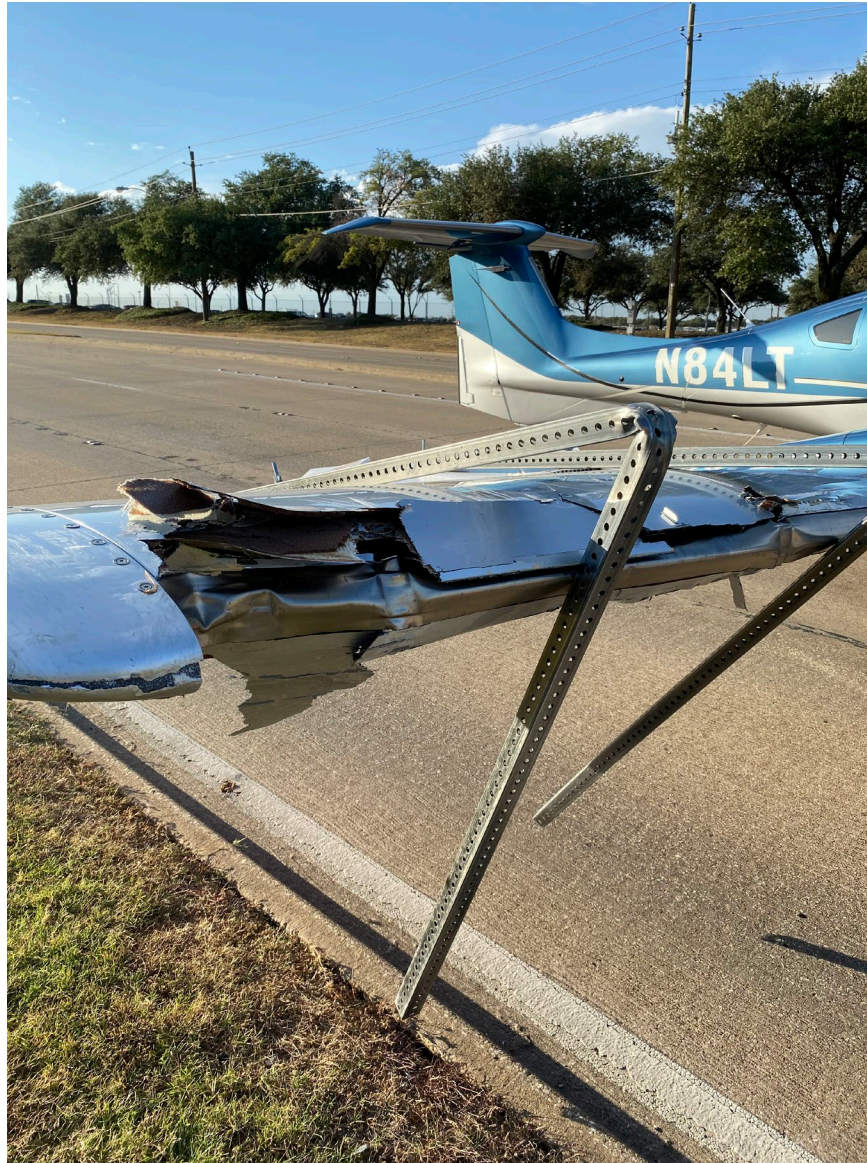
**Photograph 1 - Right Wing Damage - Front View (Courtesy of FAA)**

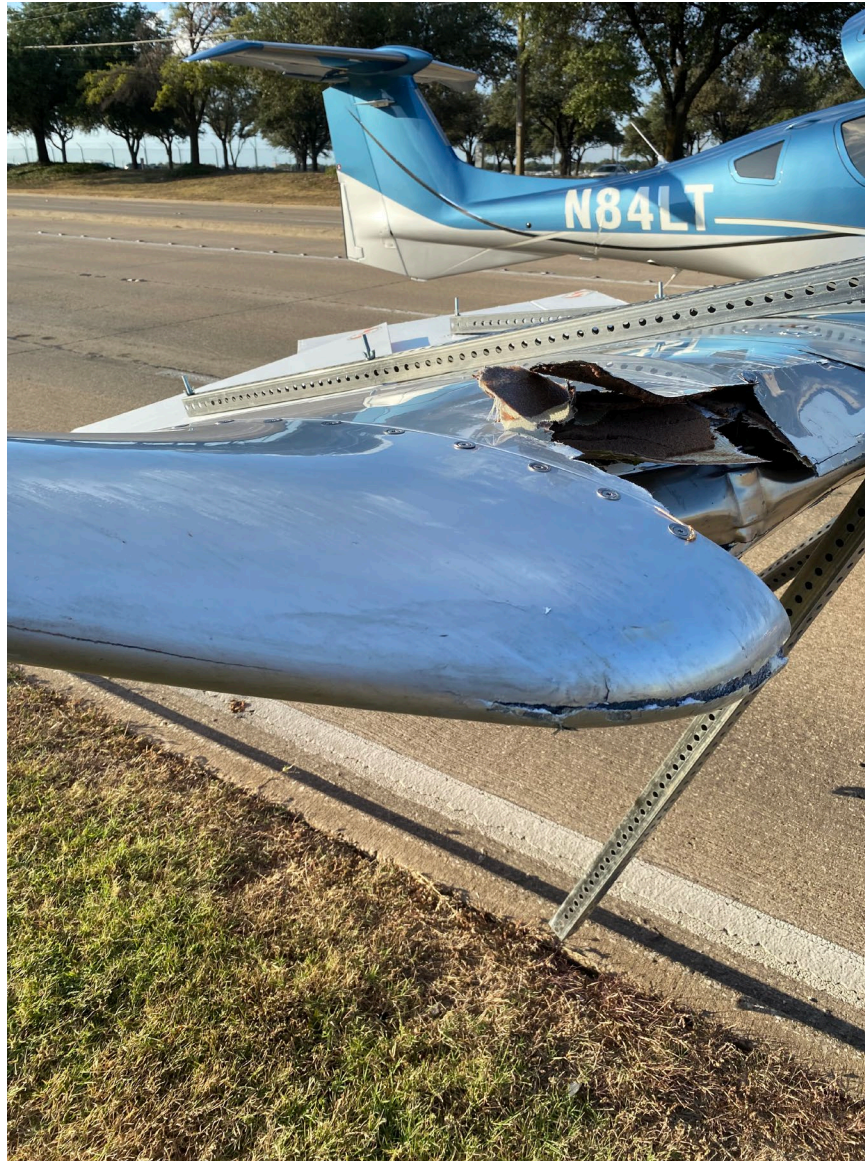
**Photograph 2 - Right Wing Damage - Side View (Courtesy of FAA)**
