# National Transportation Safety Board

CEN23LA014

Group Chair's Factual Report

Location: Dallas, TX  
Date: October 15, 2022  
Time: 1448 central daylight time (CDT)  
1948 universal coordinated time (UTC)  
Airplane: Diamond DA-62, N84LT, 62.C003

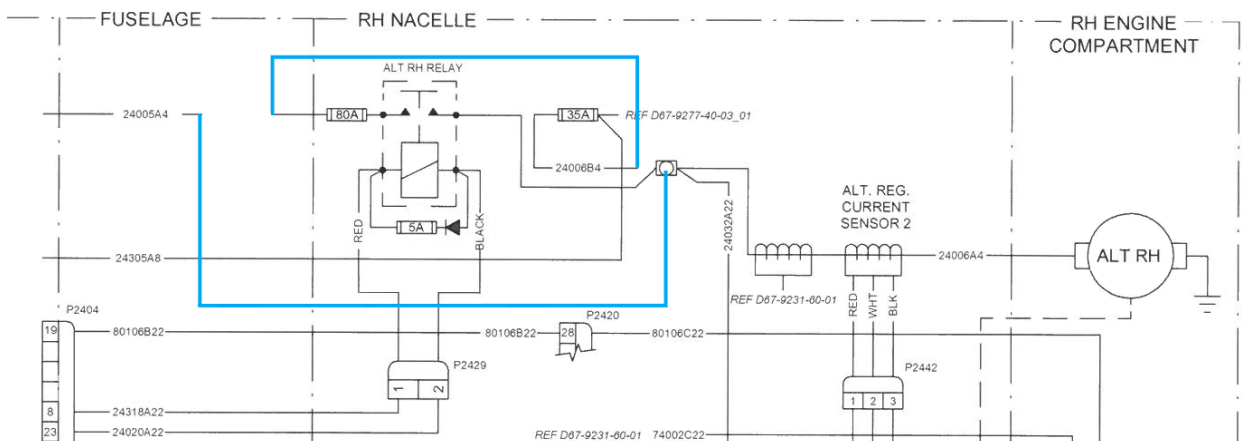
The electric wiring from the and alternators was inspected for signs of loose connections, failed fuses, burn marks or other signs of electrical issues. At both alternator relays, the wiring was incorrect. As wired, the alternator relays would NOT disconnect the alternator power from the main electrical system. The relays would cut power to the glow plugs for the respective engines. (Note that the glow plugs are only used during engine start.) In addition, the 80 Amp fuse was not between the alternator and the aircraft electrical distribution system (Figure 7).

**Figure 7.** Drawing D67-9224-30-01\_01 mark-up showing actual alternator relay wiring.

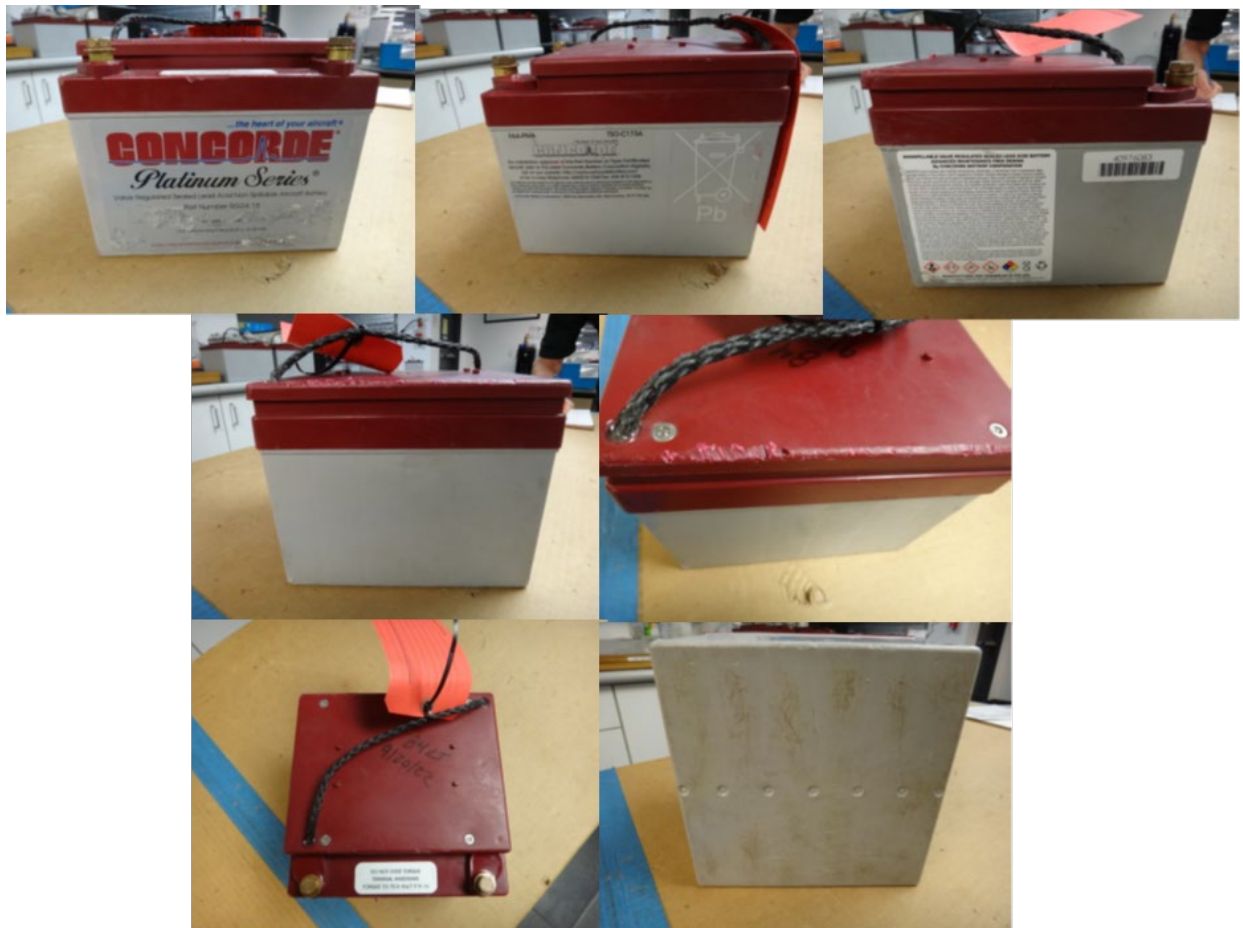
There were minor scuff marks on the rear edge of the cosmetic cover. The front label had areas where the clear laminate was peeling and some areas where the printed text was scuffed and illegible. No damage or discoloring of the battery terminals was observed. There was no sign of electrolyte leakage. There was no sign of cells open to atmosphere. Photos were taken of all sides of the battery (Figure 8).

**Figure 8.** Photos of main battery. (Courtesy of Concorde Battery)

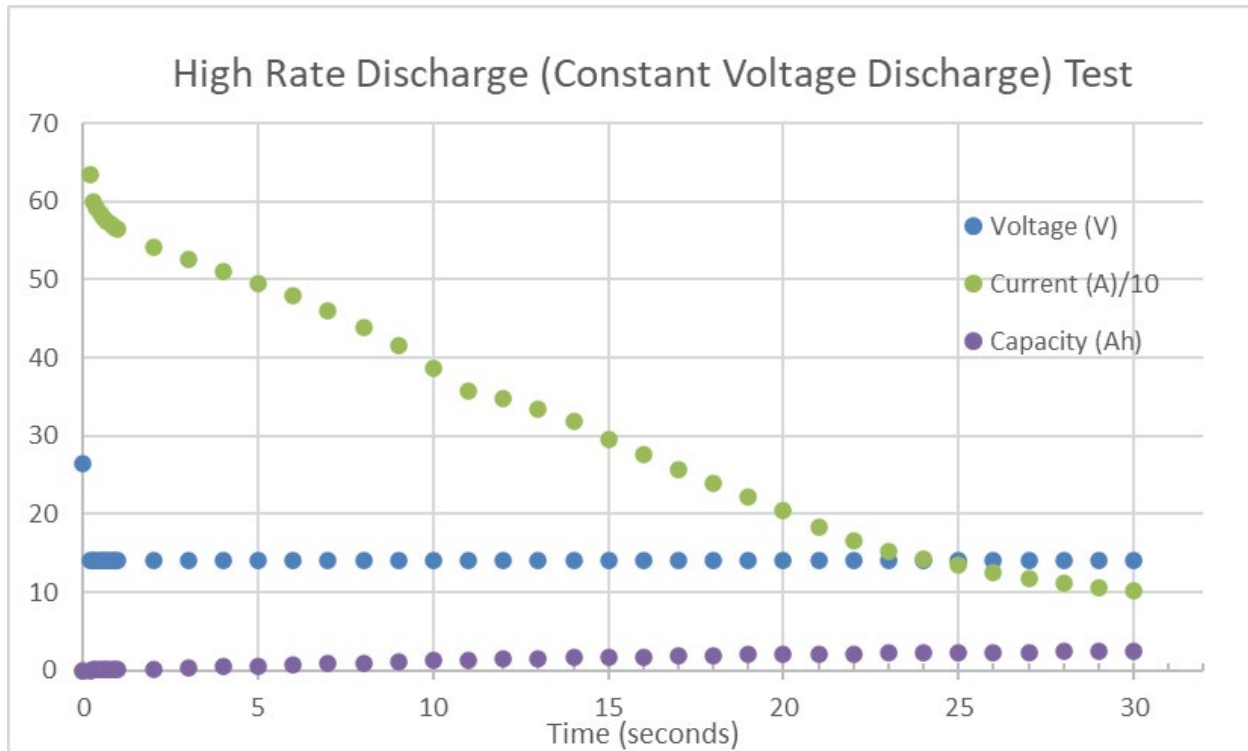
A high rate discharge (constant voltage discharge) was completed. The battery was discharged at a constant voltage of 14 V for 30 seconds. The voltage and current were recorded at 0.1 second intervals for the first second of testing and 1 second intervals for the remainder of testing. The battery delivered 599 Amps at 0.3 seconds and 296 Amps at 15 seconds. Figure 9 shows the data from the high rate discharge test. There were no pass/fail criteria for the high rate discharge test. These results were considered normal for a battery that is over 4 years old.

**Figure 9.** Plot of high rate discharge test data.

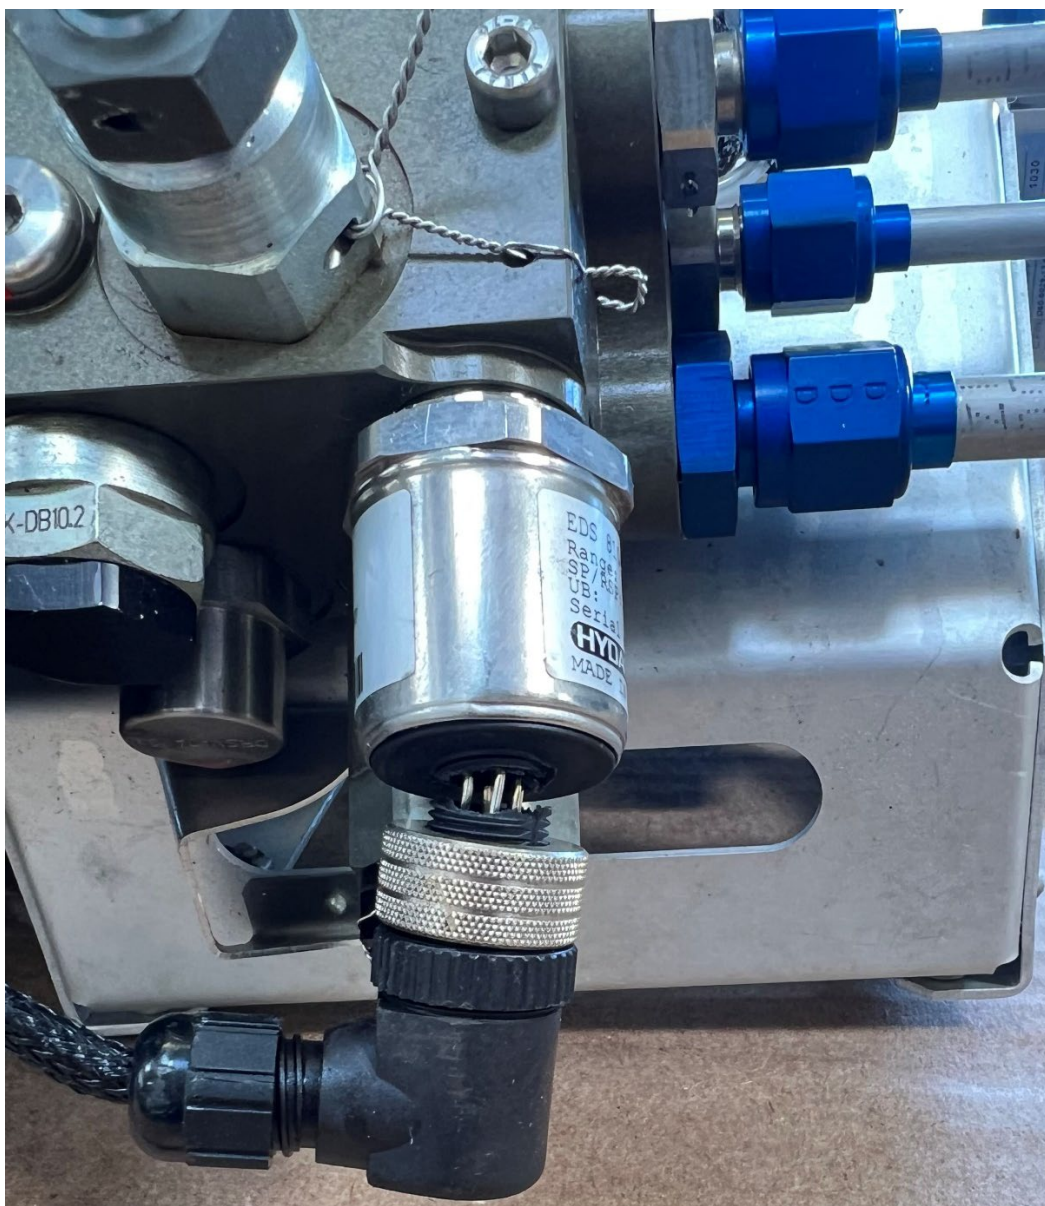
Hydraulic Power Pack part number D67-9029-13-00 serial number 0074 was tested at Austro Engines on 29 June 2023. During the receiving inspection, it was observed that the electrical connector to the pump pressure switch was damaged (Figure 11). But the unit was still able to be tested.

**Figure 11.** Photo of the damage to the pump pressure switch electrical connector. (Courtesy of Austro Engines)

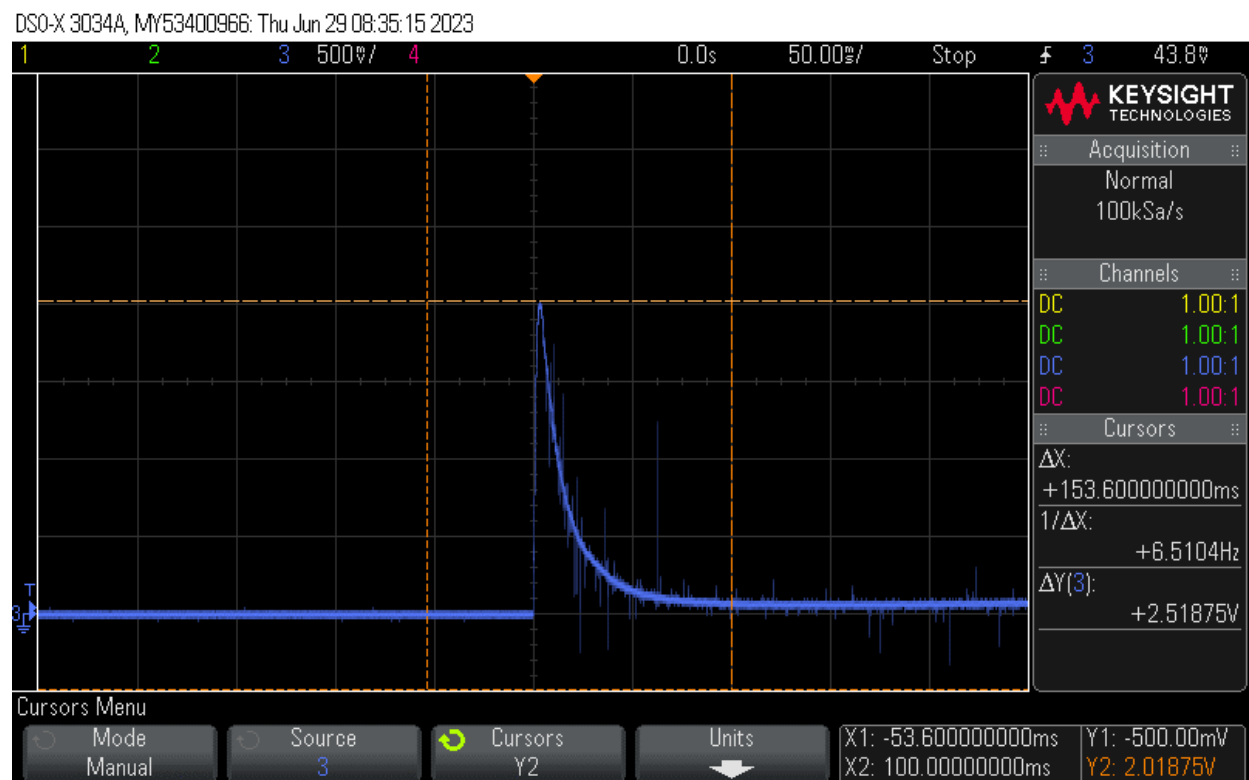
A voltage peak of 2.0 V was measured across the shunt-resistor the moment the hydraulic pump was turned on (Figure 13). This voltage corresponds to a current peak of 200 Amps. During the remainder of pump operation, a voltage drop of 0.25 V was measured across the shunt-resistor. This voltage corresponds to an average current of approximately 25 Amps (Figure 14).

**Figure 13.** Photo of the hydraulic power pack motor starting current. (Courtesy of Austro Engines)

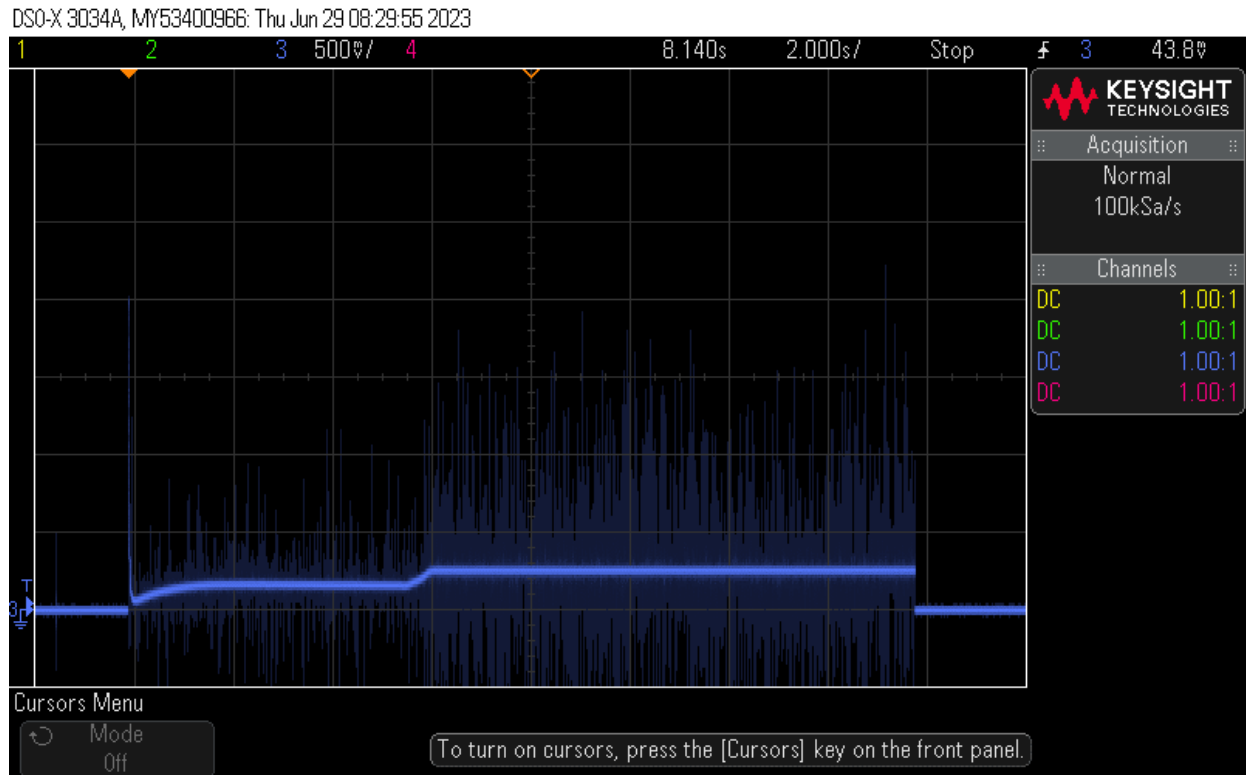
**Figure 14.** Photo of the hydraulic power pack operating current. (Courtesy of Austro Engines)

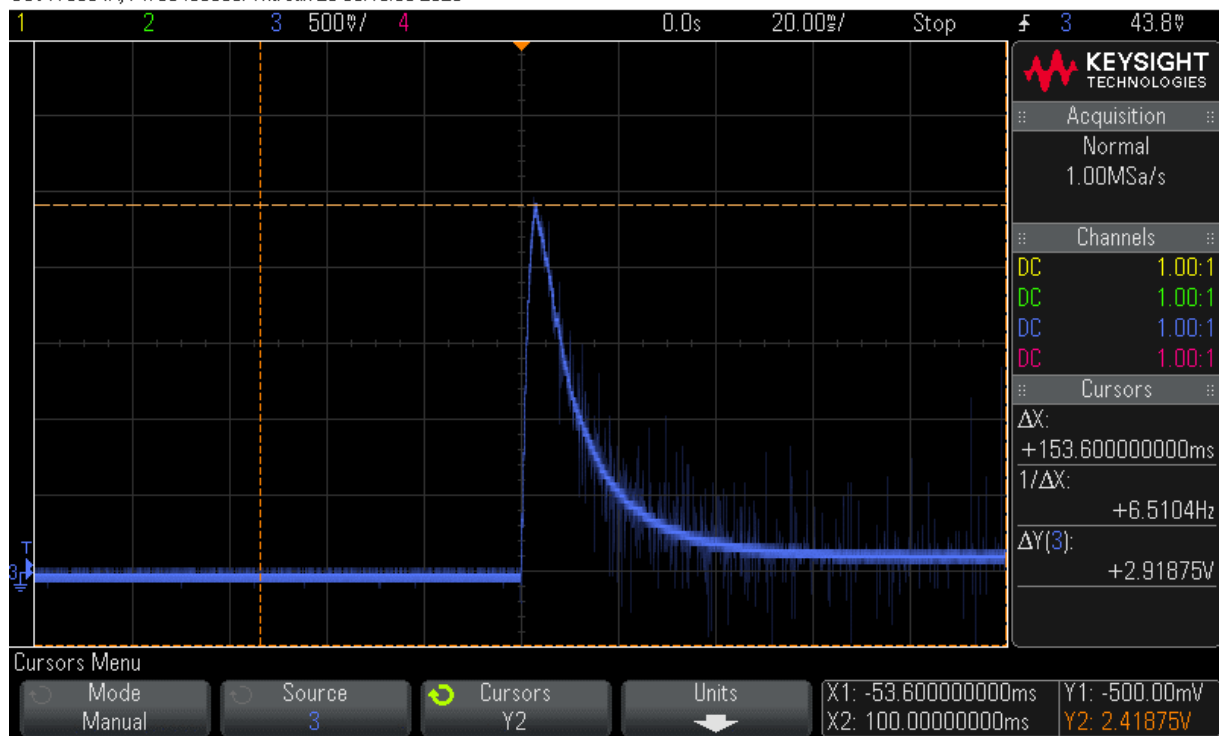
The hydraulic power pack from aircraft serial number 62.243 was used as an exemplar unit. The testing was repeated on this unit. A voltage peak of 2.4 V was measured across the shunt-resistor the moment the hydraulic pump was turned on (Figure 15). This voltage corresponds to a current peak of 240 Amps. A voltage drop of 0.25 V across the shunt-resistor corresponds to an average current of approximately 25 Amps (Figure 16).

**Figure 15.** Photo of the exemplar hydraulic power pack motor starting current. (Courtesy of Austro Engines)

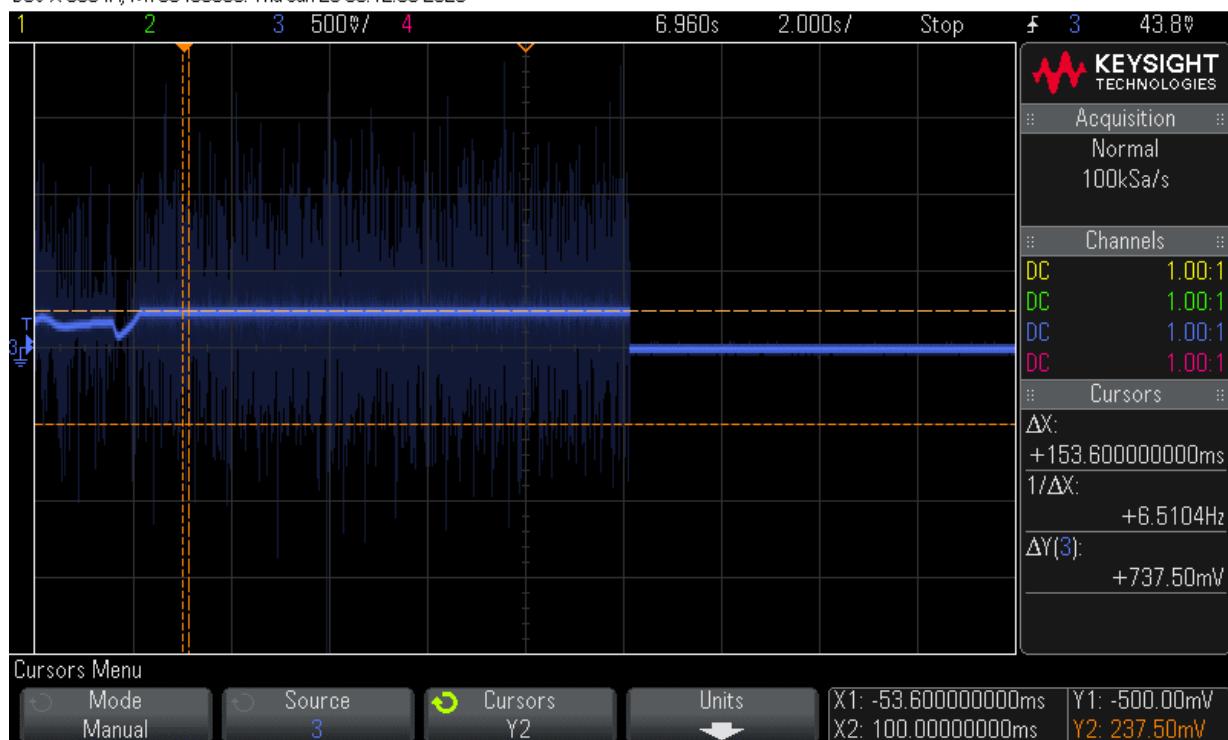
**Figure 16.** Photo of the exemplar hydraulic power pack operating current. (Courtesy of Austro Engines)
