CEN23LA040

## INVESTIGATION PHOTOGRAPHS

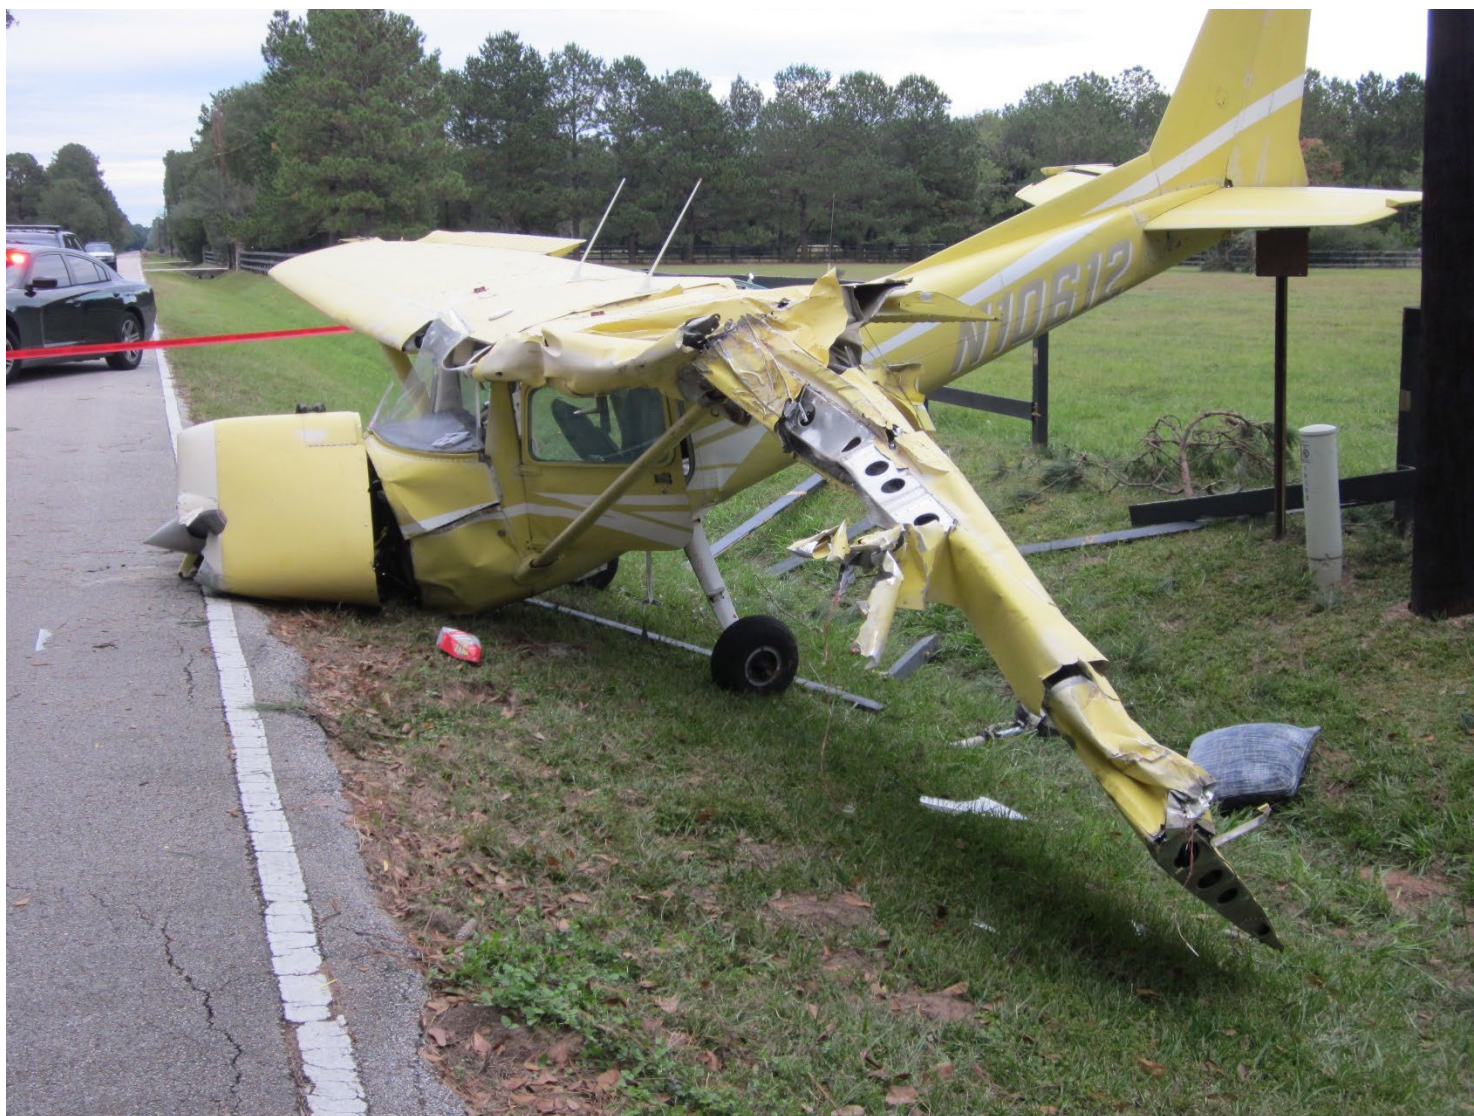
**Photograph 1 - Accident Site (Courtesy of Federal Aviation Administration)**

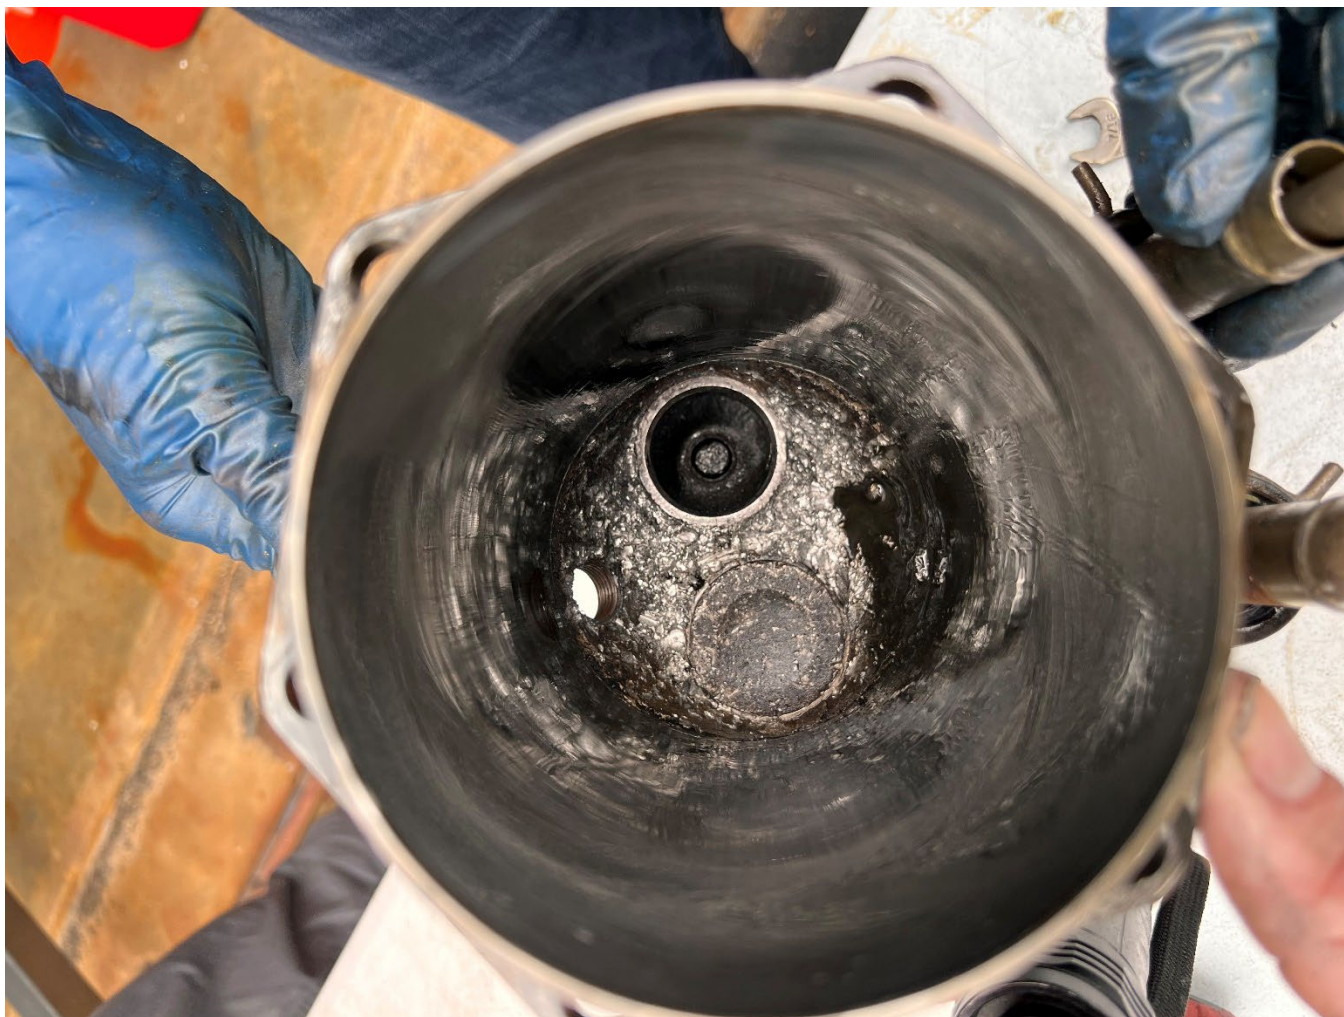
**Photograph 2 - Number Three Cylinder Head (Courtesy of Federal Aviation Administration)**

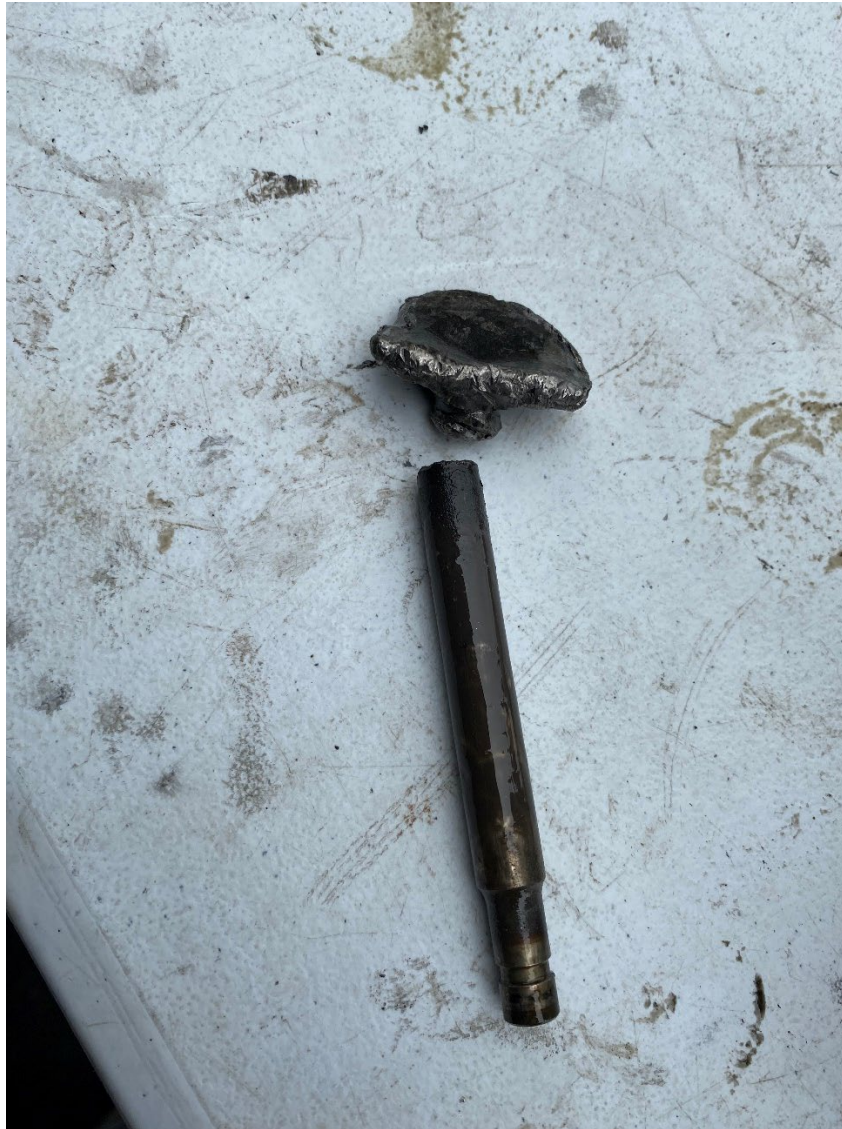
**Photograph 3 - Number Three Cylinder Exhaust Valve (Courtesy of Federal Aviation Administration)**

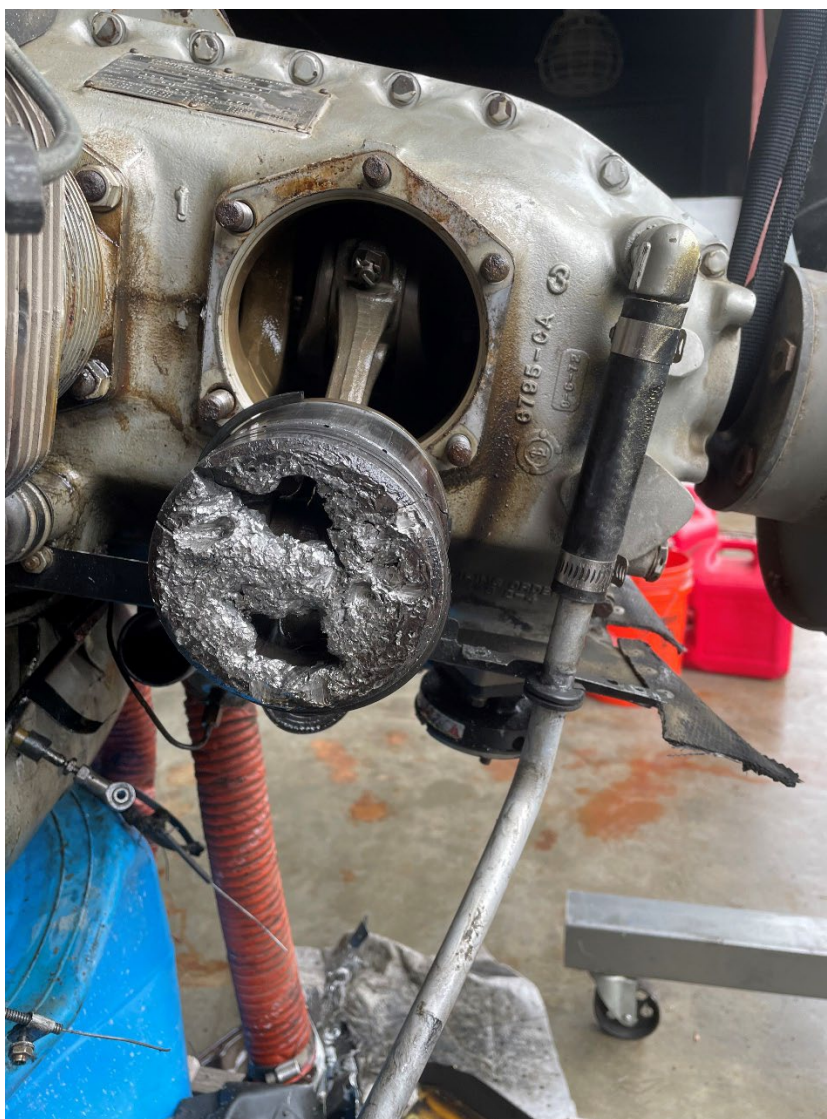
**Photograph 4 - Number Three Cylinder Piston Face (Courtesy of Federal Aviation Administration)**

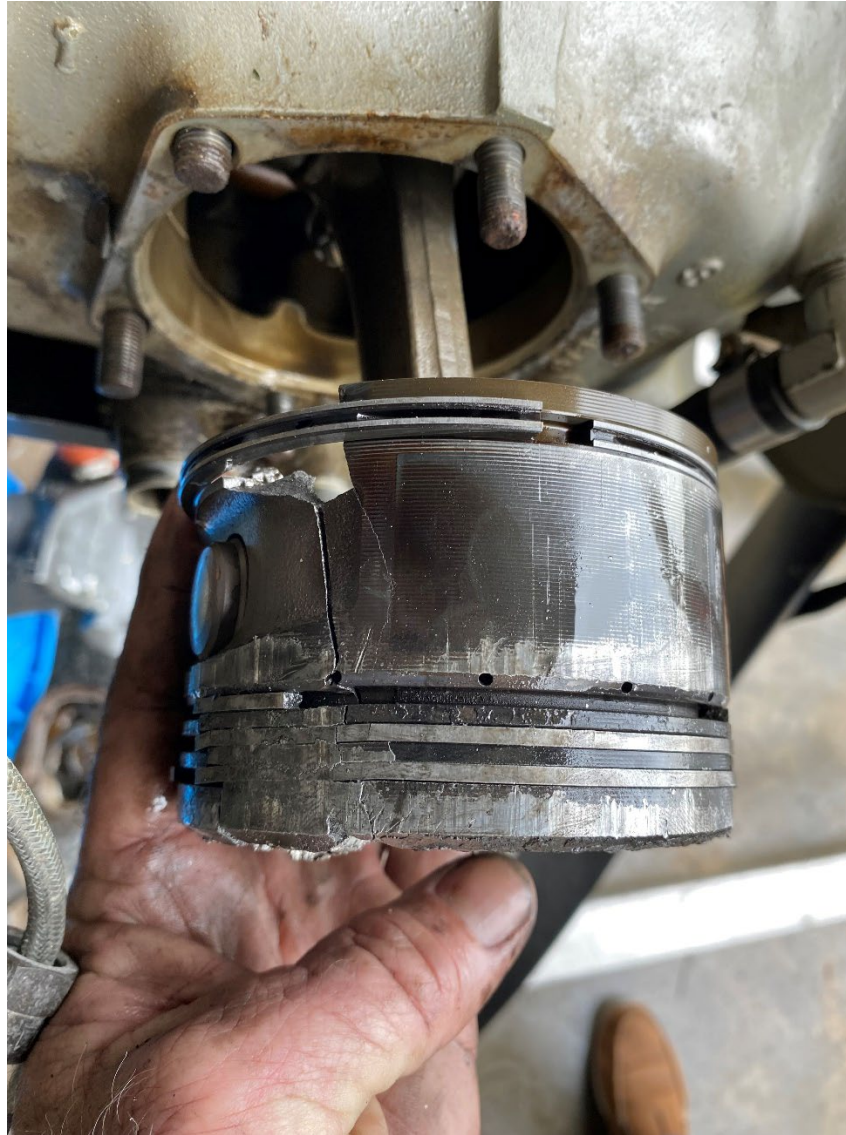
**Photograph 5 - Number Three Cylinder Piston (Courtesy of Federal Aviation Administration)**
