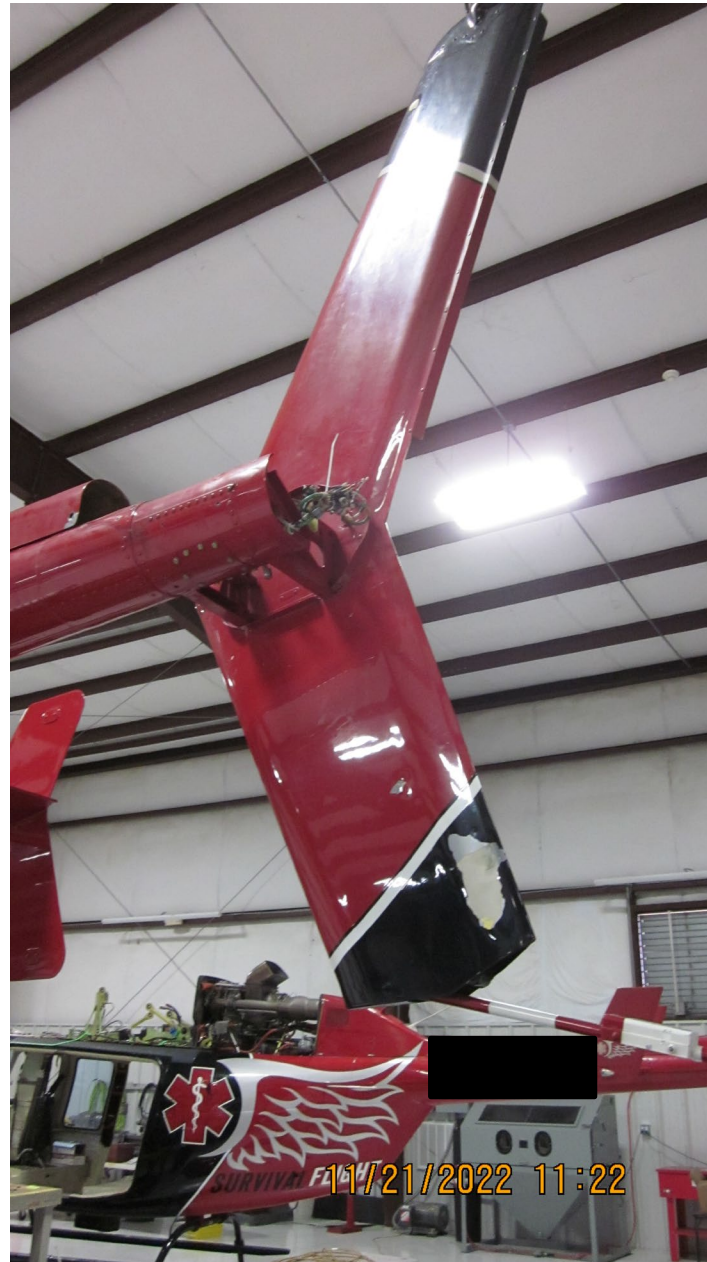
**Photo 1 – Tail of Accident Helicopter (Photo Provided by Survival Flight)**

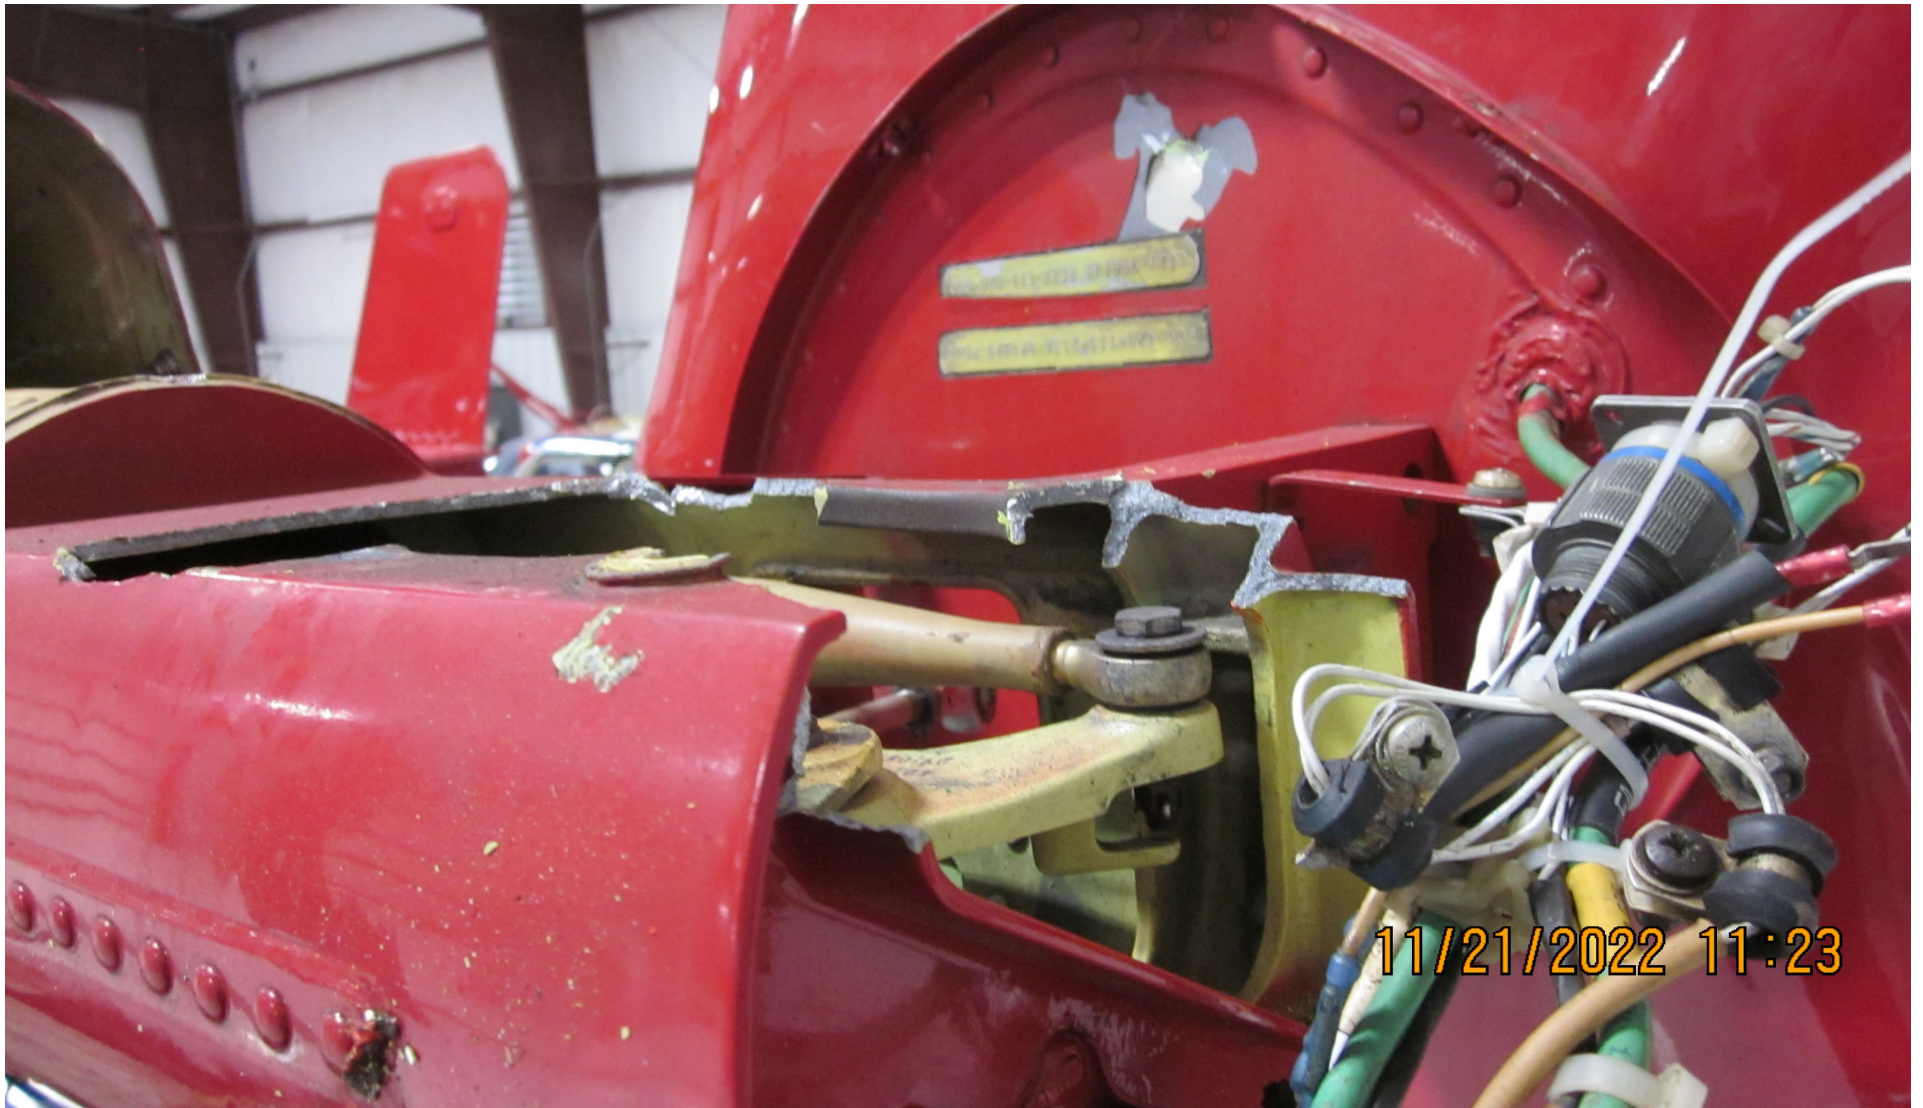
**Photo 2 – Tail Rotor Gearbox Mounting Surface (Photo Provided by Survival Flight)**

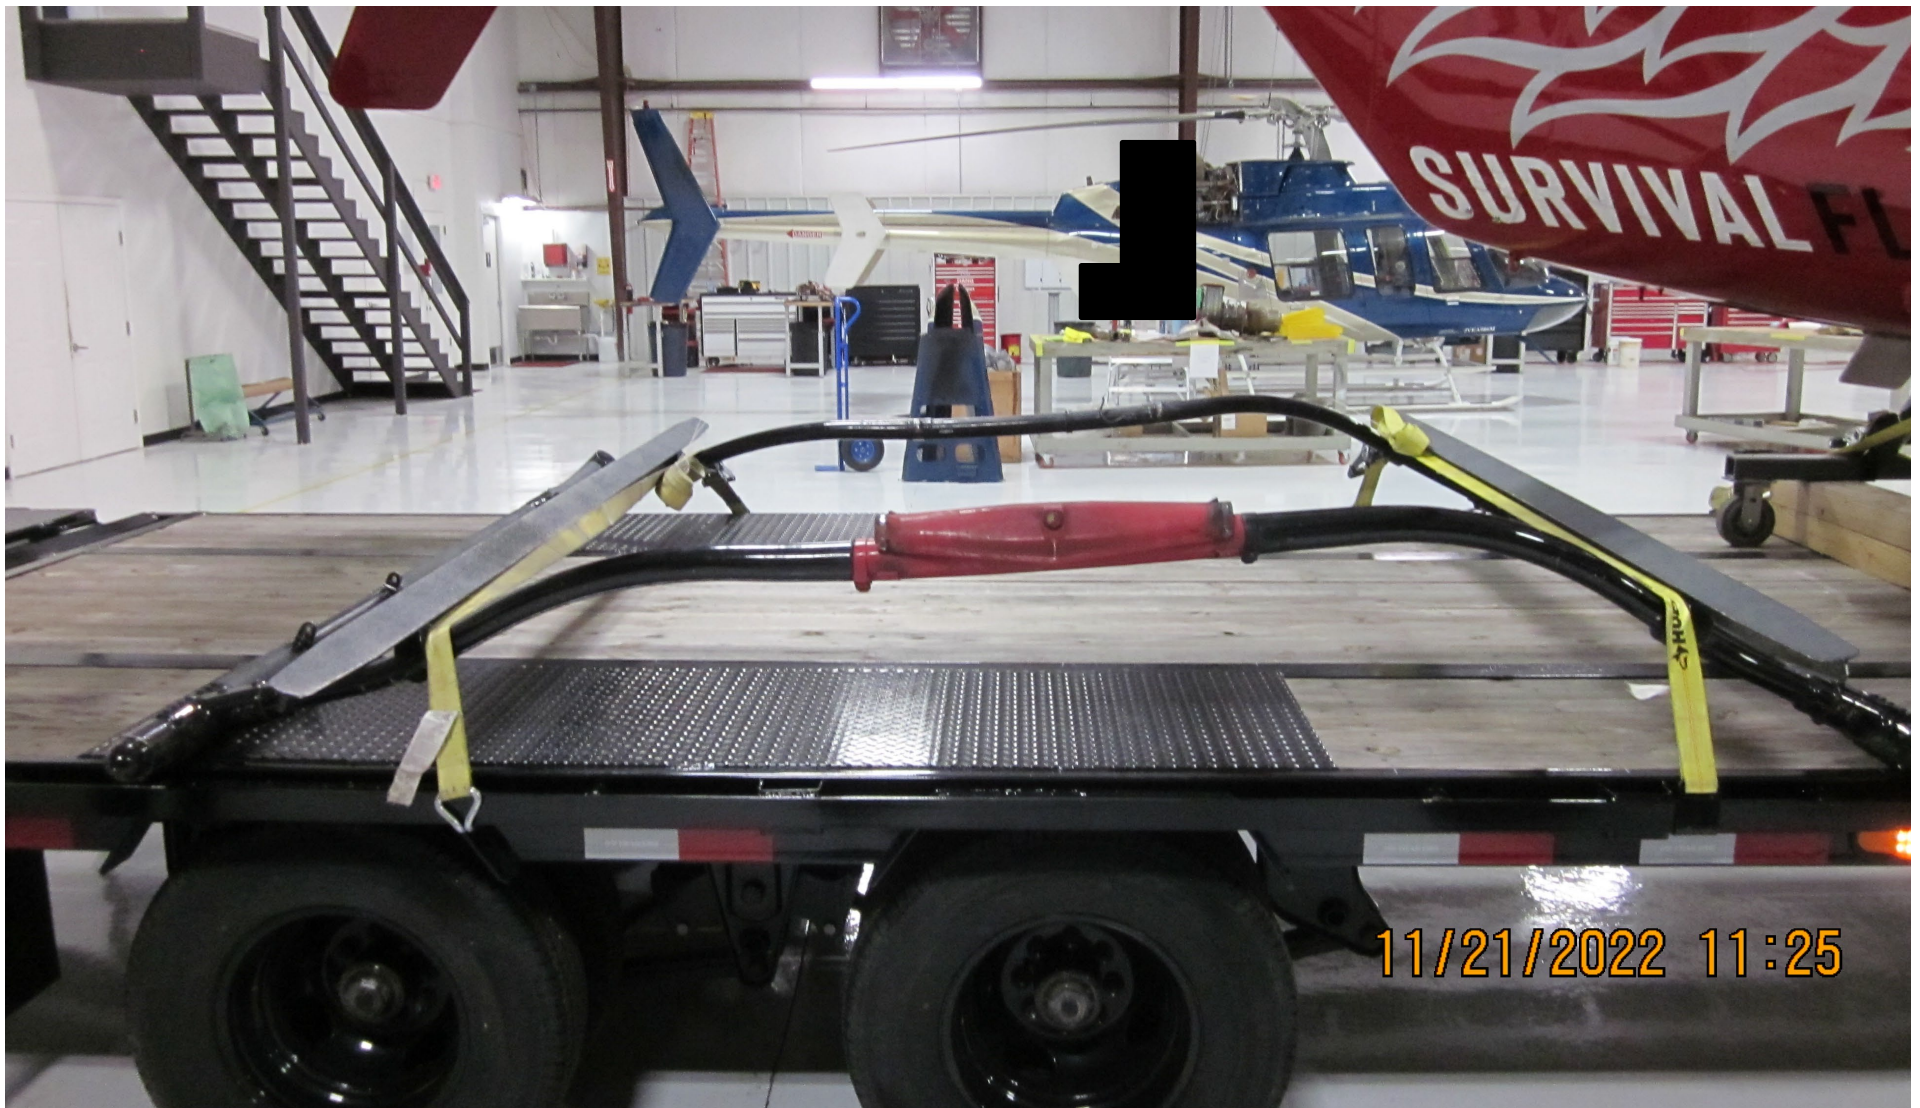
**Photo 3 – Landing Skid Removed from Accident Helicopter (Photo Provided by Survival Flight)**

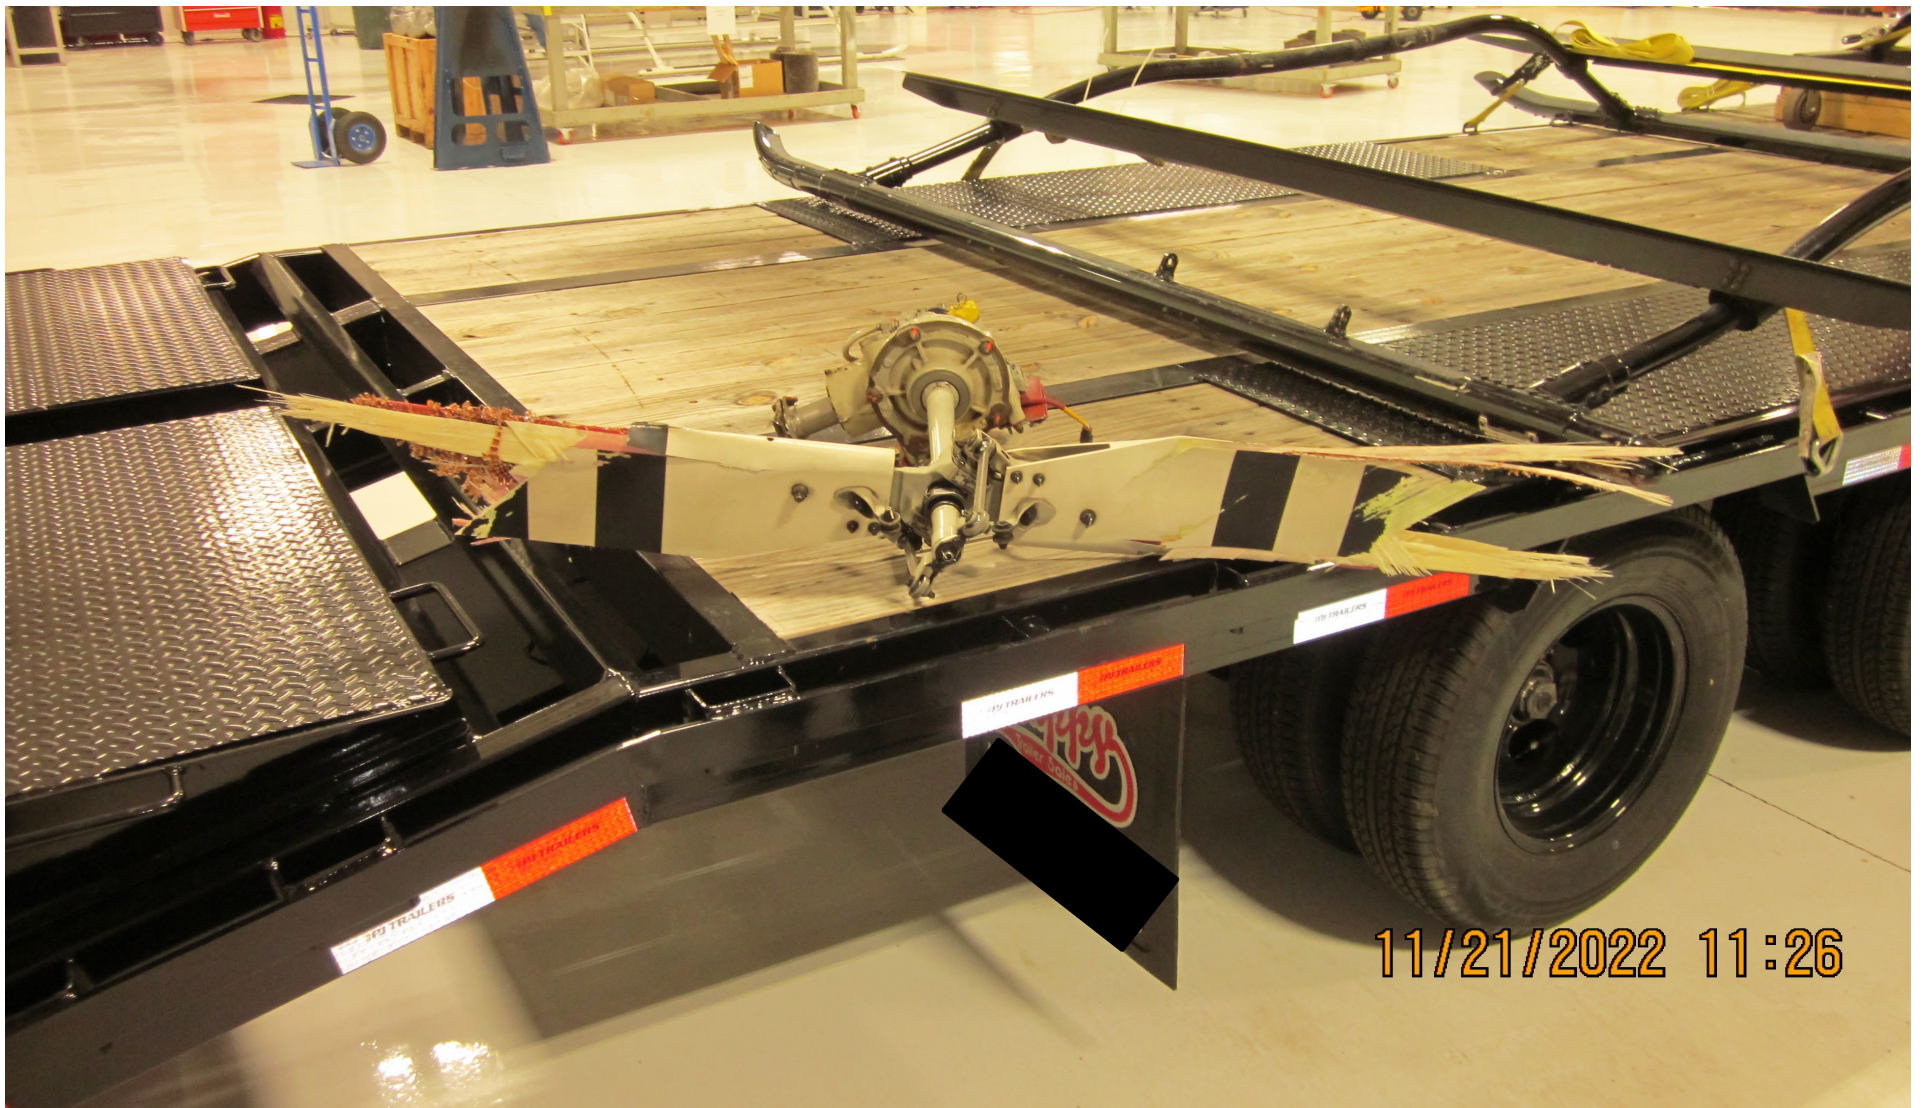
**Photo 4 – Damaged Tail Rotor (Photo Provided by Survival Flight)**

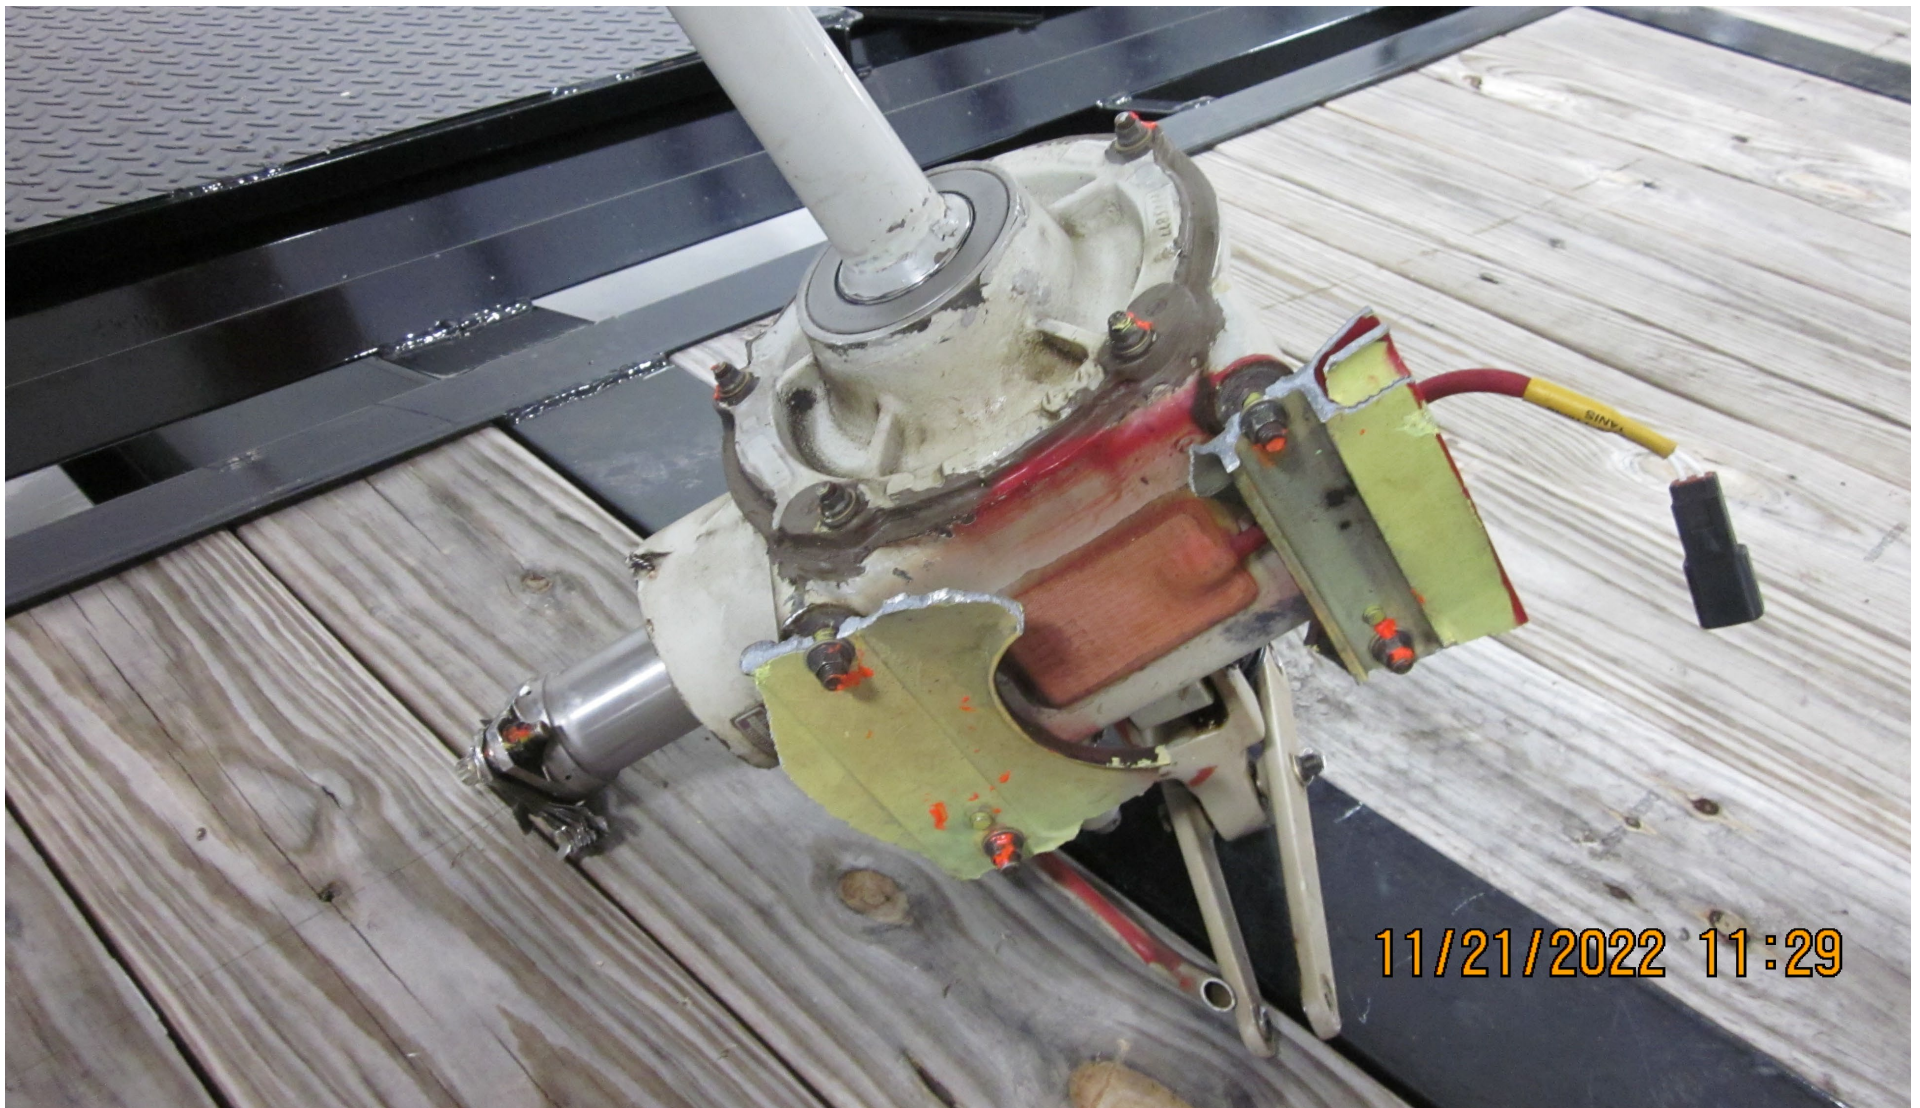
**Photo 5 - Tail Rotor Gearbox and Fractured Mounting Surface (Photo Provided by Survival Flight)**

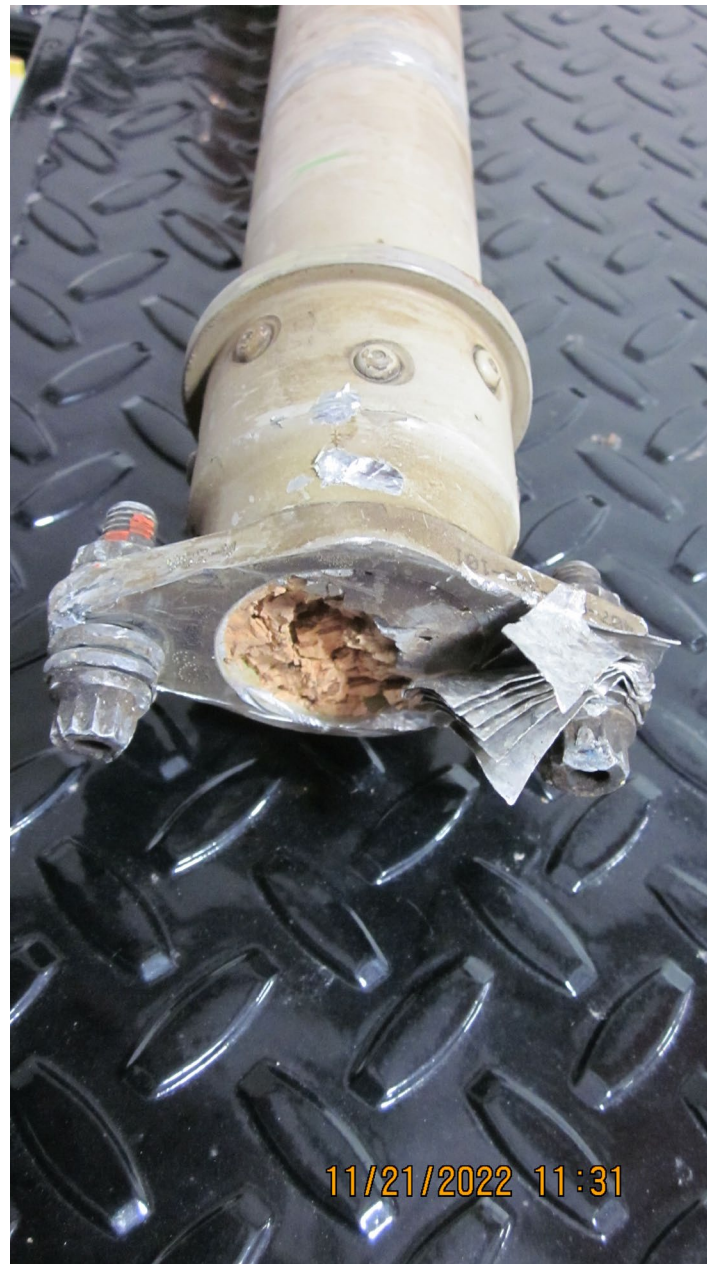
**Photo 6 – Tail Rotor Driveshaft Coupling Damage (Photo Provided by Survival Flight)**

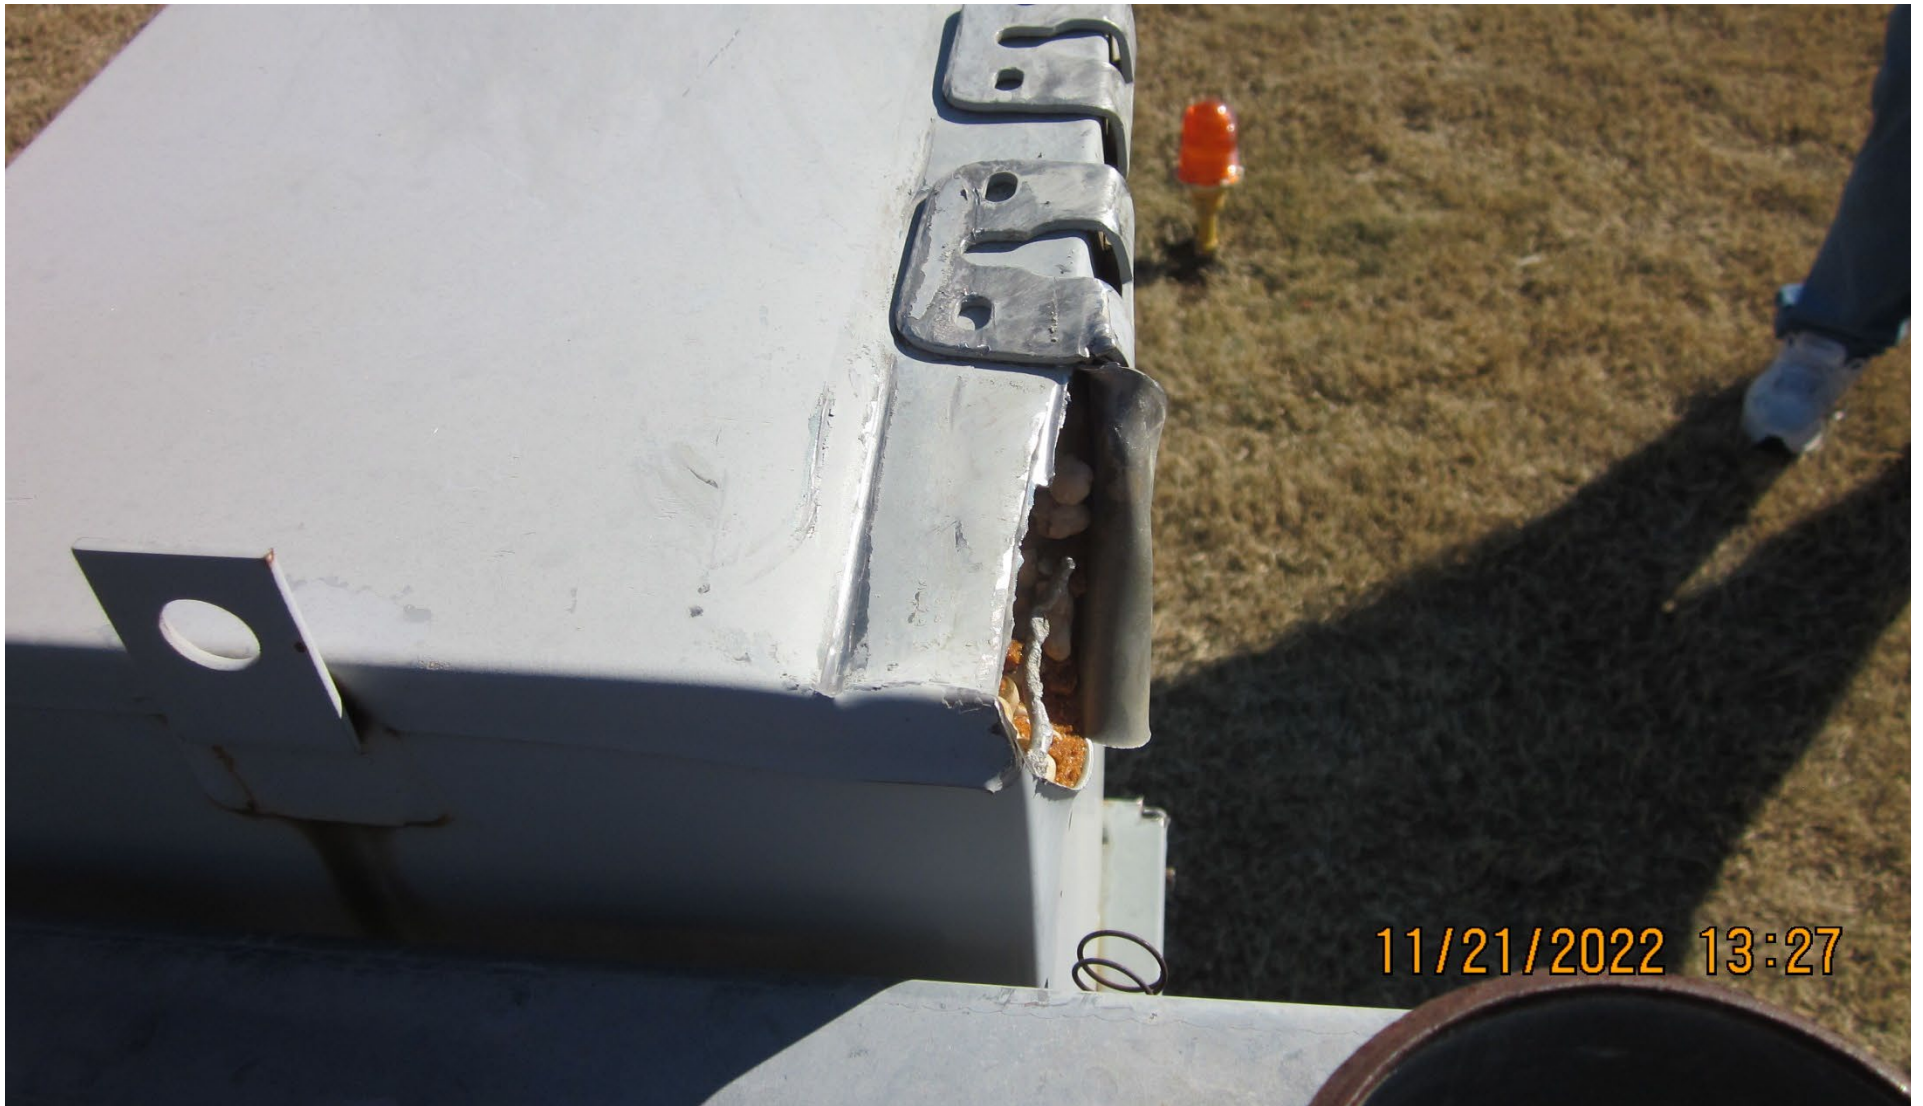
**Photo 7 – Electrical Box Struck by Tail Rotor (Photo Provided by Survival Flight)**

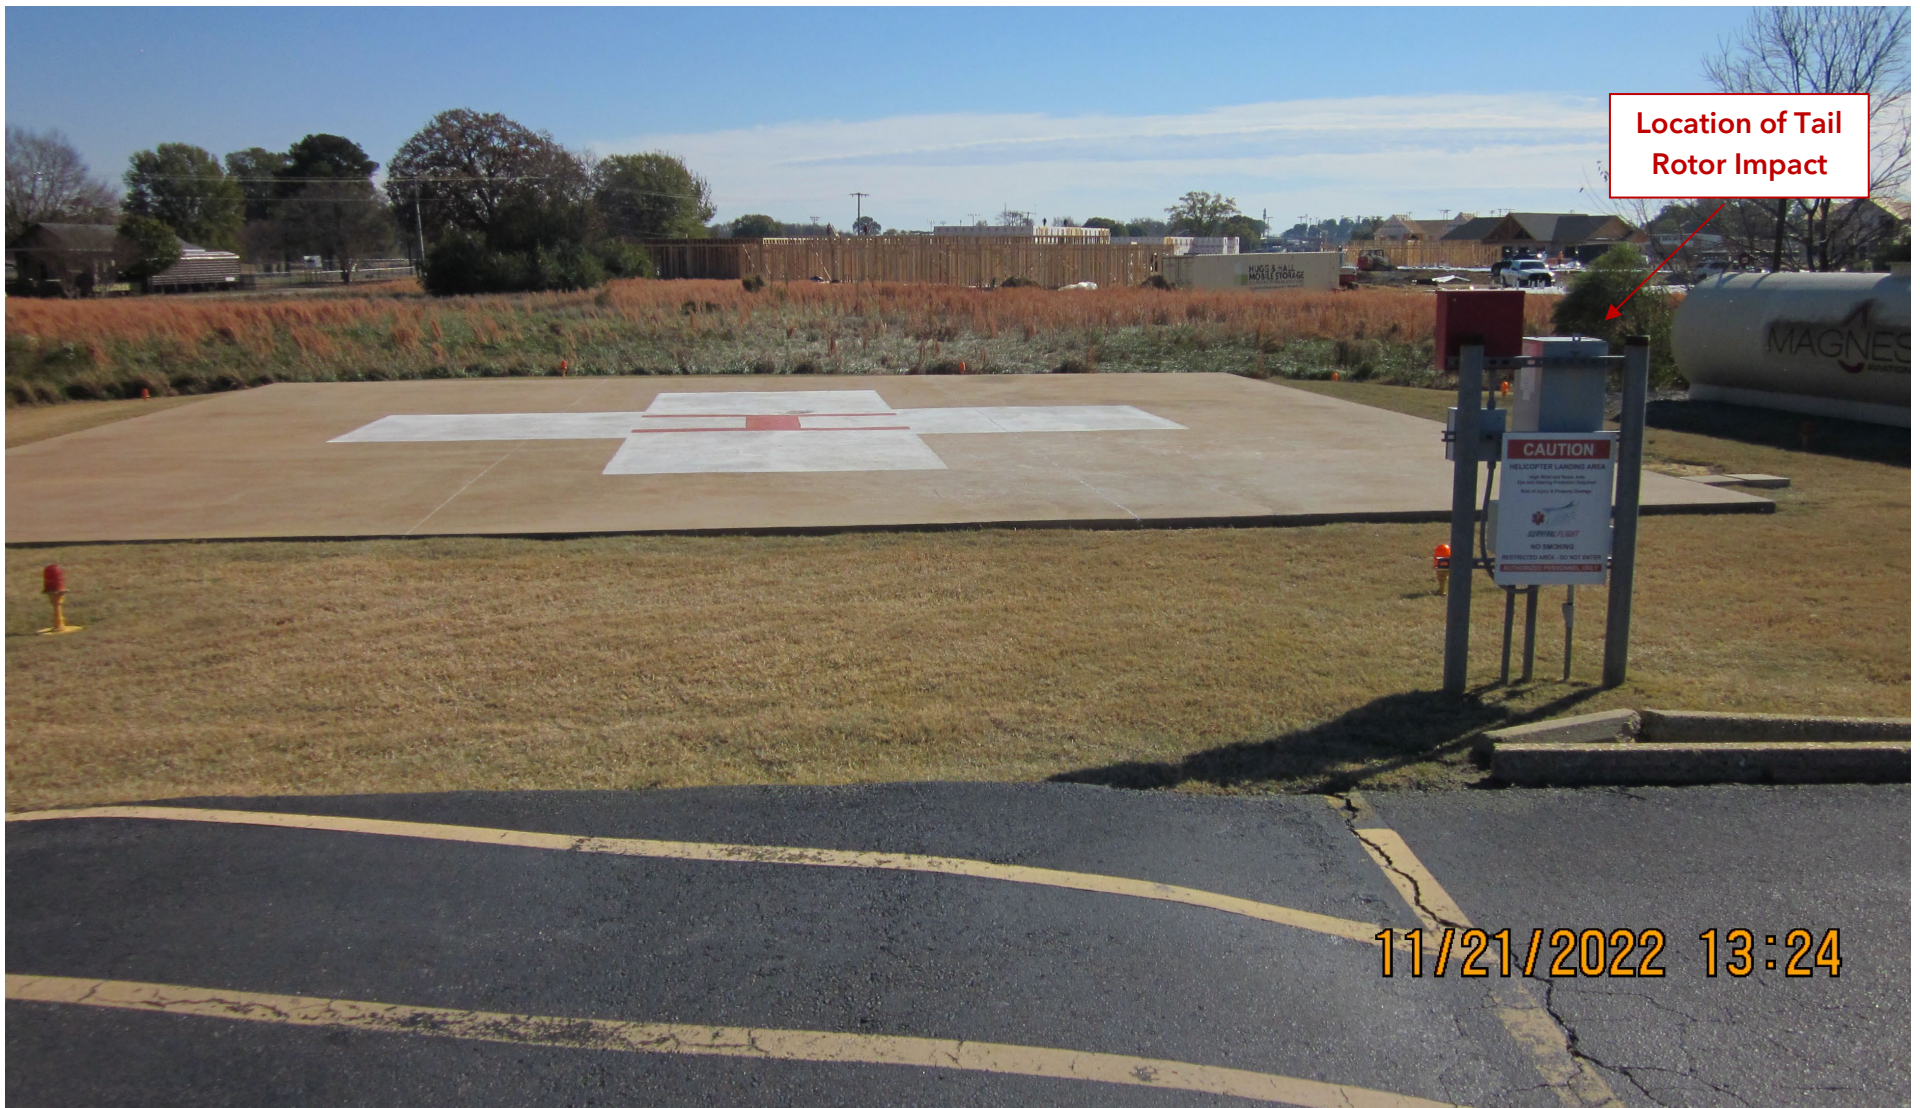
**Photo 8 – Accident Site (Photo Provided by Survival Flight)**
