## **NATIONAL TRANSPORTATION SAFETY BOARD**

### **Aircraft Examination and Accident Information Summary**

**CEN23LA056**

Aircraft: Lear 45XR

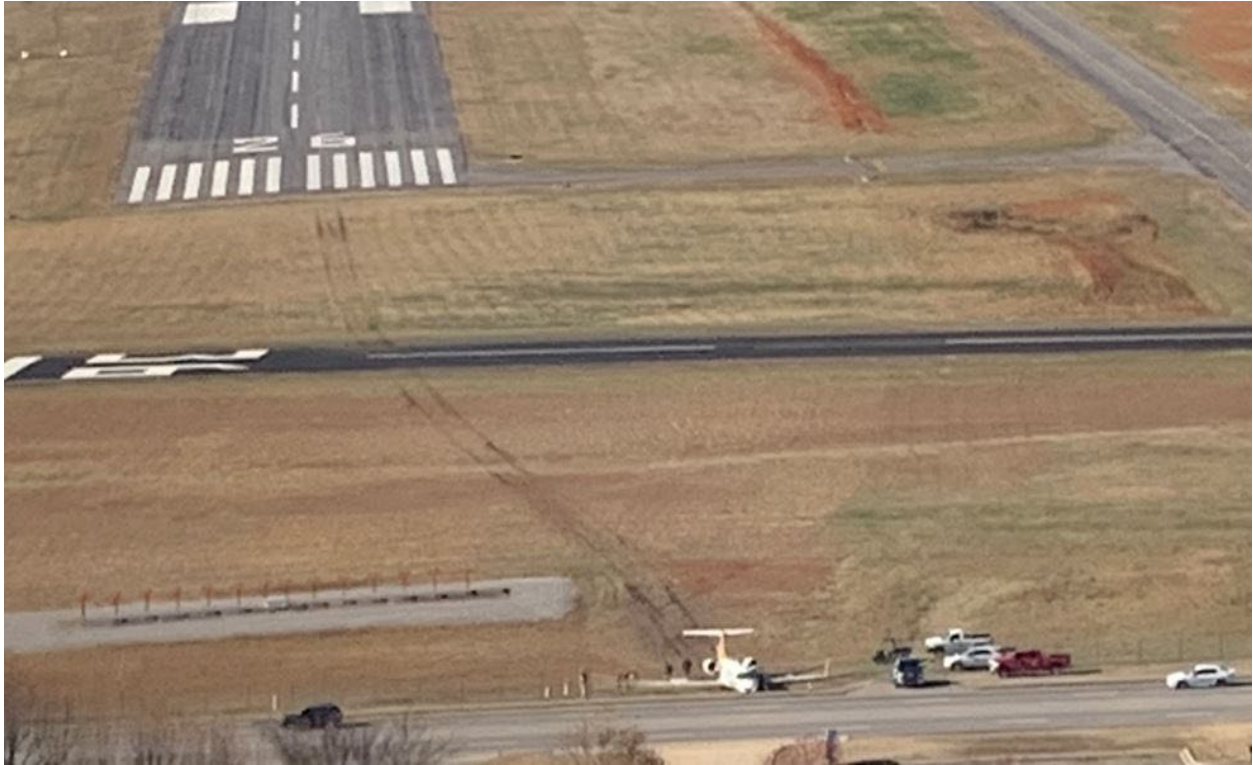
The aircraft left the runway surface 25 feet left of centerline at a surface ADS-B groundspeed of more than 100 knots. The aircraft continued through the overrun area and crossed a north/south runway. The aircraft came to rest on a 070° magnetic heading about 1,181 ft past the departure

end of Runway 8 against the airport perimeter fence alongside US Highway 167 (see Photos 1 and 2).

Photo 1 – Overhead View of Airplane at Accident Site, Courtesy of the FAA.

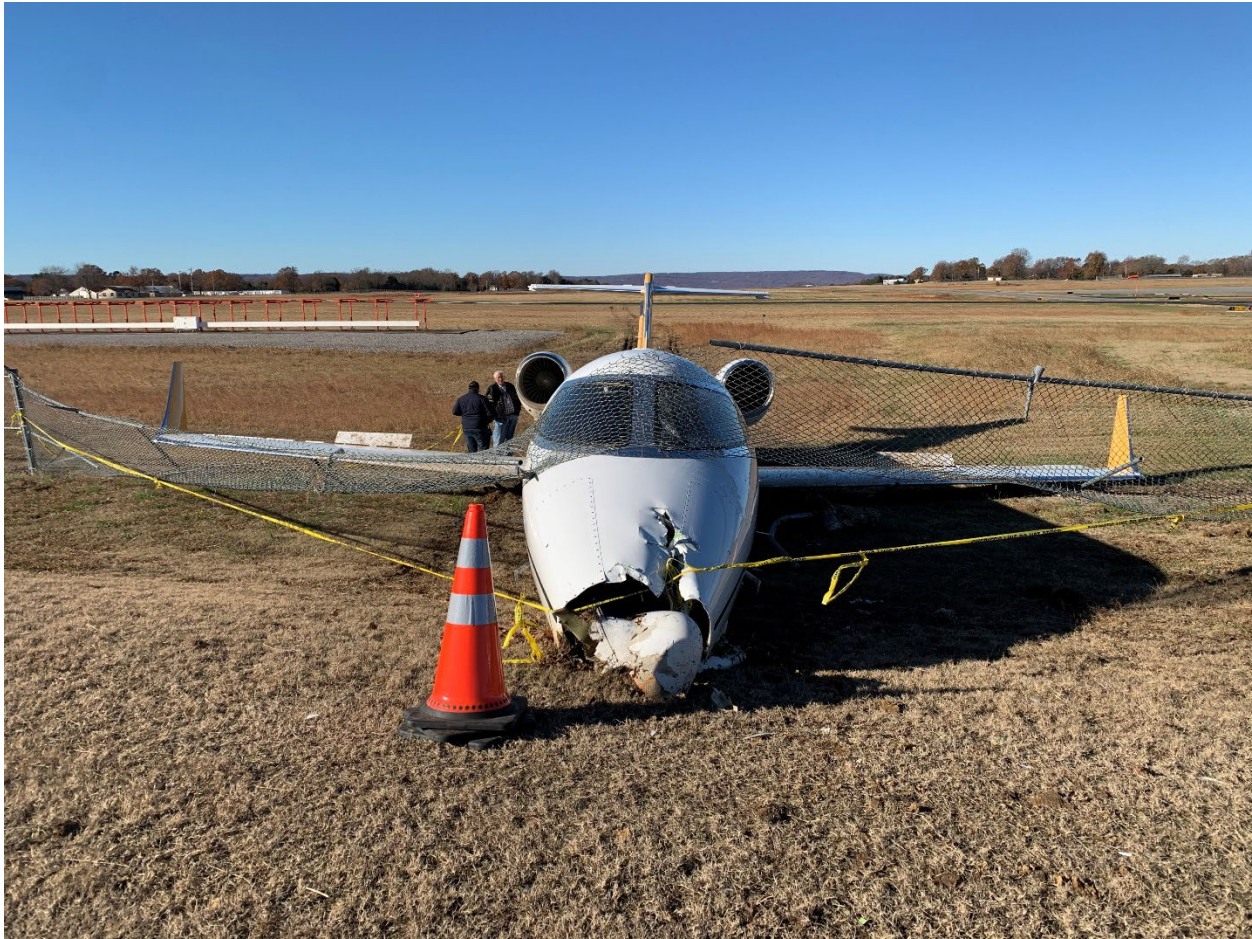
Photo 2 – Front View of Airplane at Accident Site, Courtesy of the FAA.

Examination of the structure found that everything in the nose compartment forward of flight station (FS) 144 was displaced aft. The cockpit voice recorder was removed from the aircraft and secured for download.
