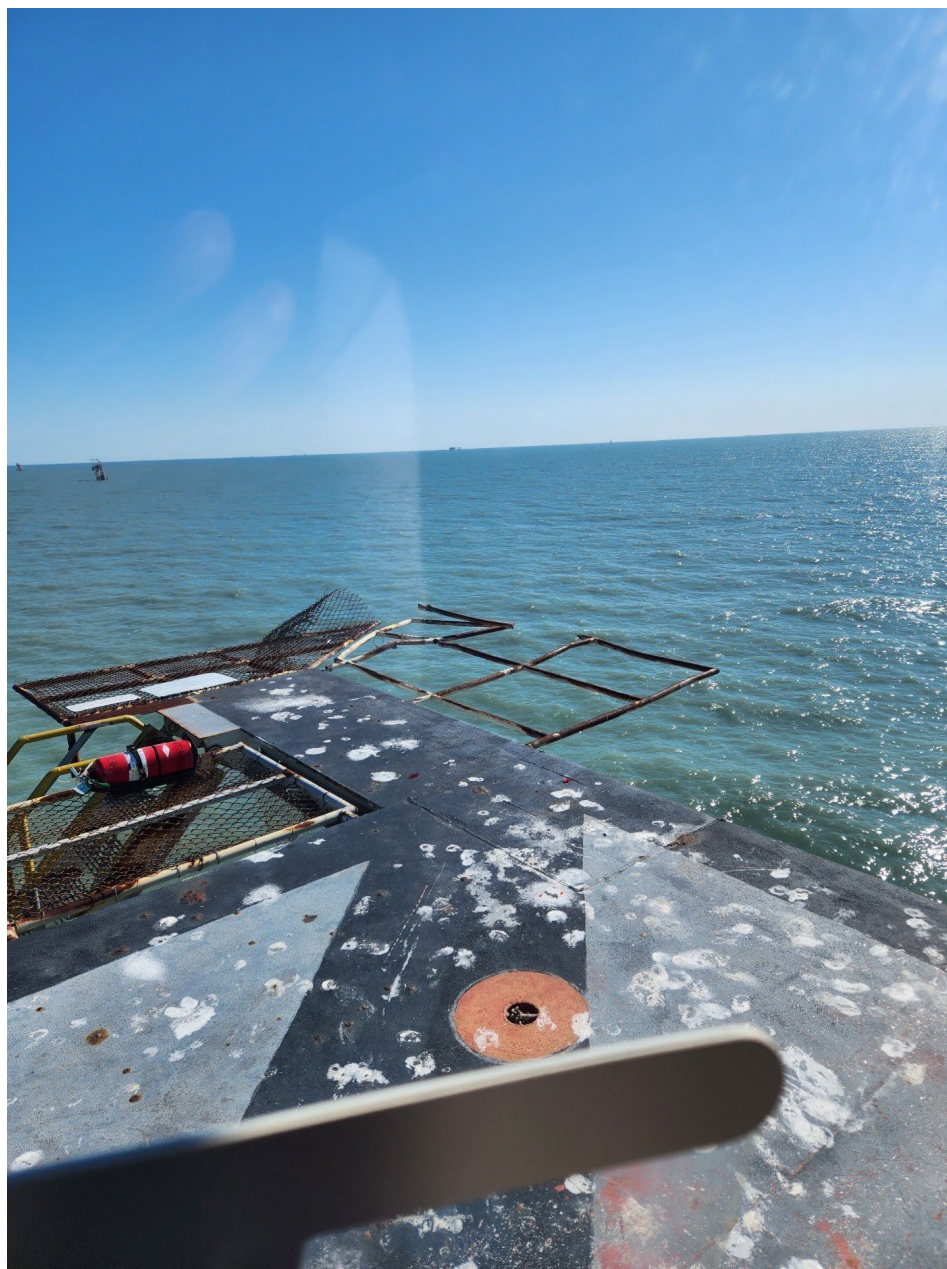
**Photo 2 – Platform skirting damage (Source: Rotorcraft Leasing Company)**

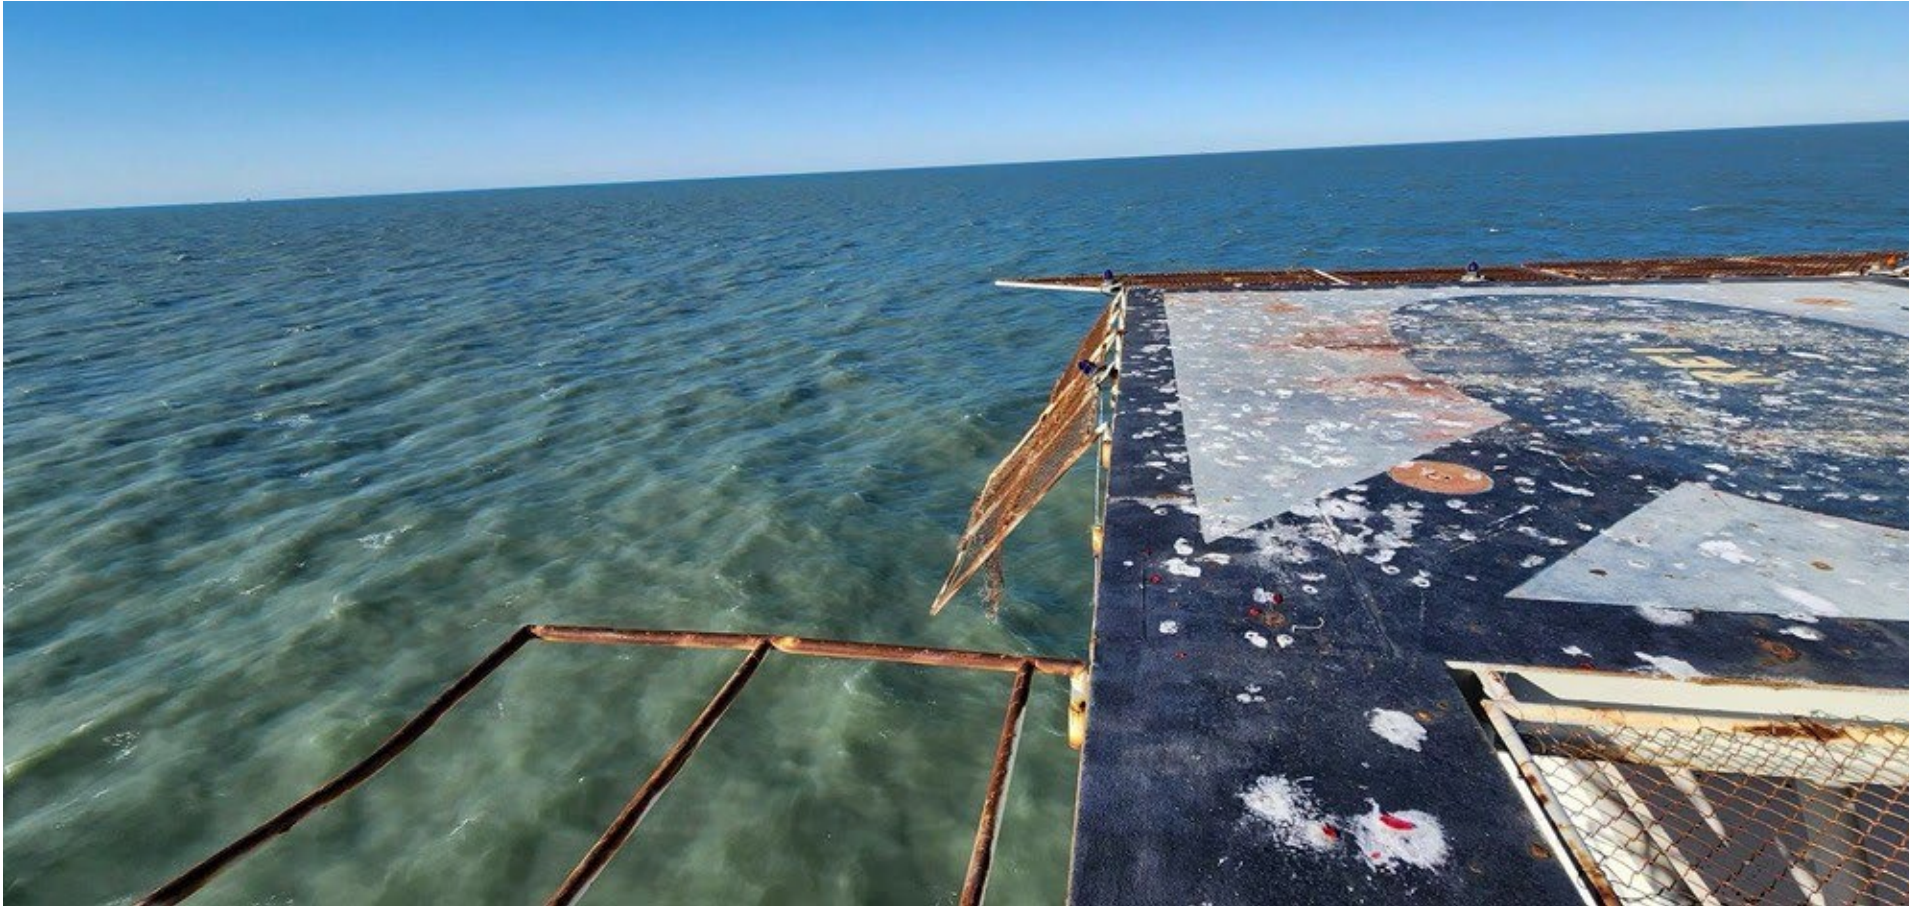
**Photo 3 – Platform skirting and light damage (Source: Rotorcraft Leasing Company)**

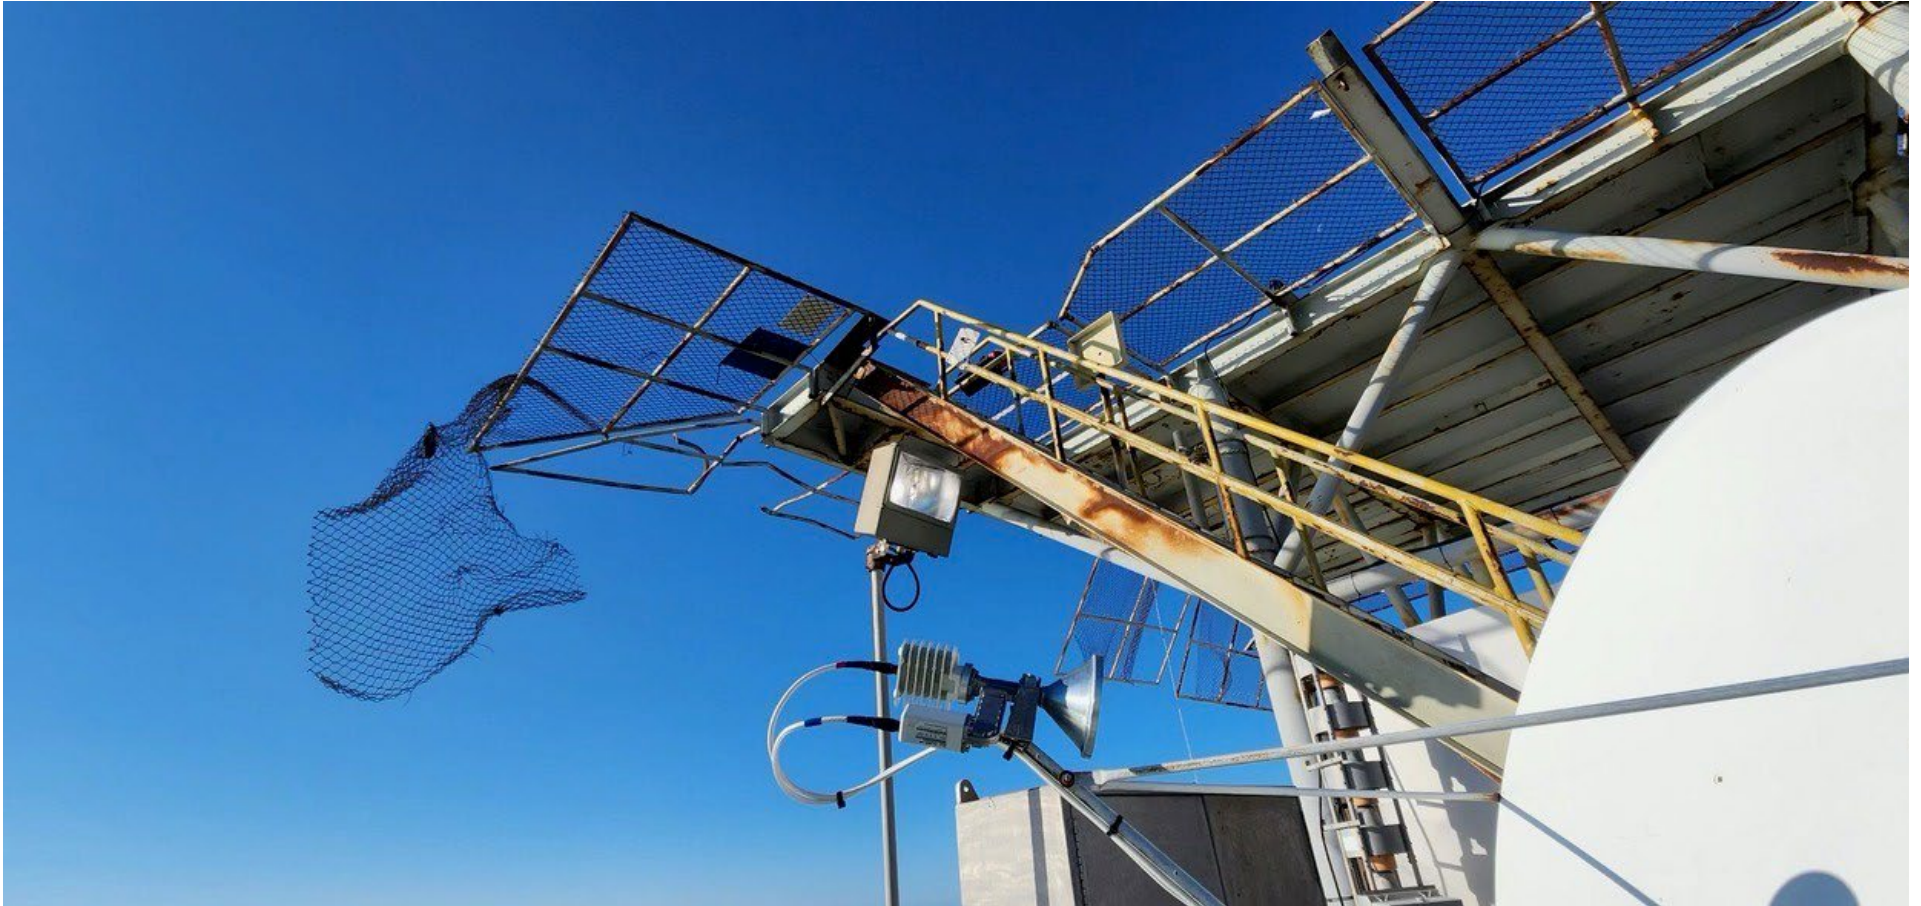
**Photo 4 – Platform skirting damage from below (Source: Rotorcraft Leasing Company)**

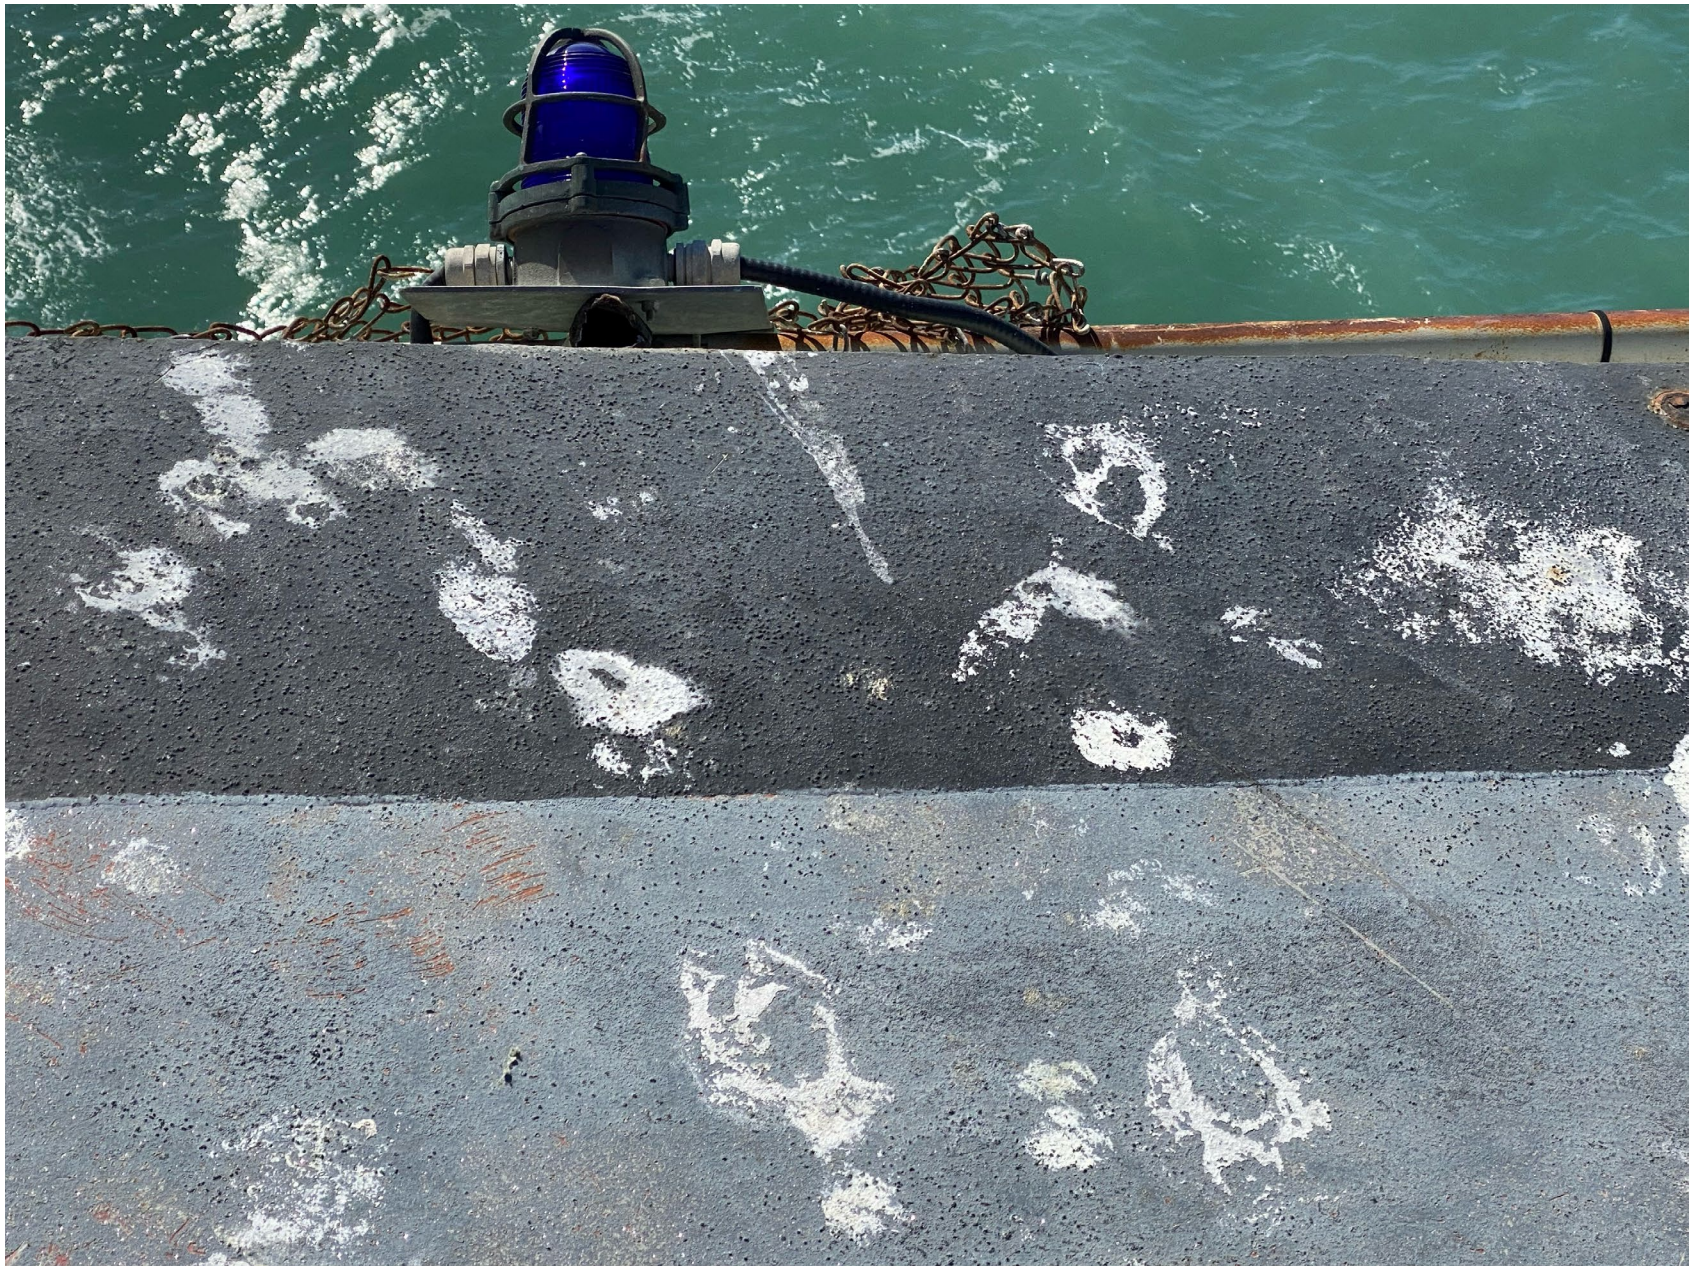
**Photo 5 – Platform skirting and light damage (Source: Rotorcraft Leasing Company)**

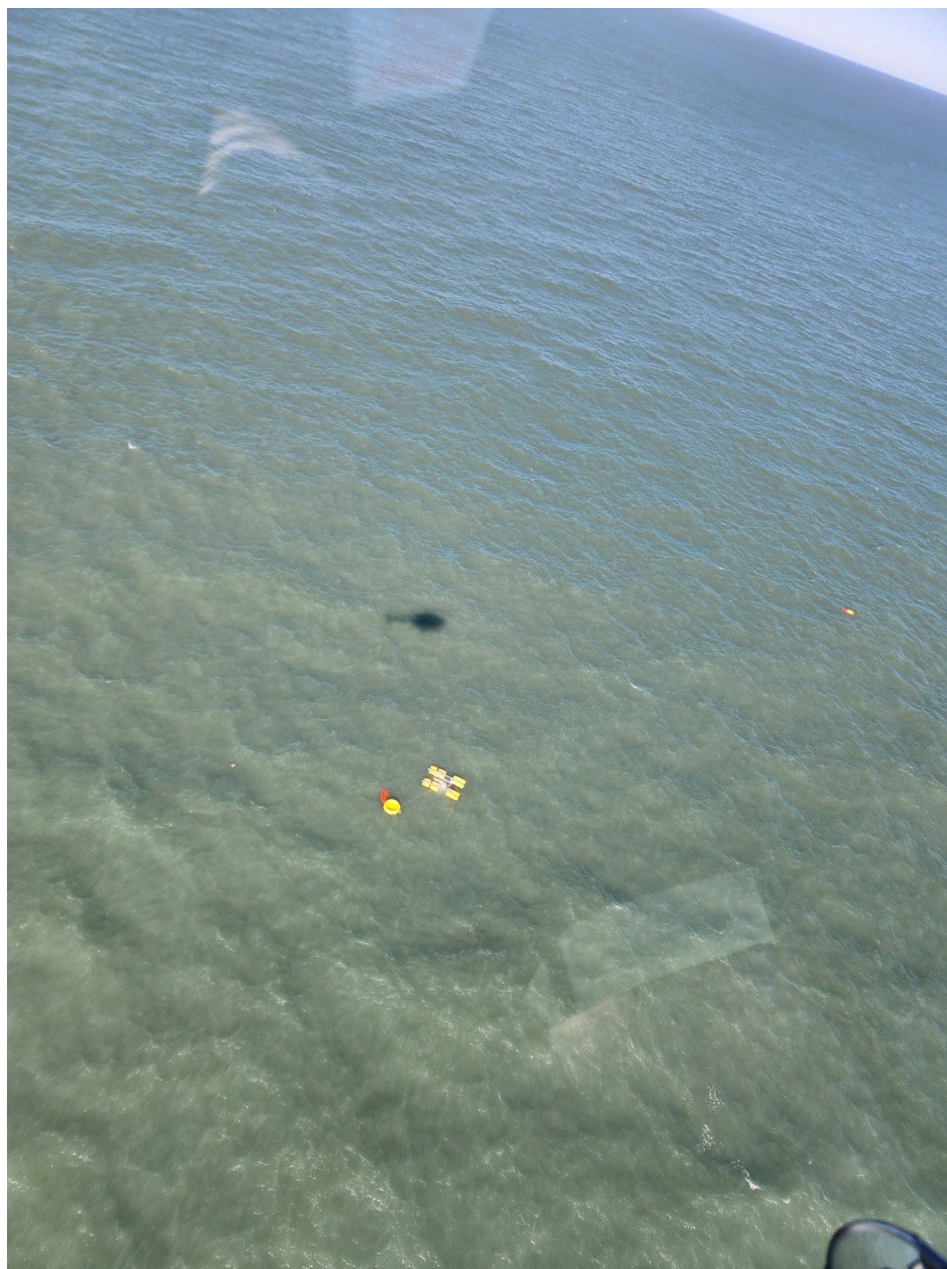
**Photo 6 – Helicopter wreckage upside down with floats inflated (Source: Rotorcraft Leasing Company)**

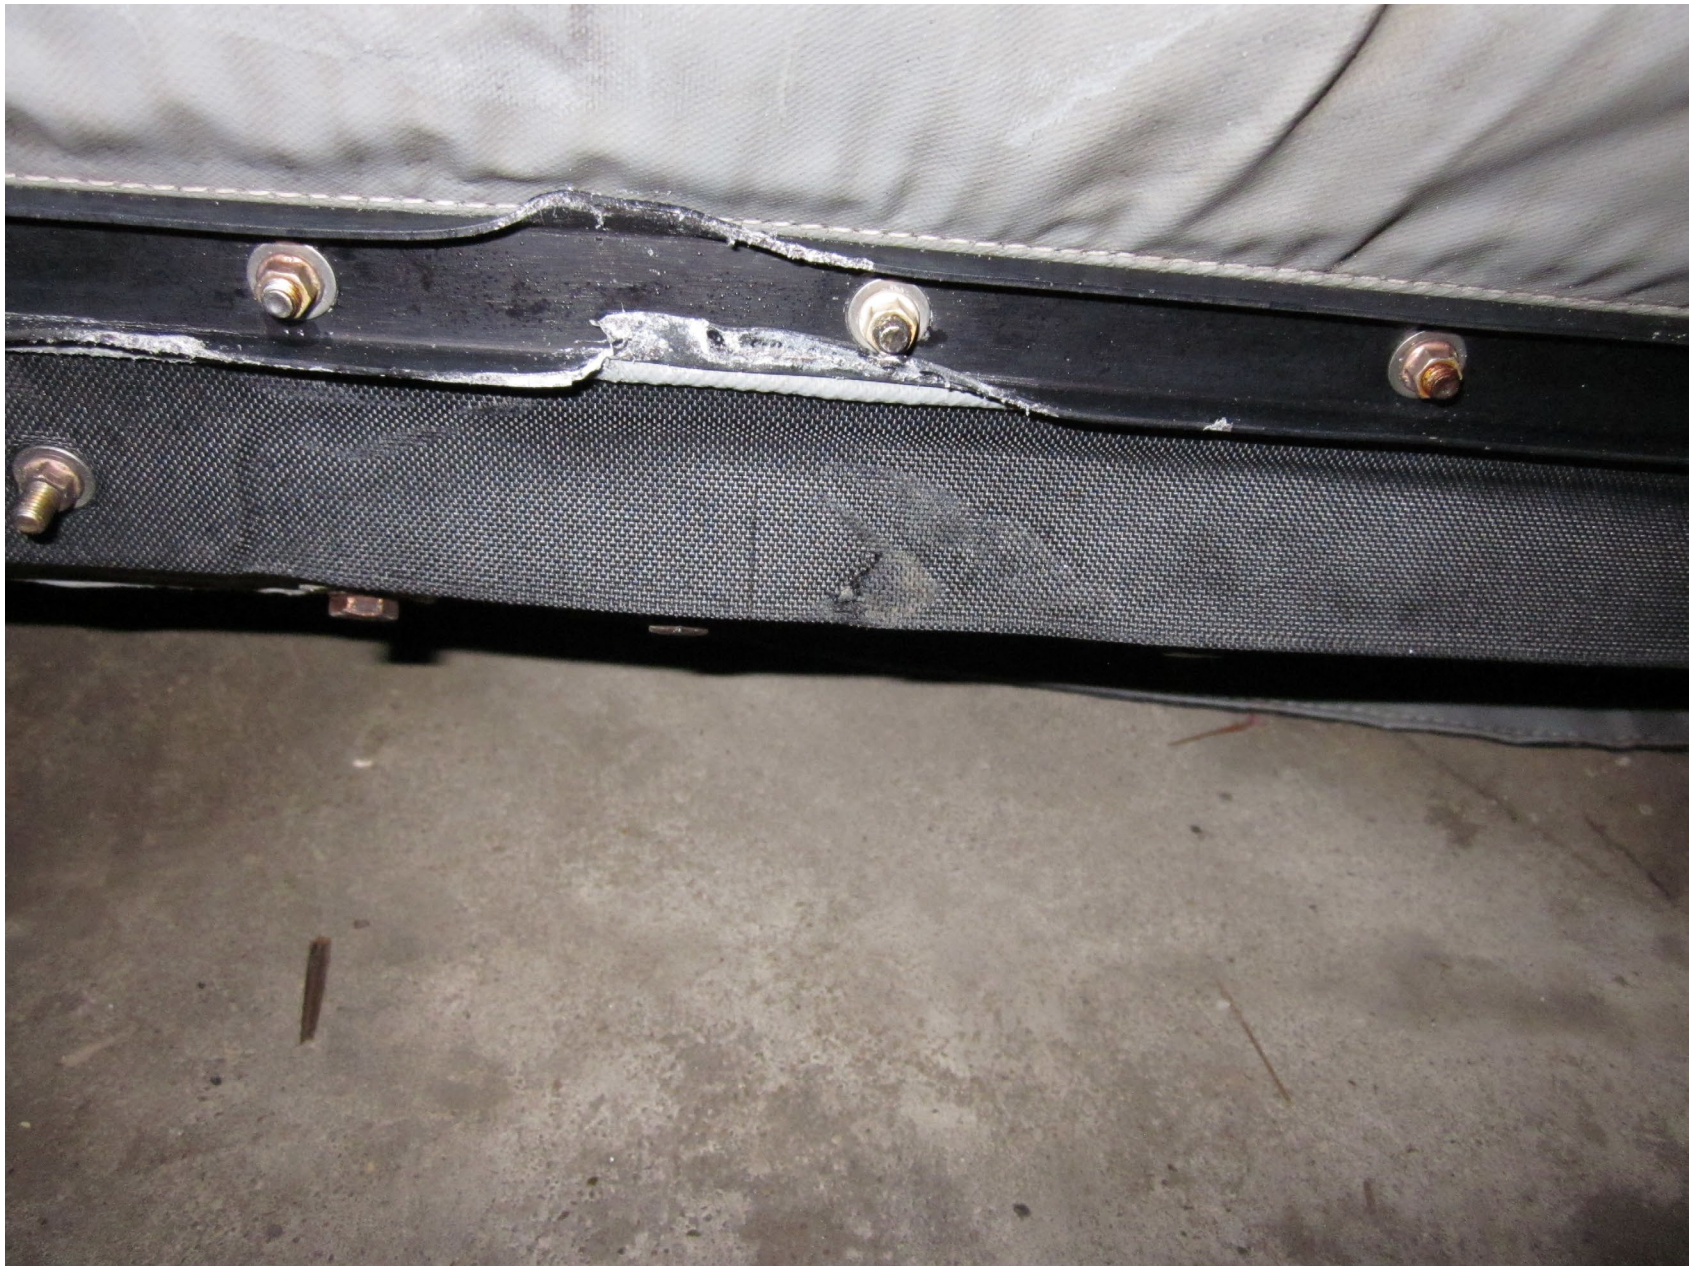
**Photo 7 – Skid damage (Source: FAA)**

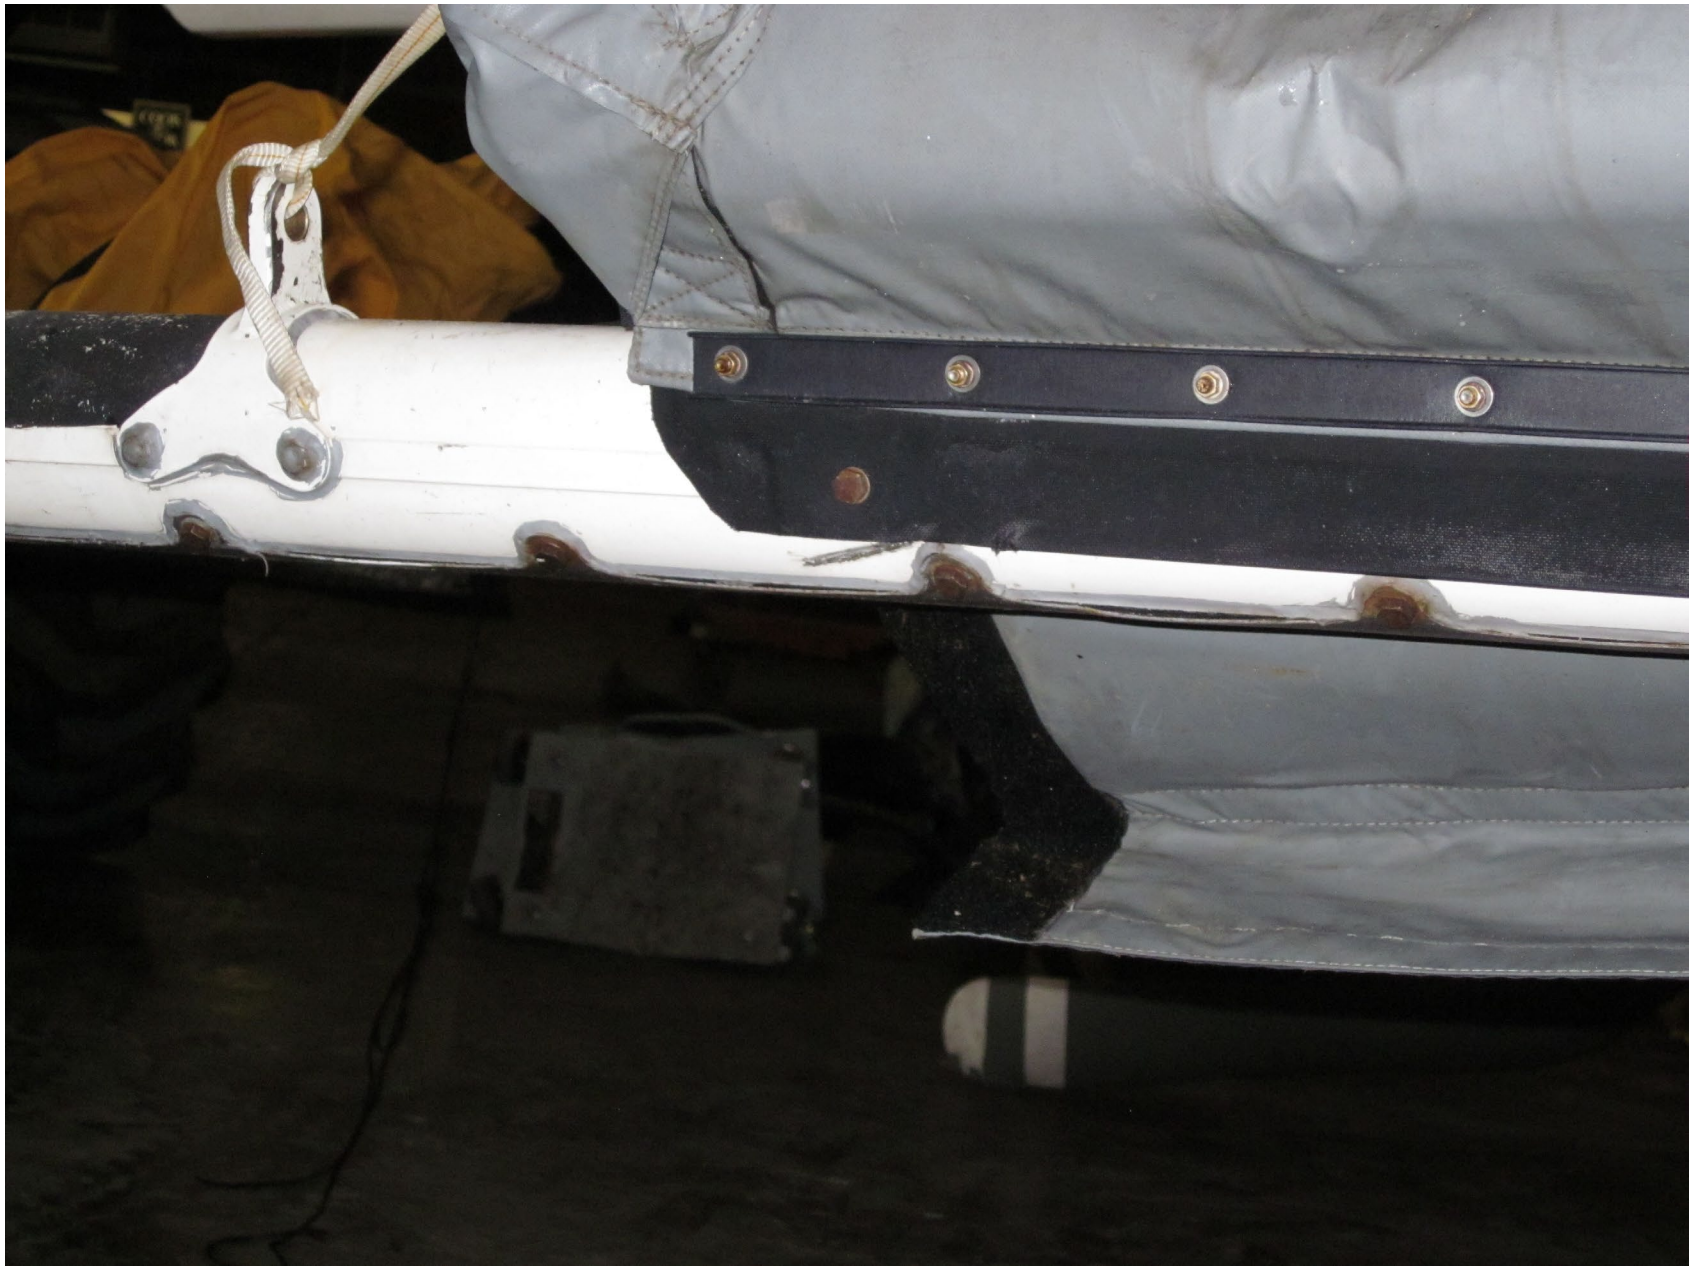
**Photo 8 – Skid damage (Source: FAA)**

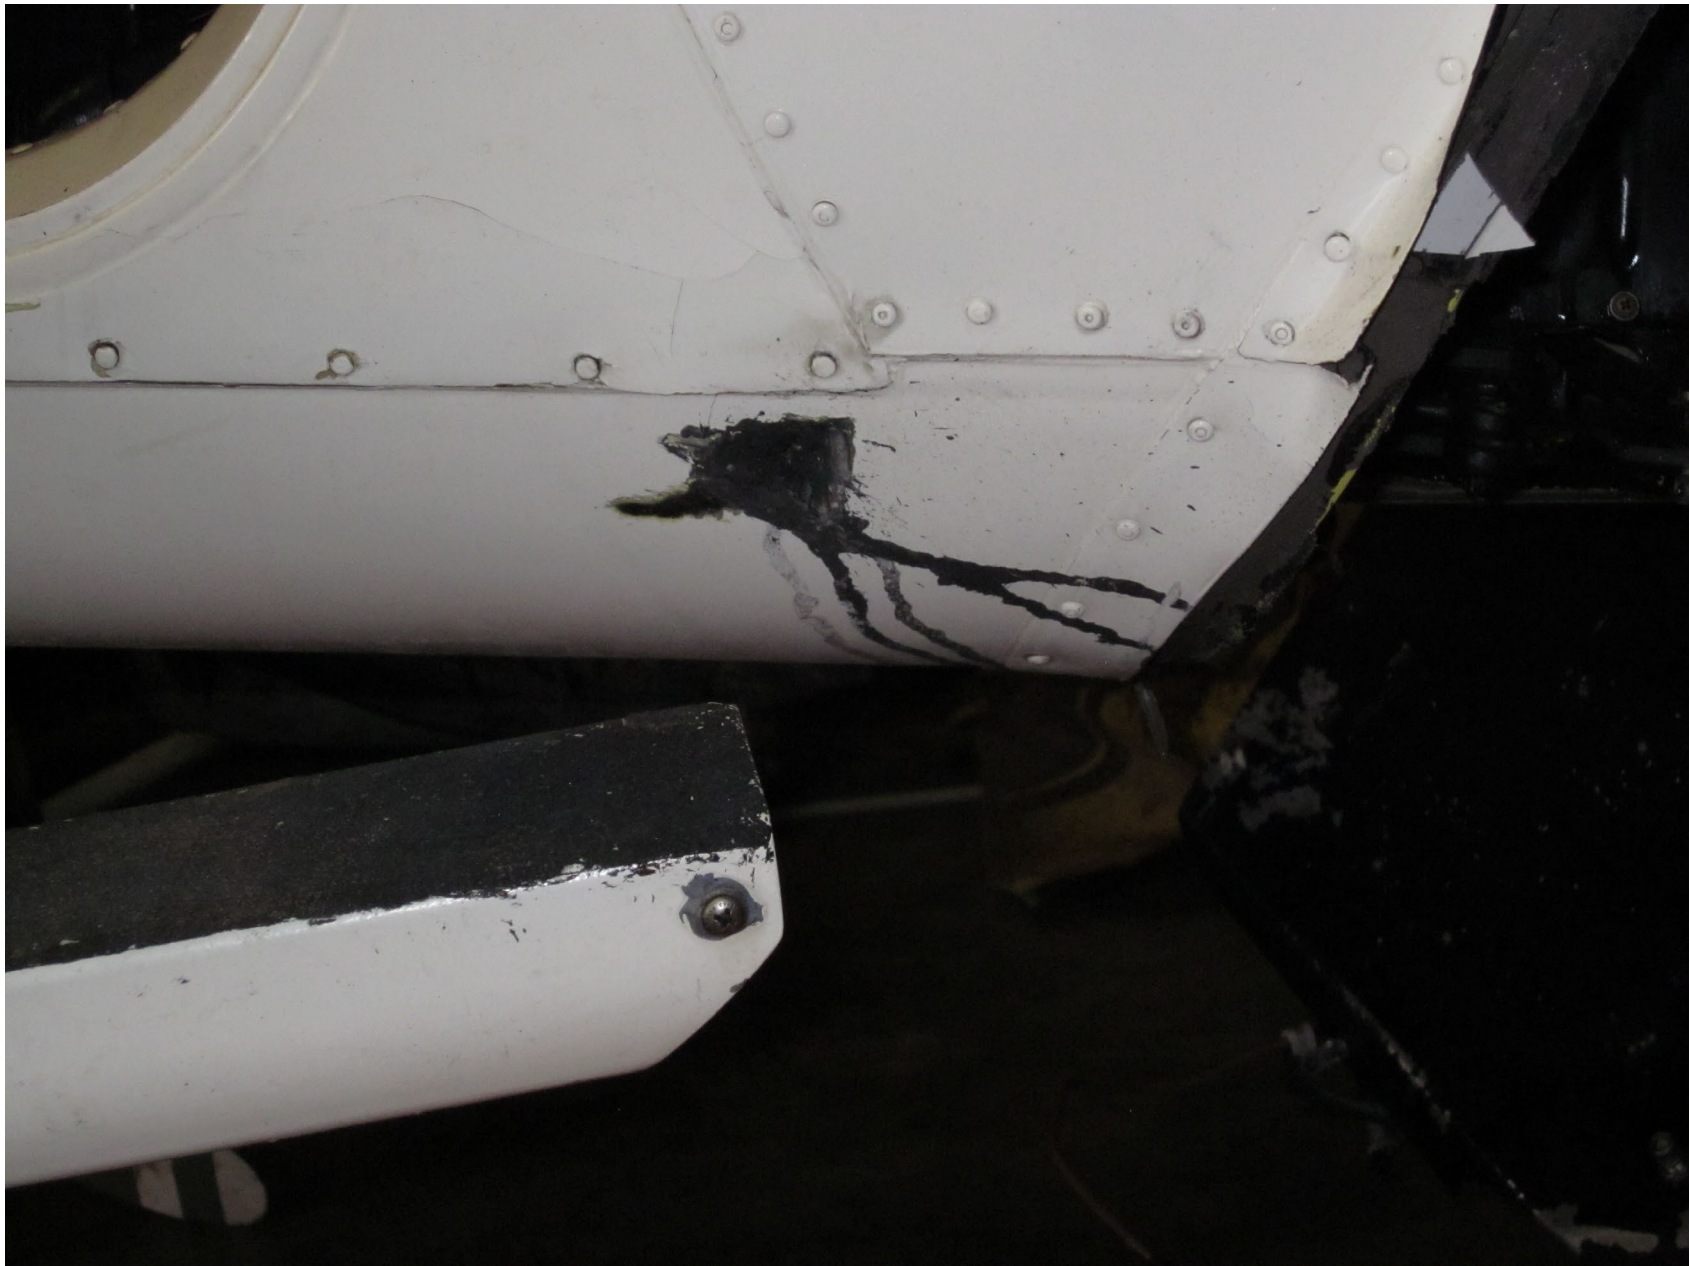
**Photo 9 – Witness marks (Source: FAA)**
