**From:** Sean Payne  
**Sent:** Wednesday, November 15, 2023 1:56 PM  
**To:** Joshua Lindberg  
**Subject:** CEN23LA064 (Patterson, Louisiana) Appareo Vision 1000 - Email Report  
**Attachments:** Appareo2.jpg; Appareo1.jpg

### Email Report

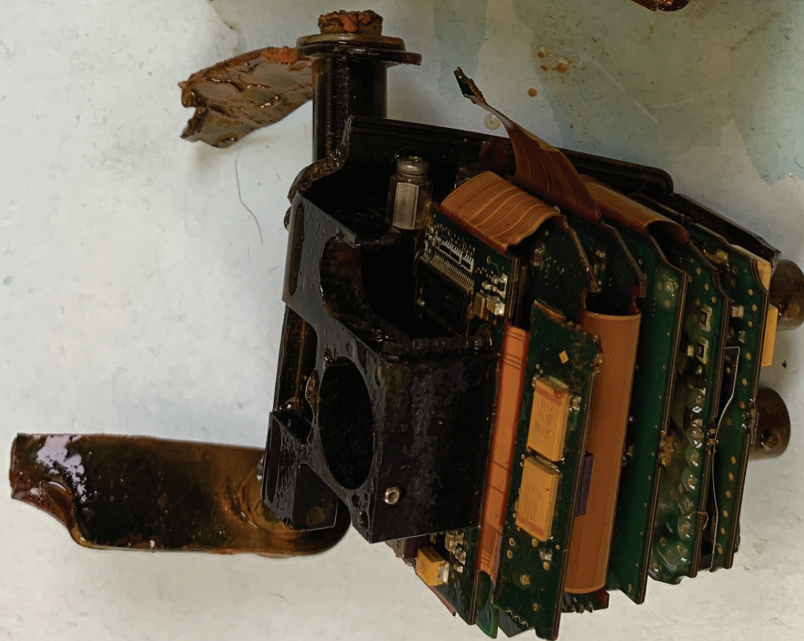
The device was absent of a removable memory device. Appareo2.jpg shows the memory device slot empty, as received.

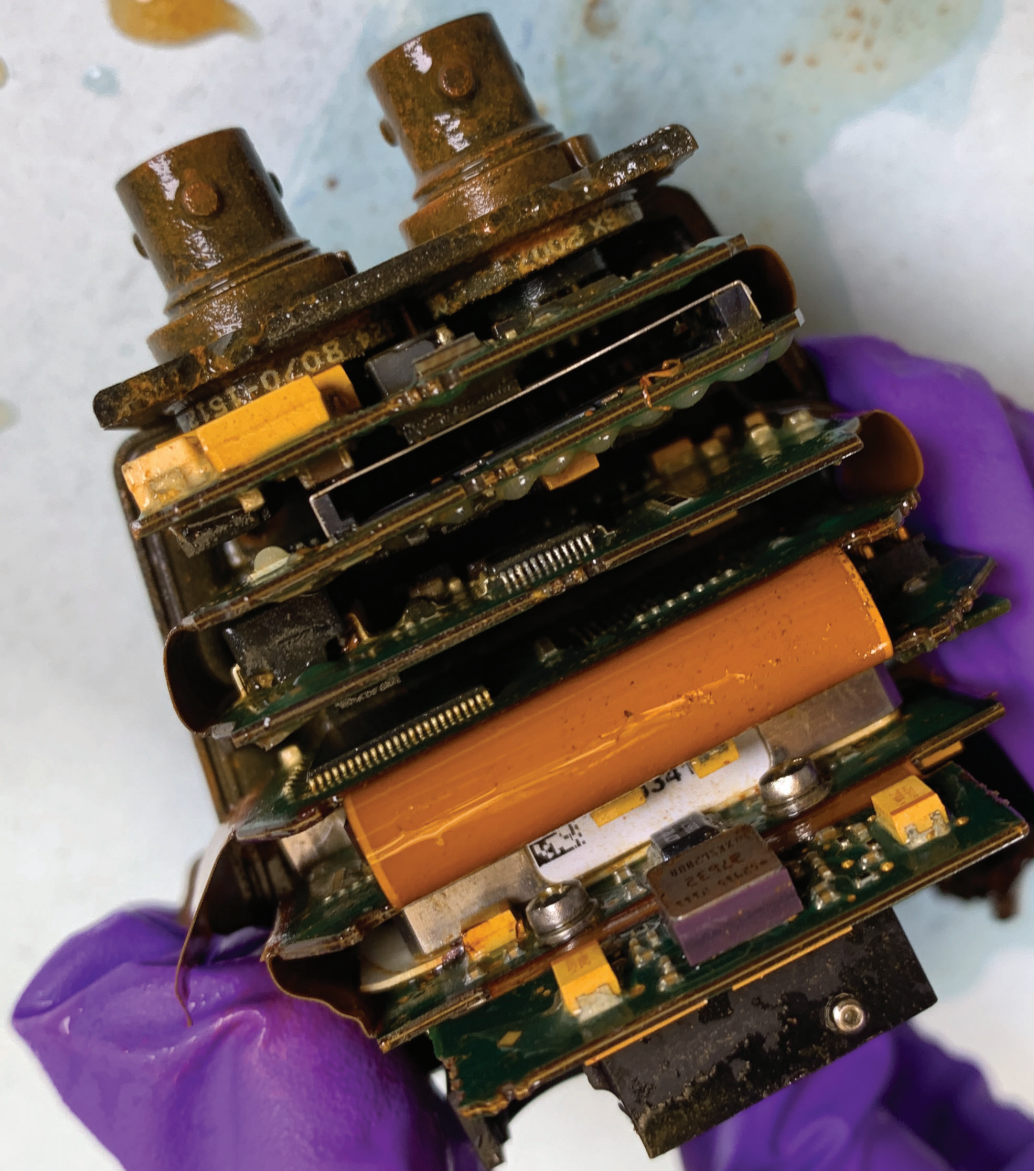
The Vehicle Recorder Division received an Appareo Vision 1000 device. The device is pictured in Appareo1.jpg. The device was subject to damp environmental conditions and was subject to corrosion before recovery from the accident site. The device exhibited moisture and corrosion throughout.
