# National Transportation Safety Board

CEN23LA066

## **ENGINE EXAMINATION**

Location: Harrison, Arkansas  
Date: December 19, 2022  
Time: 1505 CST  
2105 UTC  
Airplane: Beech A36, N8137P

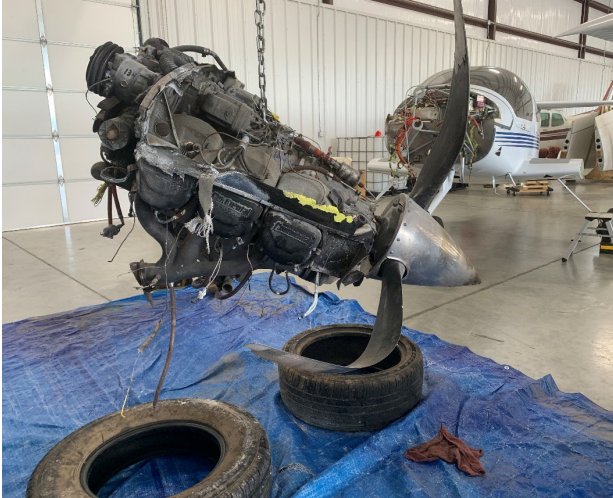
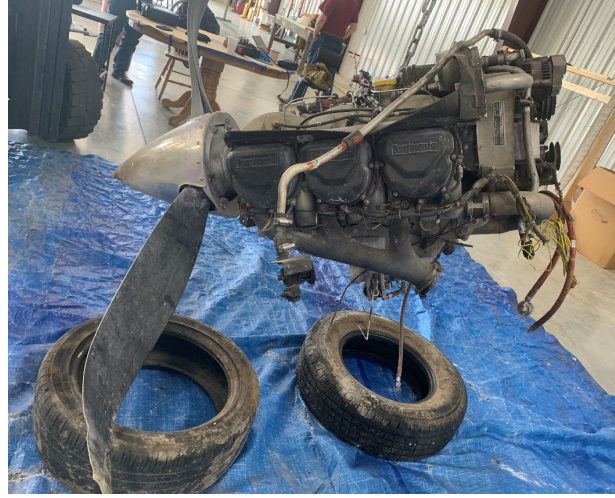
**Figure 1 Right Side of Engine**

The engine exhibited signatures consistent with exposure to a postimpact fire. Thermal distressing of the No. 1 cylinder area was evident. Heat damage was also sustained to the engine accessories.

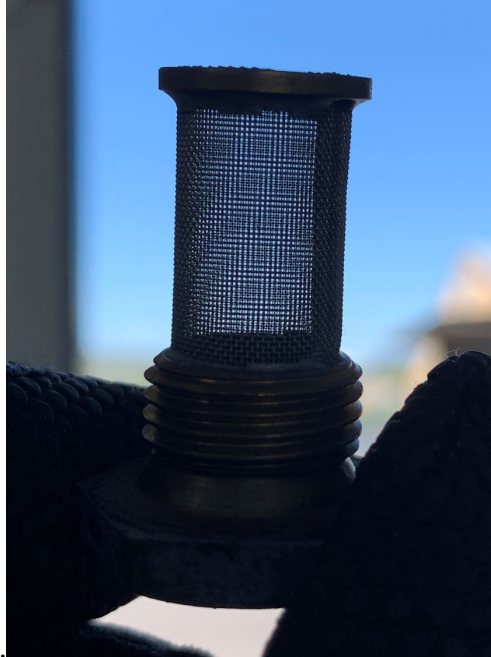
**Figure 3 Throttle Body Fuel Screen**

The fuel-air mixture unit was examined. All arms remained properly secured to the unit. The mixture arm was impact distorted but could still be rotated from stop to stop. The throttle arm moved freely. The fuel screen was removed and found to be clear of debris.

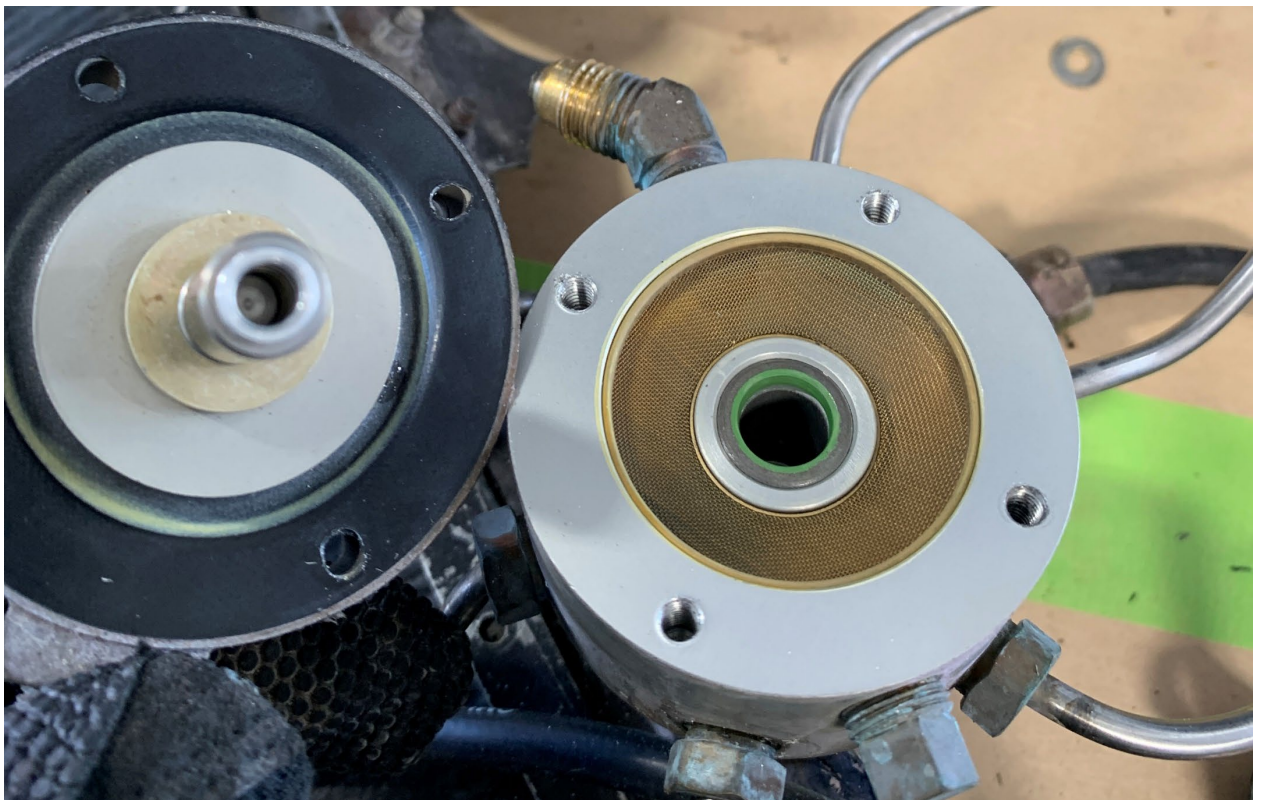
**Figure 4 Fuel Divider and Screen**

All fuel nozzles were removed and found to be clear of debris. The fuel divider was opened and was unremarkable. The screen was clear of debris

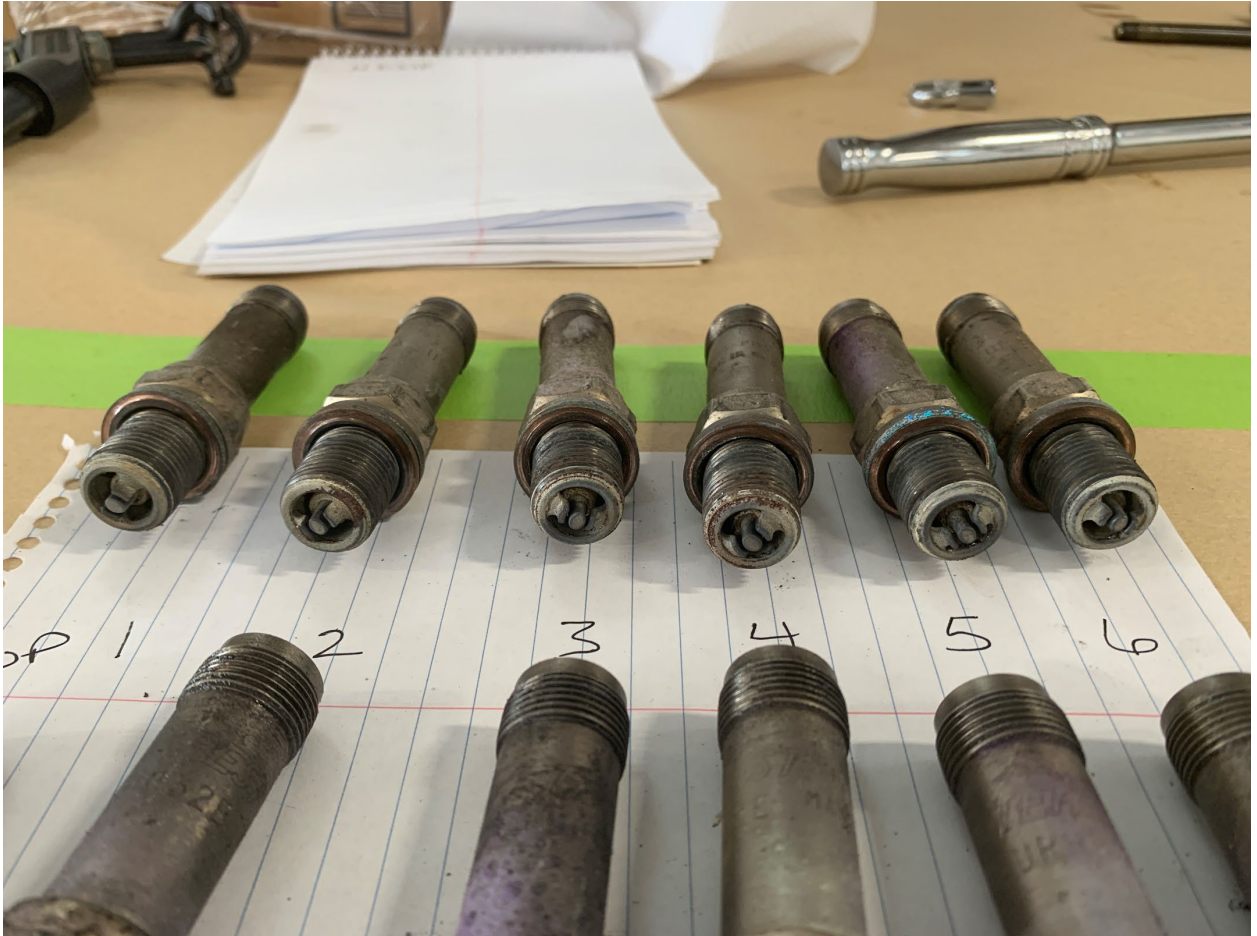
**Figure 5 Top Spark Plugs**

All 12 spark plugs were bench tested and all found to operate normally.

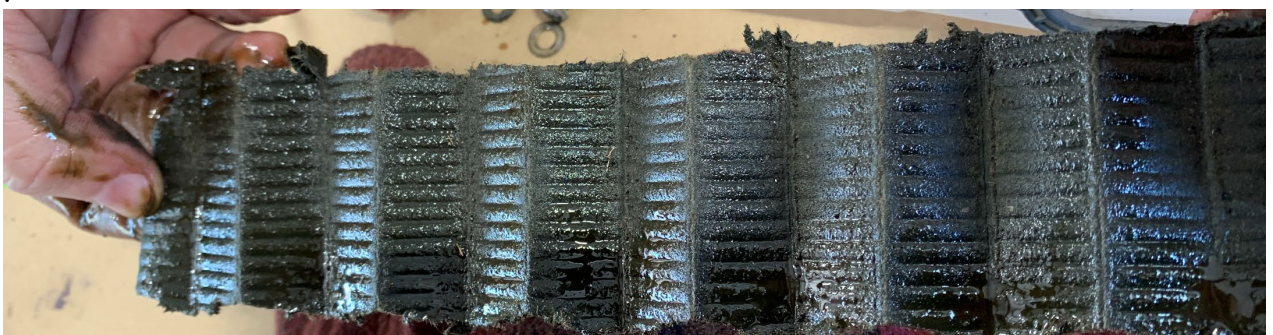
**Figure 6 Oil Filter Element**

The oil filter was removed, and the filter element cut open. No debris was noted in the filter

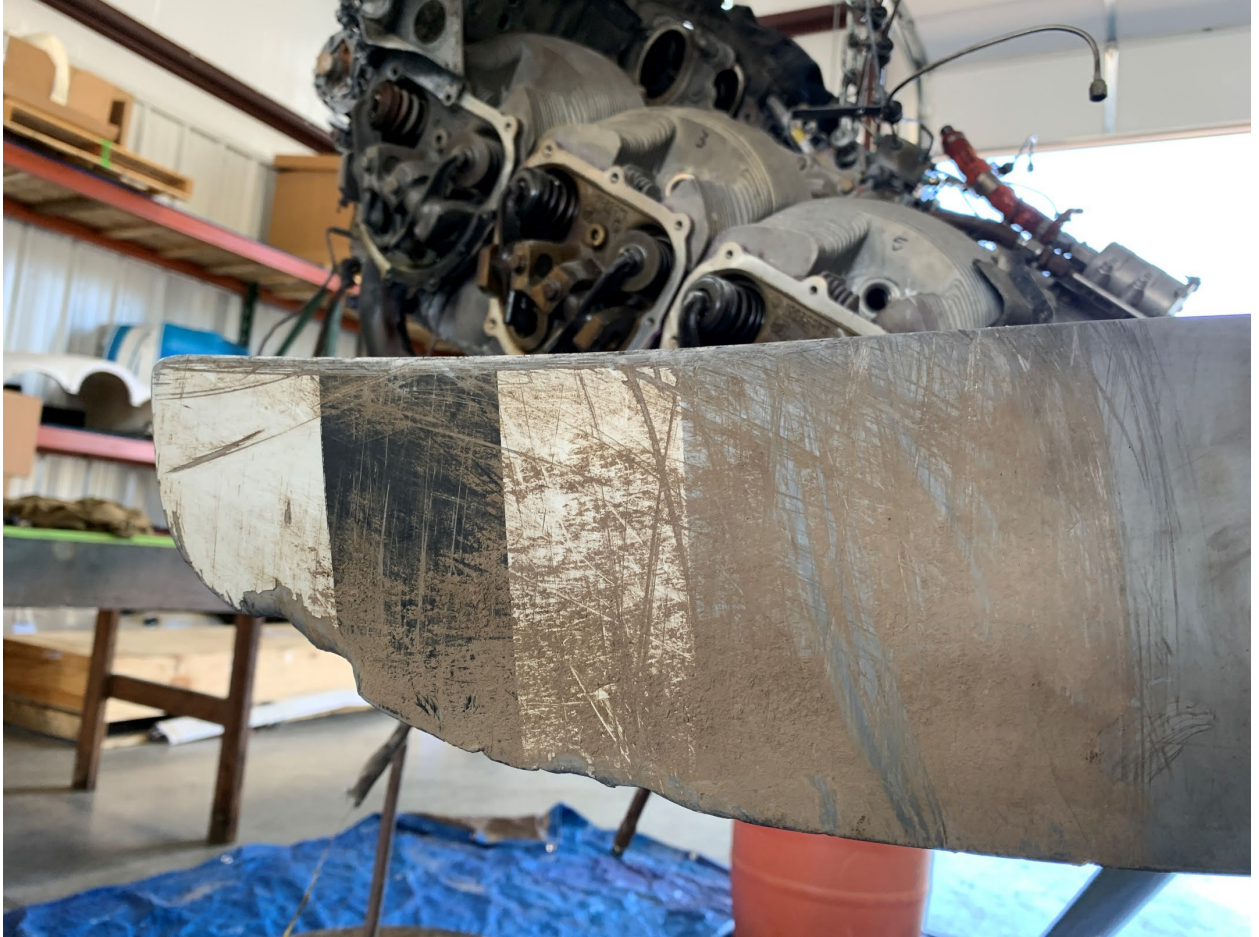
**Figure 7 Blade A**

Blade A displayed chordwise and angular scratches. There were several gouges in the leading edge of the blade.

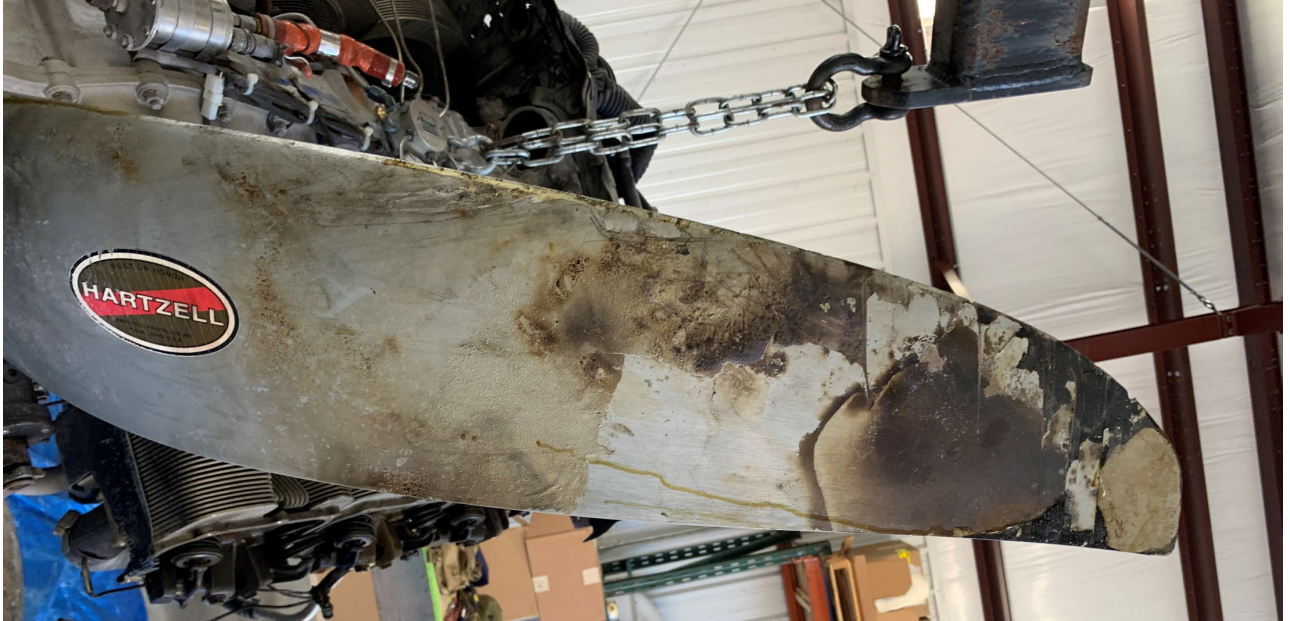
**Figure 8 Blade B**

Blade B was fire damaged. There were nicks in the leading edge and chordwise scratches.

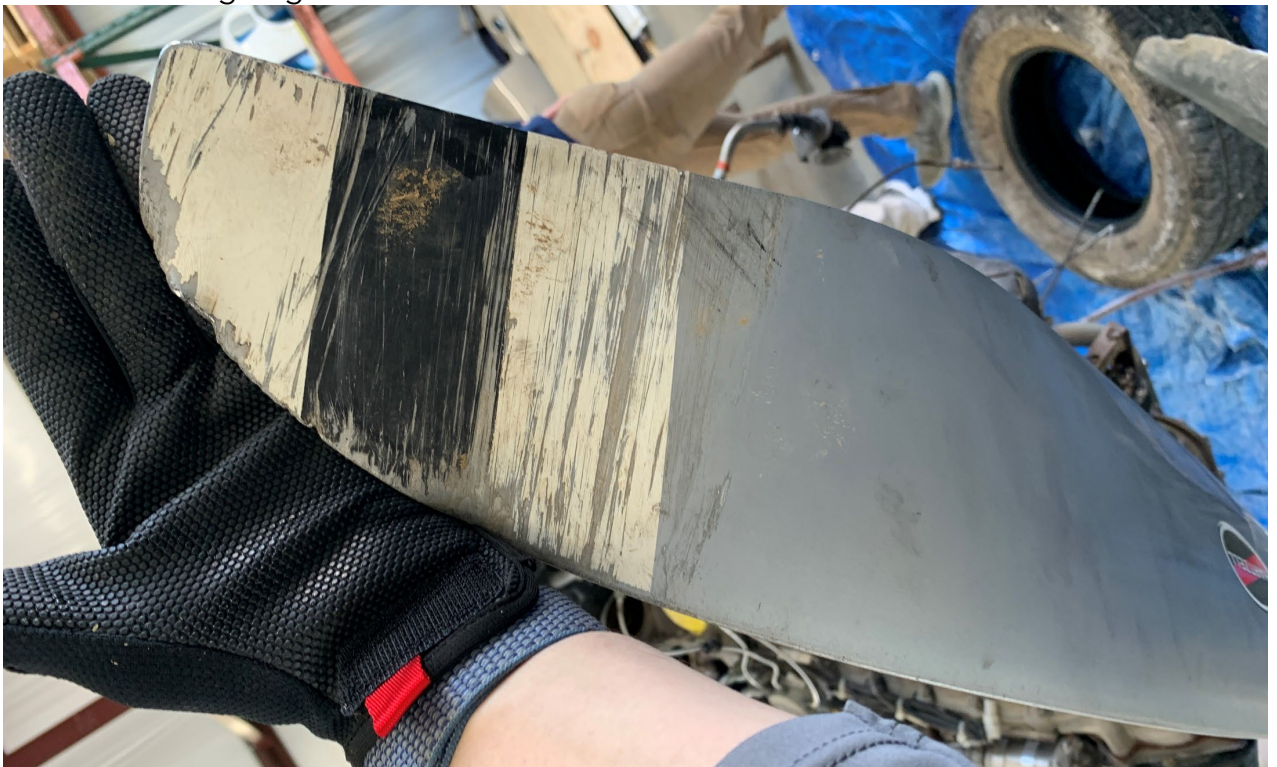
**Figure 9 Blade C**

Blade C exhibited chordwise scratches, leading edge polishing and several gouges on the leading edge.
