# National Transportation Safety Board

CEN23LA081

## **ENGINE EXAMINATION SUMMARY**

Location: Conroe, Texas  
Date: 01/14, 2023  
Time: 1425 CST  
Aircraft: Pitts Model 12; N512P

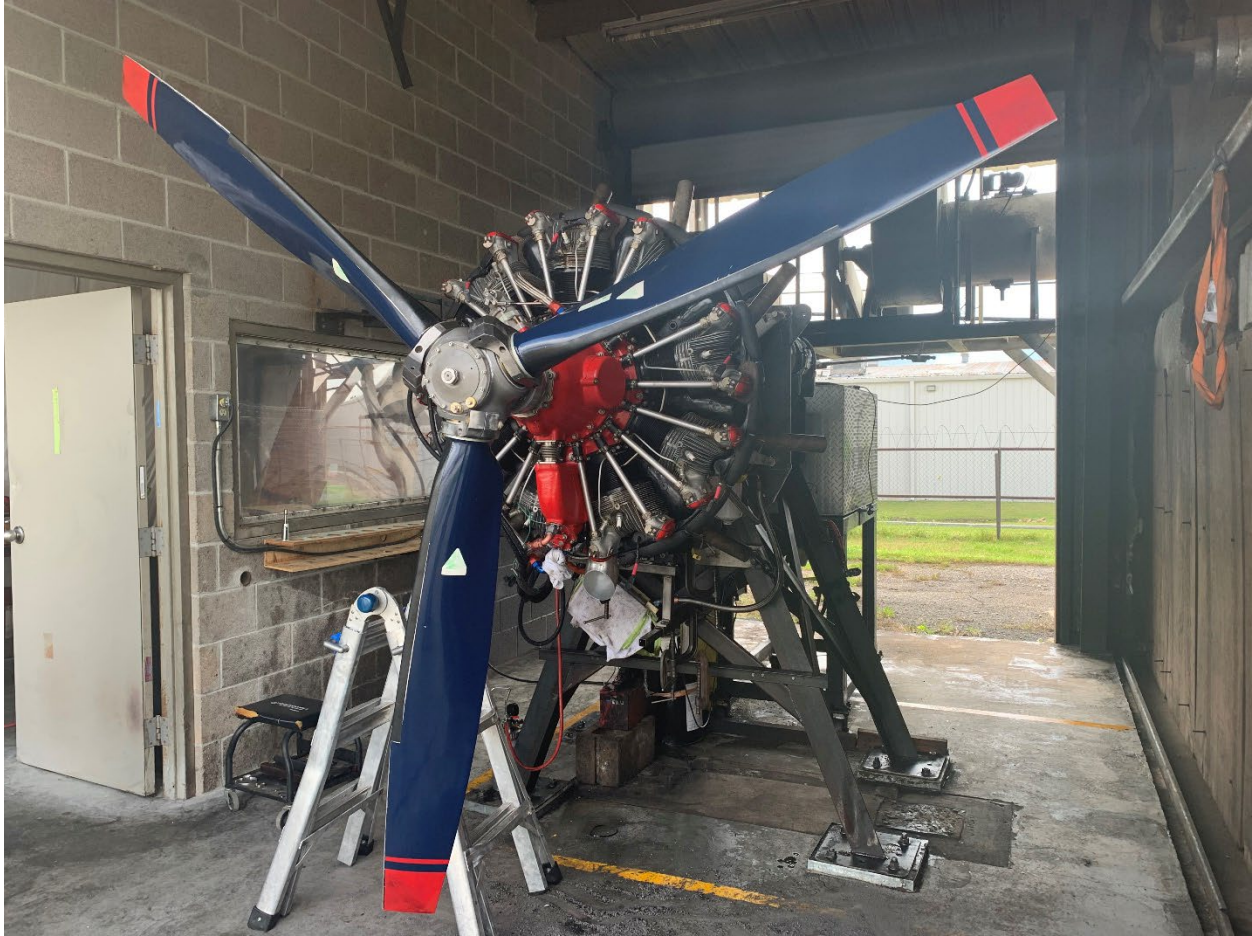
The engine was transported via truck to Barrett Precision Engines, Inc. from recovery facility, Air Salvage of Dallas. Engine crate sealed until arrival of NTSB investigator and participants. Initial photographs and documentation were completed, and engine was mounted in the test cell (see Figure 1).

Figure 1. Engine mounted in test cell

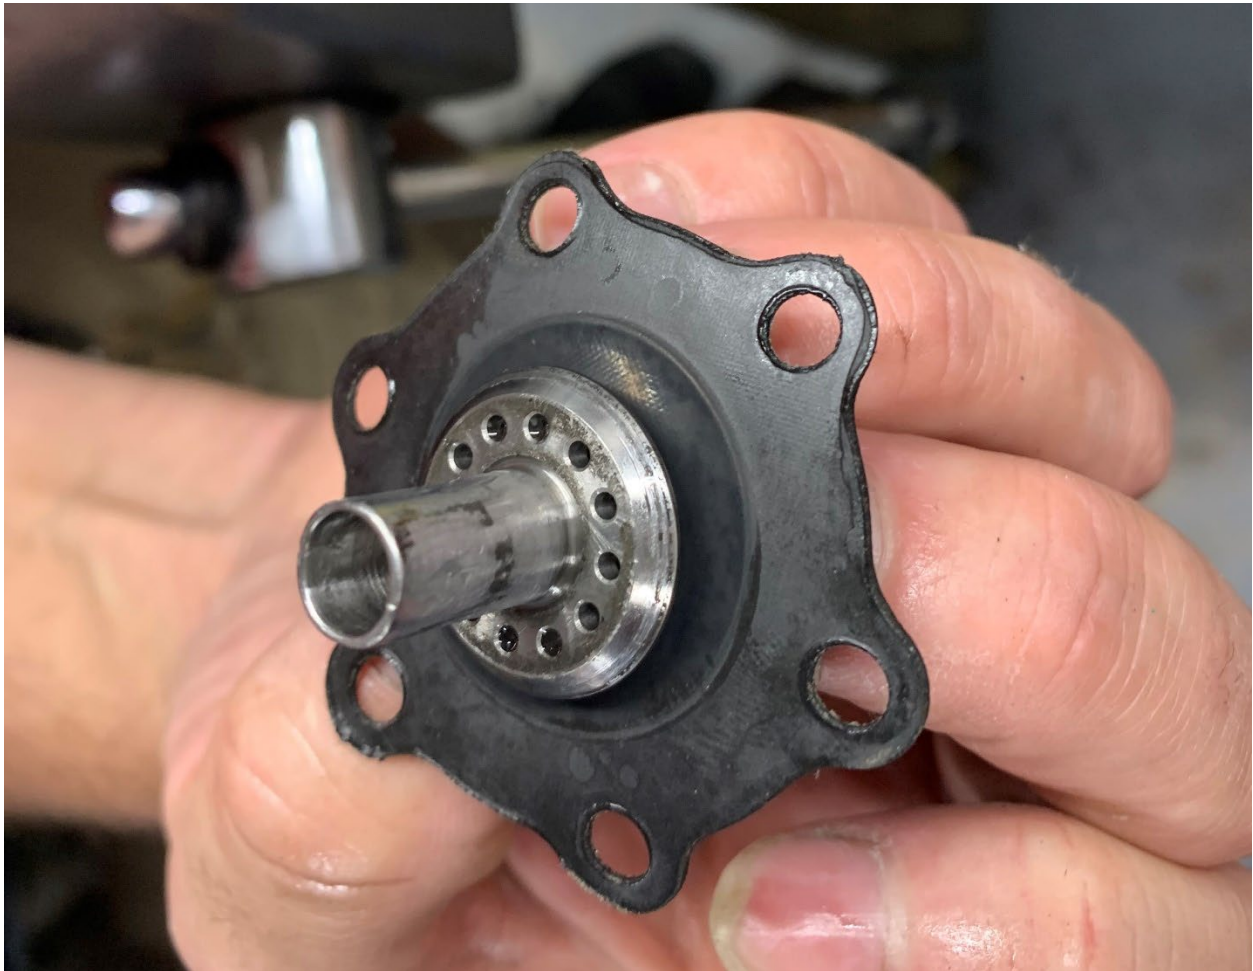
During the engine prime procedure, the engine driven fuel pump leaked from the rear pressure relief valve and diaphragm area. Due to the potential fire and safety concerns, the pump was removed and replaced with a slave pump. The pump was disassembled. Scratches and scoring marks were noted on the pressure relief valve seat, which allowed fuel into the air side of the fuel pump (see Figure 2). The diaphragm was undamaged. When the air cavity filled completely with fuel, the pump fuel pressure would equalize, or go to zero within the pump, and the pump would not

flow any fuel. During examination of the airframe, blue stains, consistent with a fuel leak, were noted on the external pump housing.

Figure 2. Pressure relief valve with diaphragm

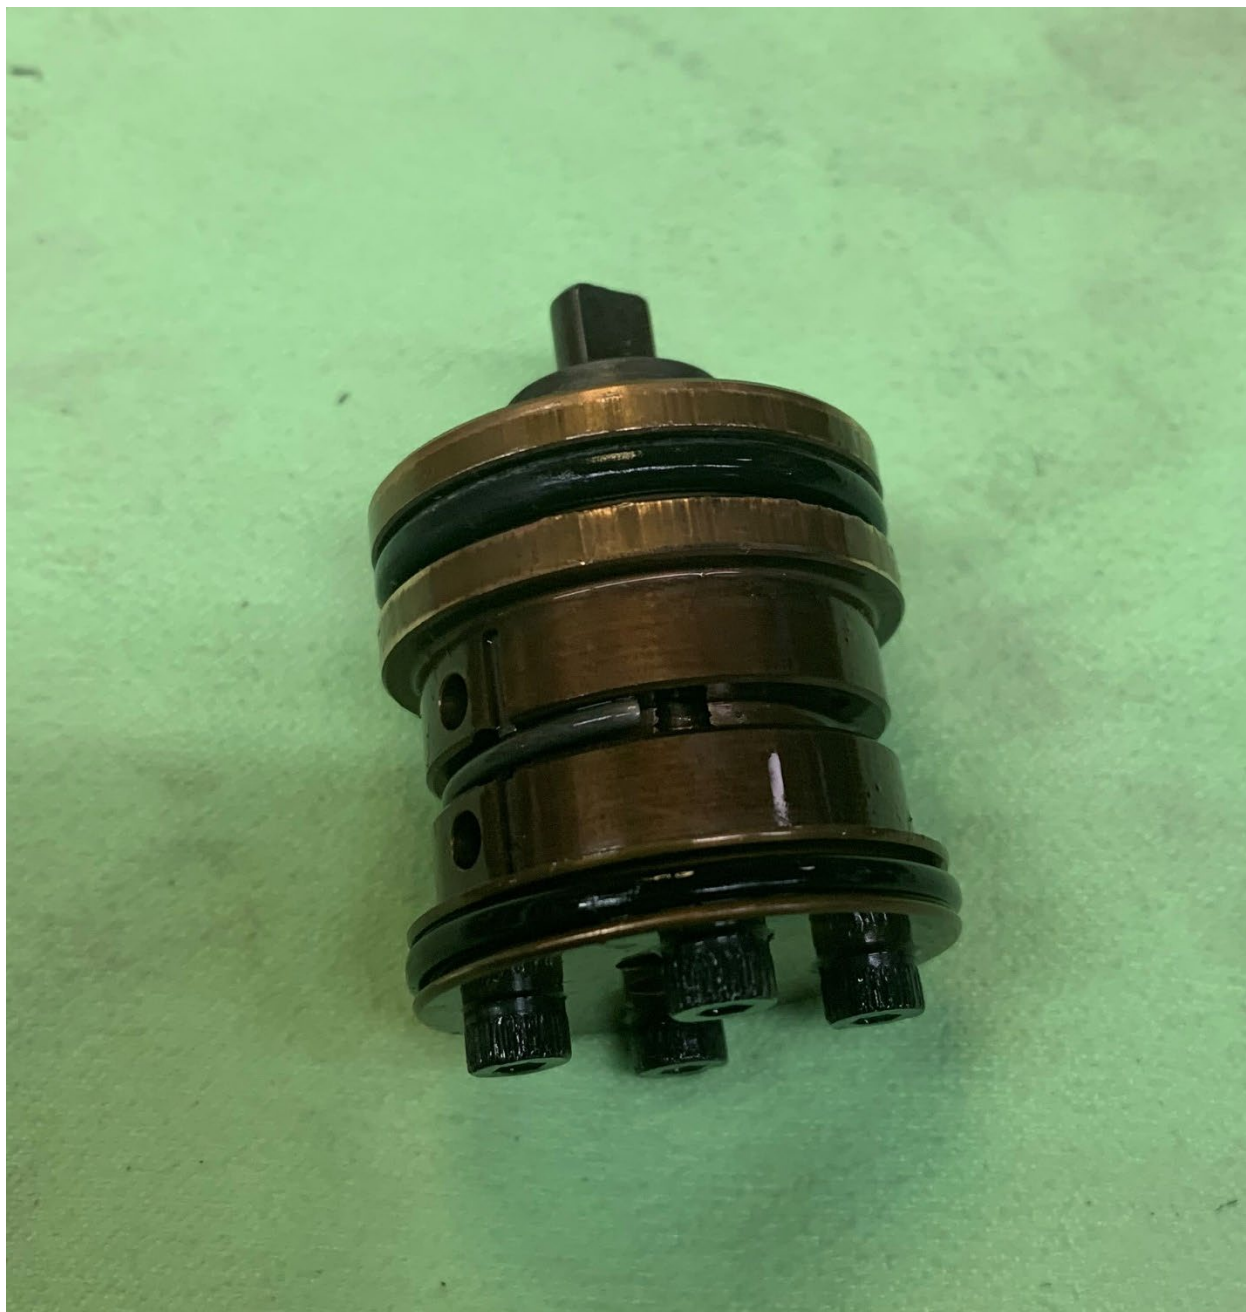
The airframe electric fuel pump, which was shipped with the engine, was tested at Aircraft Accessories. The fuel pump was flushed, and non-ferrous metal was noted in the pump (consistent with the metal noted in the airframe fuel system). The electric pump was placed on the test bench. Initial start revealed some abnormal flow and pressure, more than likely due to some additional debris. After a short time, the pump flow and pressures were normal during the test procedure. The pump was disassembled, and non-ferrous metal debris was noted within the pump. The pump rotor was difficult to remove from the housing. When removed, the outer diameter of the pump rotor contained scratches and scoring (see Figure 3).

Figure 3. Electric fuel pump rotor
