# National Transportation Safety Board

CEN23LA101

## **SURVIVAL FACTORS**

Specialist's Factual Report

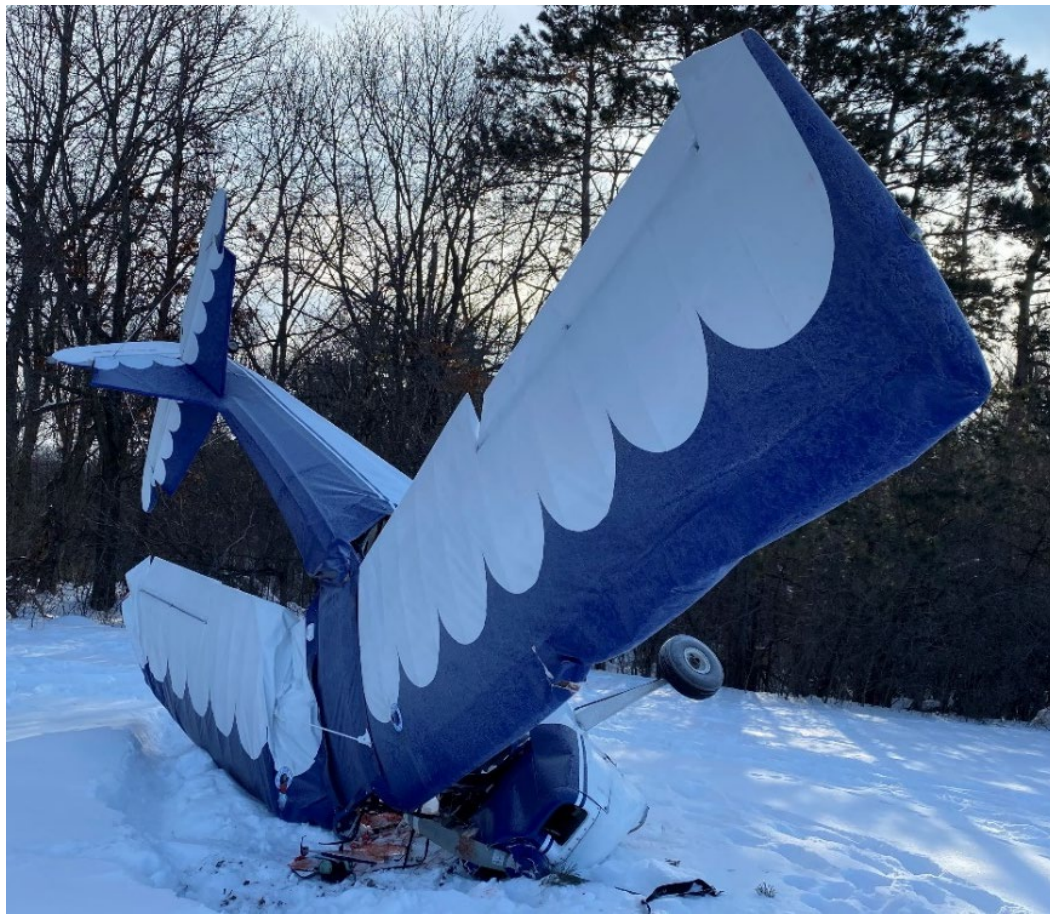
**Figure 3.** Post-crash photograph of N9111L.

The airplane was found nose down in a field by first responders. The tail was bent over to the right (see figure 3). The wings, engine, and propellers were removed during salvage operations (see figure 4).

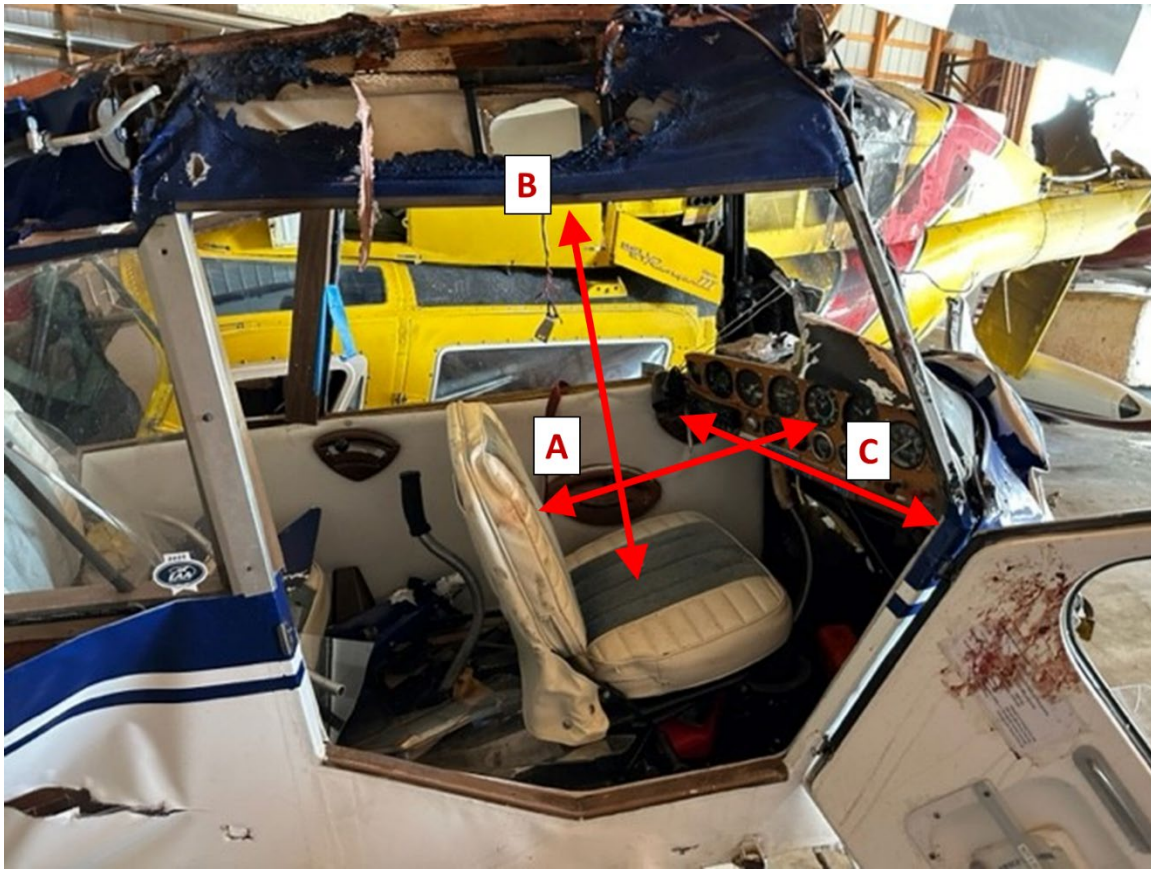
The seats were accessed by the pilots using a single door on the right side which rotate forward to open. Measurements were taken at three locations to document the occupiable volume in the cabin. See figure 5 and 6. The seats were not adjustable for/ aft or up/ down.

| Measurement Letter | Measurement Starting point | Measurement ending point | Dimension in Exemplar Airplane (inches) | Dimension in Accident Airplane (inches) | Difference (inches) |
|---|---|---|---|---|---|
| A | Front of seat back cushion | Instrument Panel | 27.0 | 23.5 | 3.5 |
| B | Top of seat bottom | Ceiling | 39.5 | 38.5 | 1.0 |
| C | Left side of airplane | Right side of airplane | 29.5 | 29.0 | 0.5 |

**Figure 6.** Diagram showing measurements from table 1.

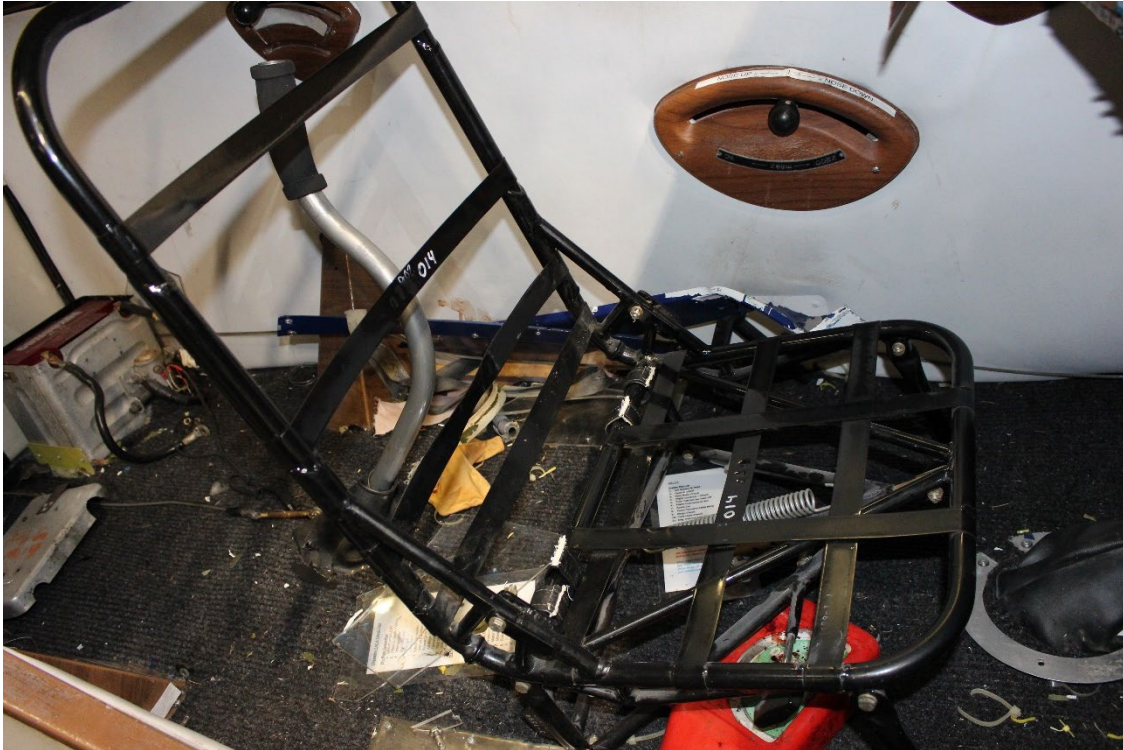
Both seats remained secured to their four seat posts which secured the seat to the airplane floor. The seat pan and seat back cushions were a monolithic foam with a leather and fabric cover. Removal of the cushions revealed the seats were tube framed with metal straps across to support the seat cushions and occupants (see figure 7).

**Figure 7.** Pilot seat frame with cushions removed.

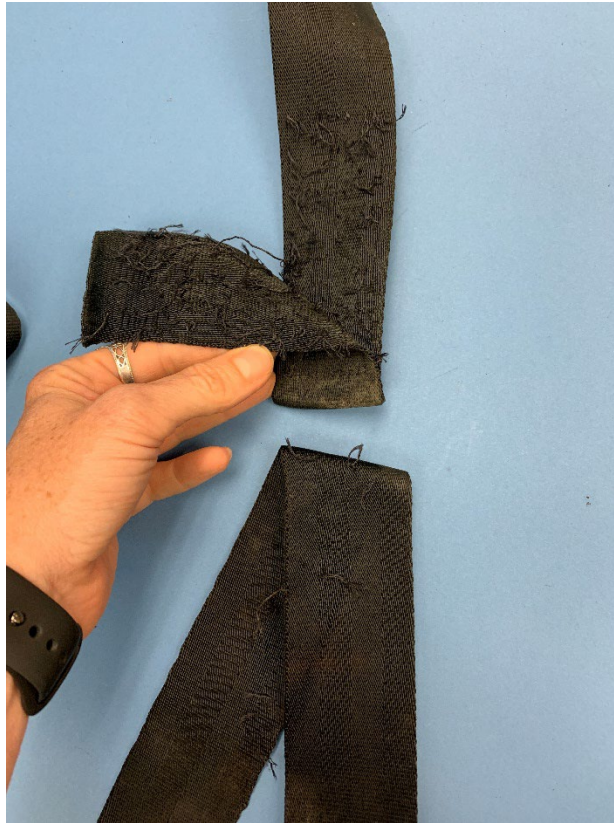
Three anomalies were noted regarding the accident airplane's restraint system. First, there was a separation of the pilot restraint threading at the 'Y' junction. (see figure 11). Second, the lap belt portions were wrapped around the seat back instead of secured directly to the seat as designed<sup>1</sup>. Finally, examination of the metal shoulder

**Figure 11.** Bellanca Aircraft 7ACA, N9111L pilot's shoulder harness showing stitching failure at the "y" junction.

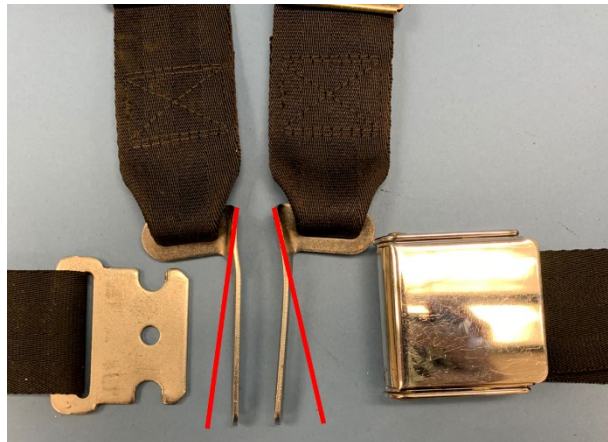
harness fittings (through which the tang is normally inserted before being inserted into the buckle) were bent (see figure 12).

**Figure 12.** Bent shoulder harness fittings from the accident pilot's restraints. (Red lines indicate approximate normal orientation.)
