CEN23LA130

## INVESTIGATION PHOTOGRAPHS

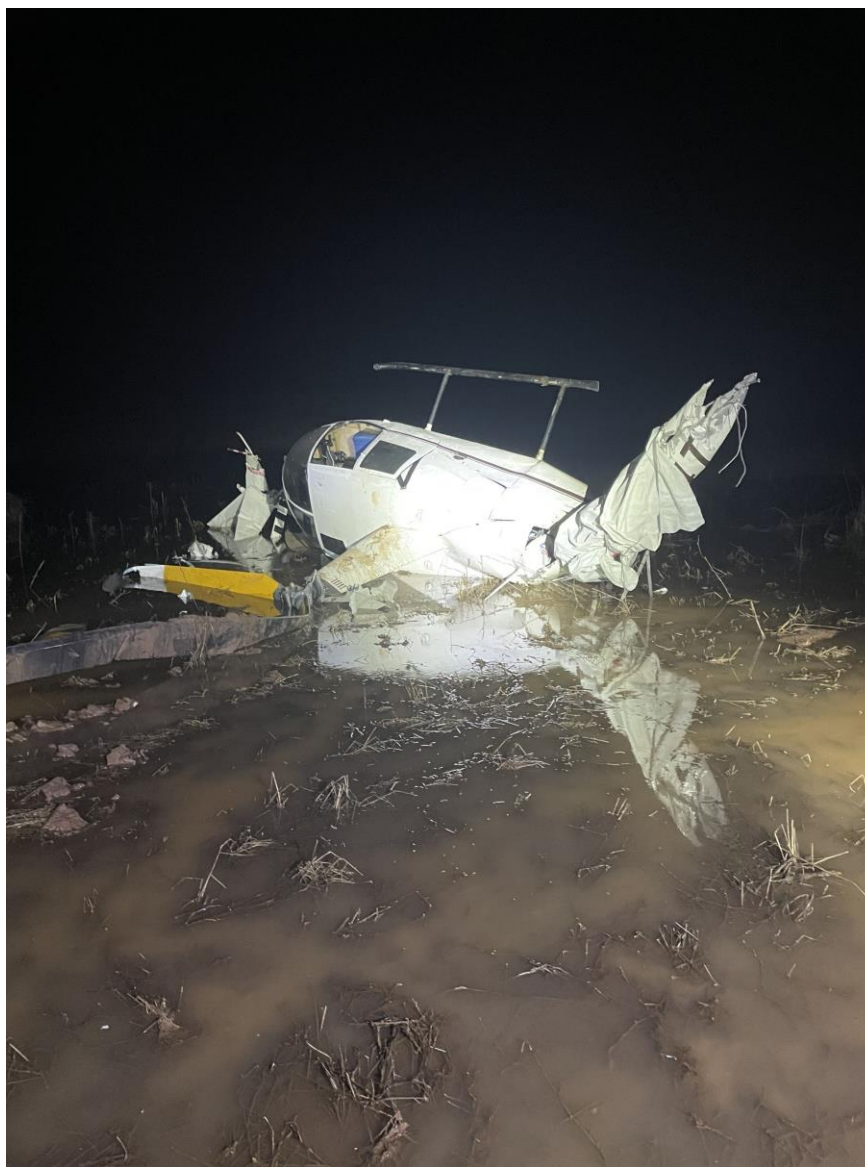
**Photograph 1 - Accident Site (FAA Photo)**

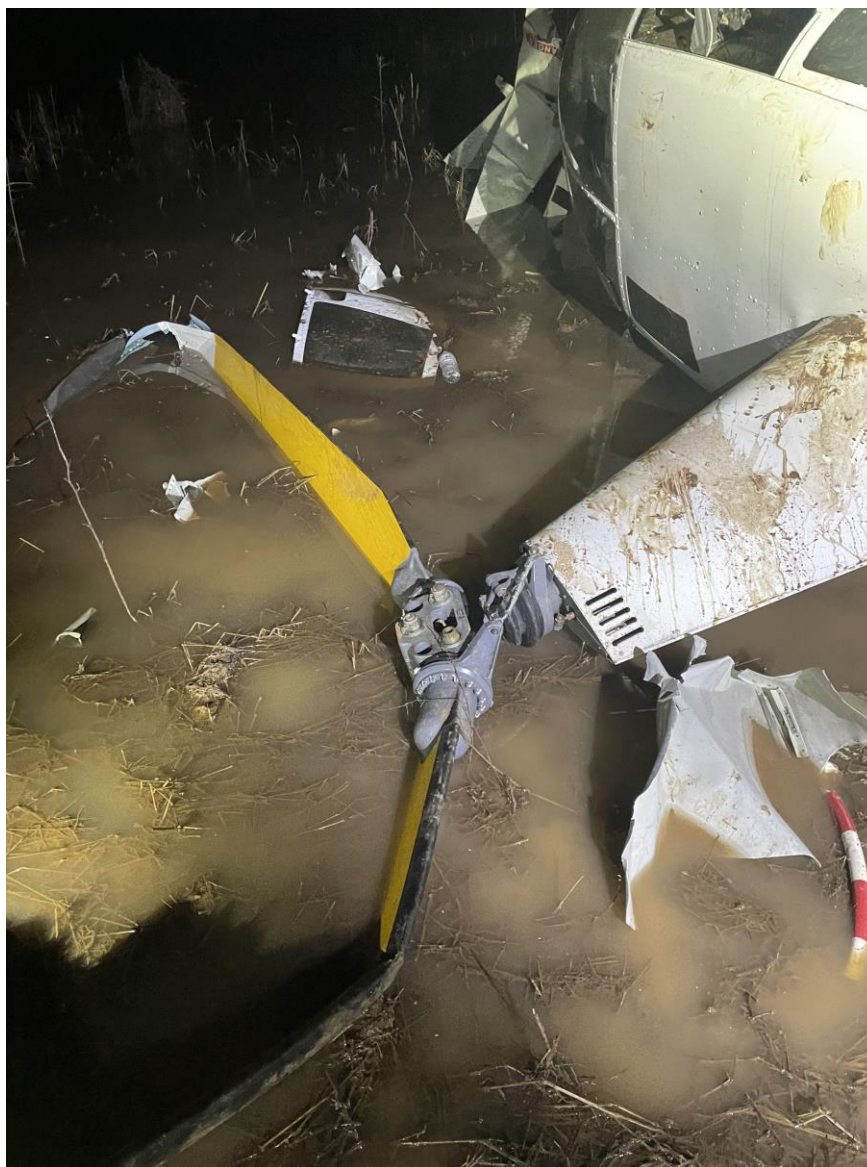
**Photograph 2 - Main Rotor Mast / Blades (FAA Photo)**

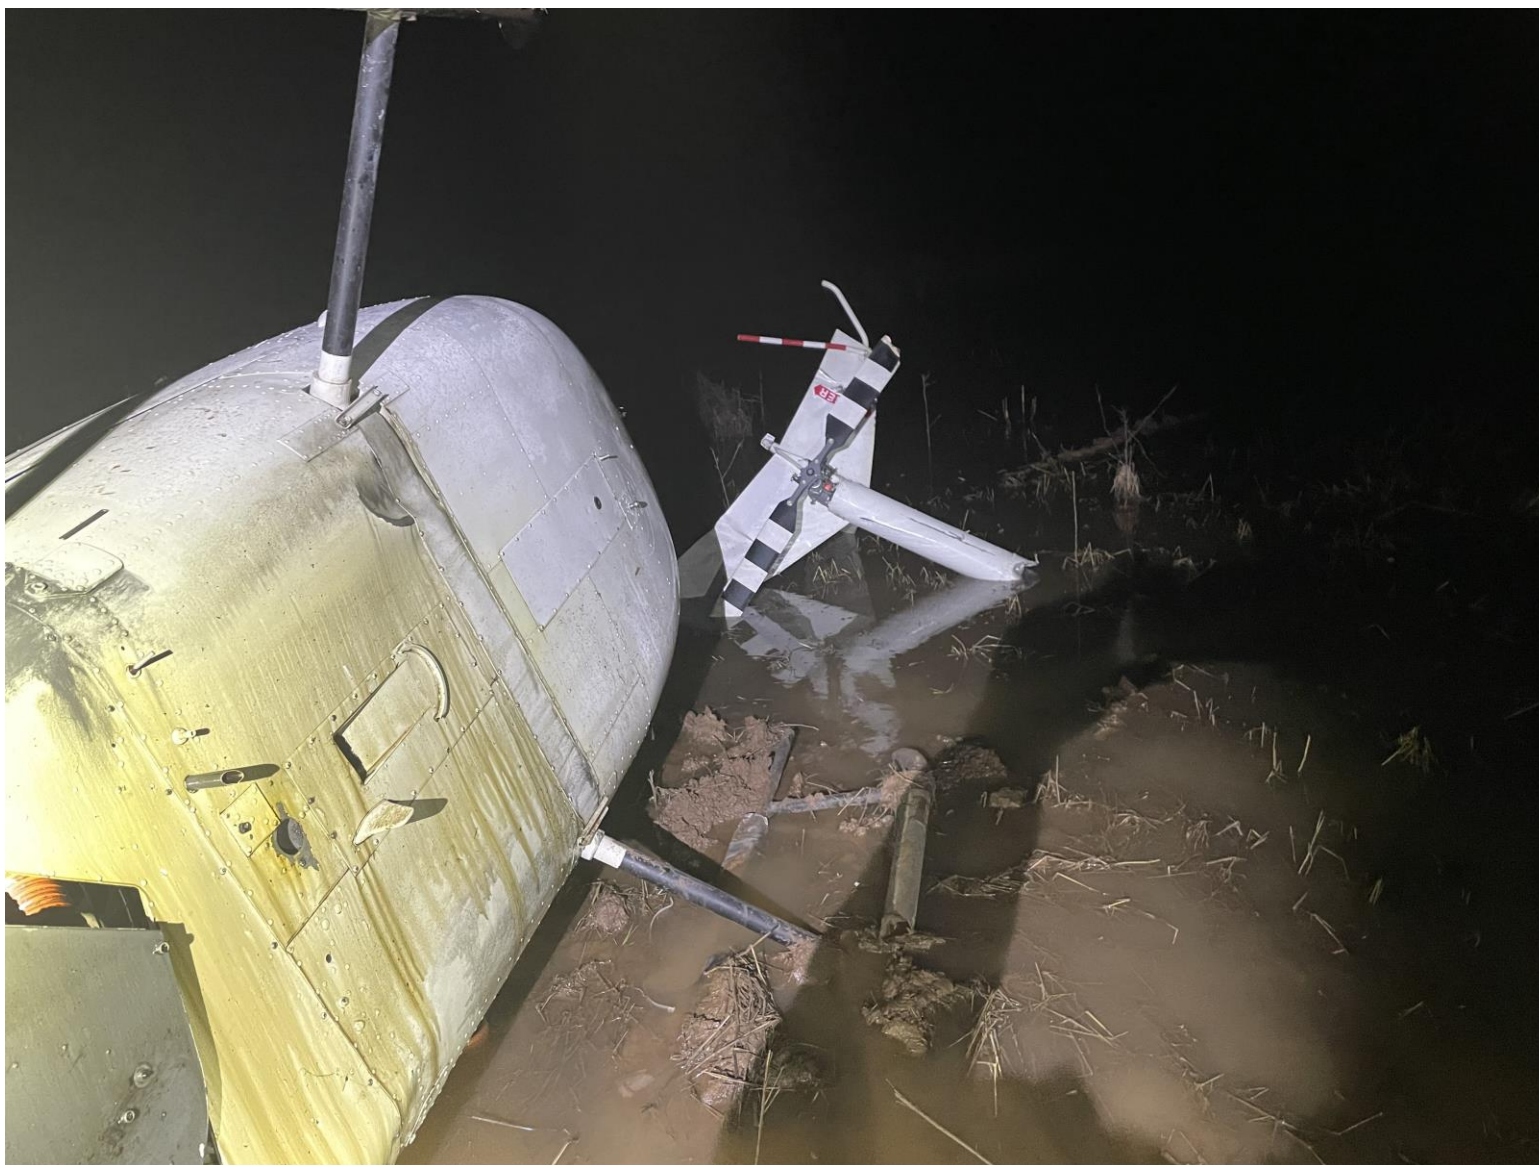
**Photograph 3 - Fuselage / Tail Boom (FAA Photo)**

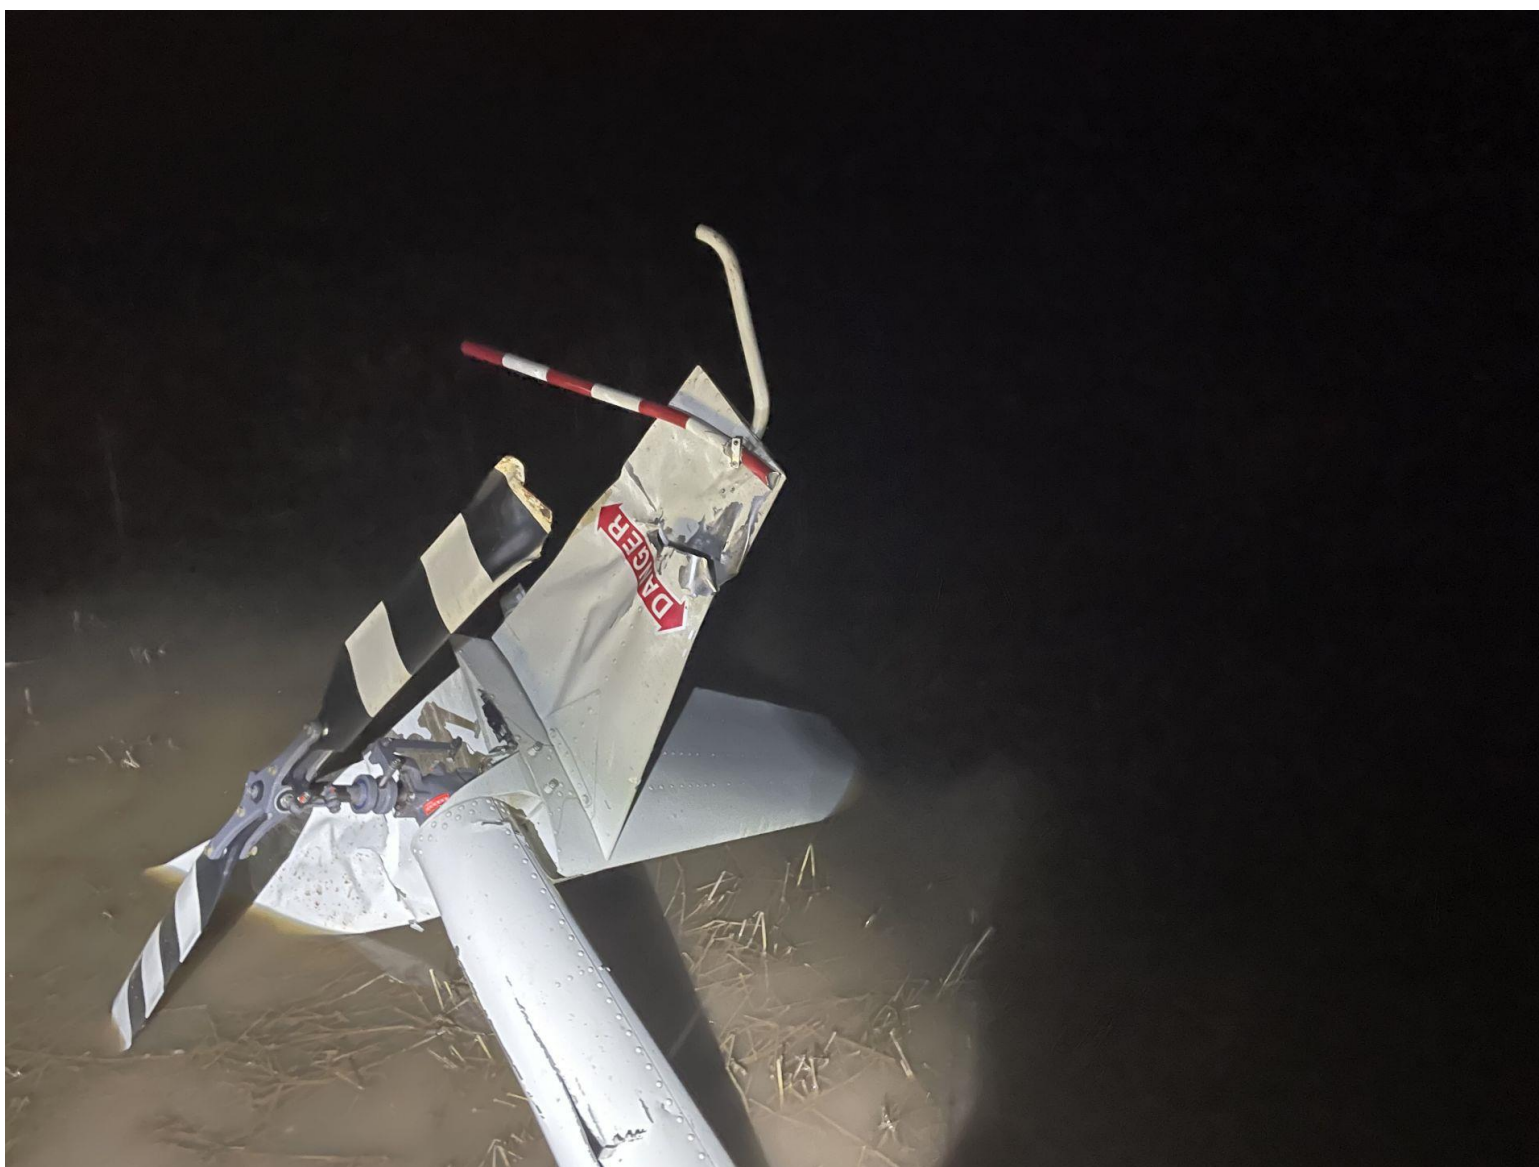
**Photograph 4 - Tail Boom / Empennage / Tail Rotor (FAA Photo)**

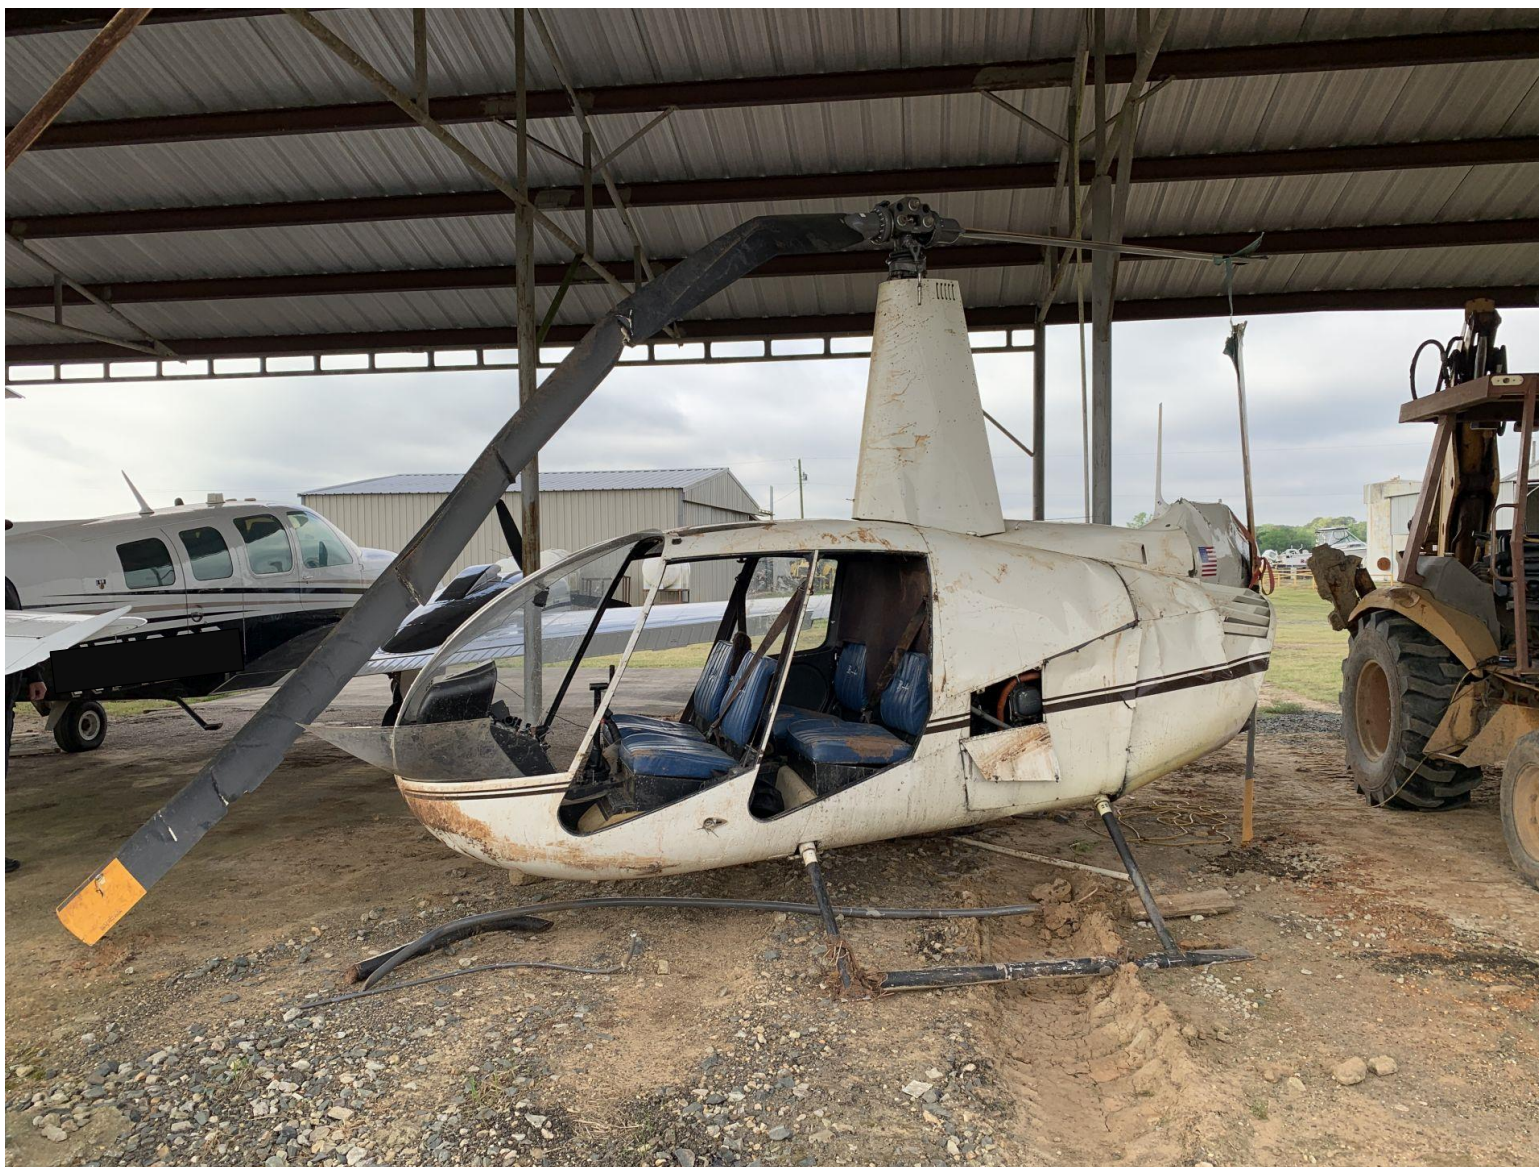
**Photograph 5 - Fuselage (NTSB Photo)**

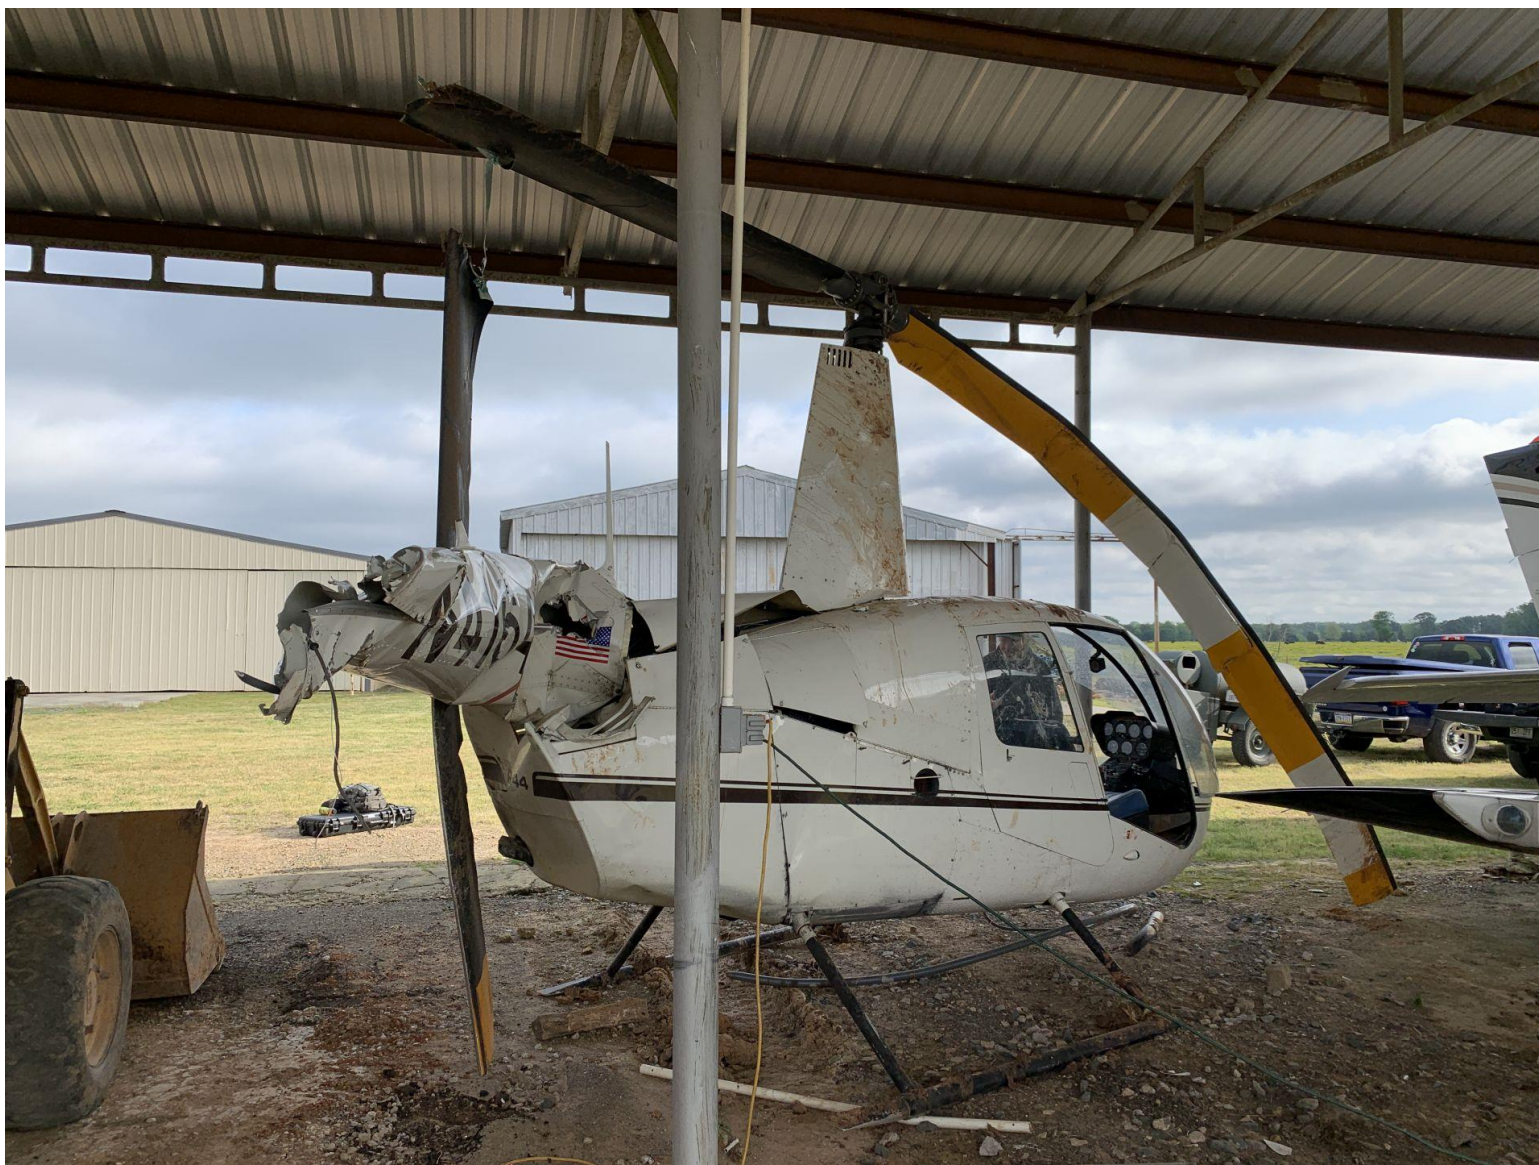
**Photograph 6 - Fuselage (NTSB Photo)**

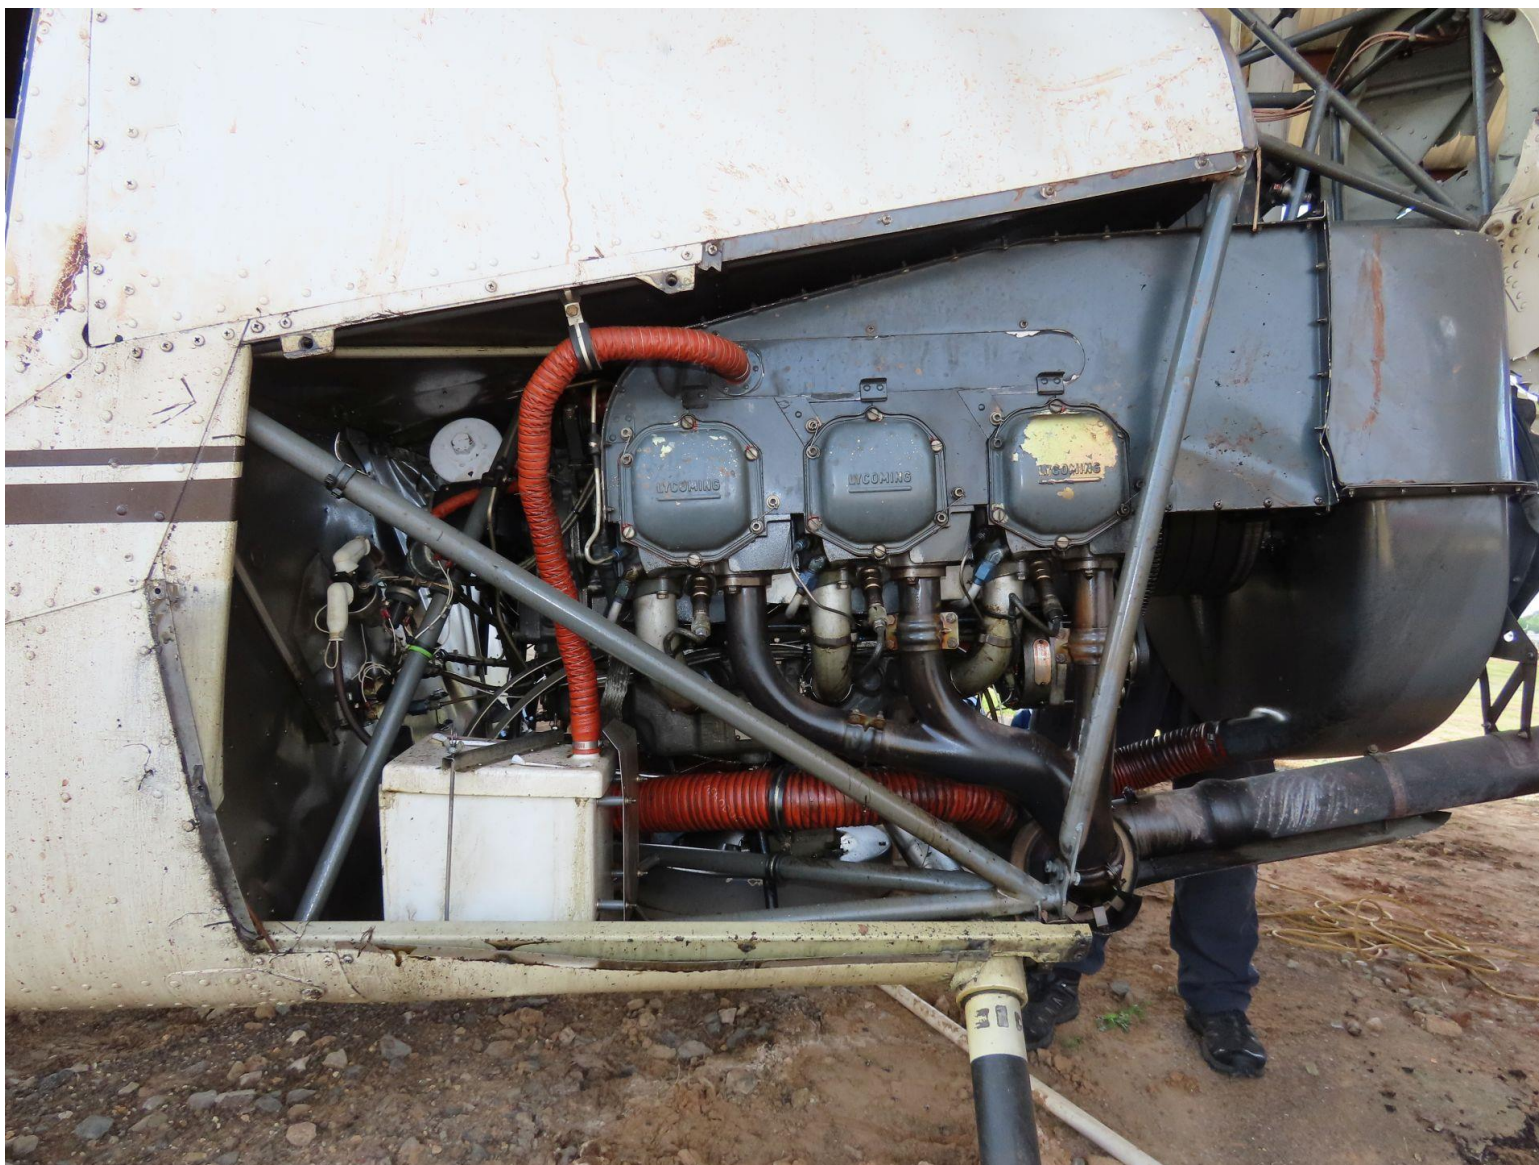
**Photograph 7 - Engine (Lycoming Photo)**

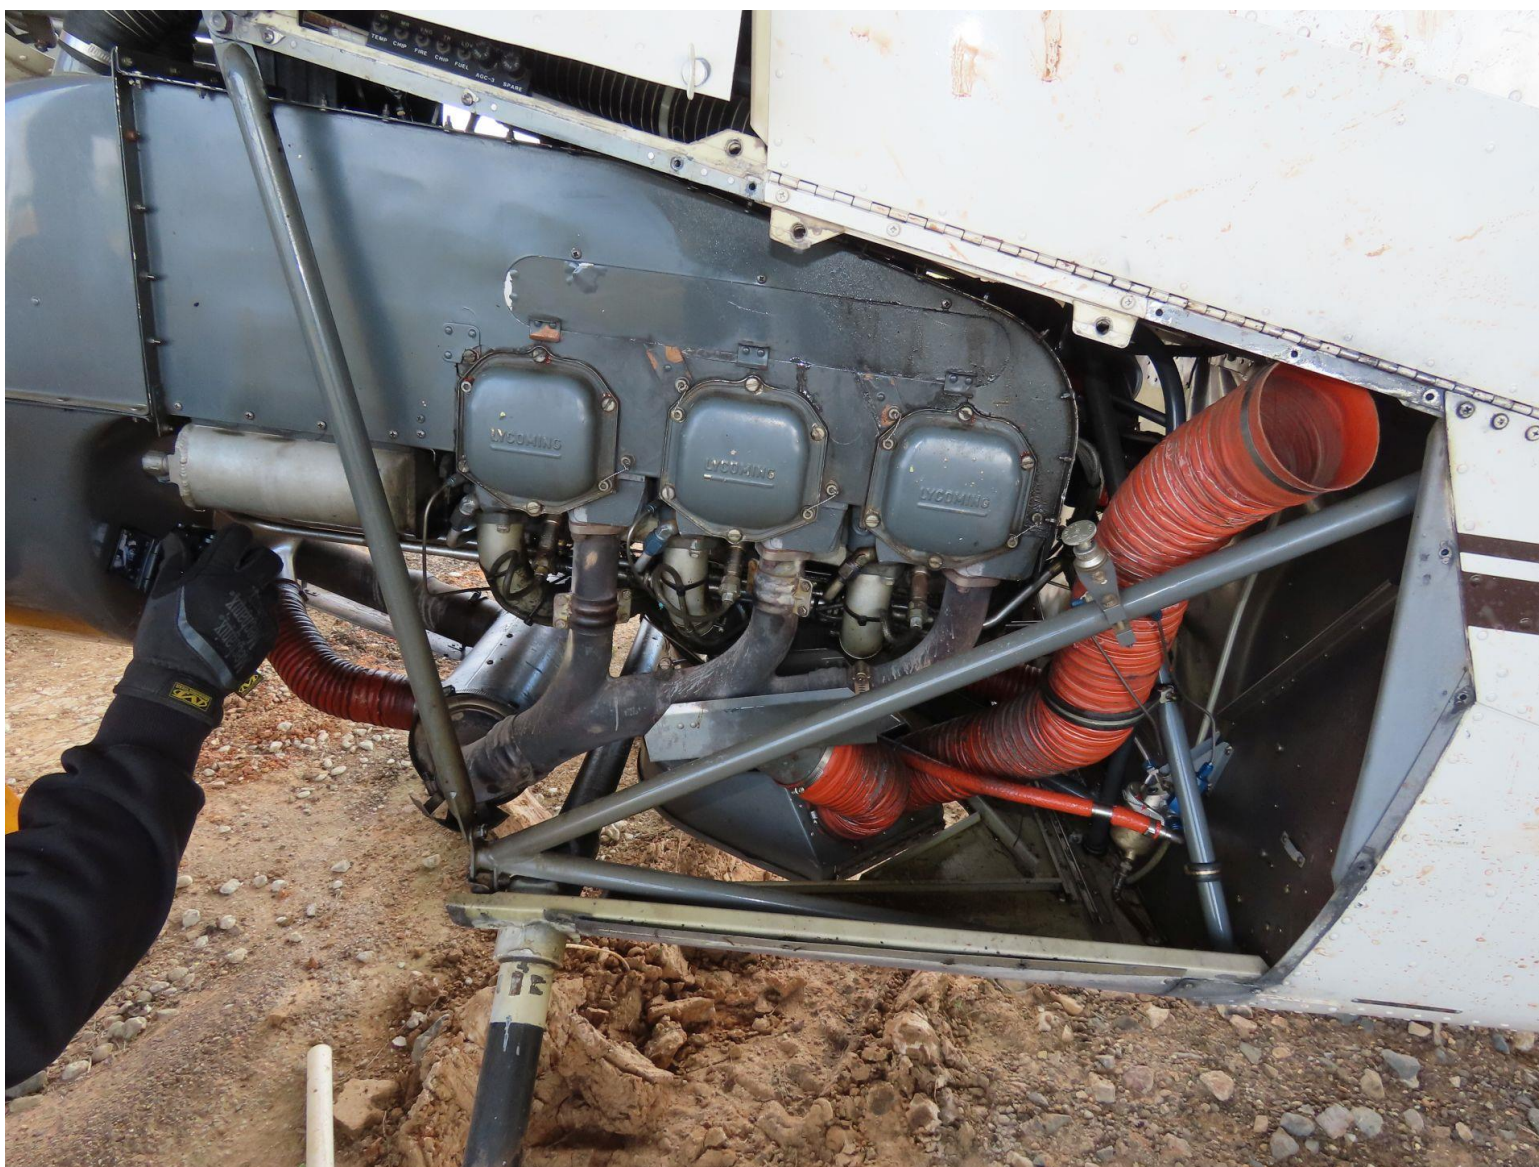
**Photograph 8 - Engine (Lycoming Photo)**
