# **NTSB File No. CEN23LA145**

## **Hartzell Air Safety Investigator Examination Notes**

Aircraft: Piper PA-32-260

Aircraft Registration: N56793

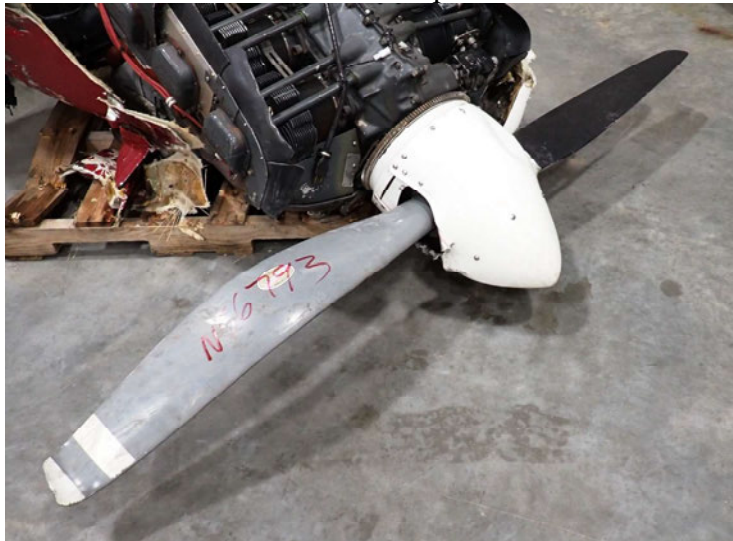
The aircraft wreckage was recovered to AMF Aviation in Springfield, TN and examined on May 17, 2023. The propeller remained attached to the engine crankshaft flange as shown in Photo #1 with all six mounting studs secure and lockwired. Both blades appeared to be in a feathered position. The blades were numbered #1 and #2 with #1, Assembly S/N, and #2 in sequence of rotation. Blade #1 was predominantly bent aft with approximately 3-4" of the tip curled forward and was rotationally loose indicating fractured pitch change mechanisms. Blade #2 had a slight, simple bend aft with no other remarkable damage and was rotationally secure. Photo #2 shows the damage on the bottom side of the spinner consistent with impact into a block wall after rotation had stopped.

Photo #1 – Propeller

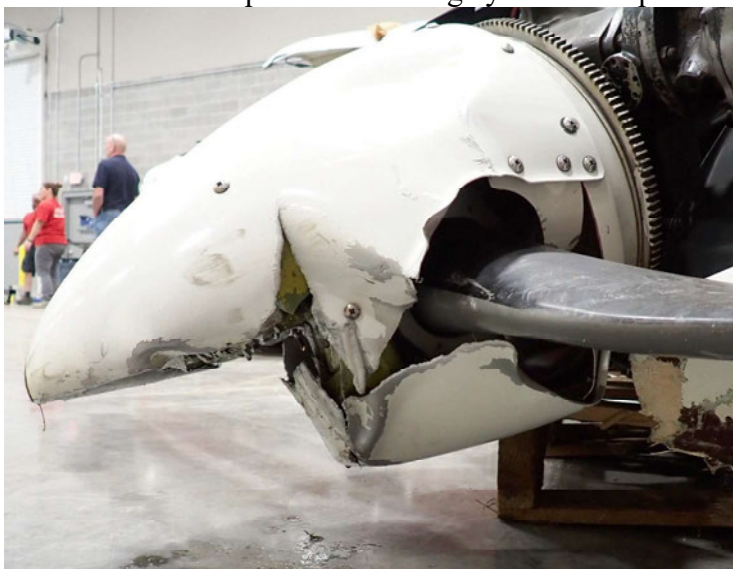
Photo # 2 – Bottom haft of spinner indicating cylinder and piston crushed aft

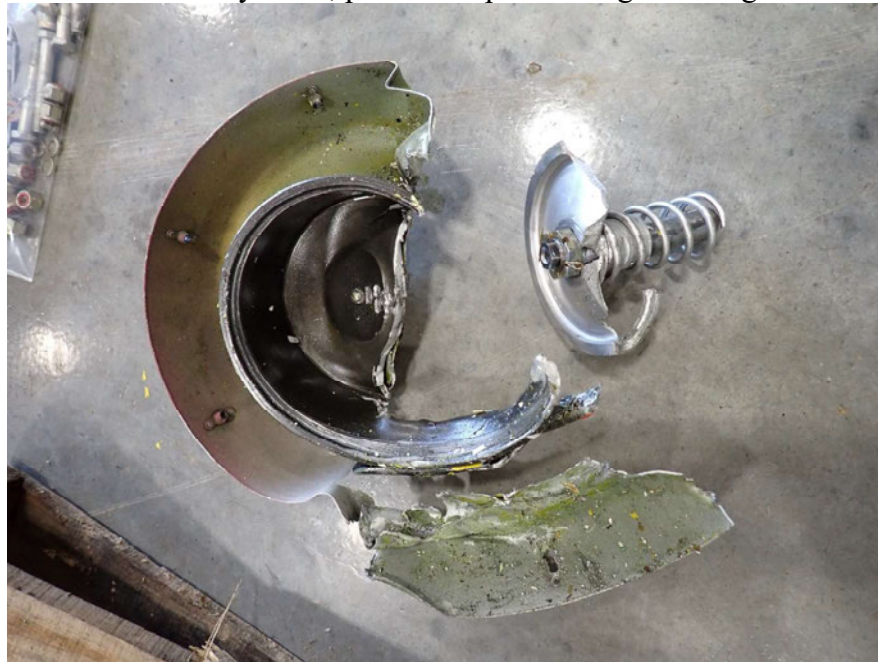
After removal of the spinner dome the propeller cylinder, the piston and a fragment of the pitch change rod fell off the assembly with the spinner forward bulkhead; they had impact separated but were loosely retained by the spinner dome. The cylinder and piston were crushed aft and partially sheared across as shown in Photo #3. The starter ring gear was fractured circumferentially and the propeller cylinder mounting boss was partially fractured and crushed. Photo #4 shows the propeller prior to removal from the engine.

Photo #3 – Cylinder, piston and pitch change rod fragment

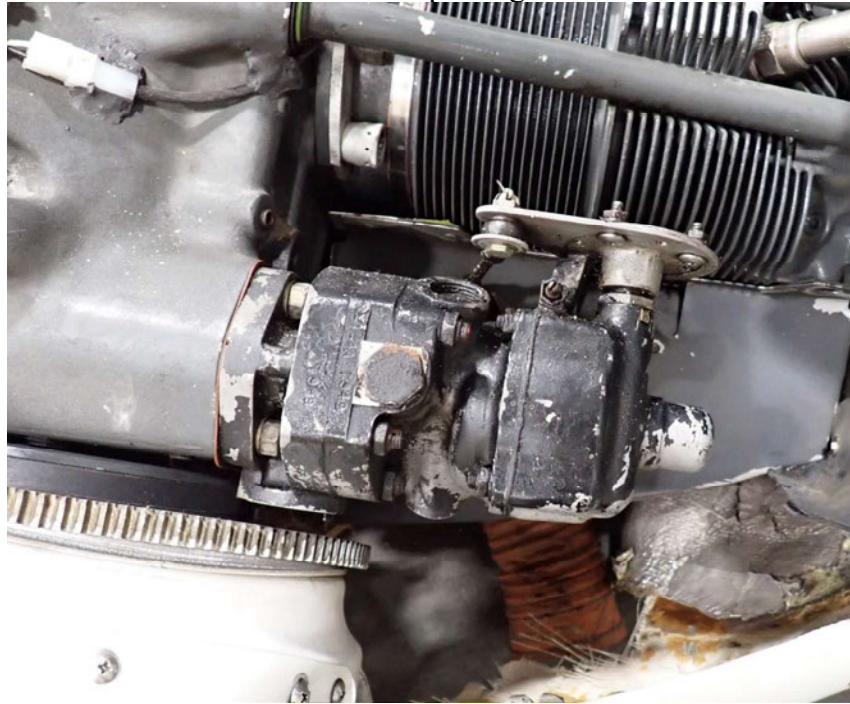
Photo #5 – Propeller governor

There were no indications of oil leaking from the propeller, propeller mounting flange or governor and governor mounting pad. The governor control arm rotated smoothly and control cable continuity was confirmed back to the point where it was intentionally cut for recovery. The governor (Photo #5) was removed and the pump shaft rotated smoothly by finger force and produced gurgling sounds. The governor gasket did not incorporate a screen but all ports were clear with no indication of debris or improper sealants.

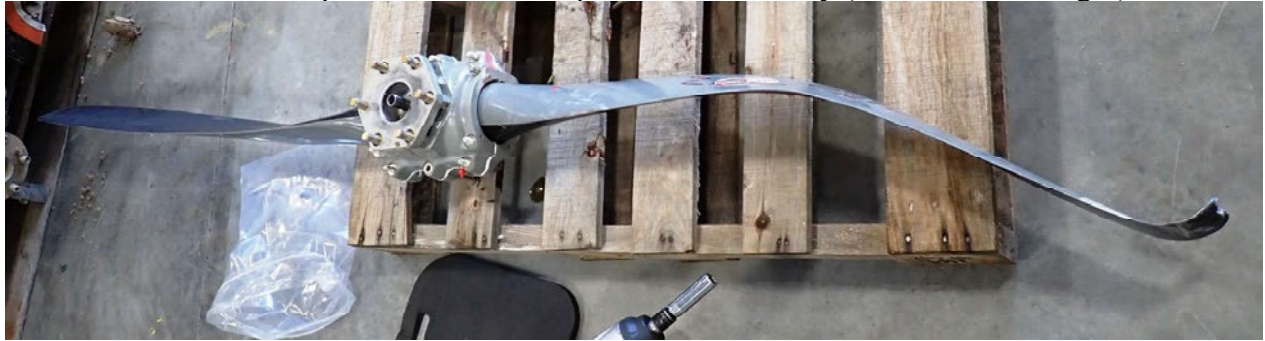
Photo #6 – Propeller removed and prior to disassembly (Blade #1 to the right)

The propeller was removed from the engine mounting flange for further disassembly as shown in Photo #6. Both blades were securely retained in the hub. The pitch change rod fractured forward of the fork, eliminating the high pitch stop and allowing the blades to travel into a feathered position. Neither blade exhibited any leading edge damage signatures consistent with powered rotation or high RPM. Blade #2 had some leading edge “flats” favoring the camber side leading edge suggesting a scraping from asphalt/concrete after rotation stopped or recovery/transport damage. There was no remarkable trailing edge damage.

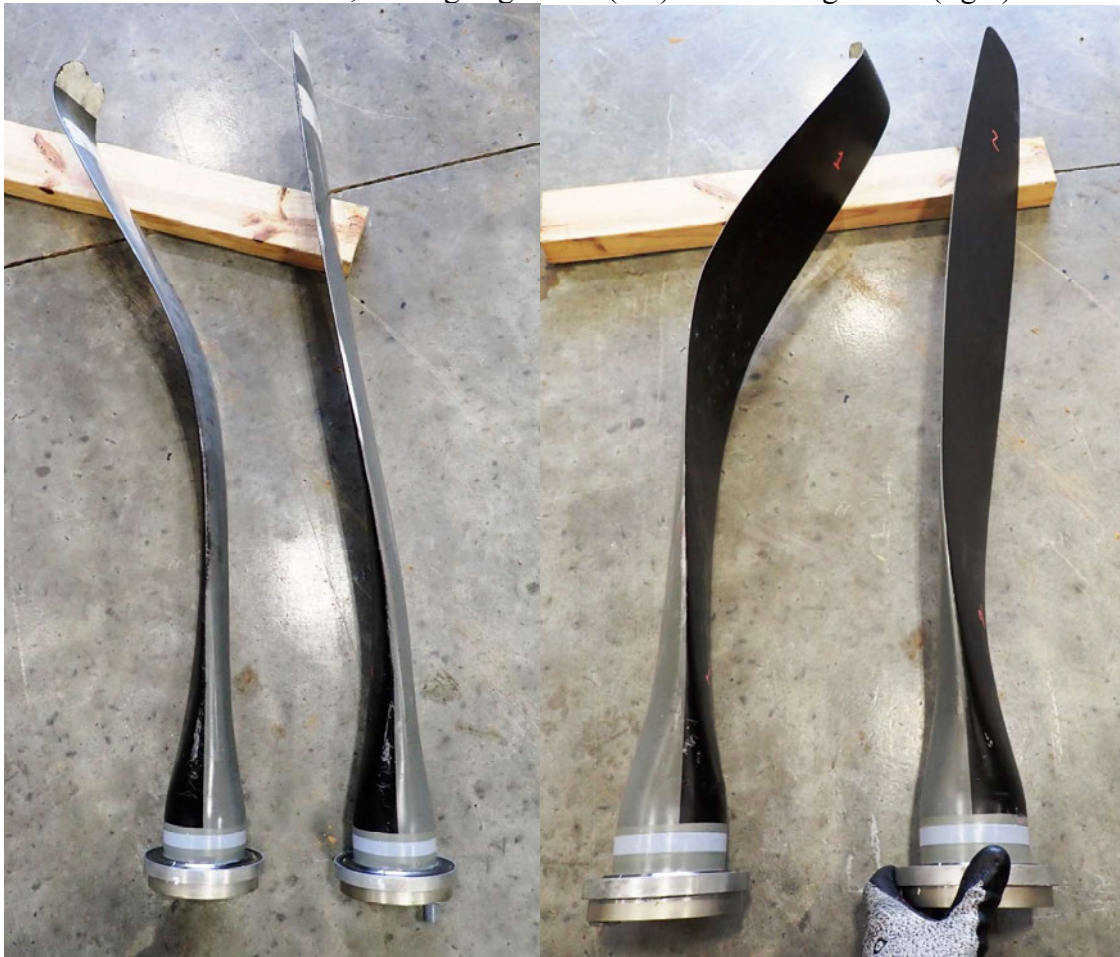
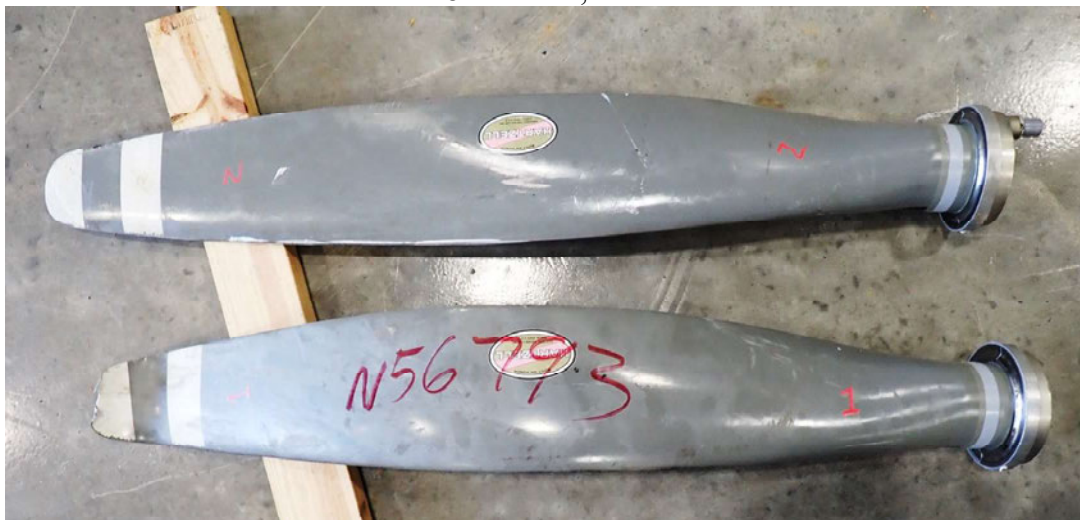
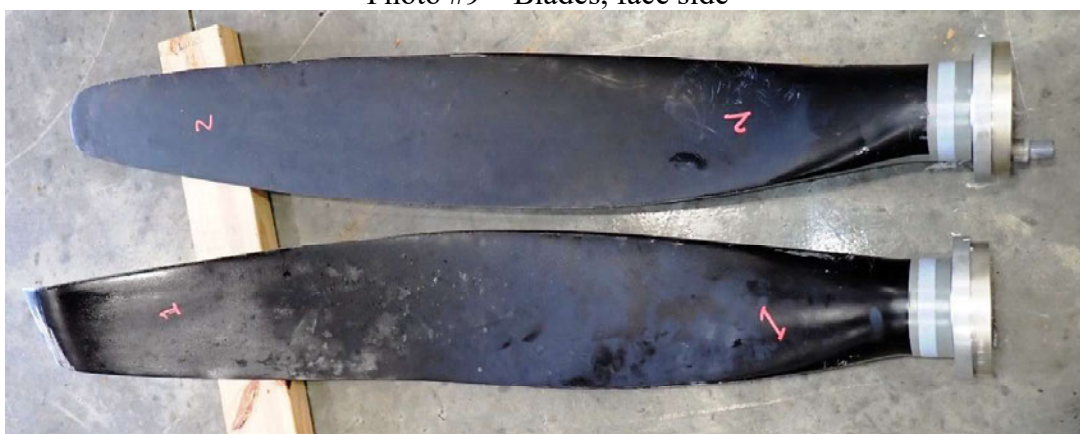
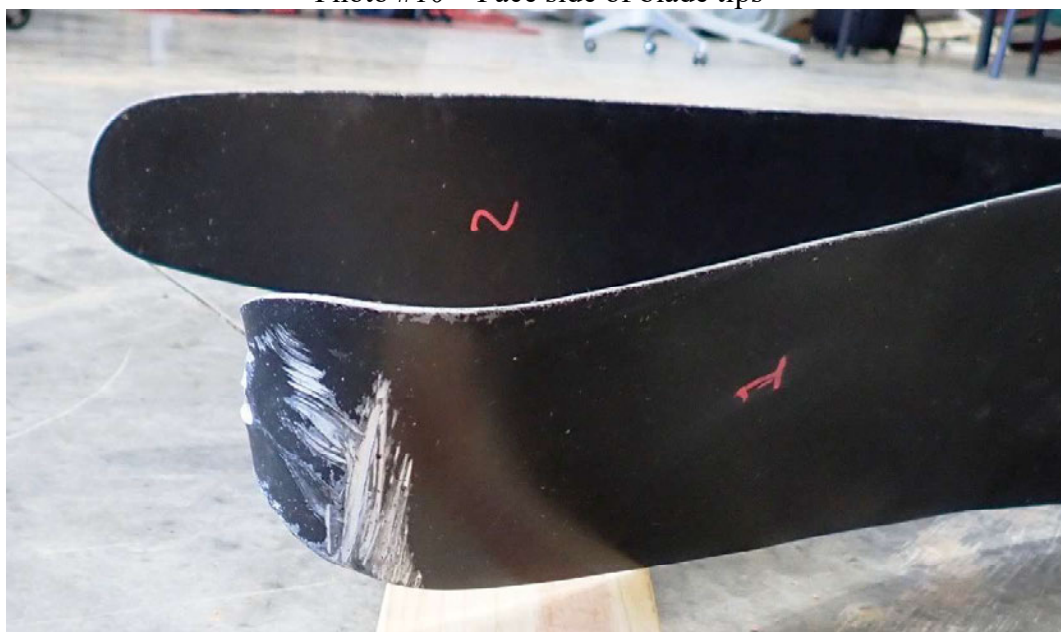
Blade #1 was predominantly bent aft with no remarkable twisting. It had some chordwise/rotational abrasion on the face side near the tip bend but limited in chordwise extent. Blade #2 was bent aft to a lesser degree than Blade #1 and had no remarkable twisting. Photos #7 through #10 illustrate the blade damage.

Photo #7 – Blades, leading edge view (left) and trail edge view (right)

Photo #8 – Blades, camber side

Photo #9 – Blades, face side

Photo #10 – Face side of blade tips

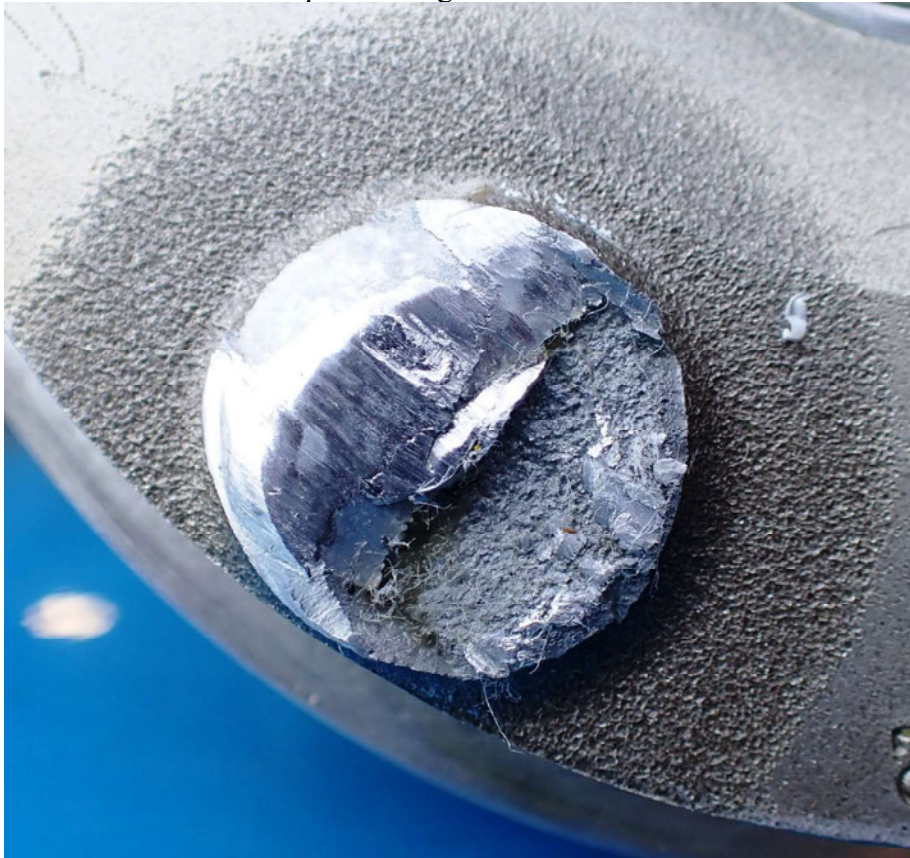
The blade #1 pitch change knob fracture-separated from the butt. Photo #11 (butt side) and Photo #12 knob fracture surfaces indicate shear/overload type fractures due to forceful rotation towards low pitch. Blade #2 pitch change knob was bent (Photo #13) also indicating forceful rotation towards low pitch.

Photo #11 – Blade #1 pitch change rod fracture surface on blade butt

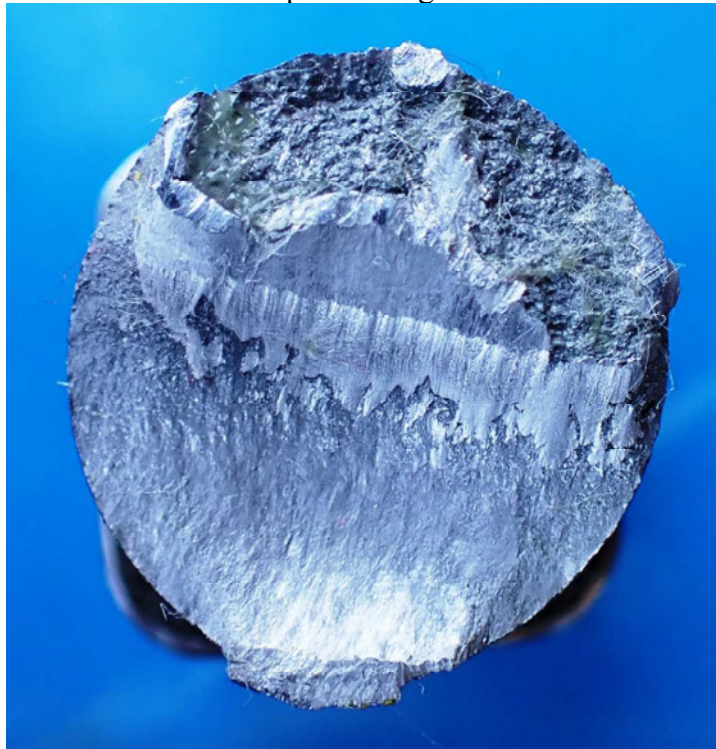
Photo #12 – Blade #1 pitch change knob fracture surface

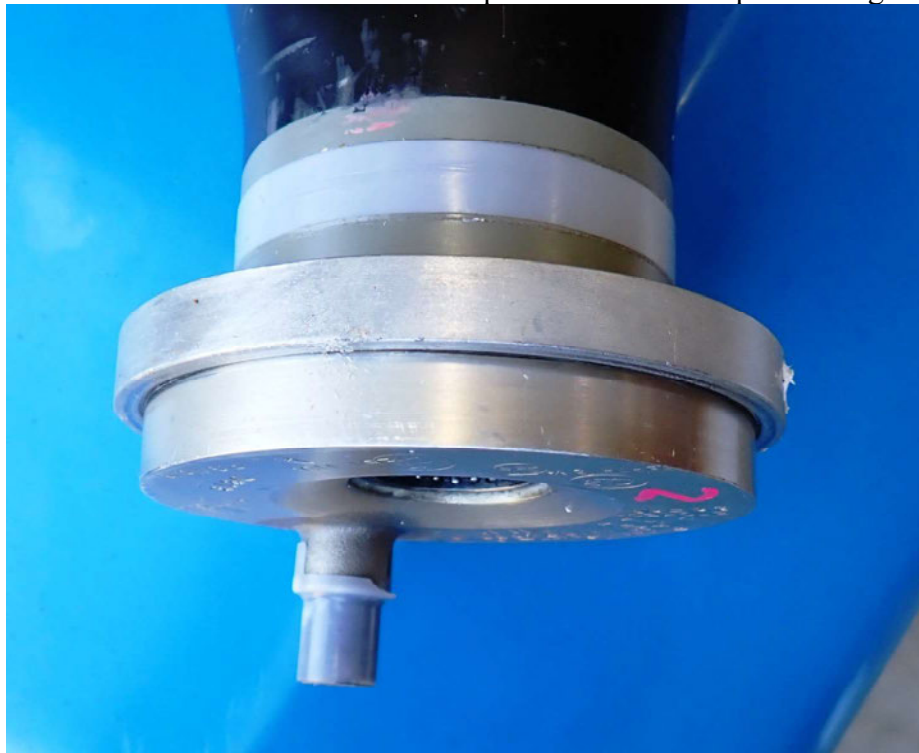
Photo #13 - Blade #2 shank/butt with impact mark and bent pitch change knob

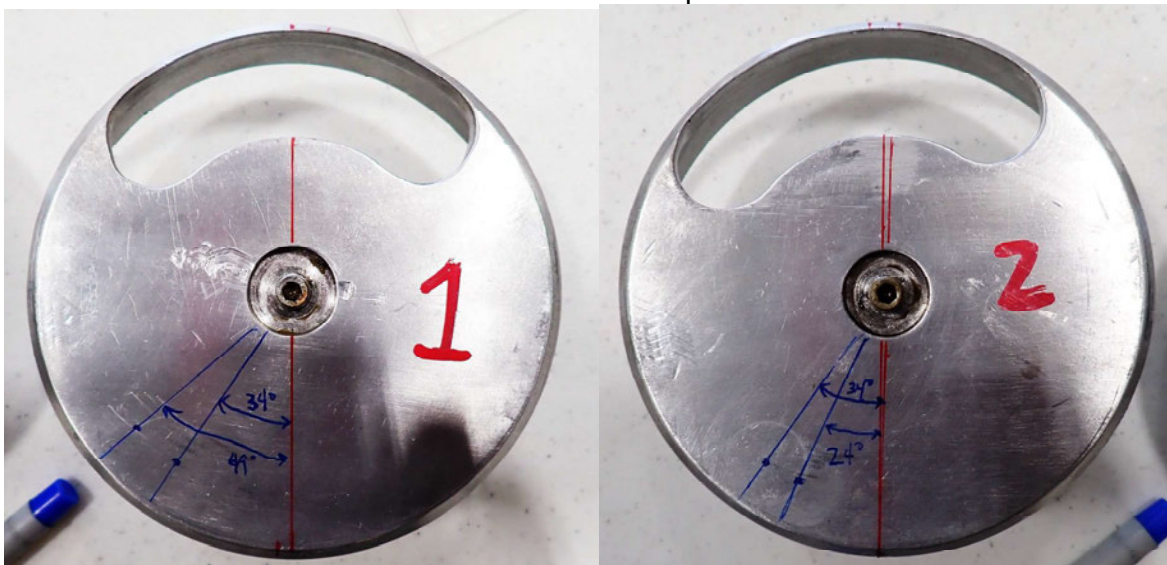
Photo #14 - Preload plates

Photo #14 shows the preload plates for each blade. Both preload plates exhibited a knob block/bumper mark at 34° forward of the split line mark which is approximately equal to 11° blade angle (IDS 827 defines the low pitch stop as 12 +/- 0.2°).

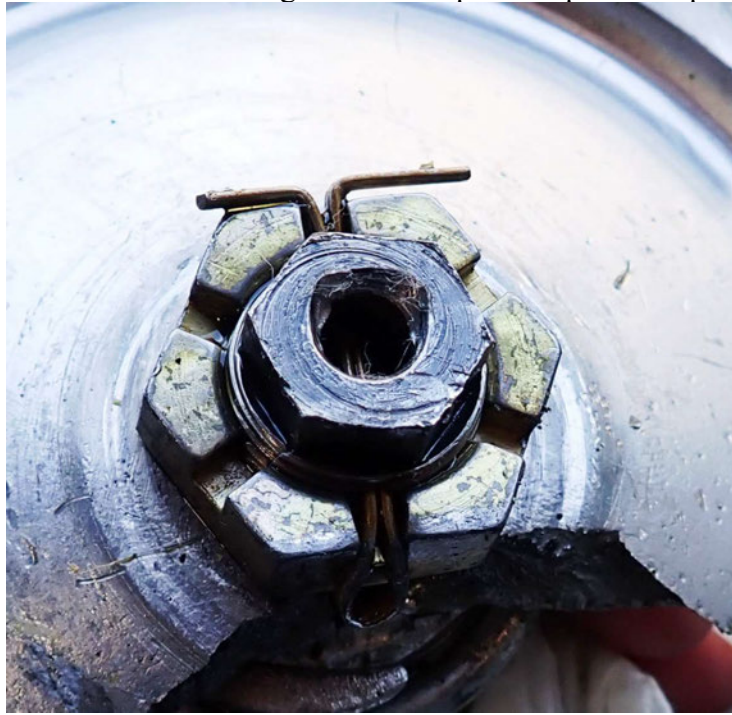
Photo #15 shows the pitch change rod point of contact with the low pitch stop screw. The damage suggests the propeller was on or near the low pitch stop when impact occurred. Additionally, the low pitch stop screw was damaged and displaced forward in the cylinder threads.

Photo #15 - Pitch change rod at low pitch stop contact point
