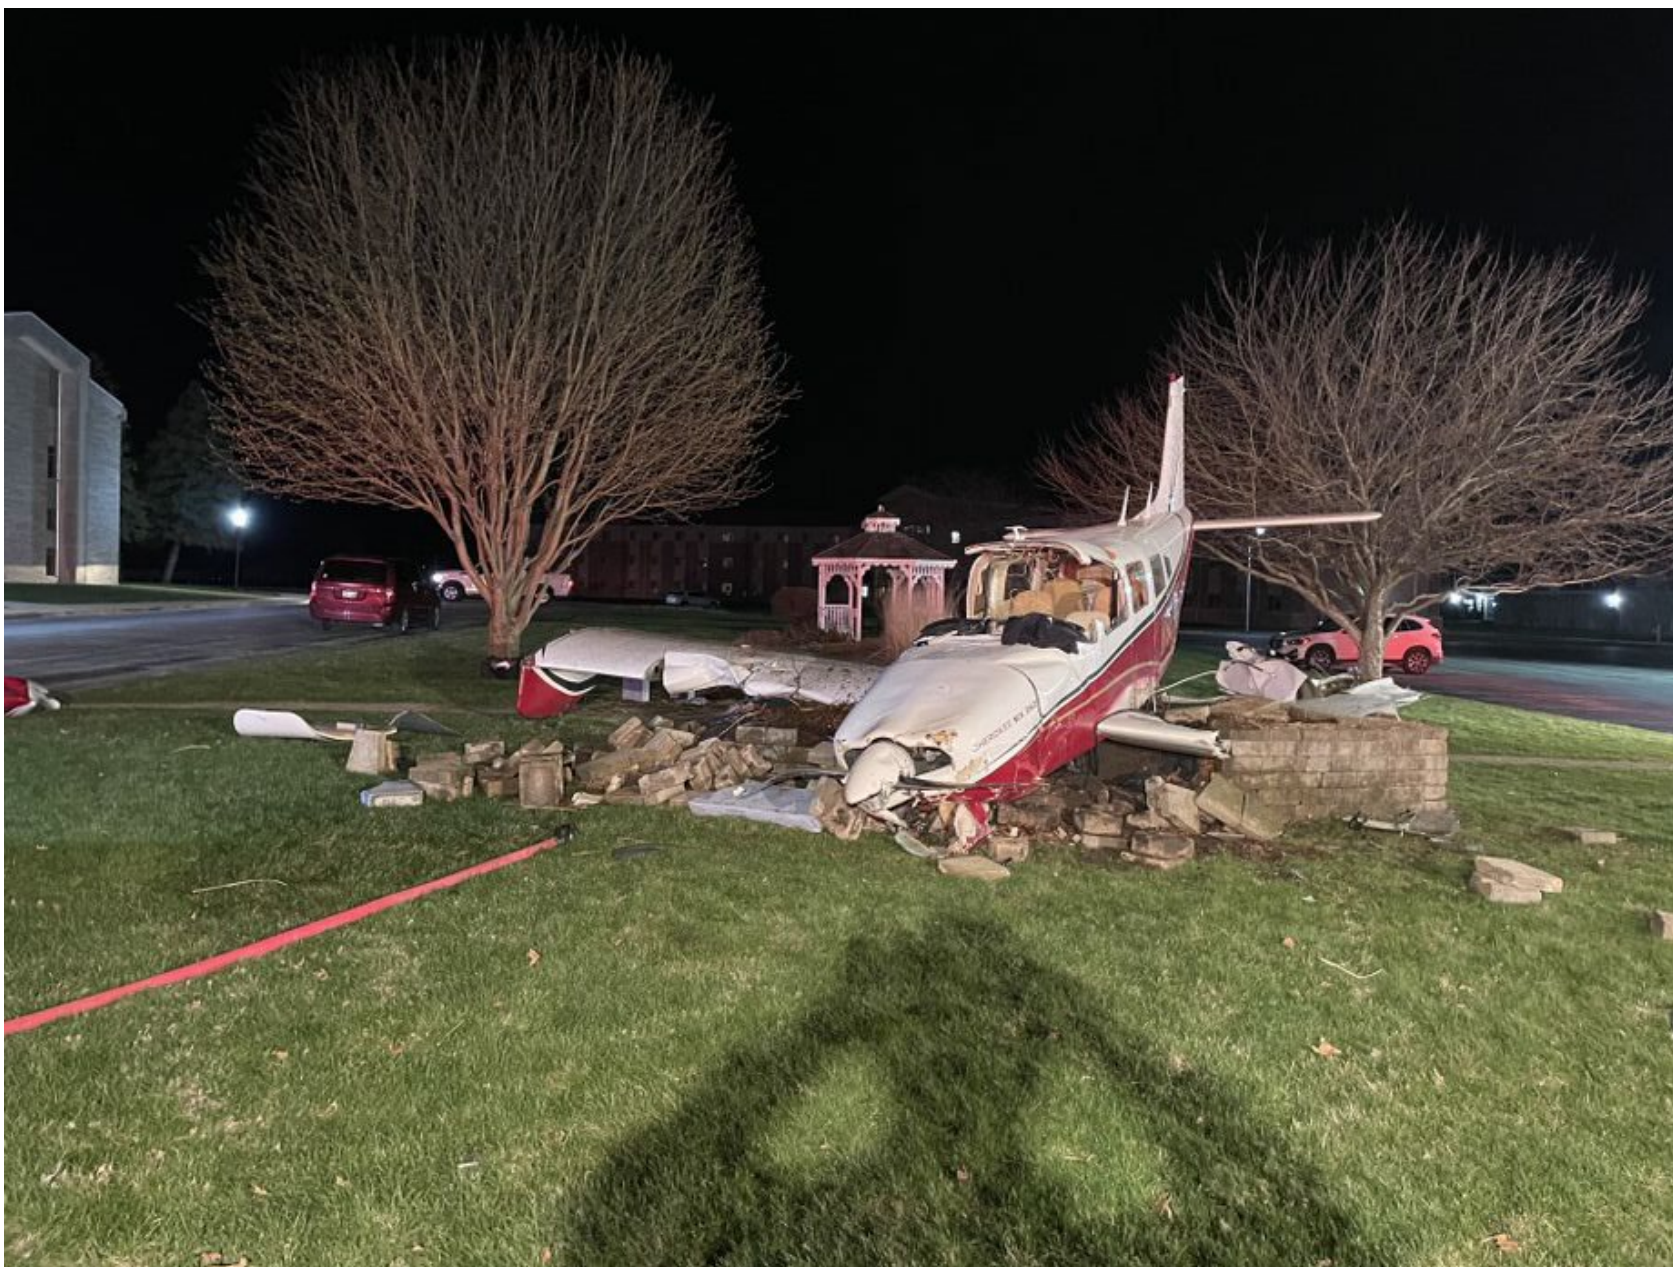
**Photo 1 – View of the front of the airplane at the accident site (courtesy of the Federal Aviation Administration).**

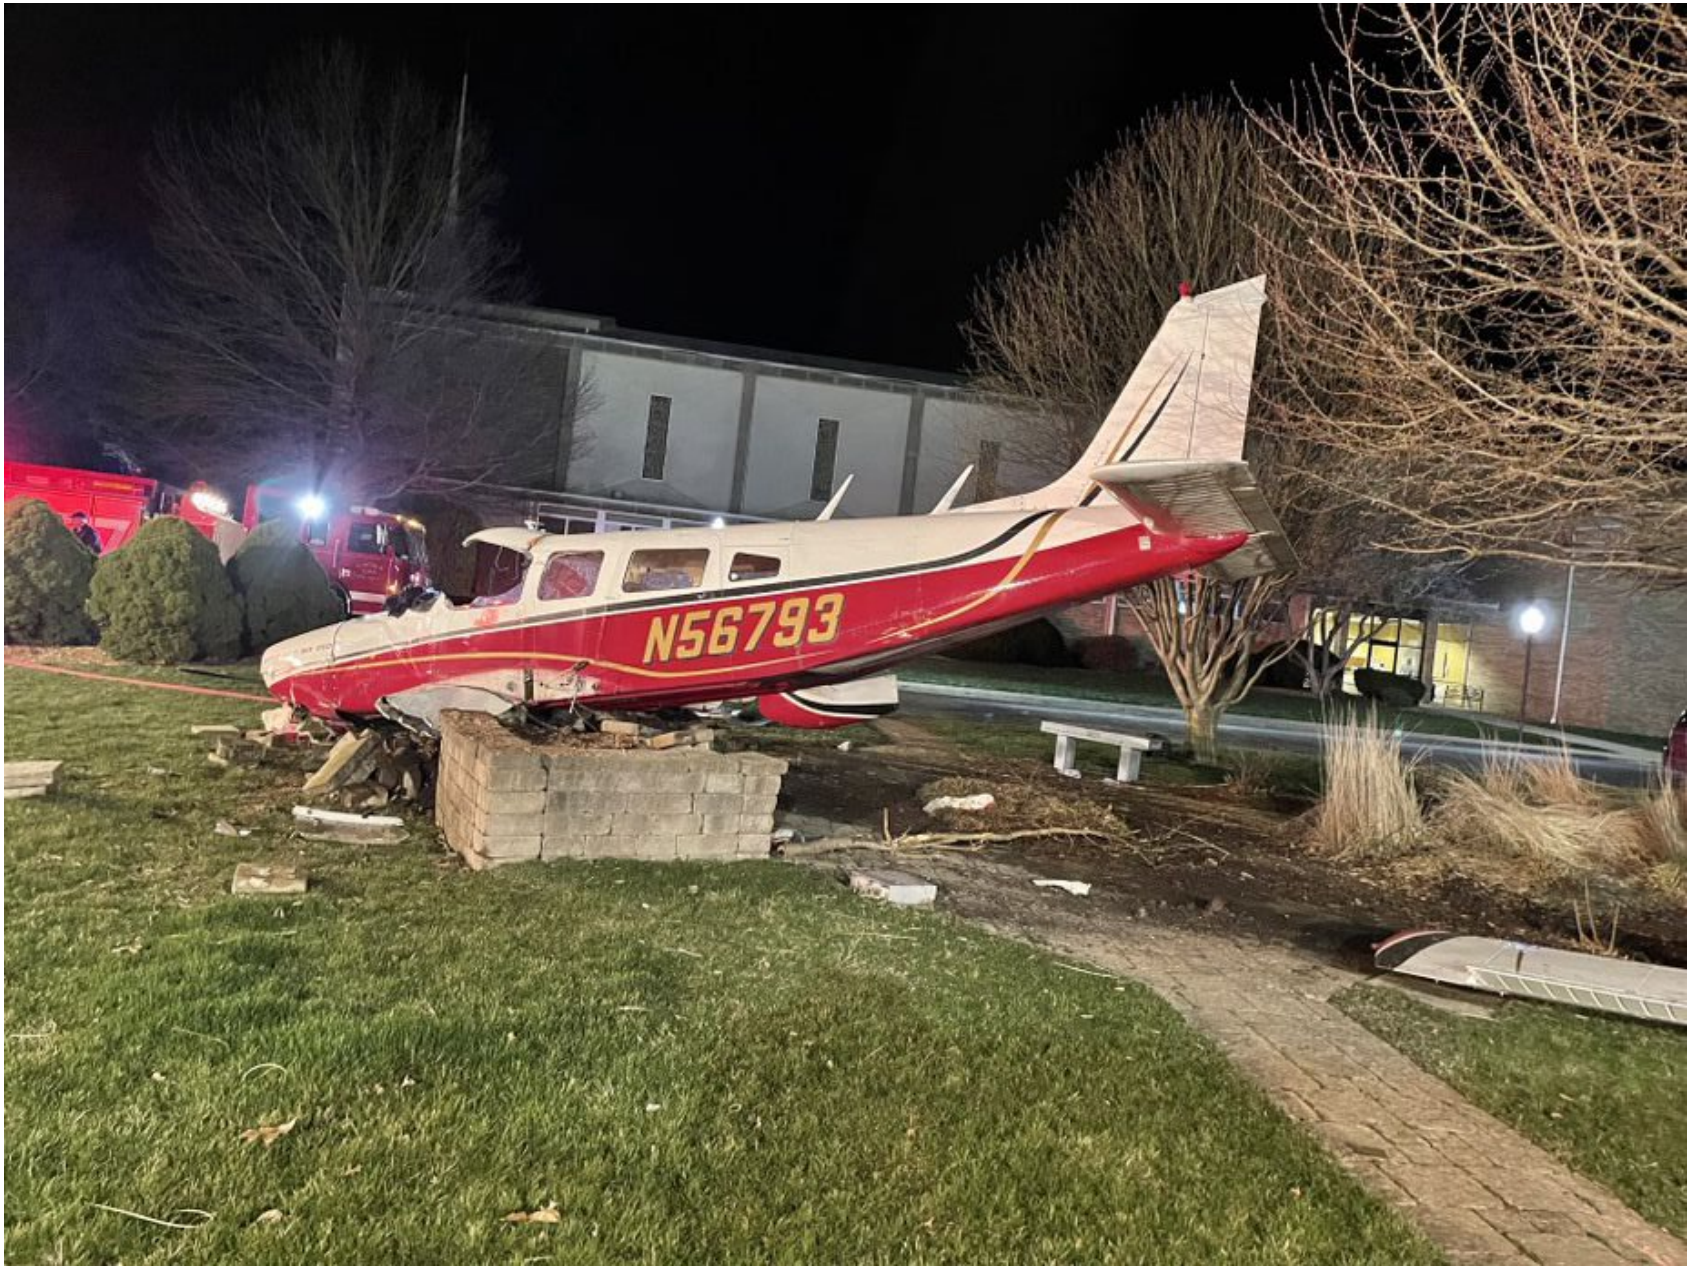
**Photo 2 – View of the left side of the airplane at the accident site (courtesy of the Federal Aviation Administration).**

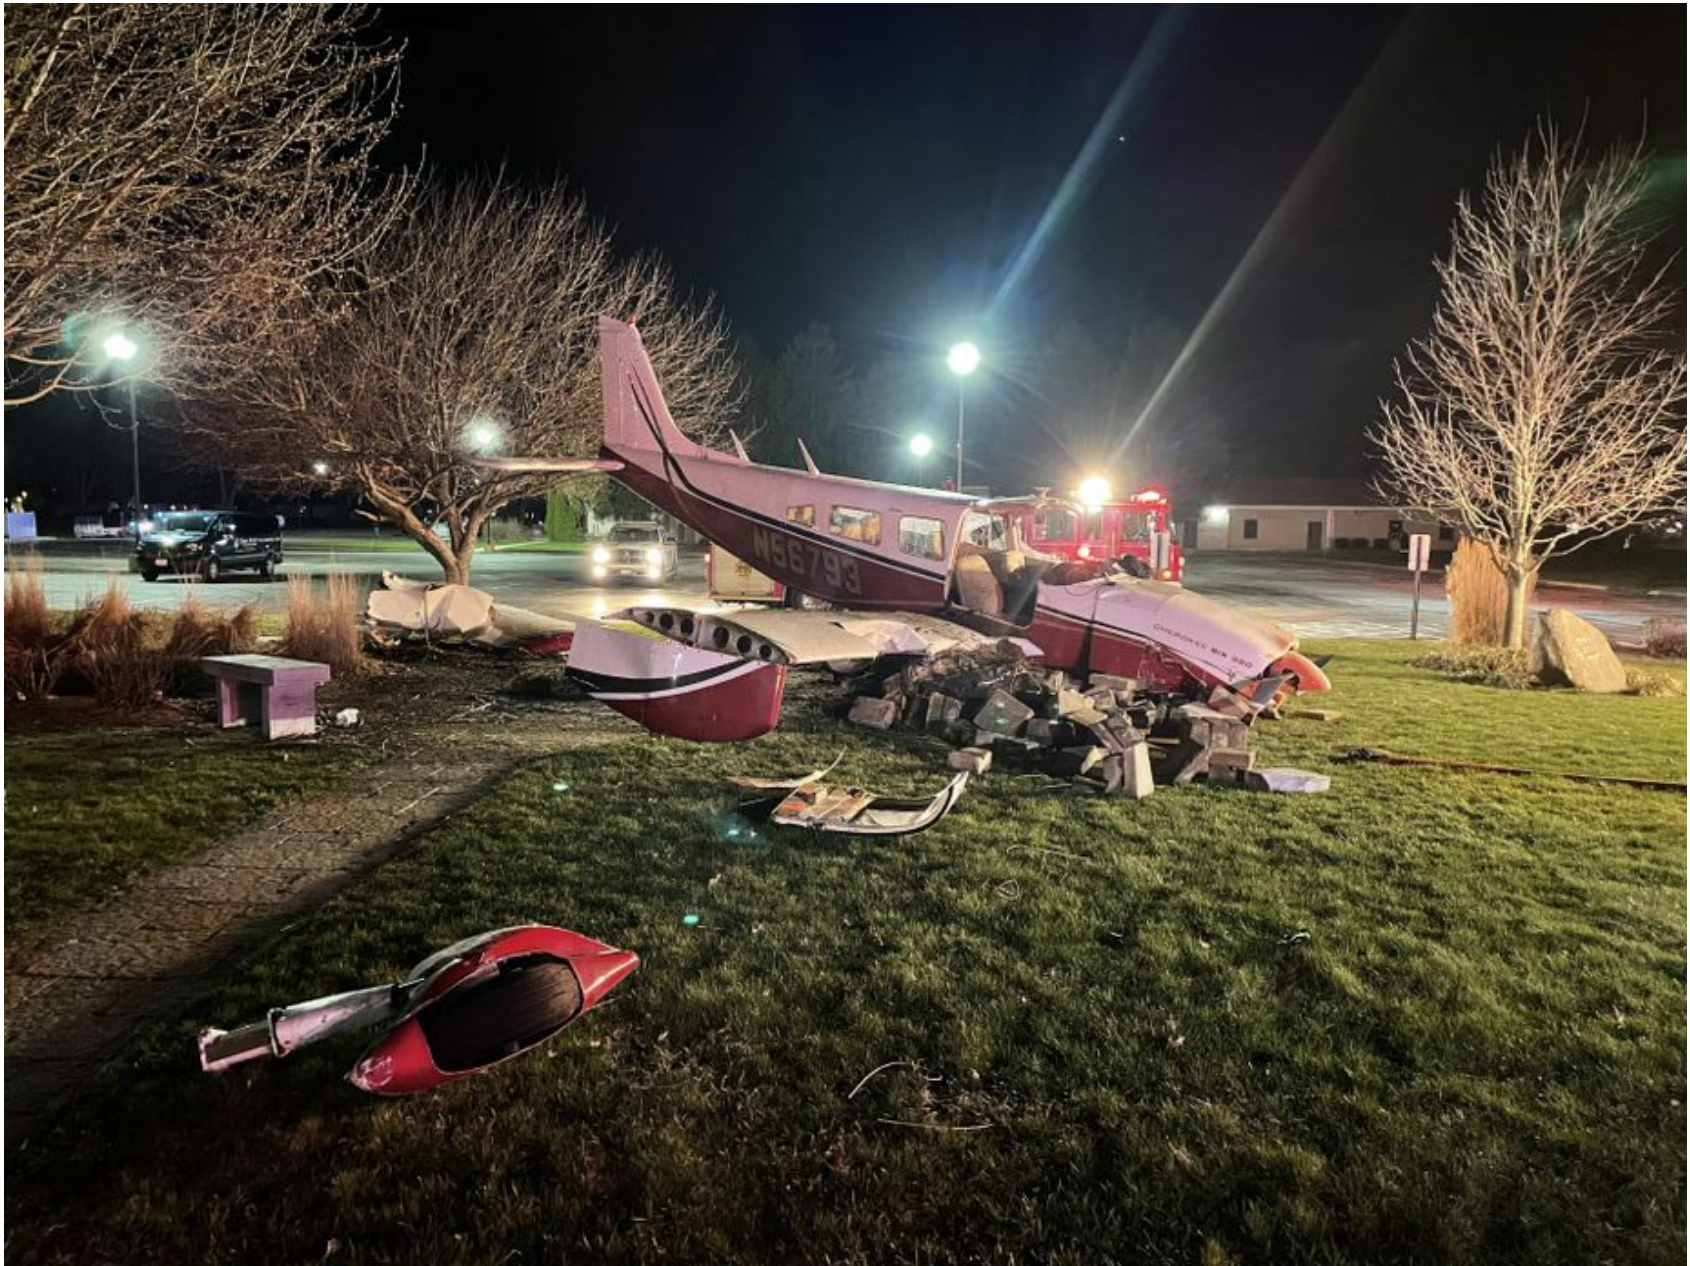
**Photo 3 – View of the right side of the airplane at the accident site (courtesy of the Federal Aviation Administration).**

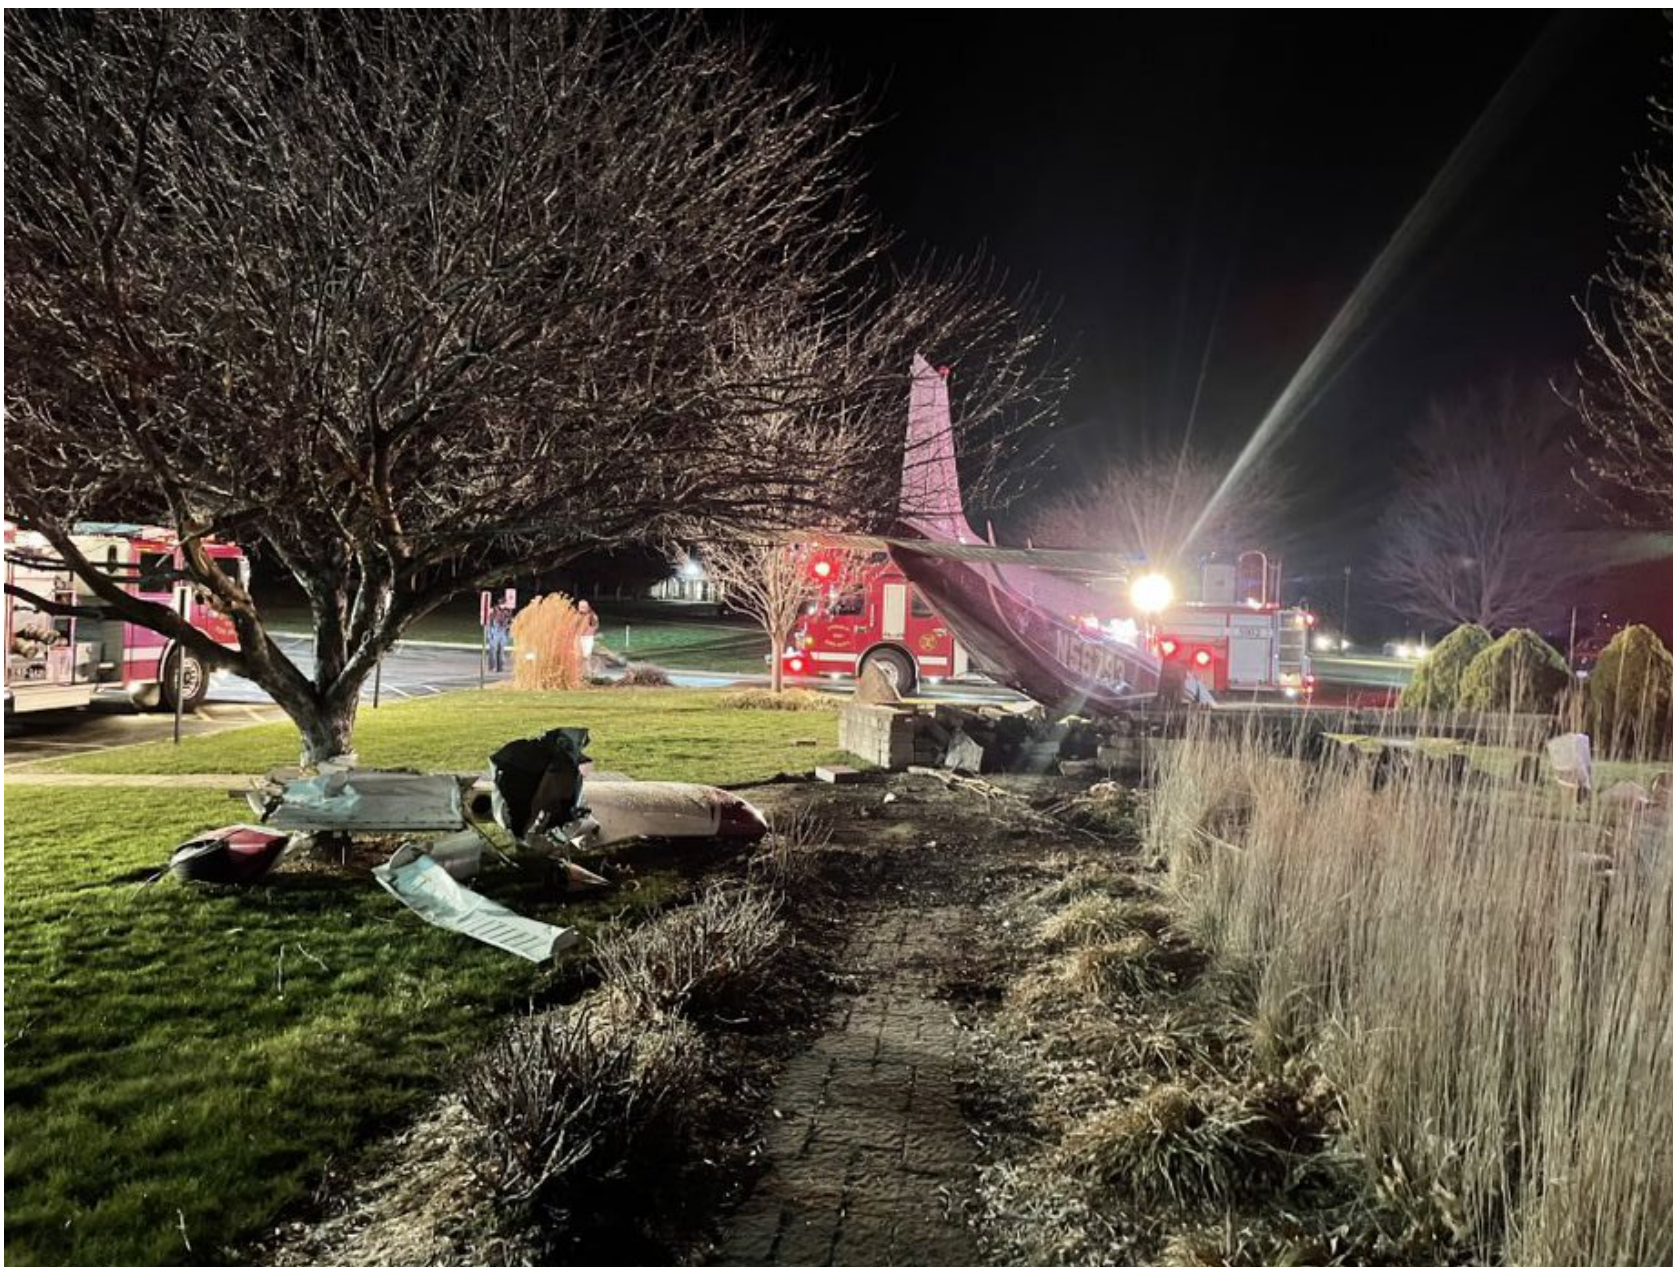
**Photo 4 – View of the rear of the airplane at the accident site (courtesy of the Federal Aviation Administration).**

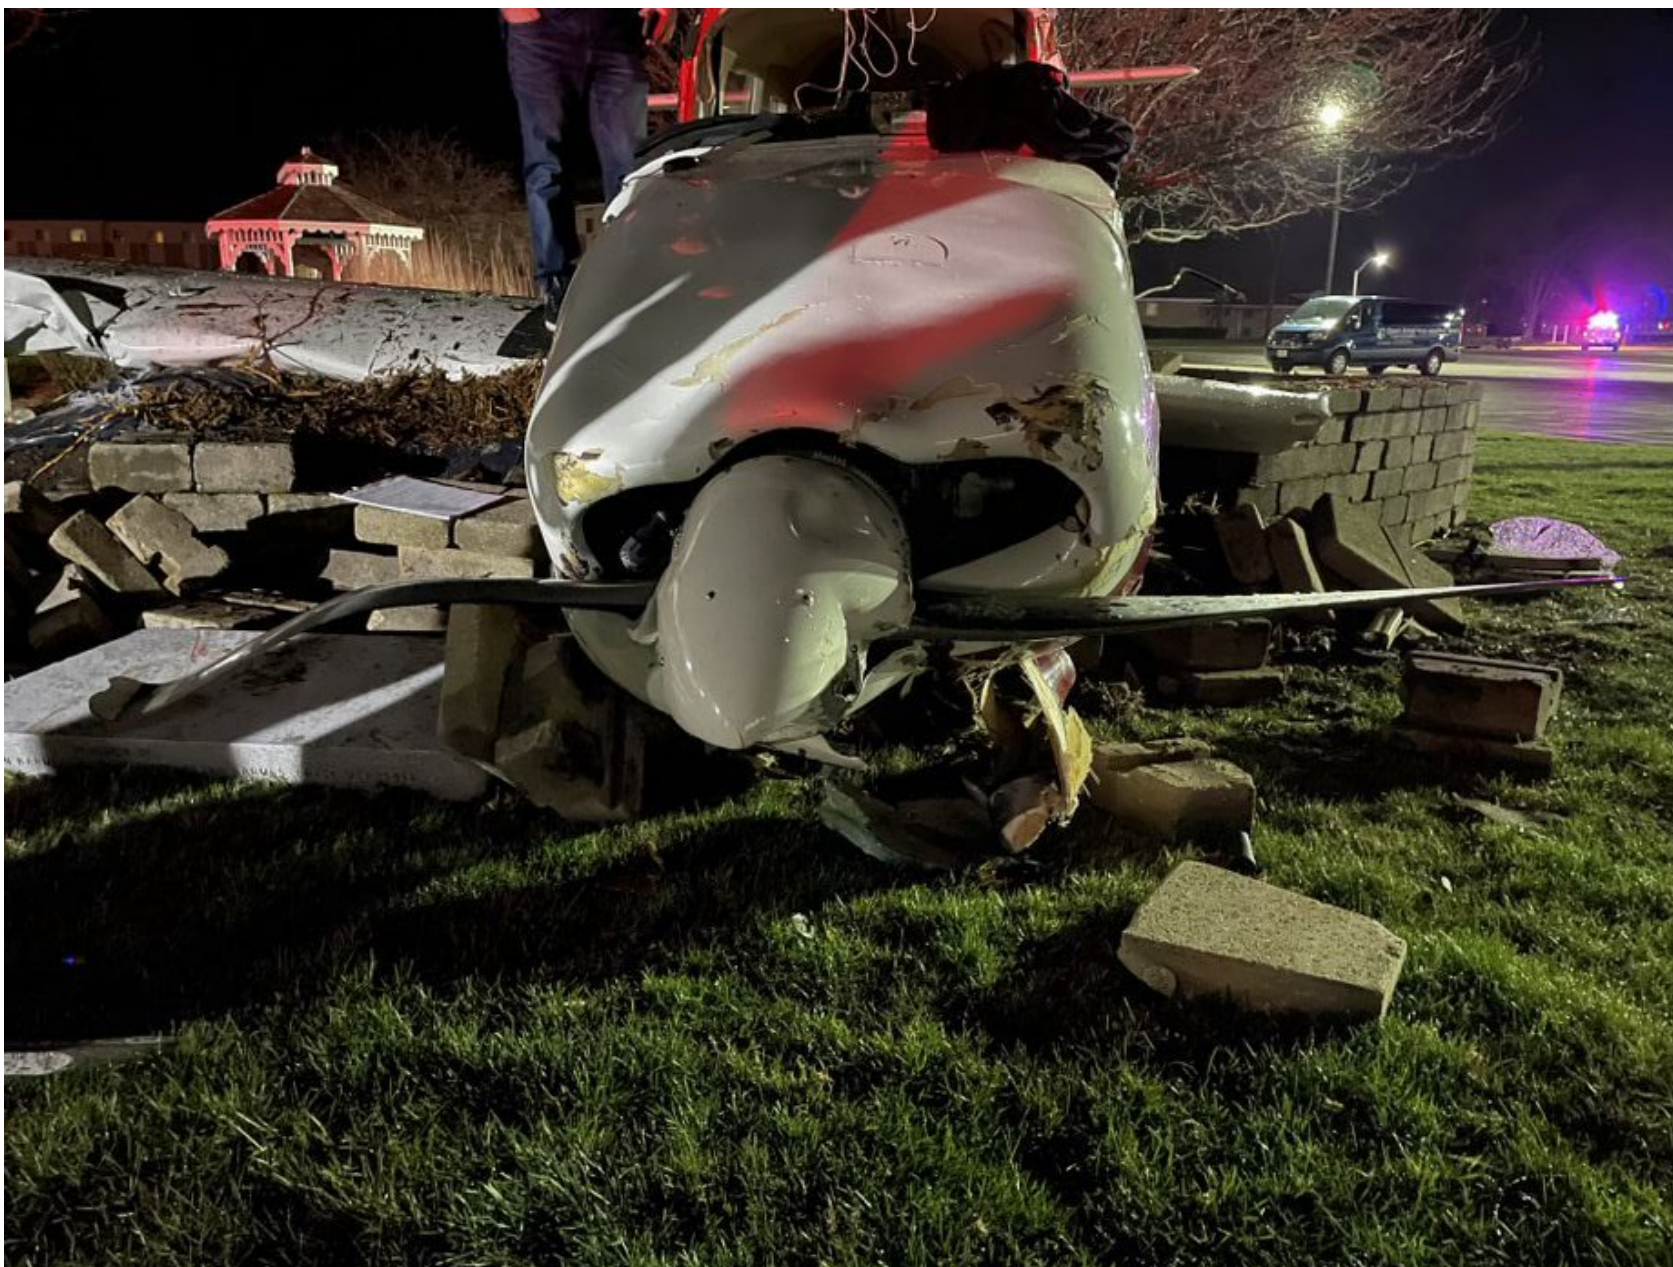
**Photo 5 – View of the engine and the propeller at the accident site (courtesy of the Federal Aviation Administration).**

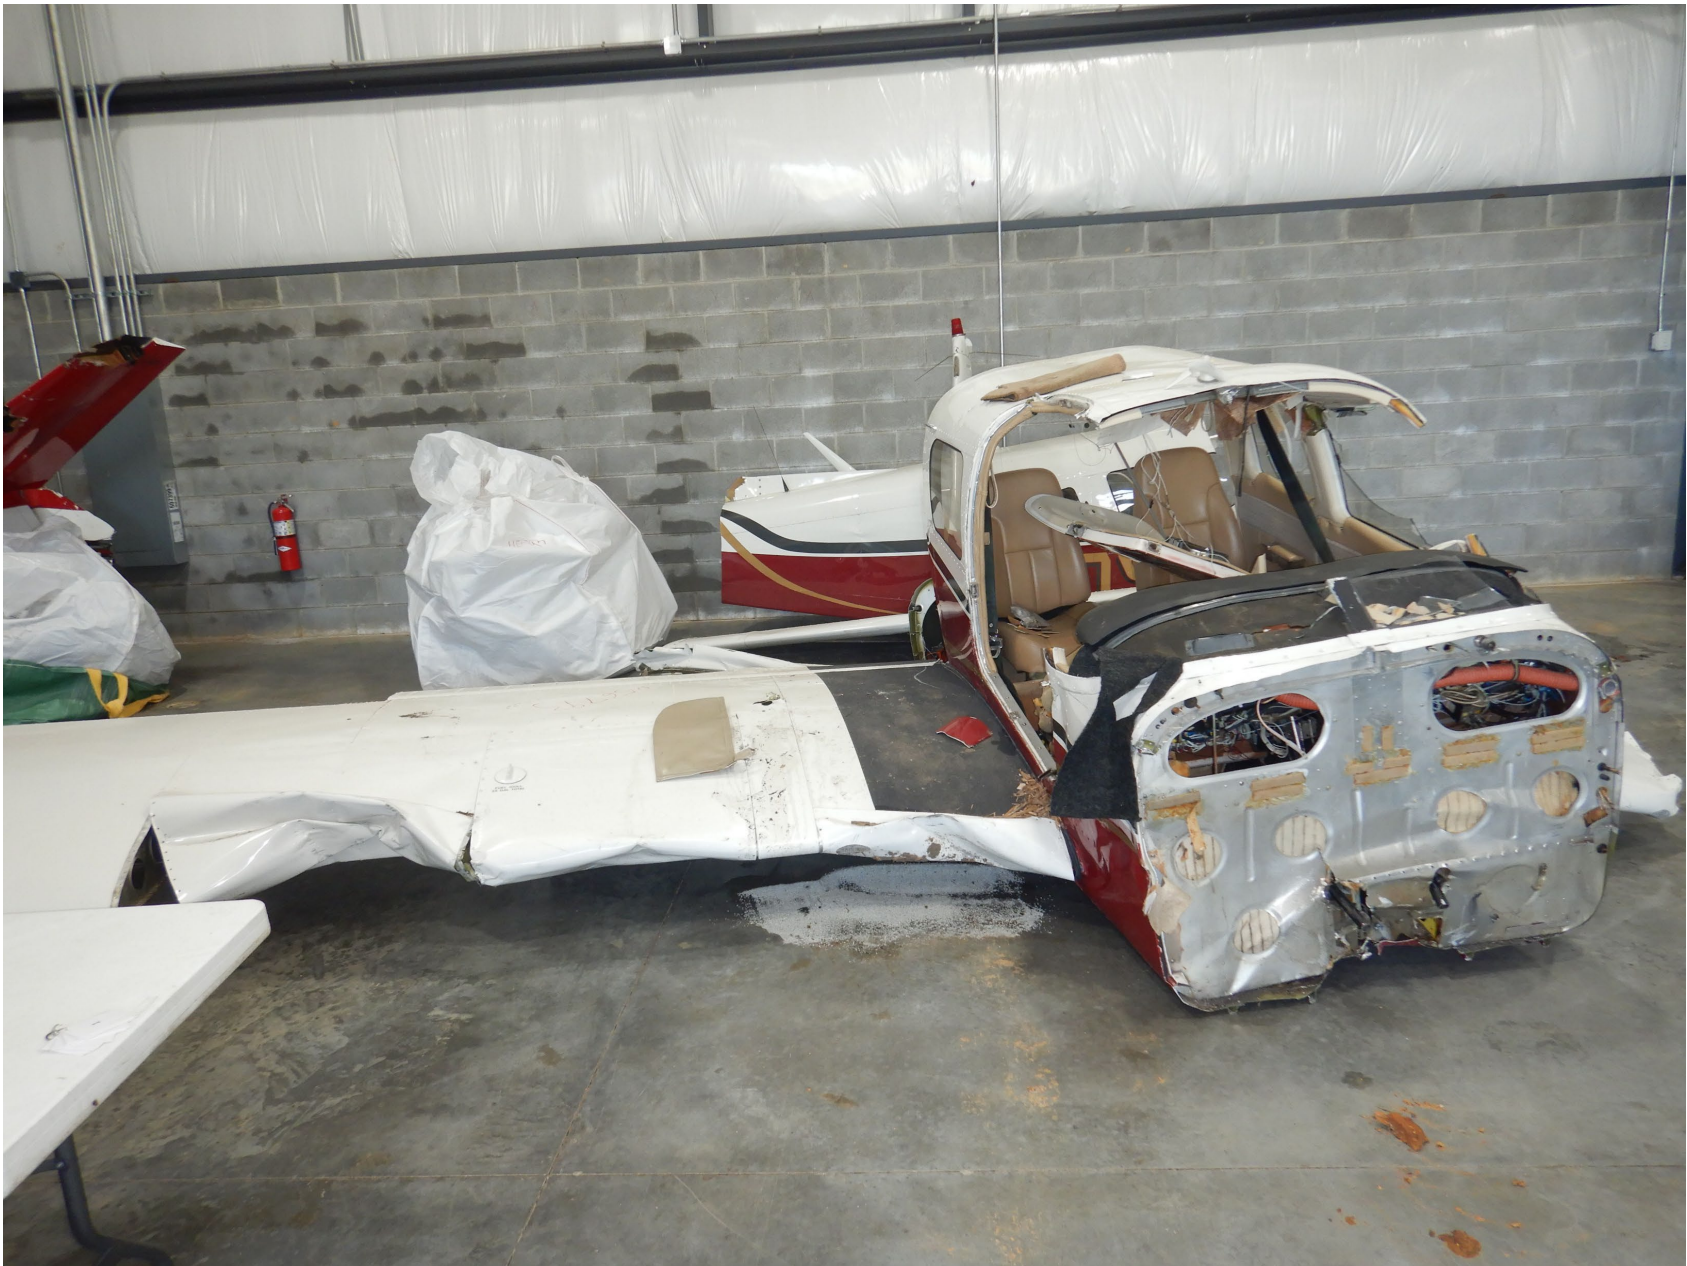
**Photo 6 – View of the front of the airframe during the examination (courtesy of Piper Aircraft).**

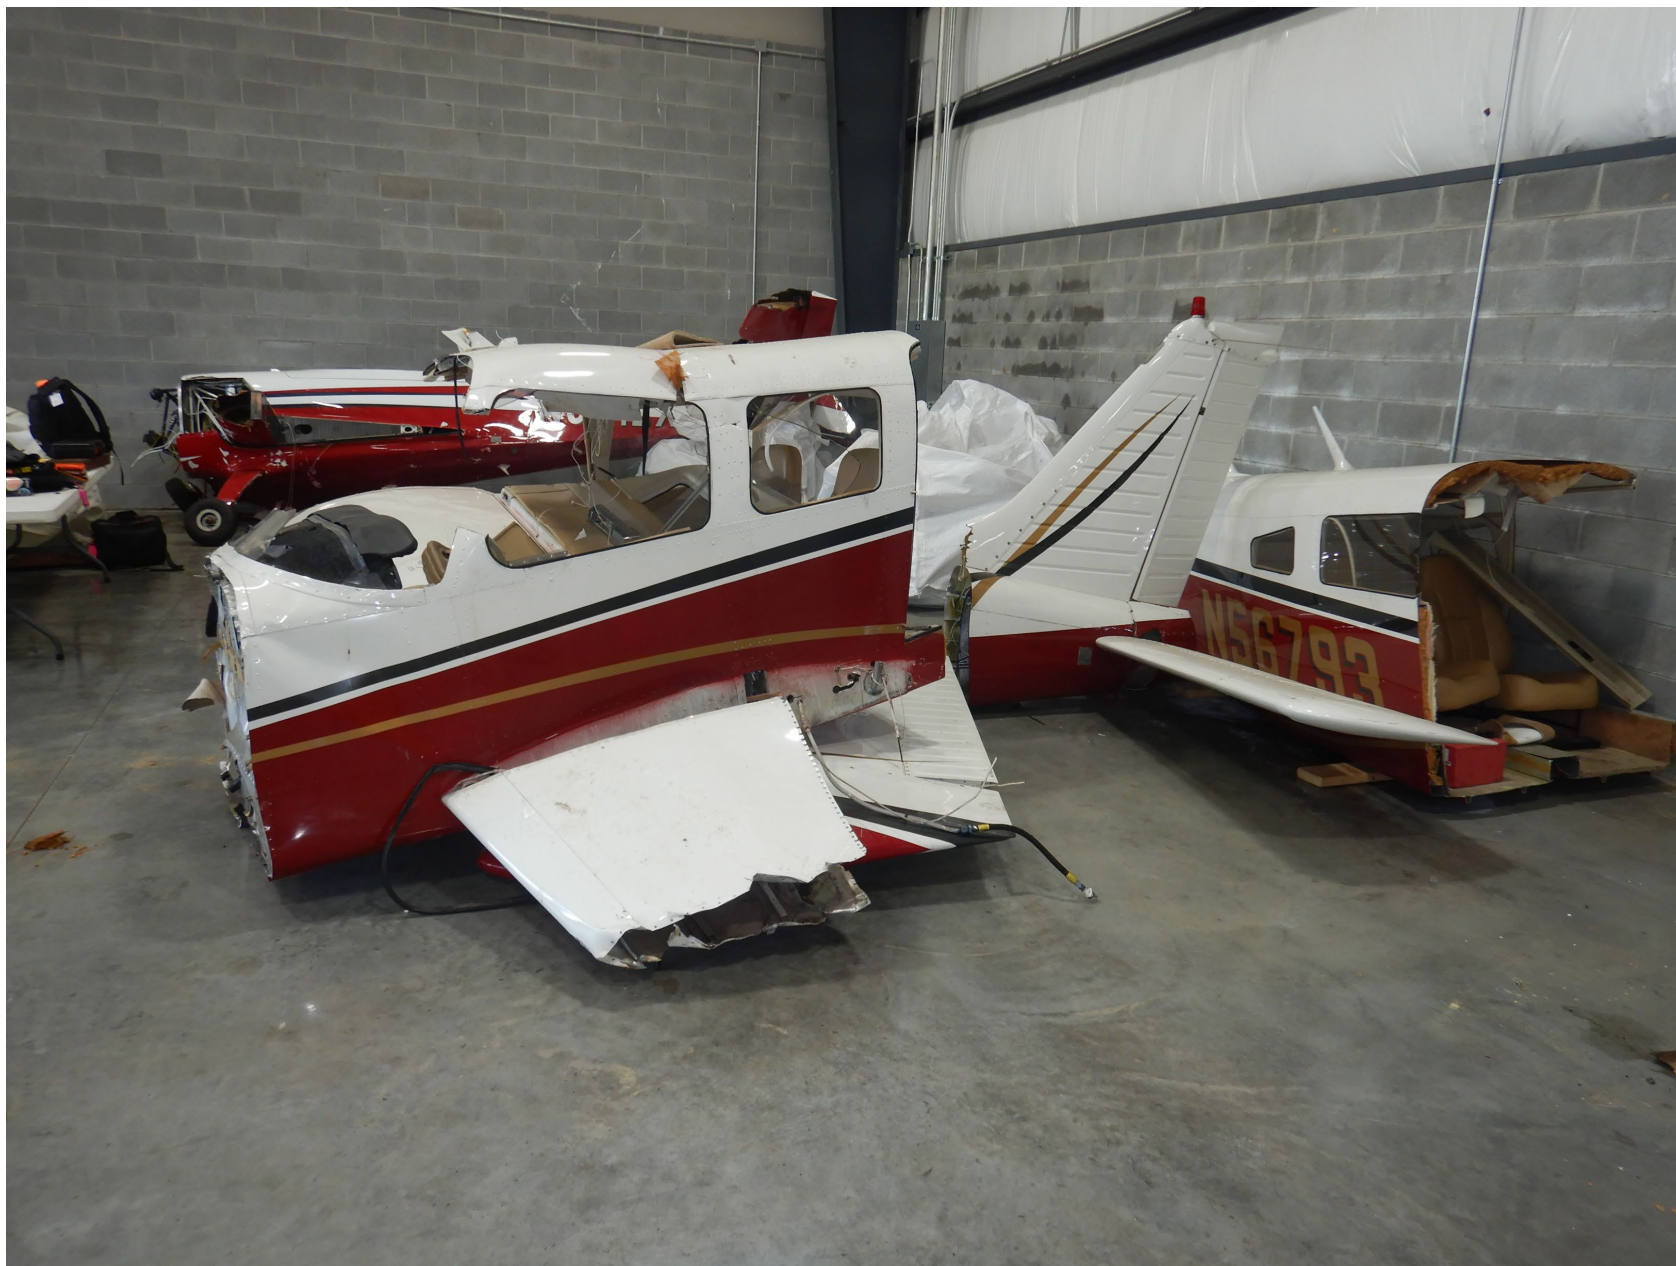
**Photo 7 – View of the left side of the airframe during the examination (courtesy of Piper Aircraft).**

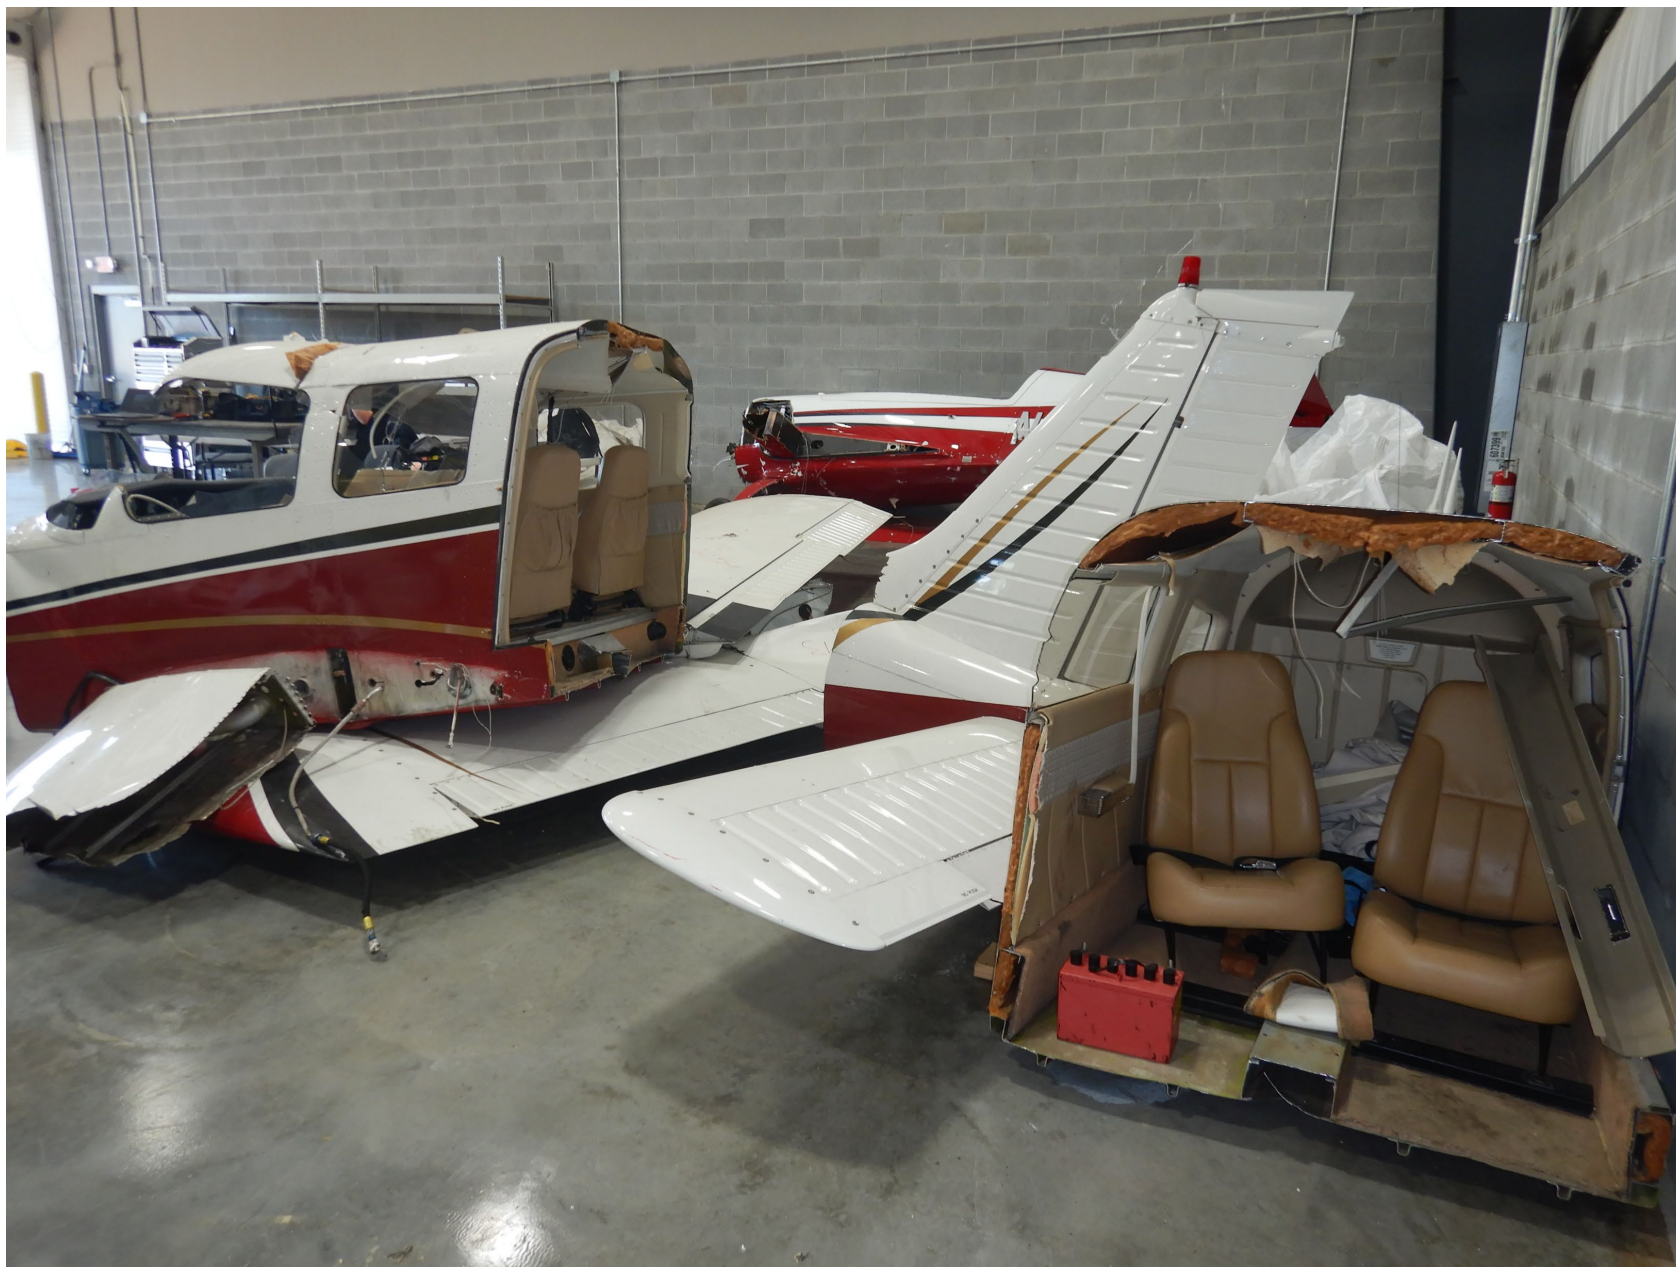
**Photo 8 – View of the cabin during the examination (courtesy of Piper Aircraft).**

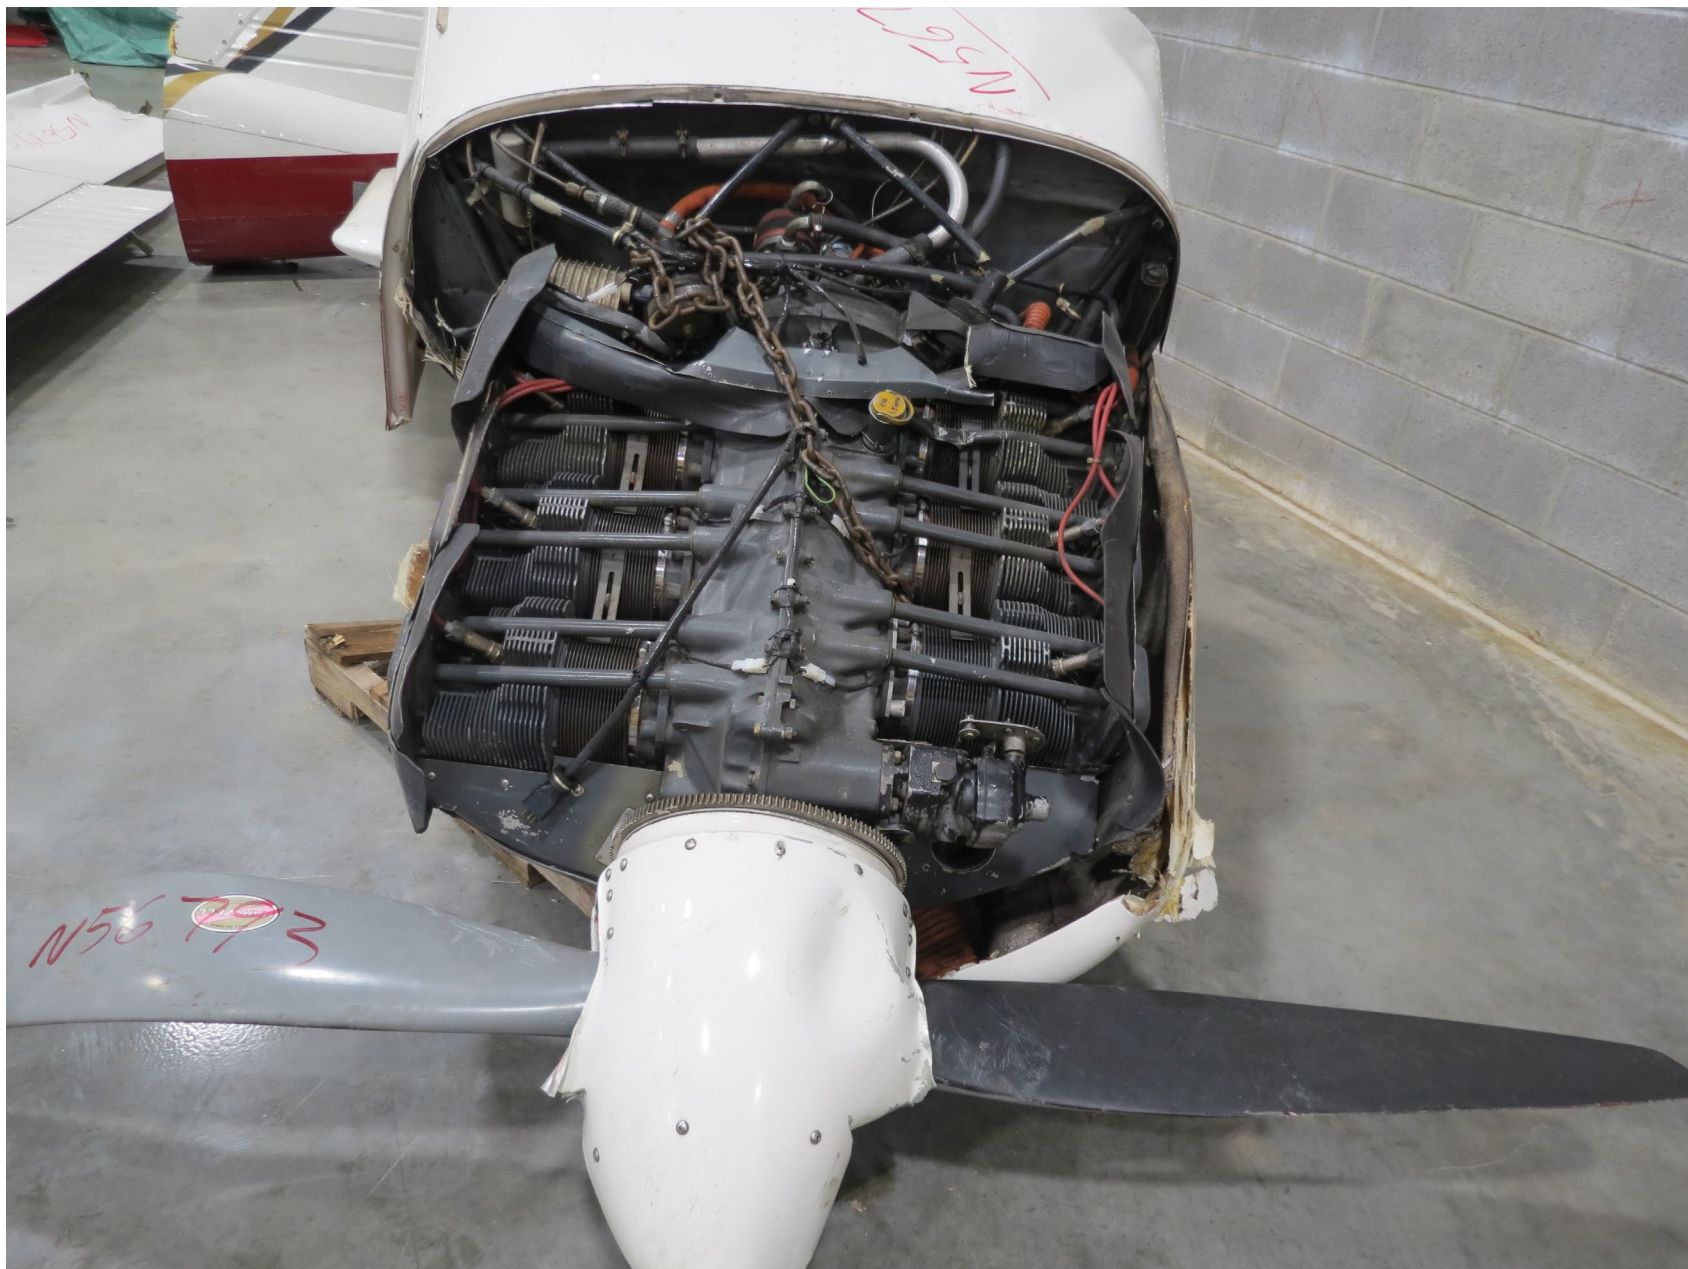
**Photo 9 – View of the top of the engine during the examination (courtesy of Lycoming Engines).**

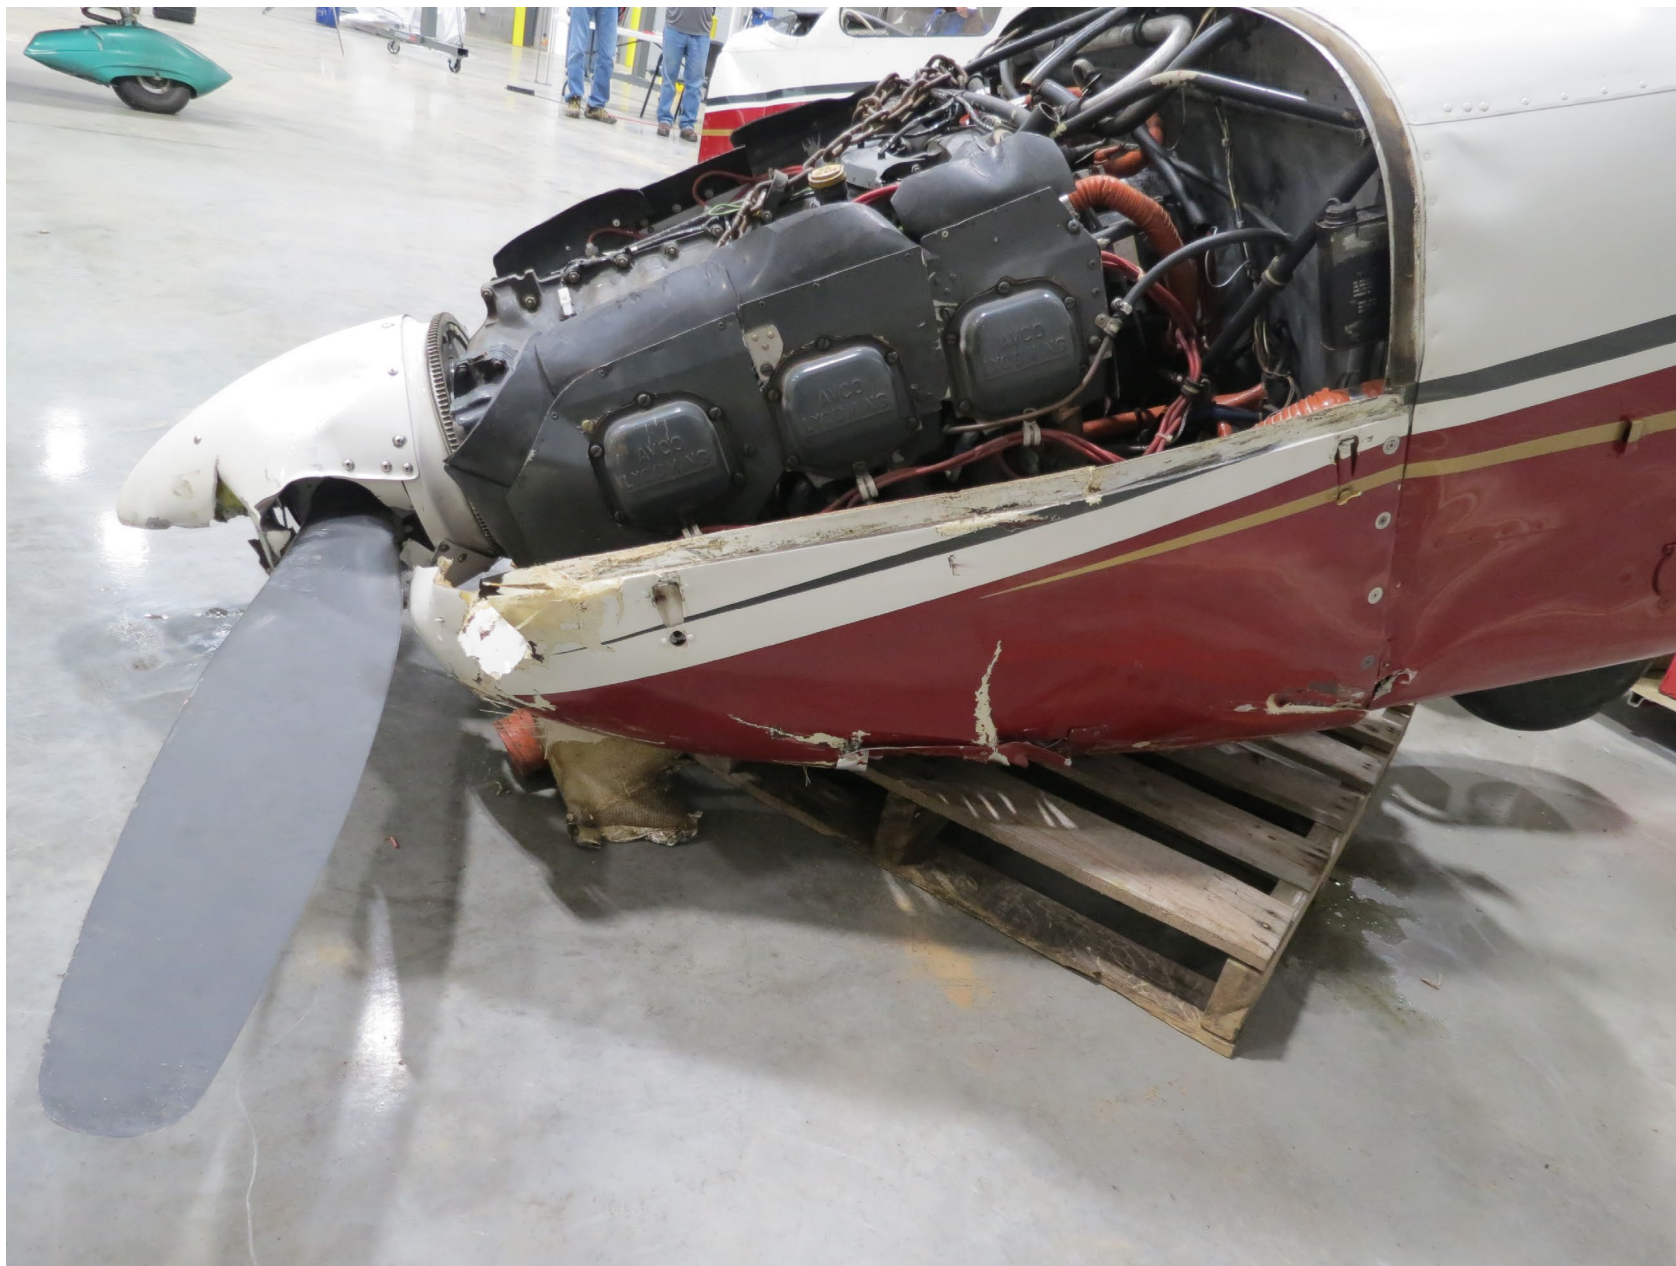
**Photo 10 – View of the left side of the engine during the examination (courtesy of Lycoming Engines).**
