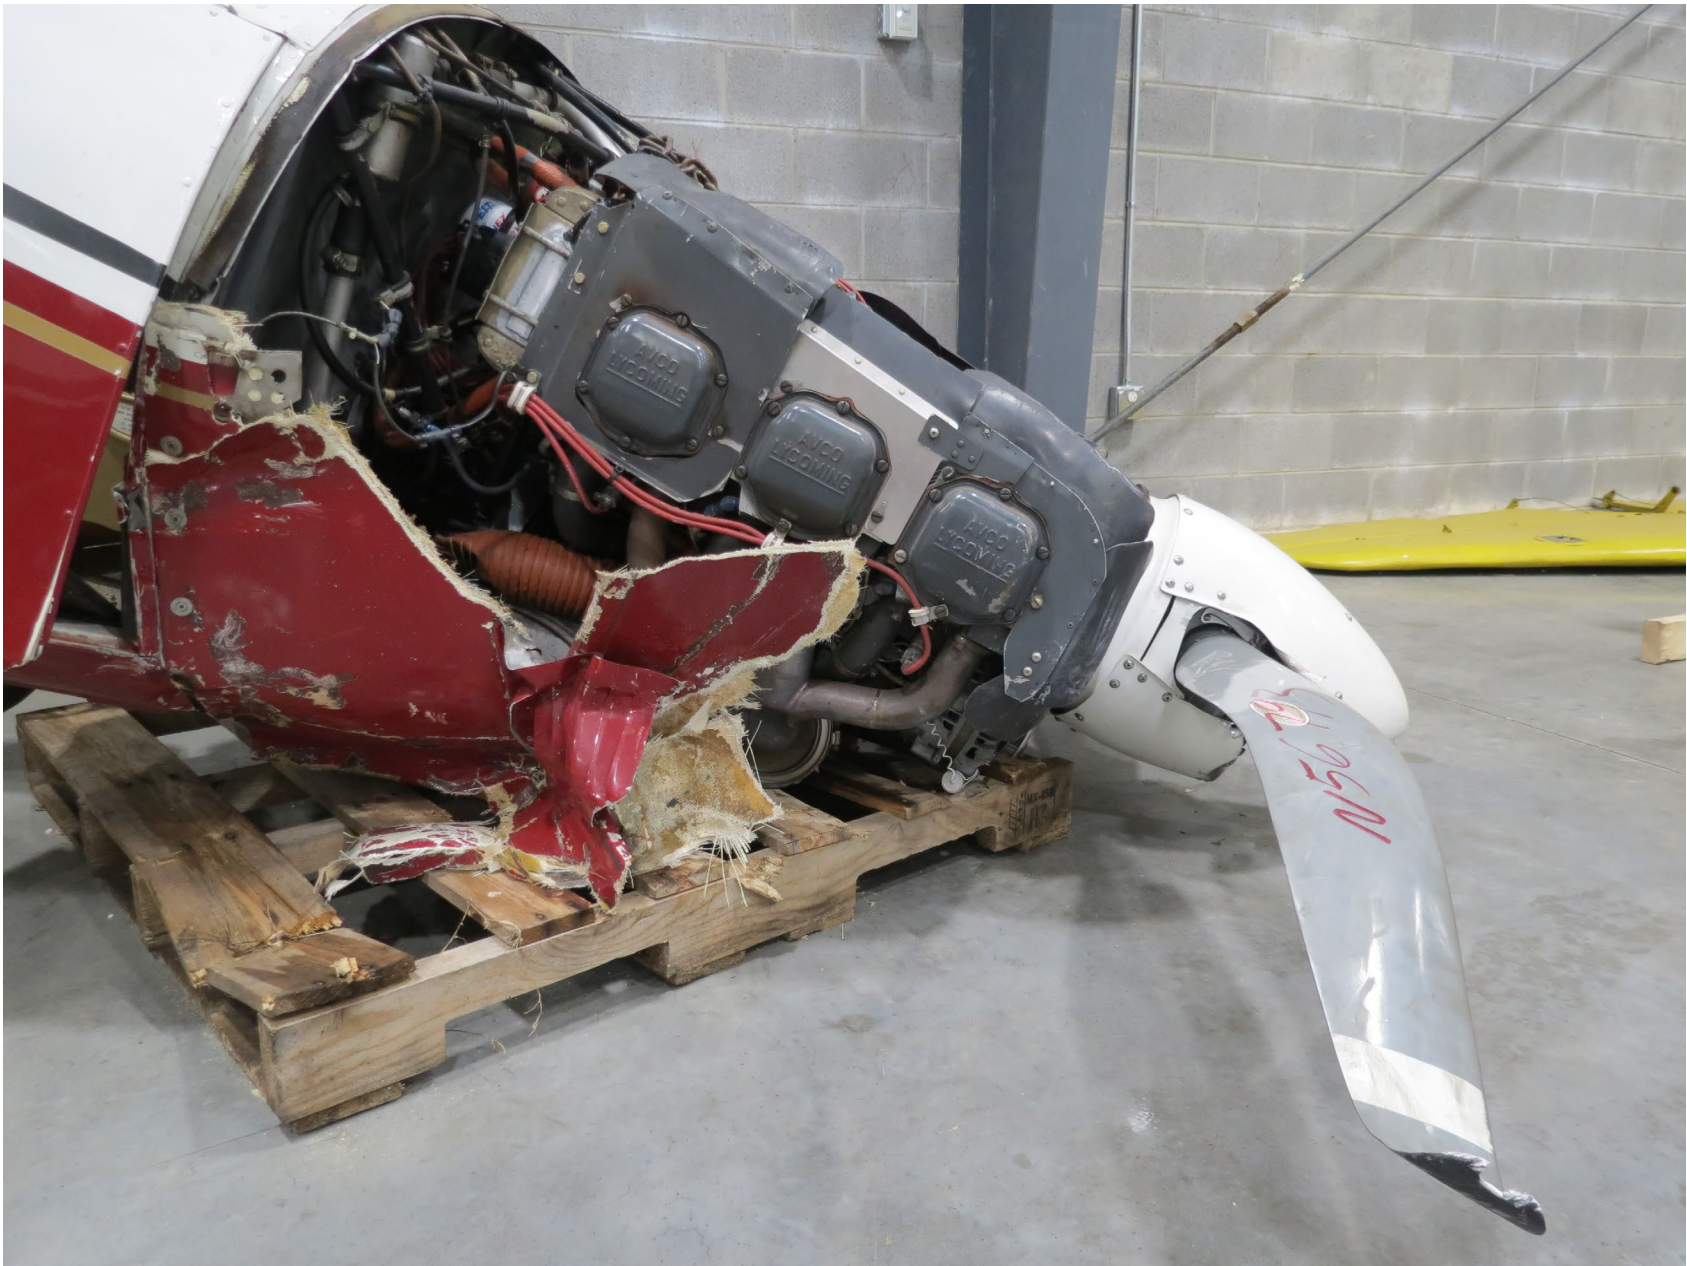
**Photo 11 – View of the right side of the engine during the examination (courtesy of Piper Aircraft).**

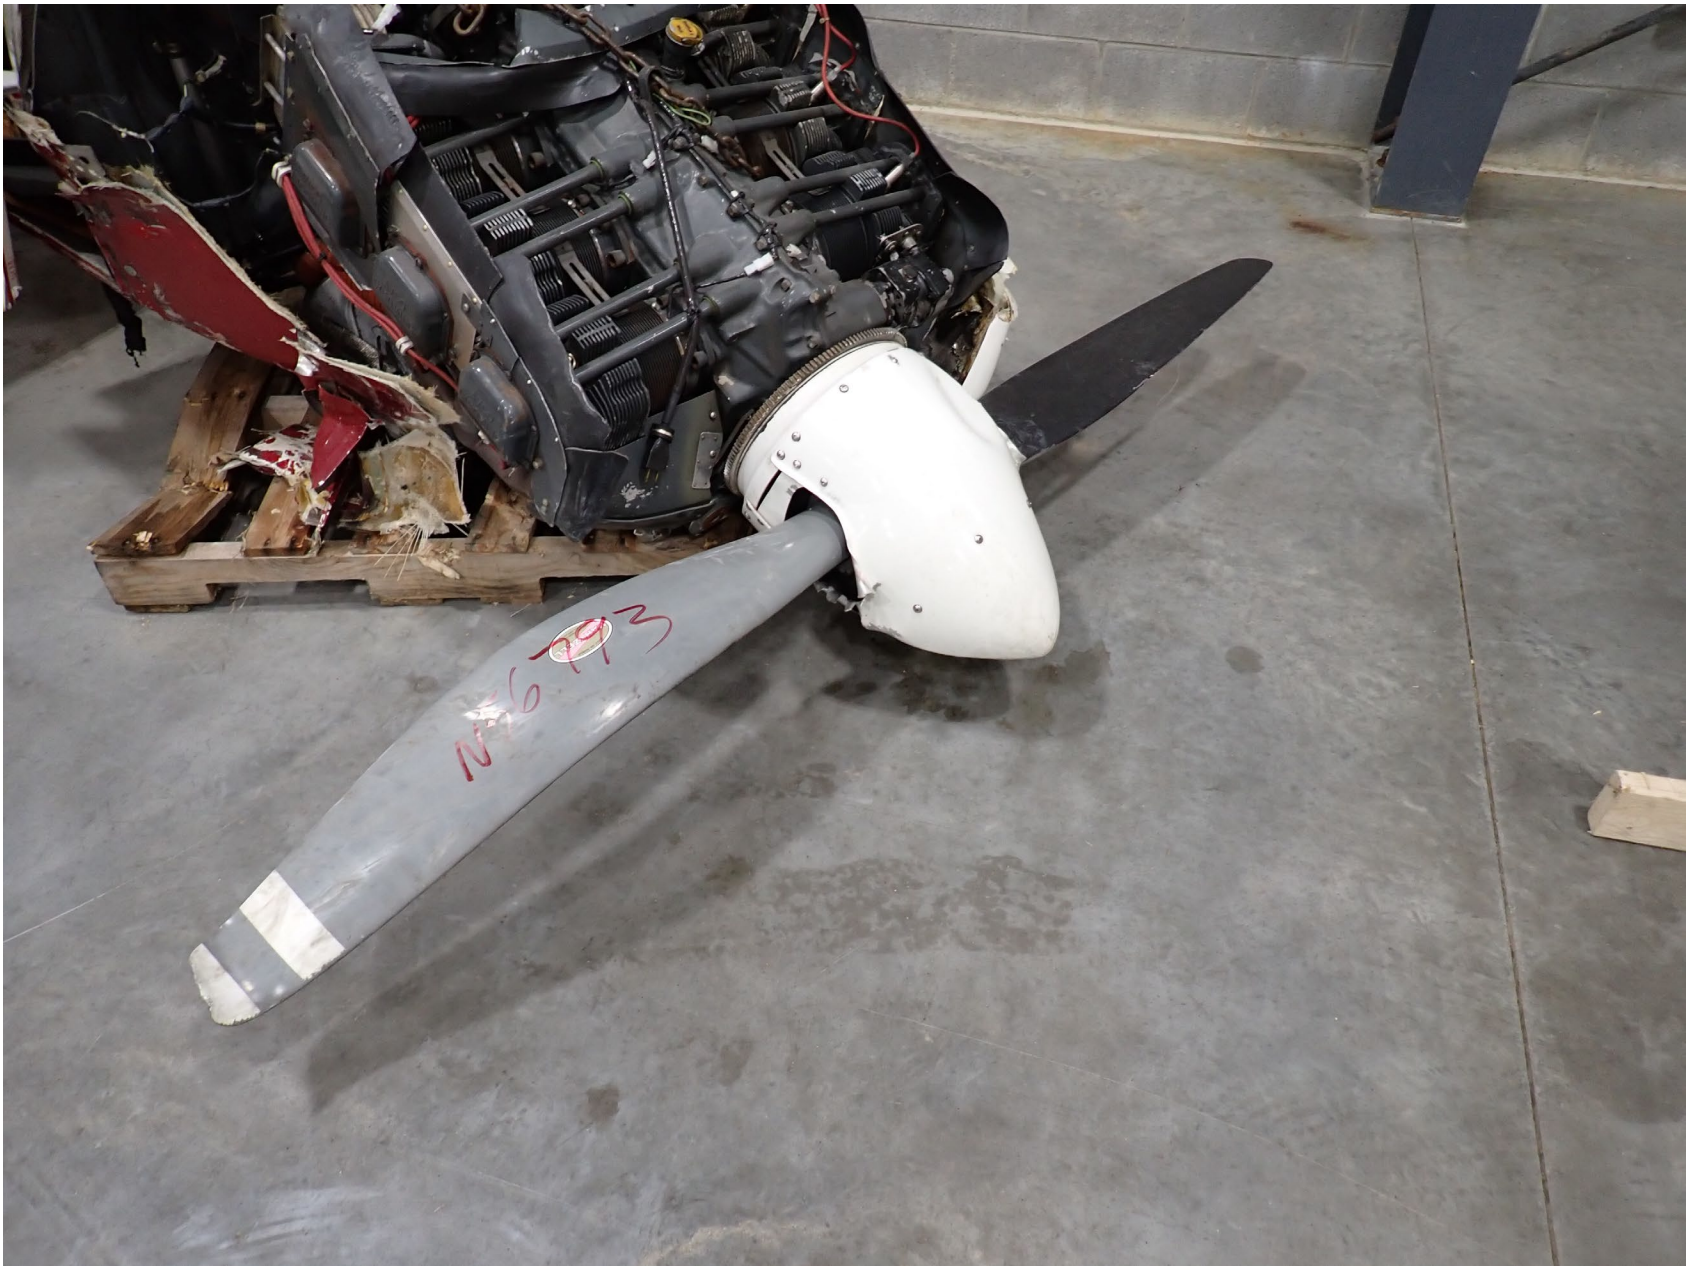
**Photo 12 – View of the propeller during the examination (courtesy of Hartzell Propeller).**

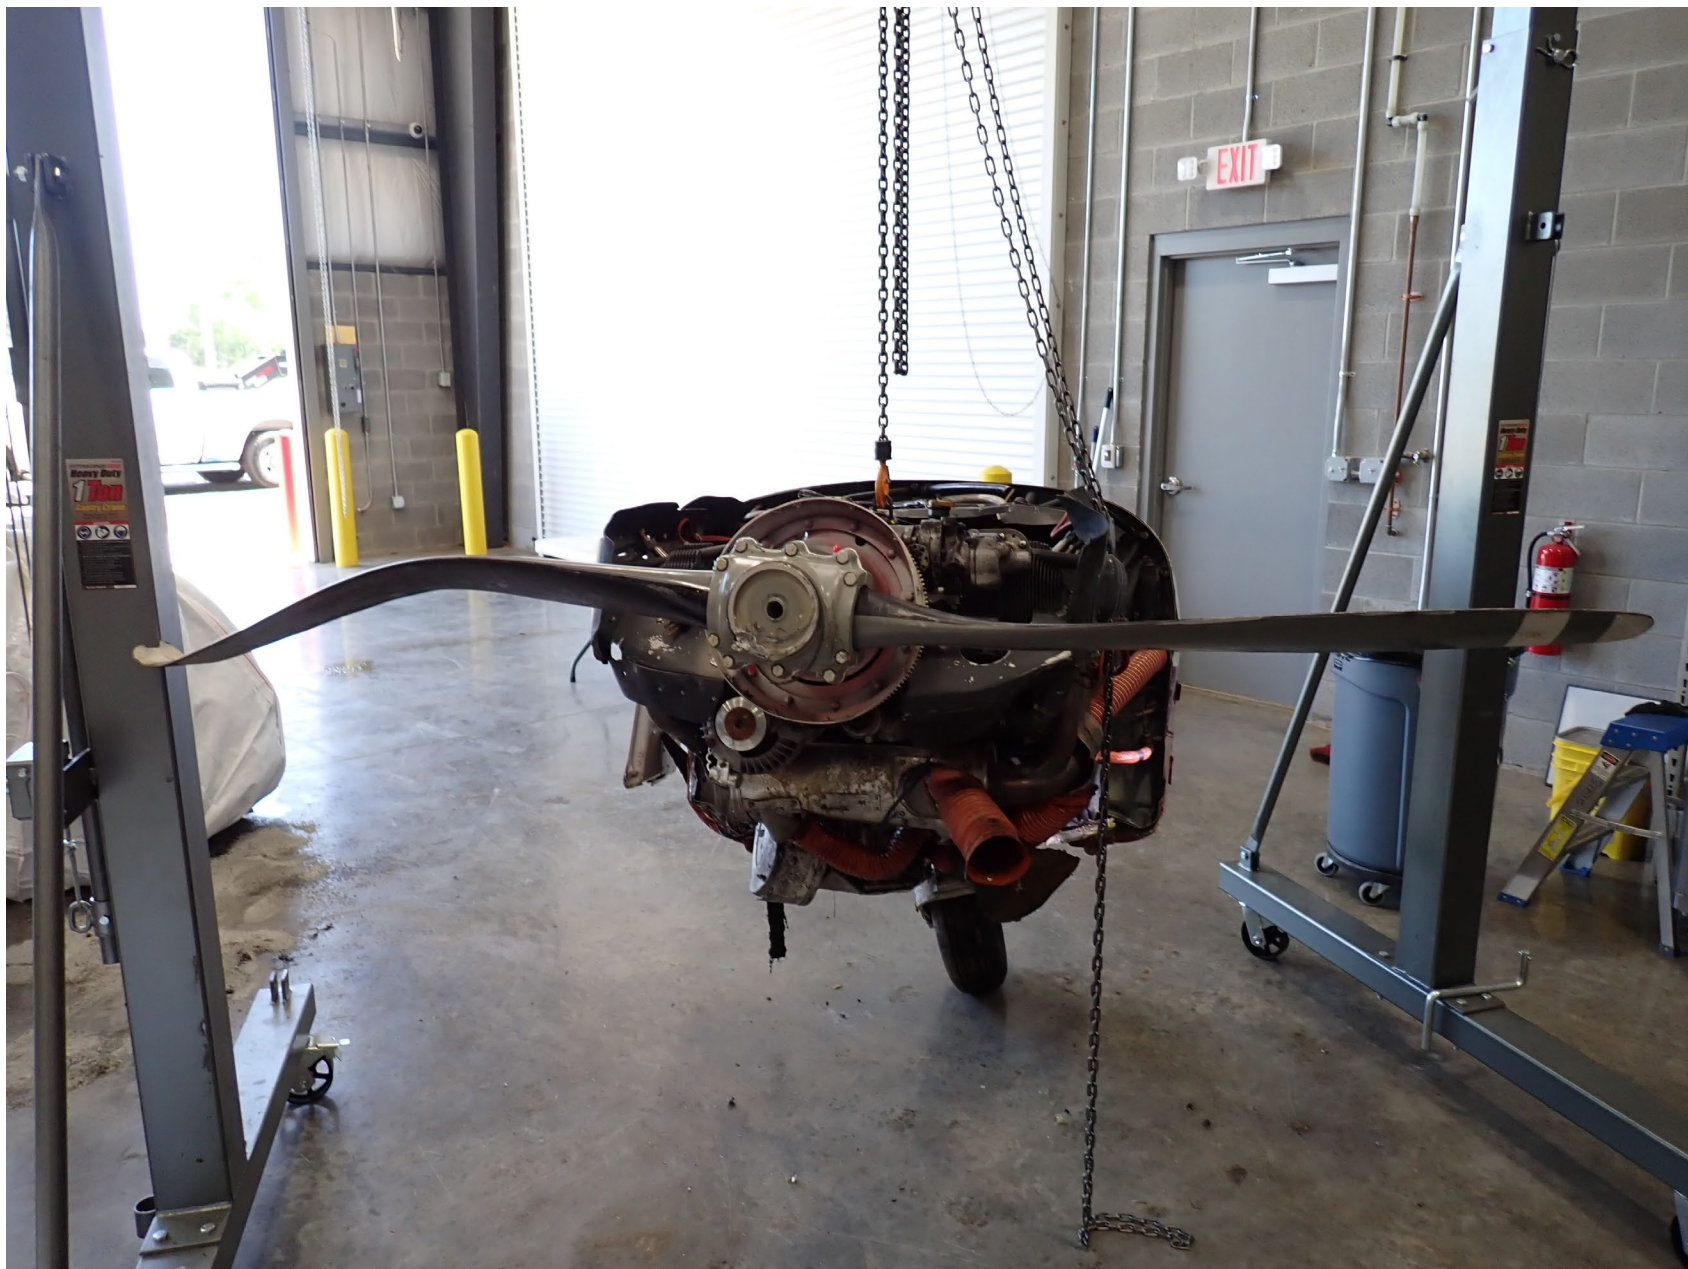
**Photo 13 – View of the propeller during the examination (courtesy of Hartzell Propeller).**

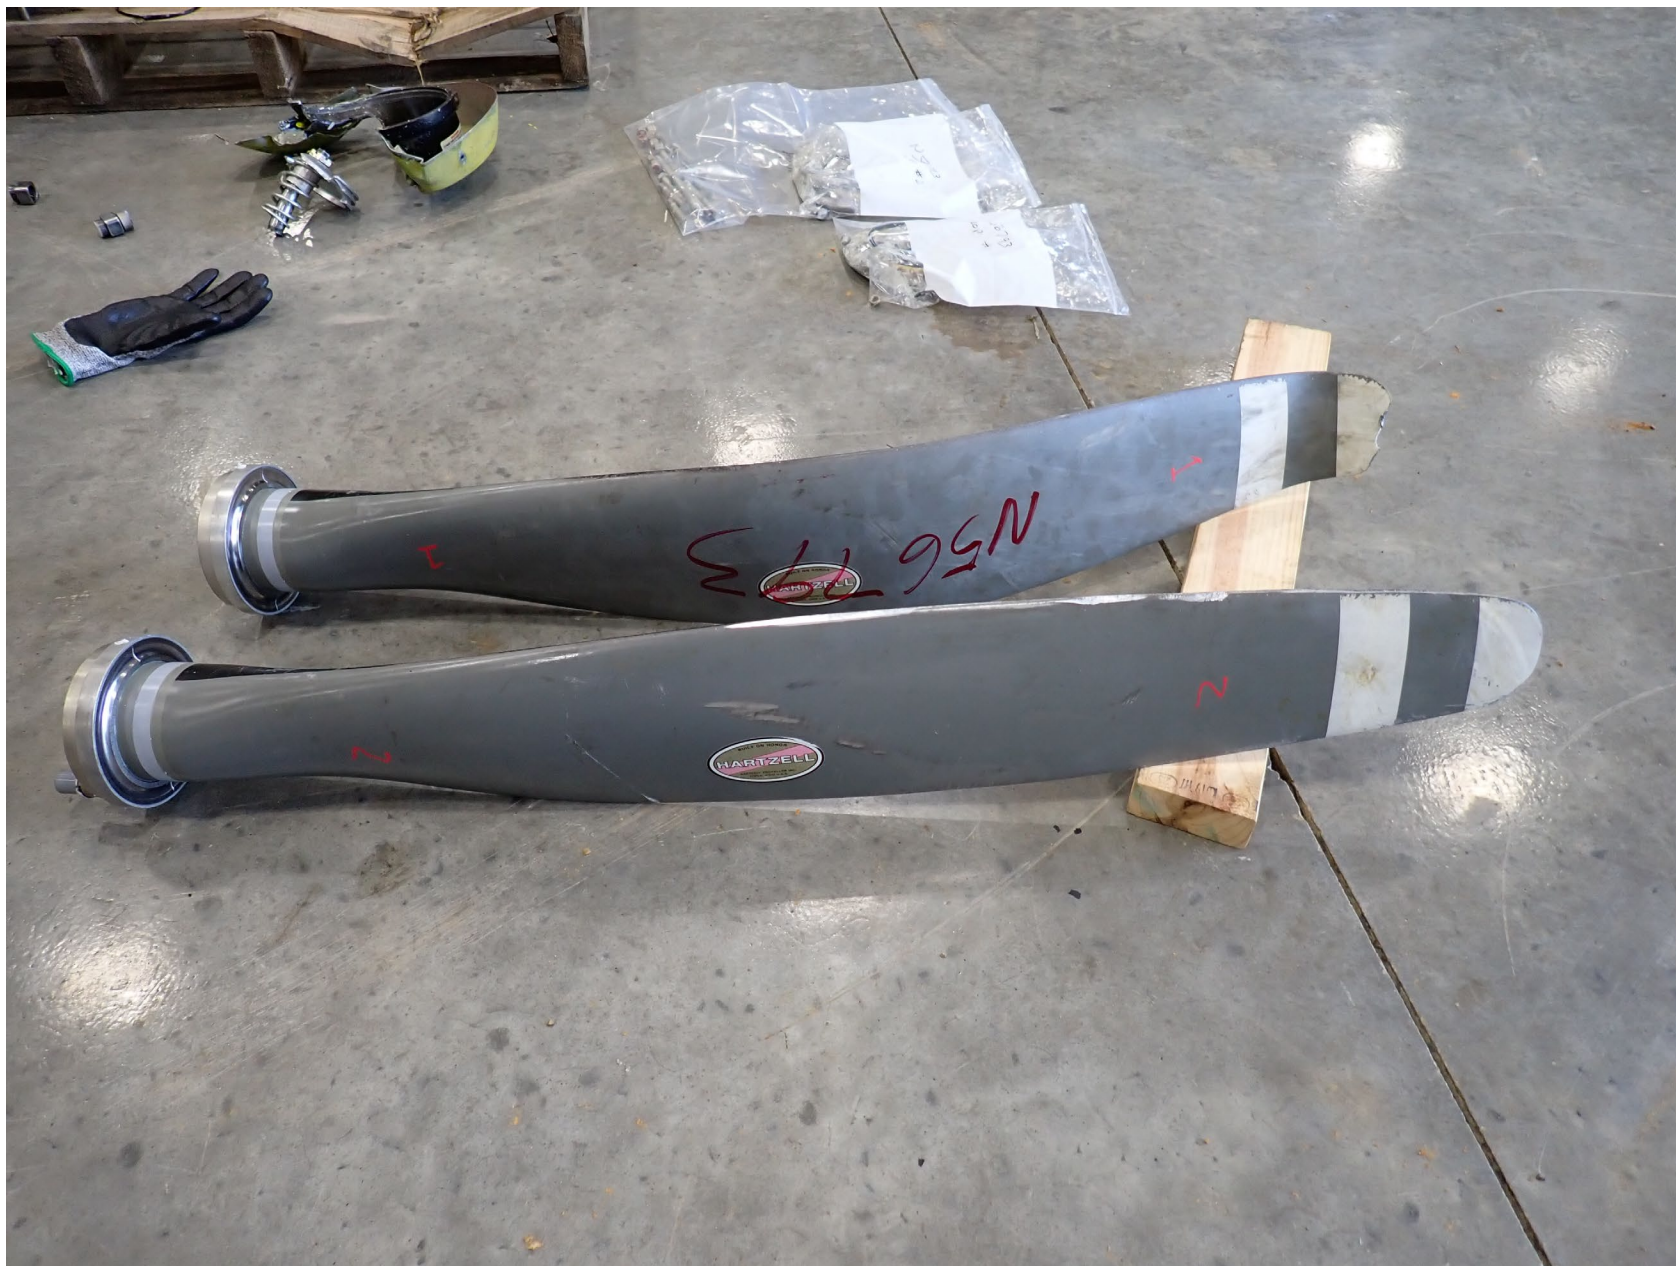
**Photo 14 – View of the propeller blades during the examination (courtesy of Hartzell Propeller).**
