CEN23LA149

## INVESTIGATION PHOTOGRAPHS

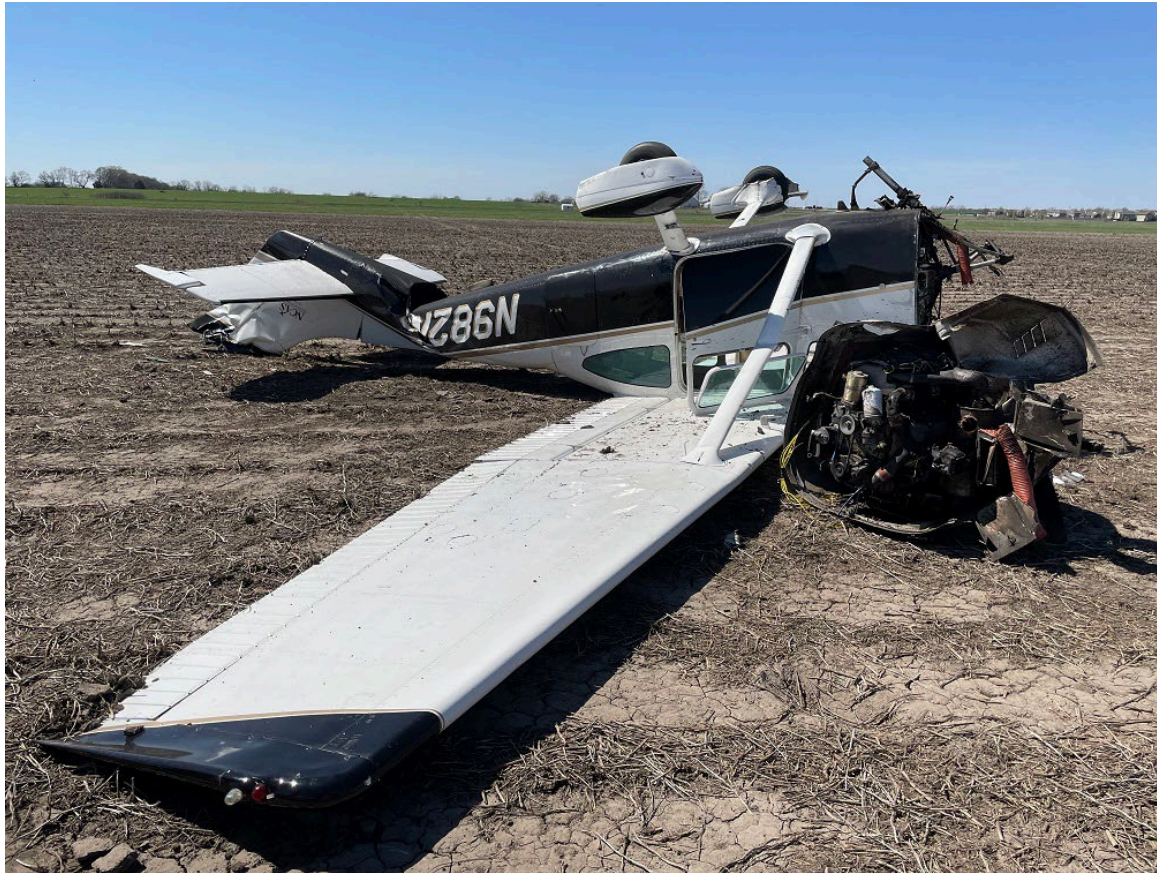
**Photograph 1 - Airplane at accident site (Courtesy of FAA)**

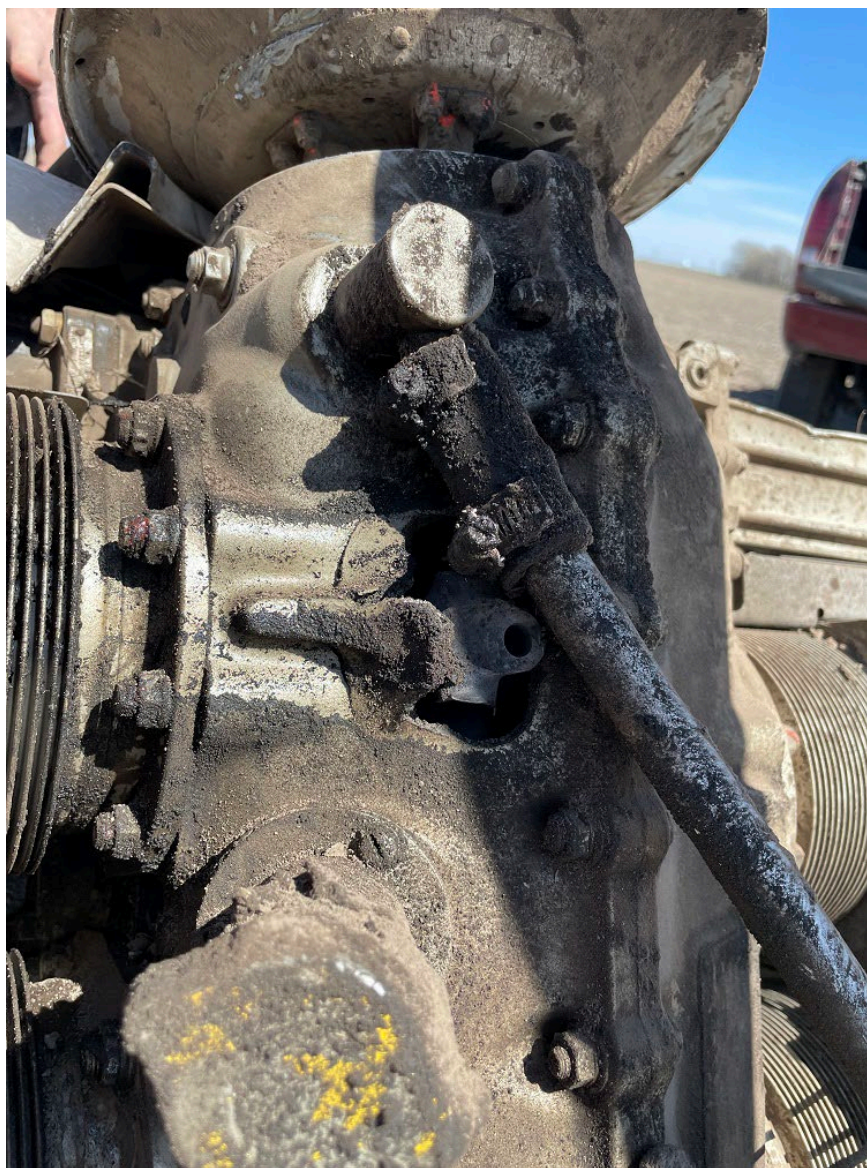
**Photograph 2 - Engine at accident site (Courtesy of FAA)**
