CEN23LA166

## INVESTIGATION PHOTOGRAPHS

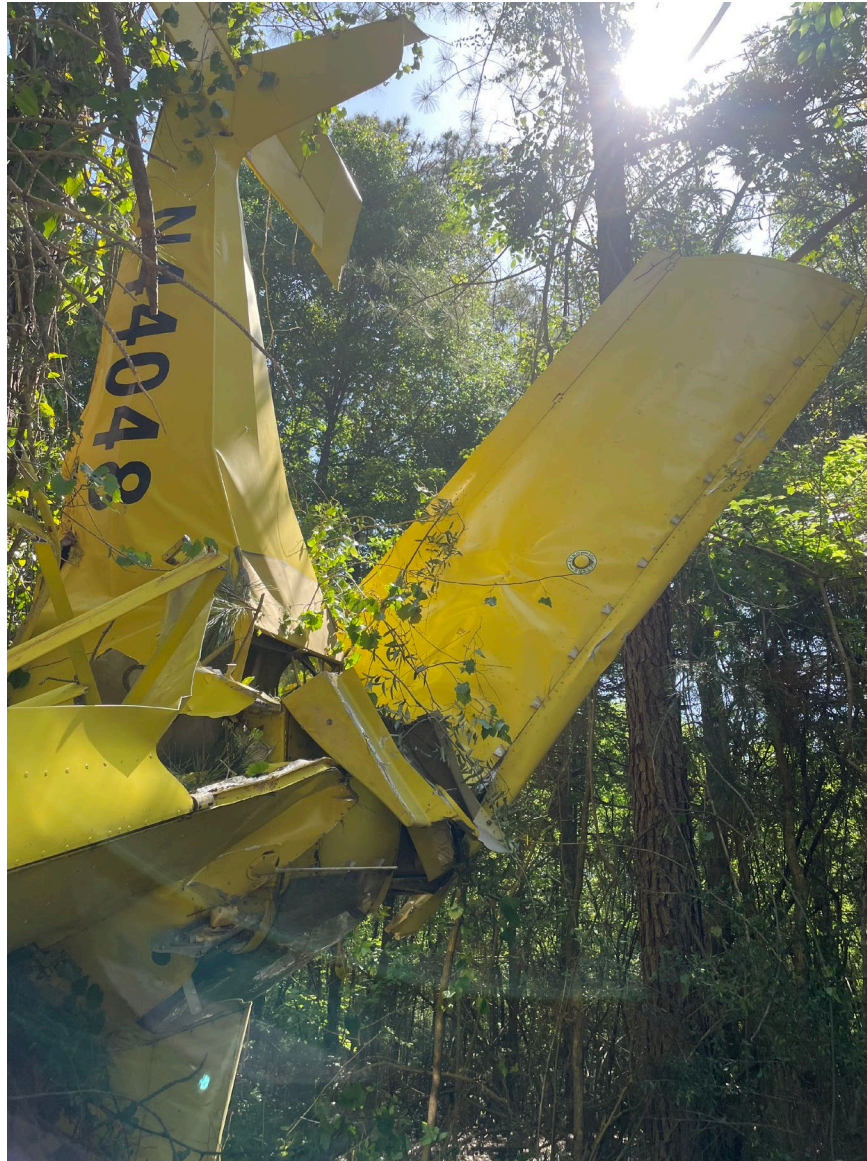
**Photograph 1 - Airplane at accident site (Courtesy of FAA)**

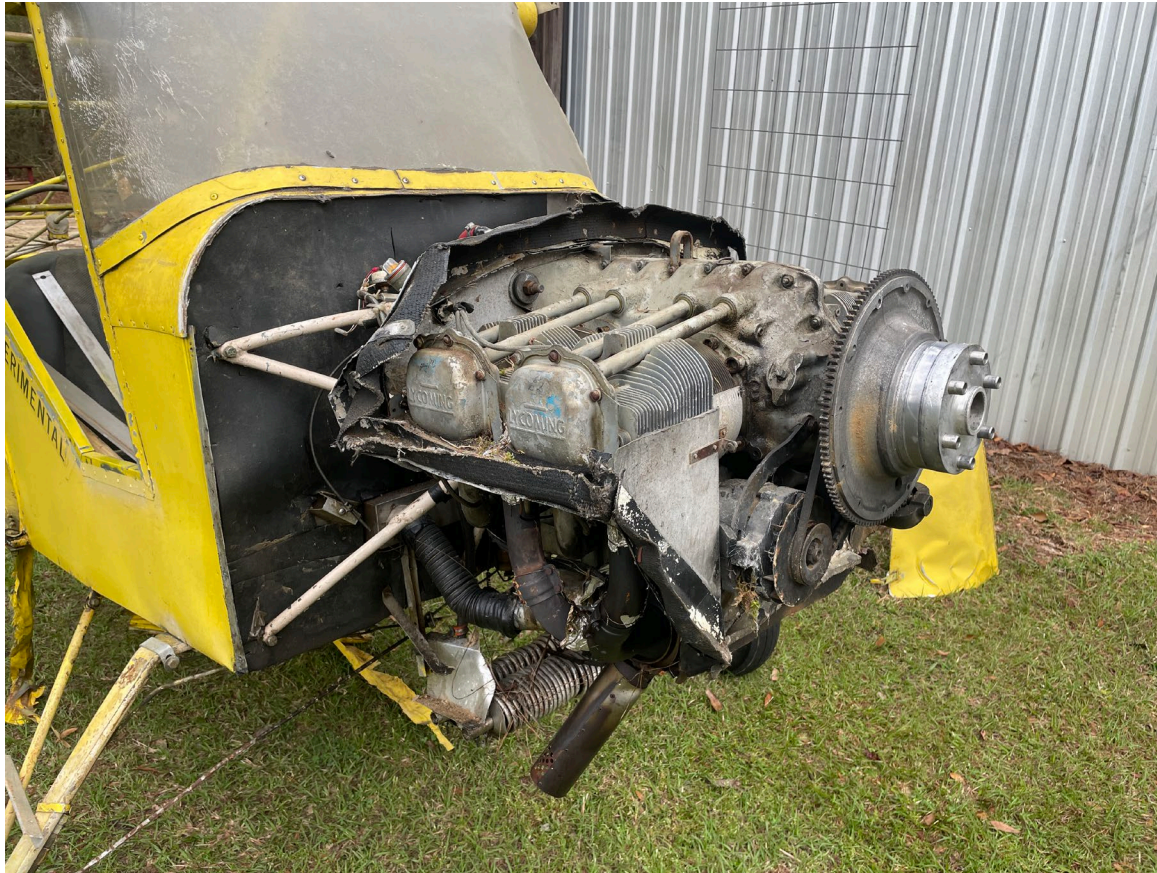
**Photograph 2 - Engine during examination (NTSB Photo)**
