# National Transportation Safety Board

CEN23LA168

## **ENGINE EXAMINATION SUMMARY**

Location: Batesville, Mississippi  
Date: May 1, 2023  
Time: 1345 CDT  
1845 UTC  
Airplane: Cessna 182D - N8713X

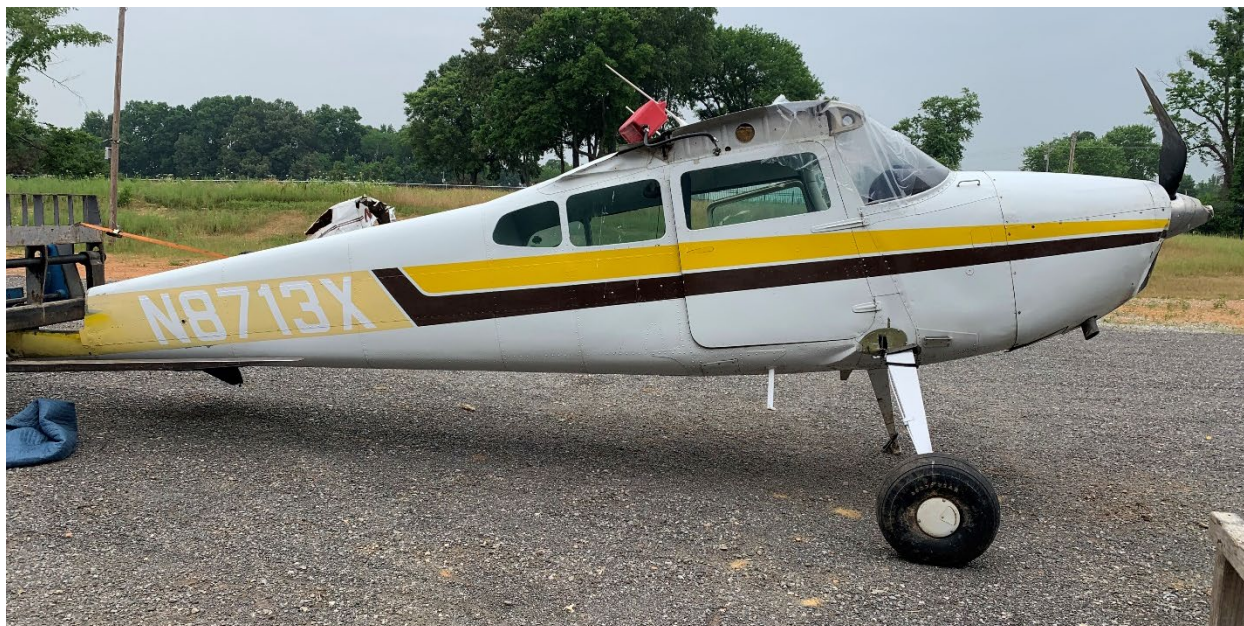
**Figure 1. View of fuselage.**

The fuselage remained intact and was wrinkled. The wings, horizontal stabilizers, elevators, vertical stabilizer, and rudder were removed to facilitate recovery. The right fuel tank finger screen was examined and was not obstructed. The left wing fuel pickup screen was damaged during the recovery, however it was not obstructed.

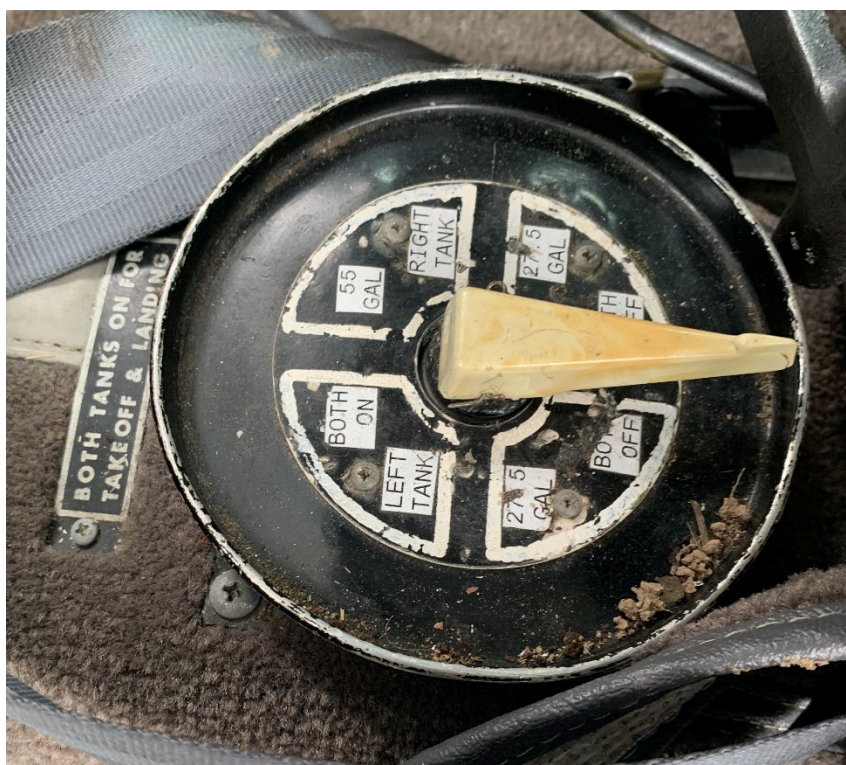
**Figure 2. Fuel Selector.**

The fuel selector was in the off position.

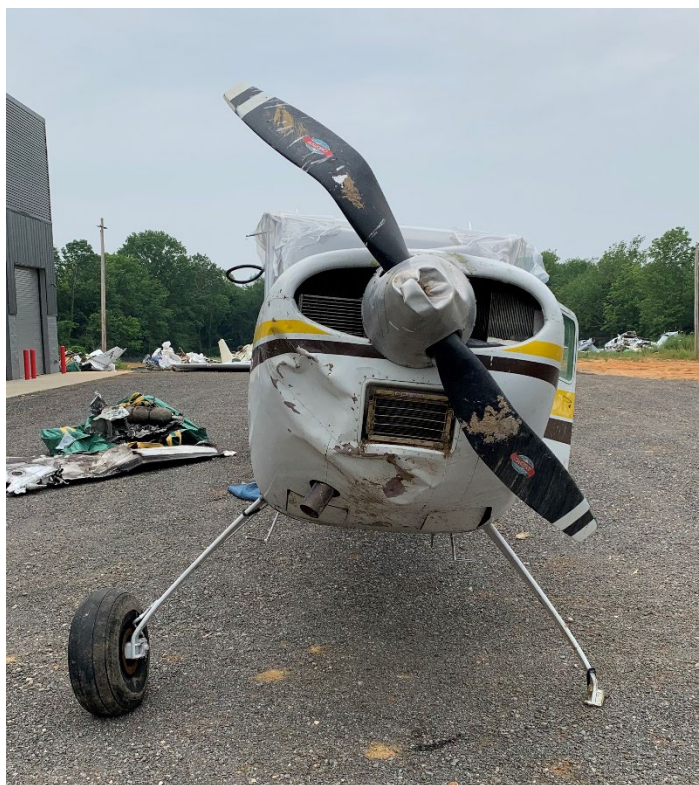
**Figure 3. View of propeller.**

The propeller remained attached to the engine and both blades remained attached to the hub. In addition, both blades were bent aft about 45° and exhibited chordwise scratching.
