# National Transportation Safety Board

CEN23LA170

## **MATERIALS LABORATORY**

Factual Report 23-102

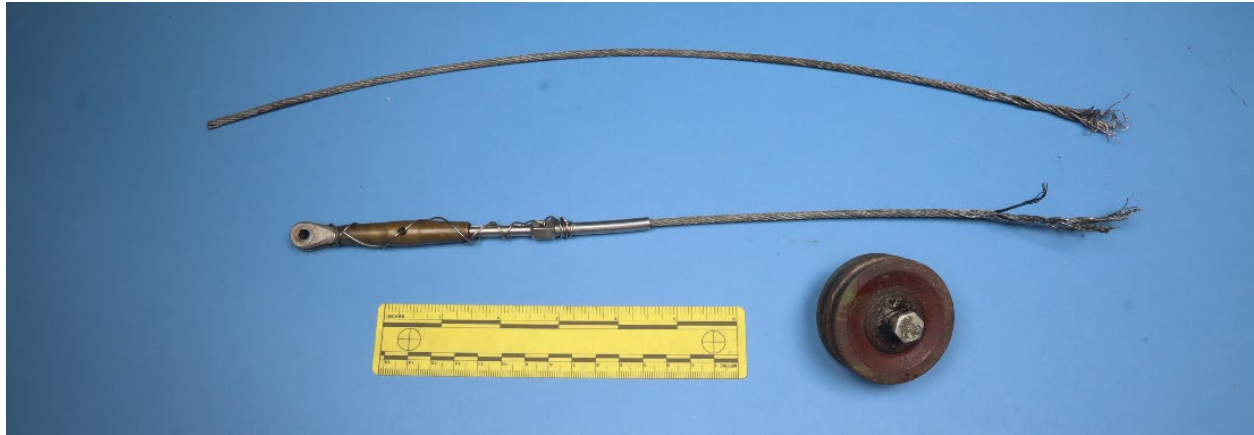
An overall view of the submitted rudder control cable pieces and the two pulleys with attachment hardware are shown as received in figure 1. The cable was fractured approximately 12 inches from the clevis fitting attachment holes on the turnbuckle. The pulleys were intact and had a 2 inch outside diameter.

**Figure 1.** Overall view of the submitted cable pieces and pulleys.

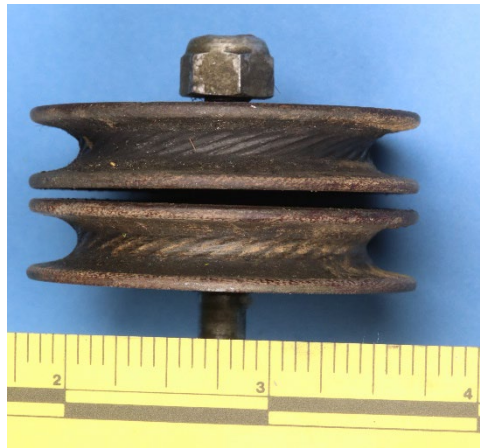
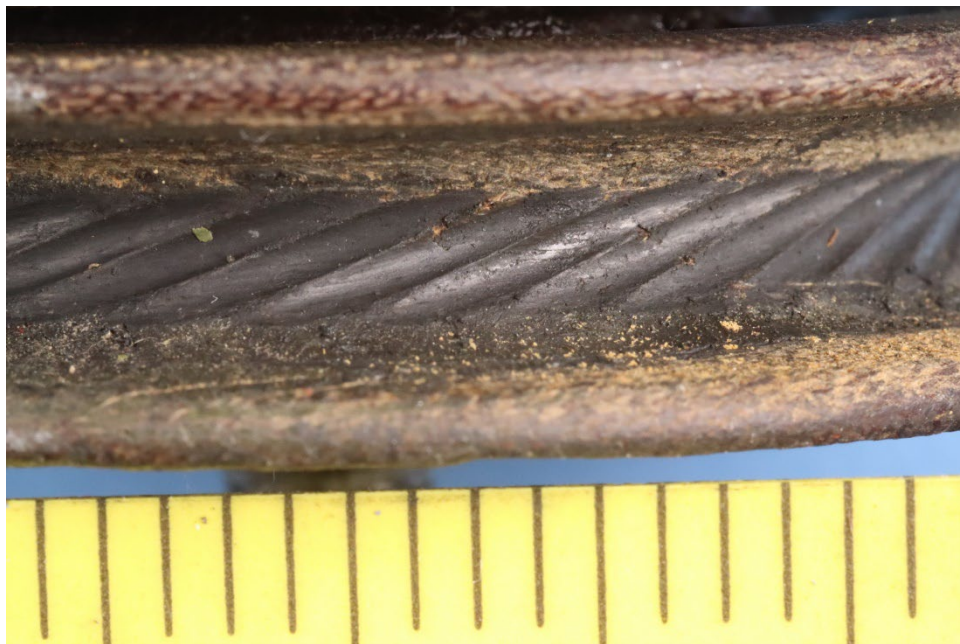
The pulley on the nut side of the pair had relatively deep cable wear marks on the bottom of the groove as shown in figure 2. The wear extended around the circumference of the pulley. The pulley on the bolt head side of the assembly had relatively shallower wear marks that were present around half the circumference of the pulley.

**Figure 2.** View of the pulley grooves (upper image) with a closer look at cable wear impressions in the bottom of the groove in the pulley closer to the nut (lower image).

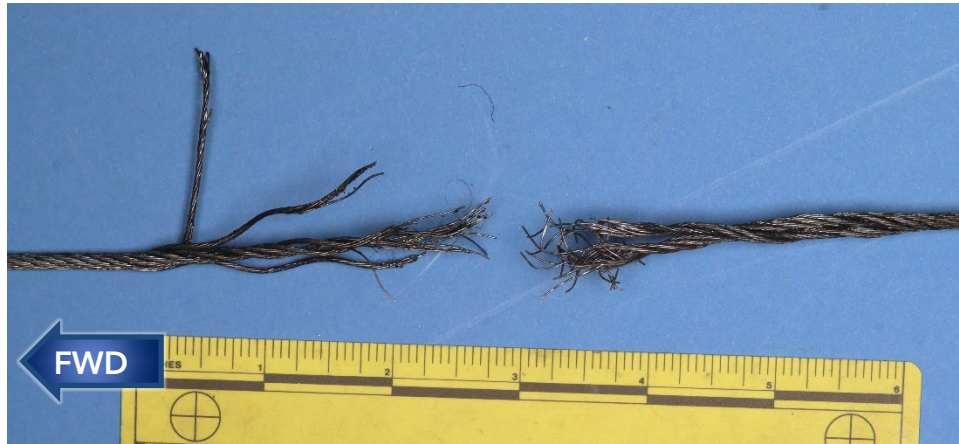
A close view of the mating fractured ends of the rudder cable are shown in figure 3. The fracture locations of wires in each strand were located in close proximity to each other lengthwise. The cable surfaces were generally covered with grease. To facilitate a closer examination of the fractures and the adjacent cable surfaces, the forward side of the fracture (closer to the turnbuckle end) was selected for additional cleaning and examination.

**Figure 3.** Closer view of the fractured cable ends.

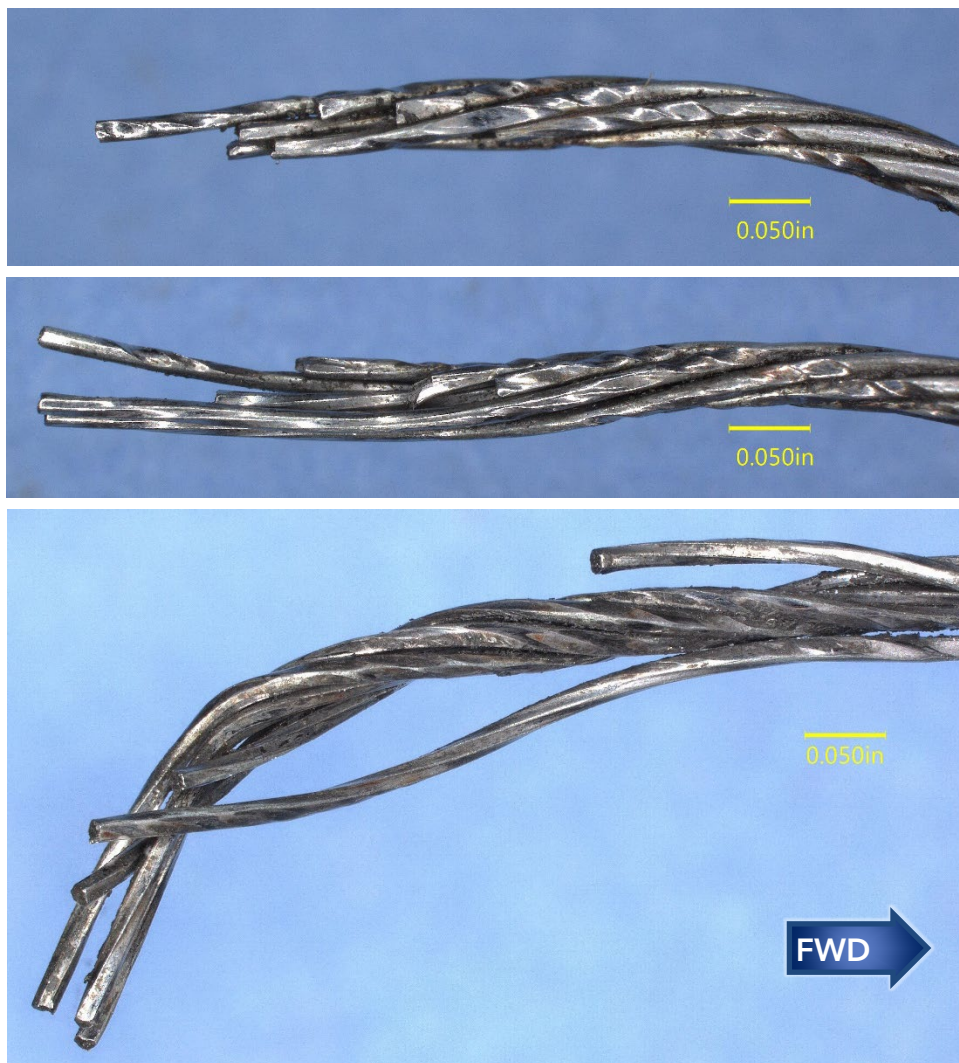
Representative optical images of the fractured ends of the cleaned and separated strands are shown in figure 4. The sides of the strands had relatively deep grooves across the wires consistent with wear contact with wires on adjacent strands. The individual wires were fractured within the distance of one lay, and most showed flat fracture features in a plane perpendicular to the wire axis, features consistent with fatigue.

**Figure 4.** Images of the fractured ends of individual strands showing two representative outer strands (upper and middle images) and the core strand (lower image) obtained using a Keyence VHX-7000 optical microscope in depth mode.

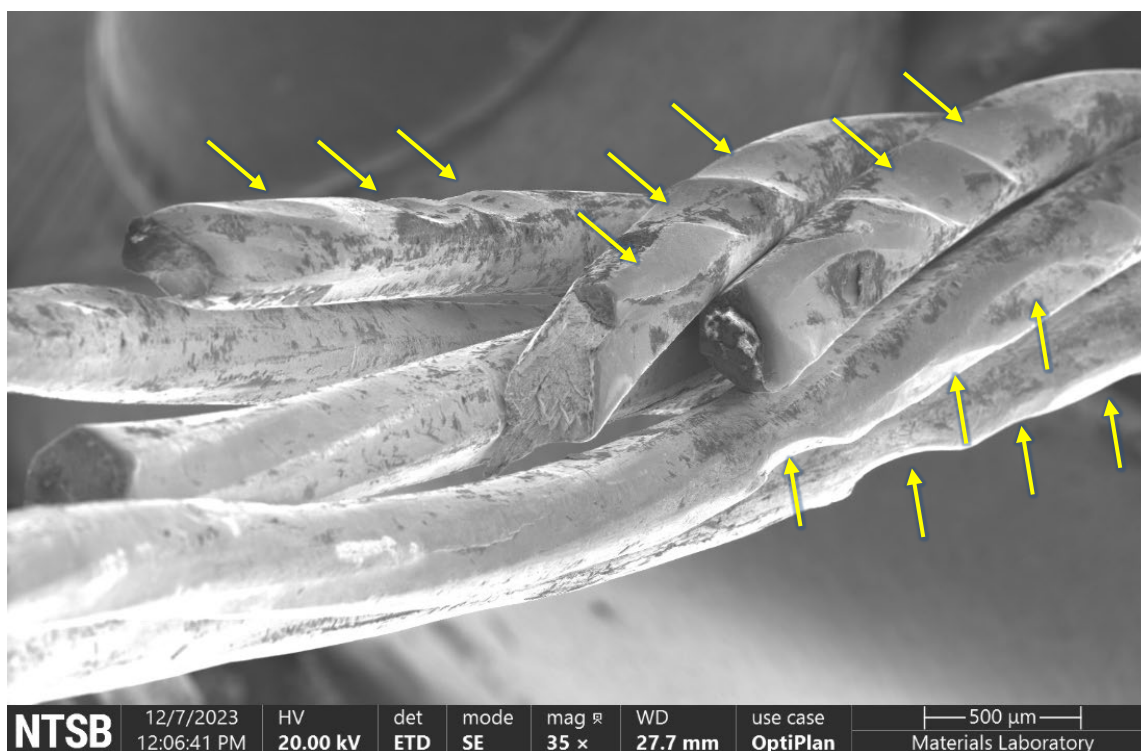
Next, the forward cable piece was cut just forward of the splayed end to facilitate an examination using a scanning electron microscope (SEM). The splayed end was then submerged in acetone and cleaned using an ultrasonic cleaner. A representative SEM image of an outer strand is shown in figure 5. Arrows in figure 5 point to wear grooves corresponding to wear contact with wires on adjacent strands. In some areas, the wear appeared to extend through approximately half the cross-section.

**Figure 5.** Representative SEM image of an outer strand showing extensive wear damage and fractured wires. Arrows point to wear grooves corresponding to contact with wires on adjacent strands.

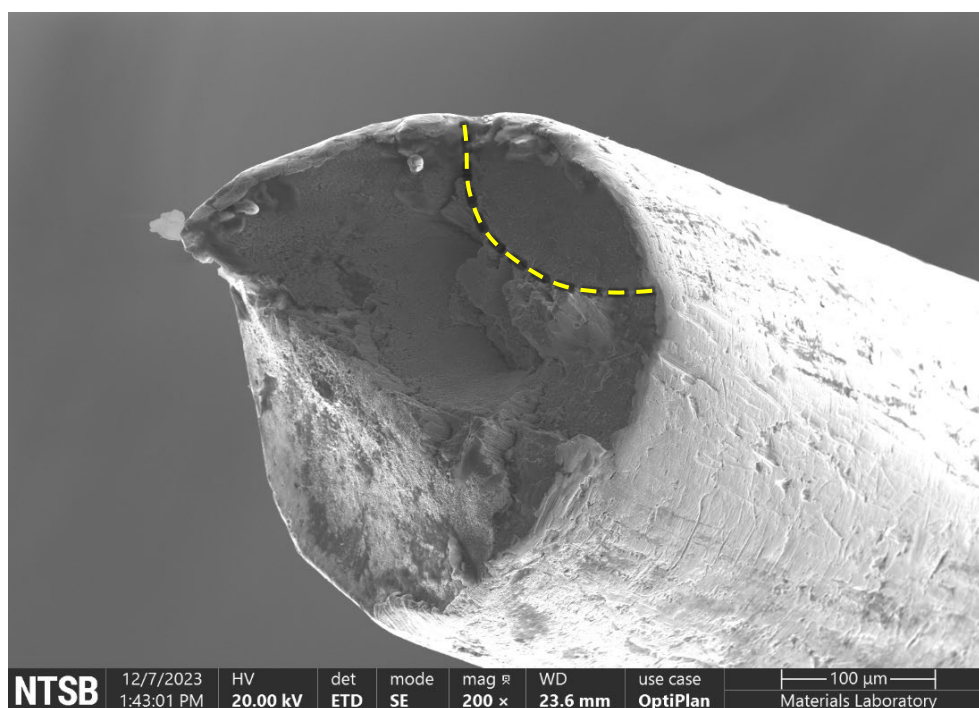
Representative SEM images of individual wire fracture features are shown in figures 6 through 9. Forty-eight of the 49 individual wires were examined. In many cases, fine fracture features were obscured by residual grease deposits, oxidation, and post-fracture rubbing damage. Direct viewing of the fracture for some wires was also limited by the orientation of the strand in the fixture. However, 83% of the wires had a flat region perpendicular to the wire axis, features consistent with fatigue, extending across 10 to 100 percent of the cross-section. Some of the flat regions had distinct curving boundaries such as the wire with one of the smaller fatigue regions shown in figure 6. Two wires showed clear evidence of reverse bending fatigue such as the wire shown in figure 7. Sixteen wires, including 3 from the core strand and 1 to 4 wires in each of the outer strands, had flat regions consistent with fatigue across the entire cross section such as the wire shown in figure 8. Eight wires, consisting of 1 to 3 wires in 4 of the outer strands, had rough features on slant planes with necking deformation features consistent with ductile overstress fracture. One of the wires with ductile overstress fracture features is shown in figure 9.

**Figure 6.** Representative SEM image of a wire with a fatigue region that extended across a fraction of the fracture surface. A dashed line indicates the fatigue boundary.

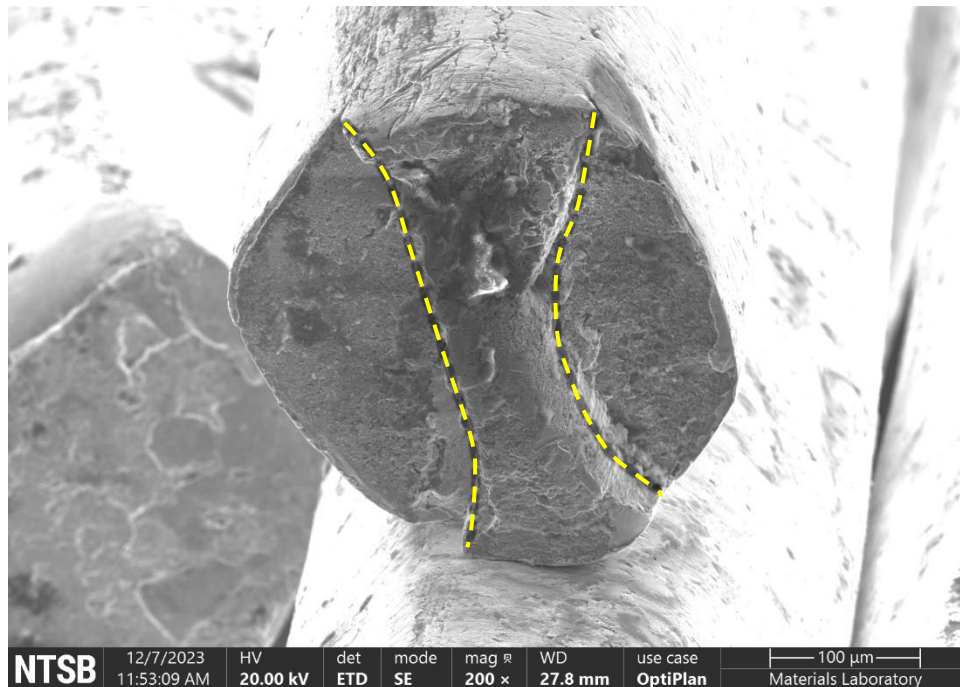
**Figure 7.** Representative SEM image of a wire with fatigue regions on opposite sides of the wire consistent with reverse bending fatigue. Dashed lines indicate the fatigue boundaries.

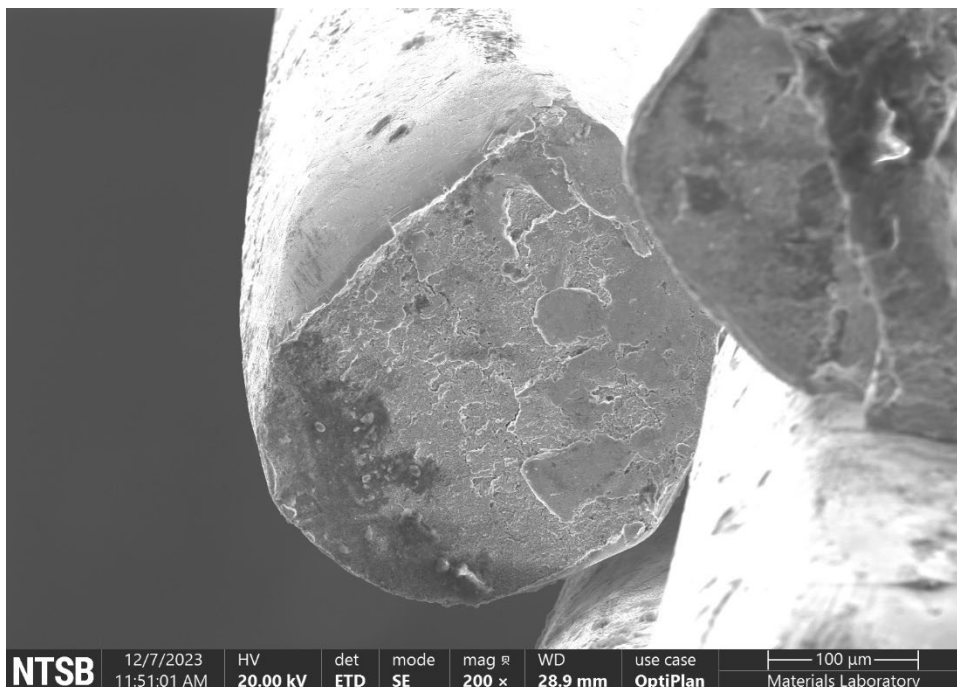
**Figure 8.** Example of a wire fracture with flat fracture features perpendicular to the wire axis across the fracture with no necking deformation.

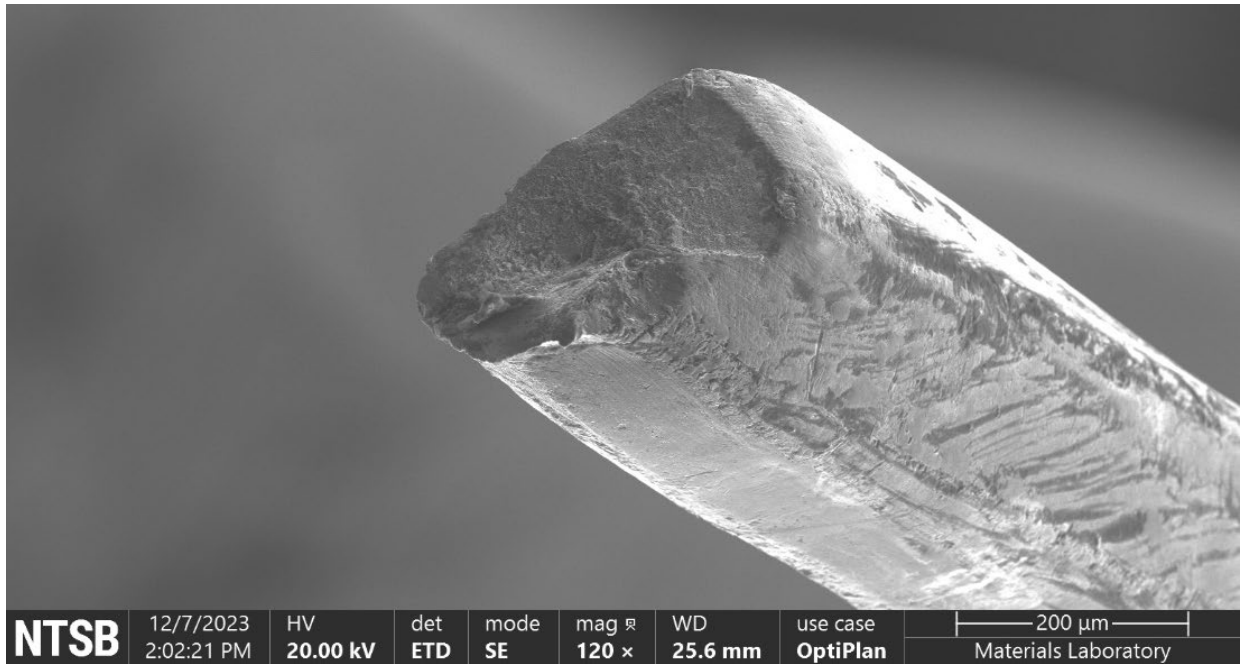
**Figure 9.** Representative SEM image of a wire with ductile overstress fracture features.
