CEN23LA170

## INVESTIGATION PHOTOGRAPHS

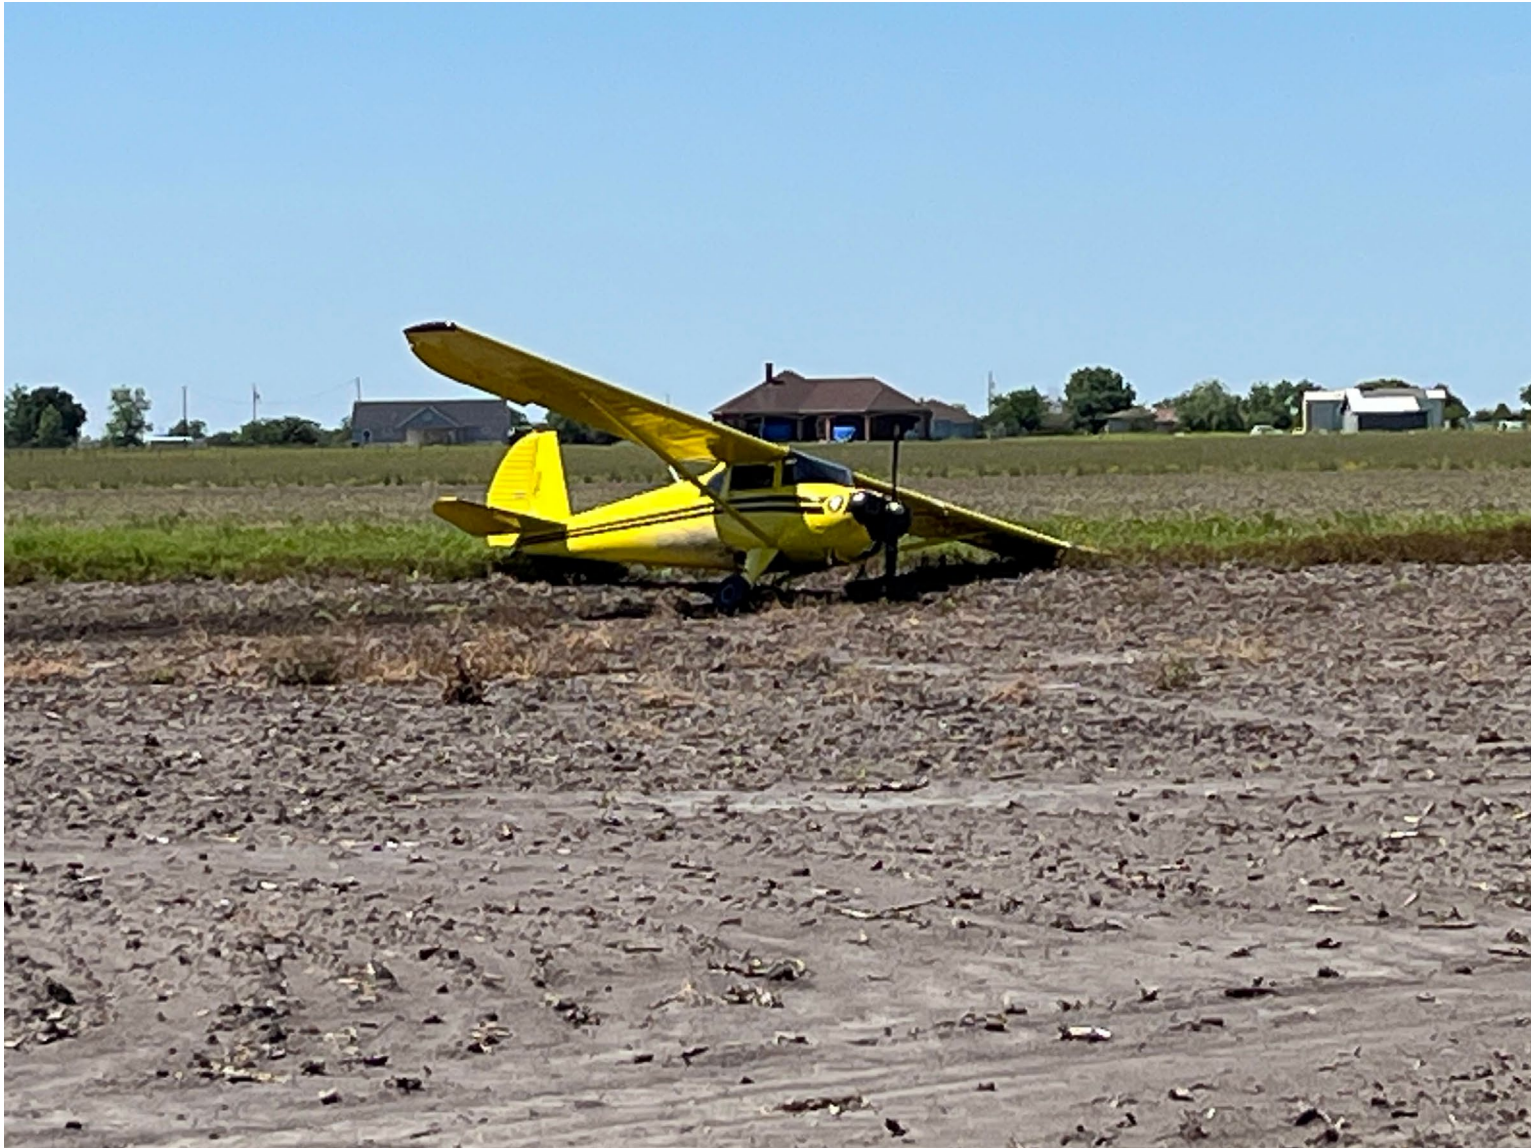
**Photograph 1 - Accident Airplane Overview (Courtesy of airplane owner)**

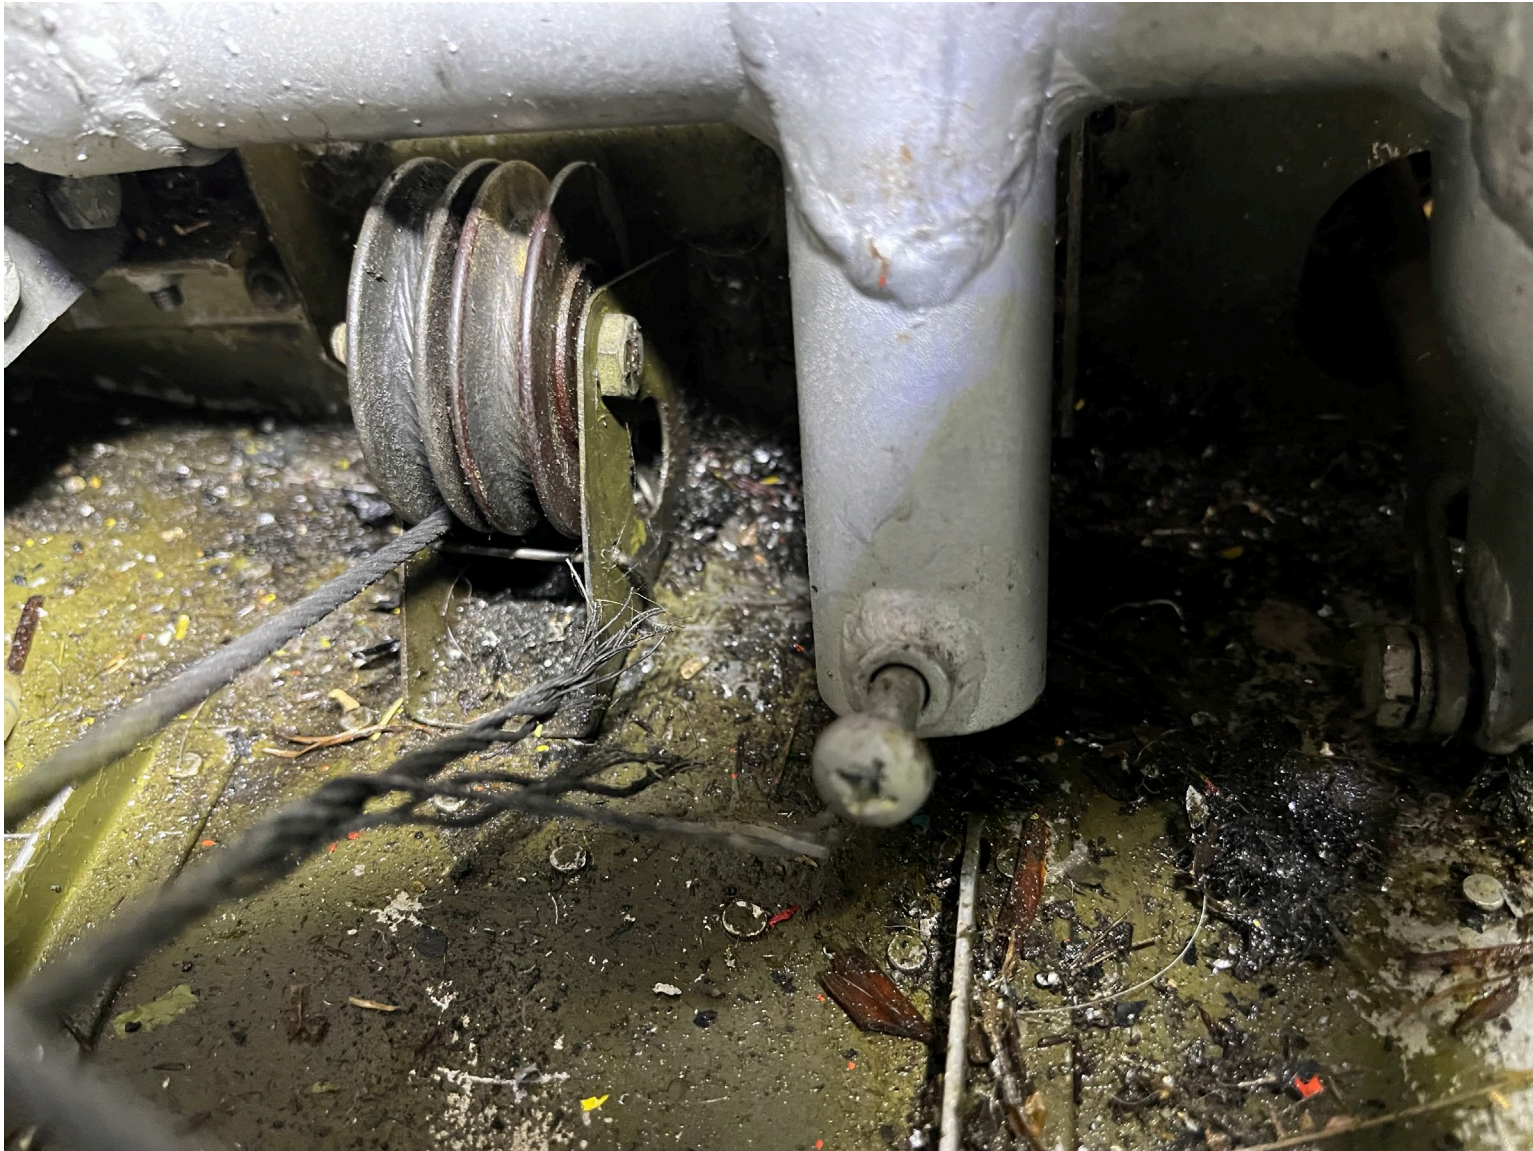
**Photograph 2 - Broken Left Rudder Cable at the Pulley (Courtesy of Federal Aviation Administration)**

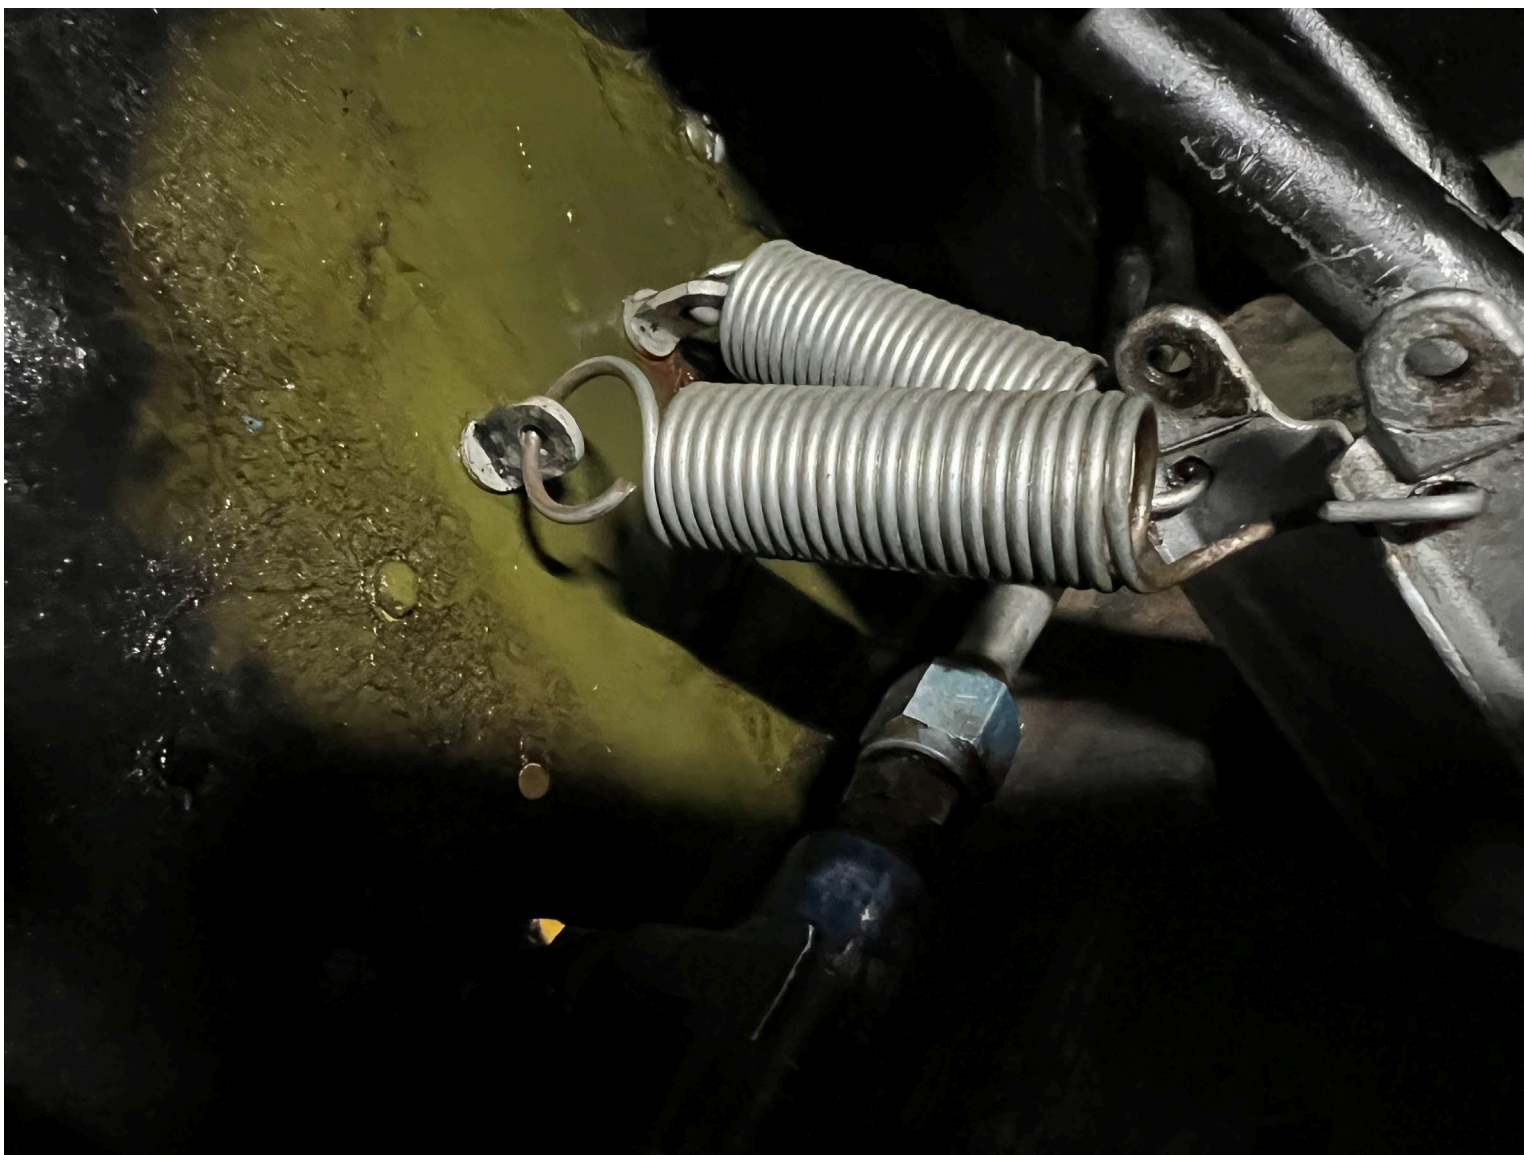
**Photograph 3 - Rudder Return Springs with Missing Part on Left Spring (Courtesy of Federal Aviation Administration)**

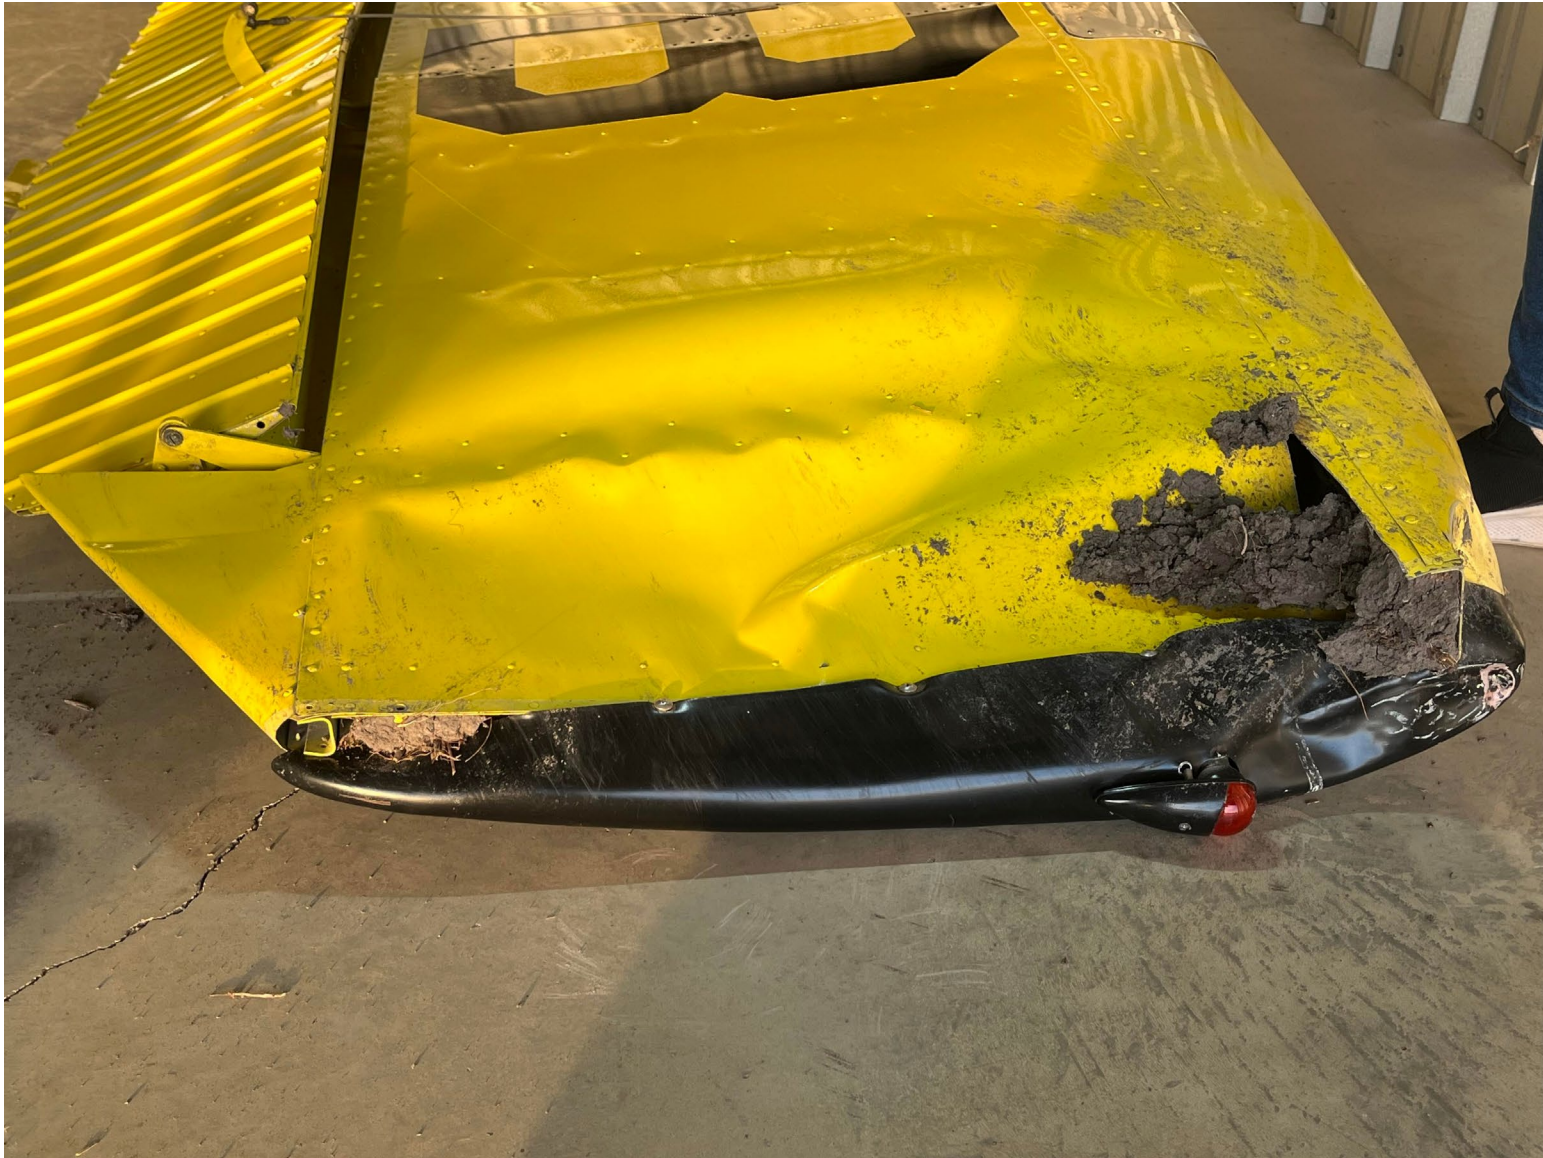
**Photograph 4 - Left Wing Damage (Courtesy of airplane owner)**
