# National Transportation Safety Board

CEN23LA170

## EXAMINATION SUMMARY

Location: Palmer, Texas  
Date: April 30, 2023  
Time: 1450 LCL  
1950 UTC  
Airplane: N1113B, Luscombe Series 8F, S/N 5740

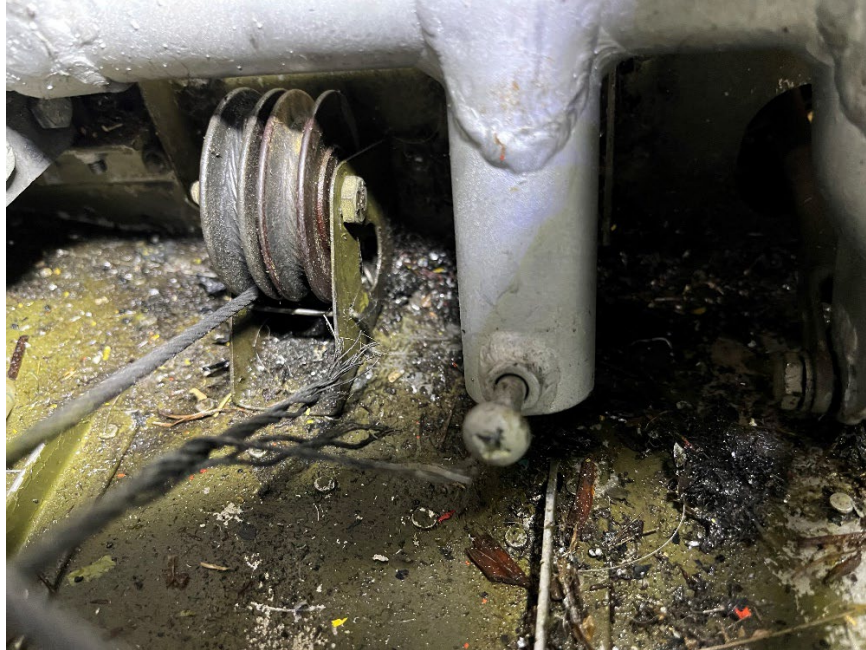
The left rudder cable was inspected and found to be separated and frayed with a bird cage appearance at the pulley located under the cabin floor. The cable was removed from the rudder pedal assembly to the failure point and the failure point aft about 1 ft. The cable was separated aft of the failure point with a cable cutter and wrapped to protect from unraveling. The left rudder cable pulley rotated smoothly when moved by hand. No areas of cable to fuselage rub were observed along the entire length of the cable.

Figure 1. Left Rudder Cable failure point.

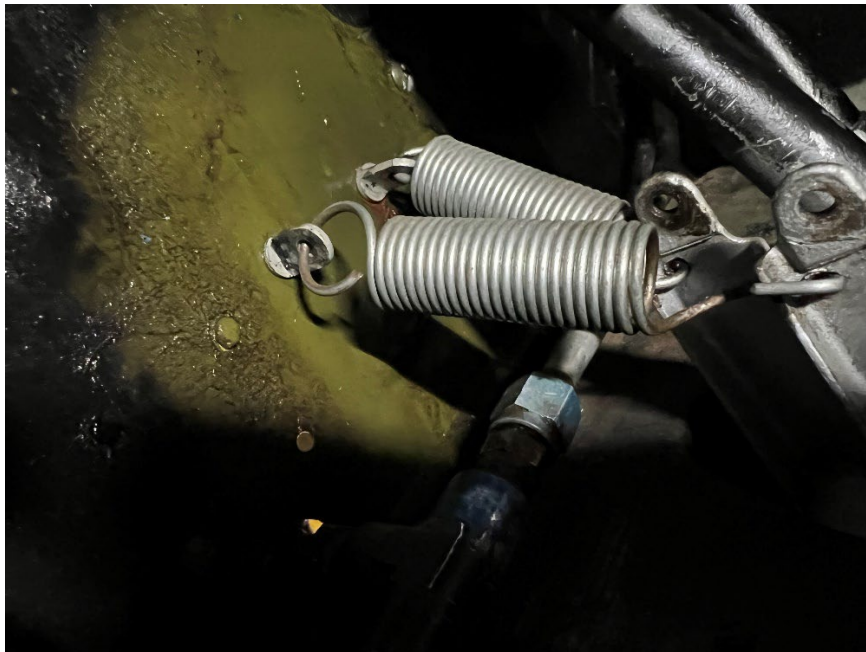
Further inspection of the rudder system showed that the left rudder return spring was missing the rudder attach link between the spring and firewall.

Figure 2. Rudder Return Springs. Left Rudder is the forward spring.
