# National Transportation Safety Board

CEN23LA188

Factual Report 23-107

Location: Flower Mound, Texas  
Date: May 16, 2023  
Vehicle: Cessna 172N, N5550J  
Investigator: Jason Aguilera (AS-CEN)

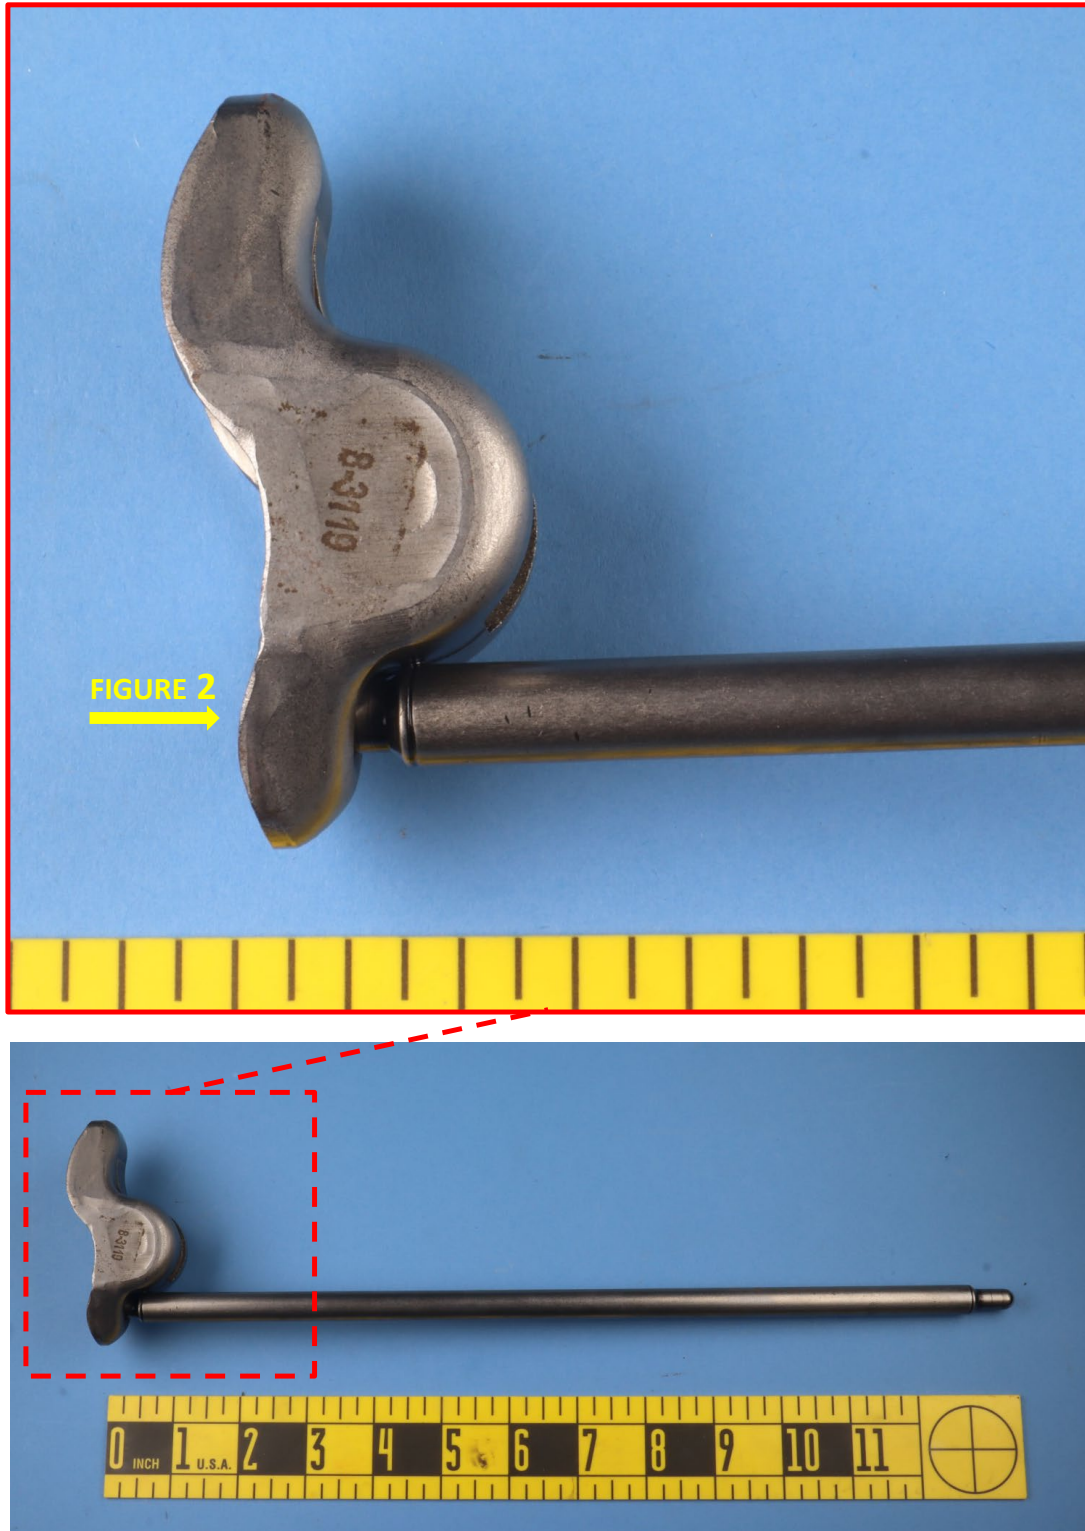
A rocker arm from a Lycoming O-320 engine installed on the subject aircraft was submitted with the mating pushrod. The pushrod had broken through and was jammed inside the oil squirt hole in the rocker arm. The stuck together mating parts are shown in Figures 1 and 2.

**Figure 1.** Overall (bottom) and close-up (top) photos showing the stuck together pushrod and rocker arm. A close-up photo showing the inner surface of the rocker arm looking in the direction of the yellow arrow is shown in Figure 2.

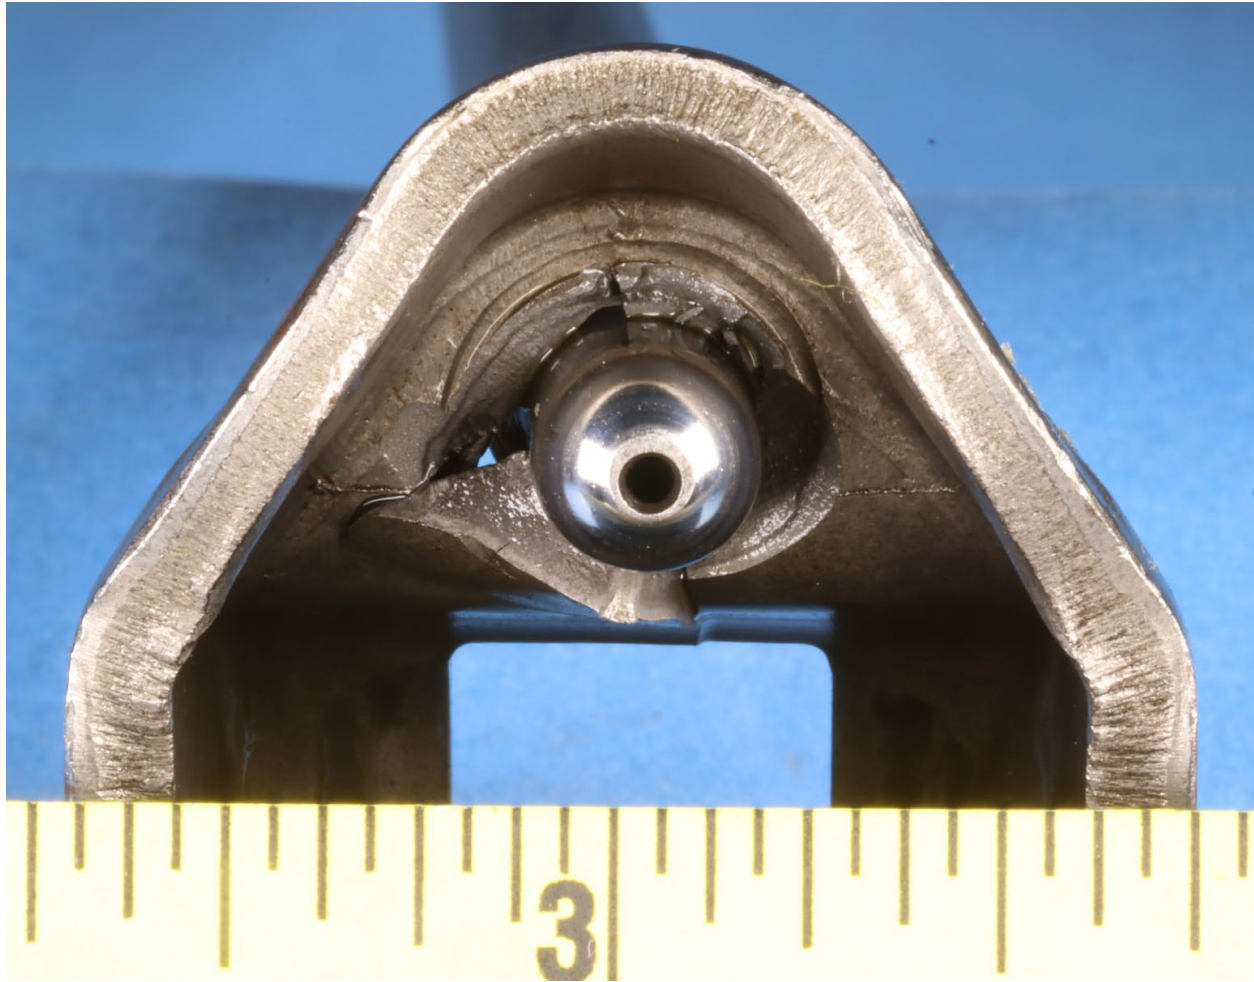
**Figure 2.** Close-up photo showing the inner surface of the rocker arm looking in the direction of the yellow arrow shown in Figure 1.

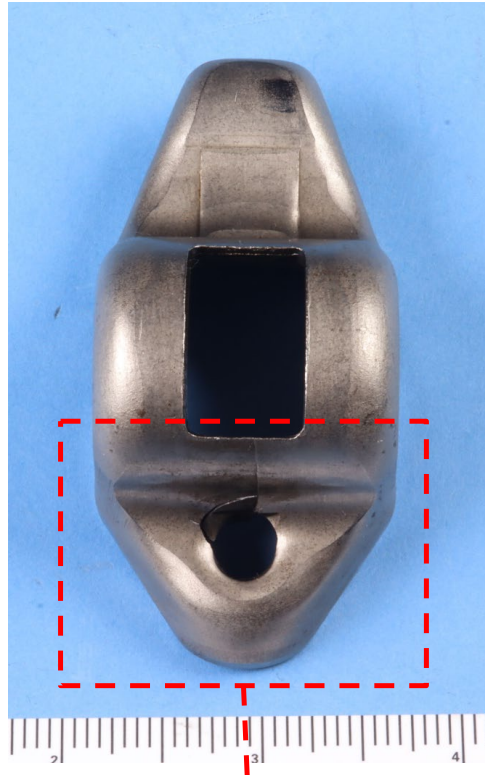
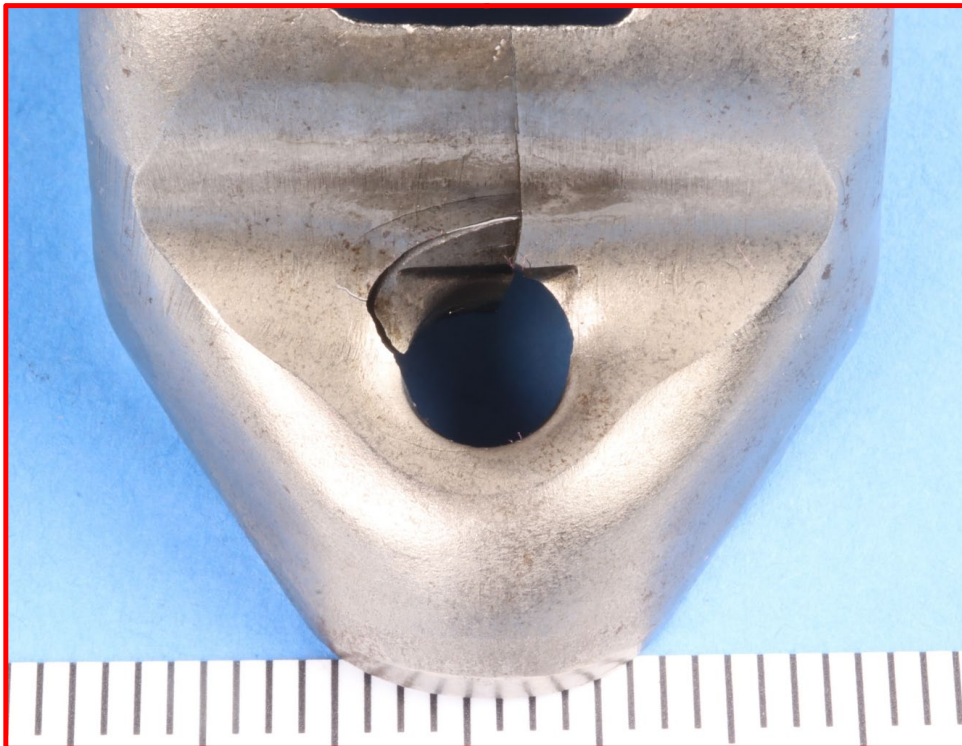
The pushrod was mechanically removed from the rocker arm in the laboratory. The oil squirt hole in the rocker arm after the pushrod had been removed is shown in Figures 3 and 4. A piece adjacent to the hole was pressed inwards in the direction the pushrod drives the rocker arm. A fracture surface was visible on the inner surface of the rocker arm extending circumferentially around the hole.

**Figure 3.** Overall (top) and close-up (bottom) photo showing the outer surface of the rocker arm after the pushrod had been removed.

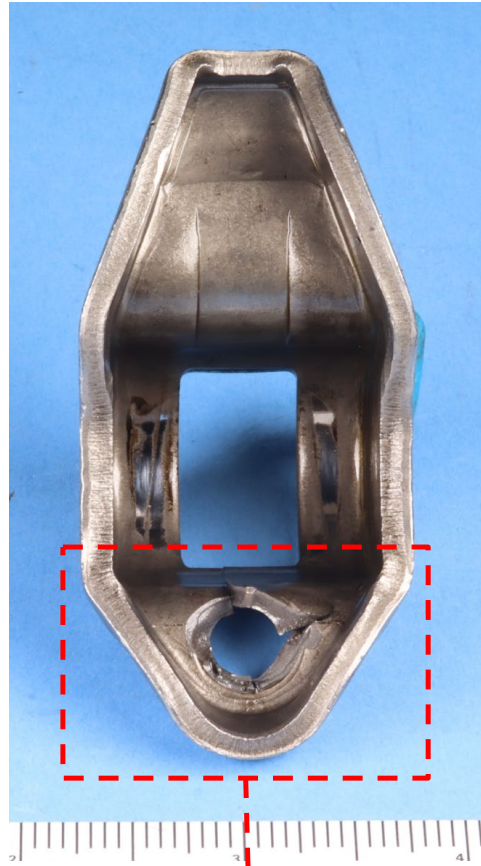
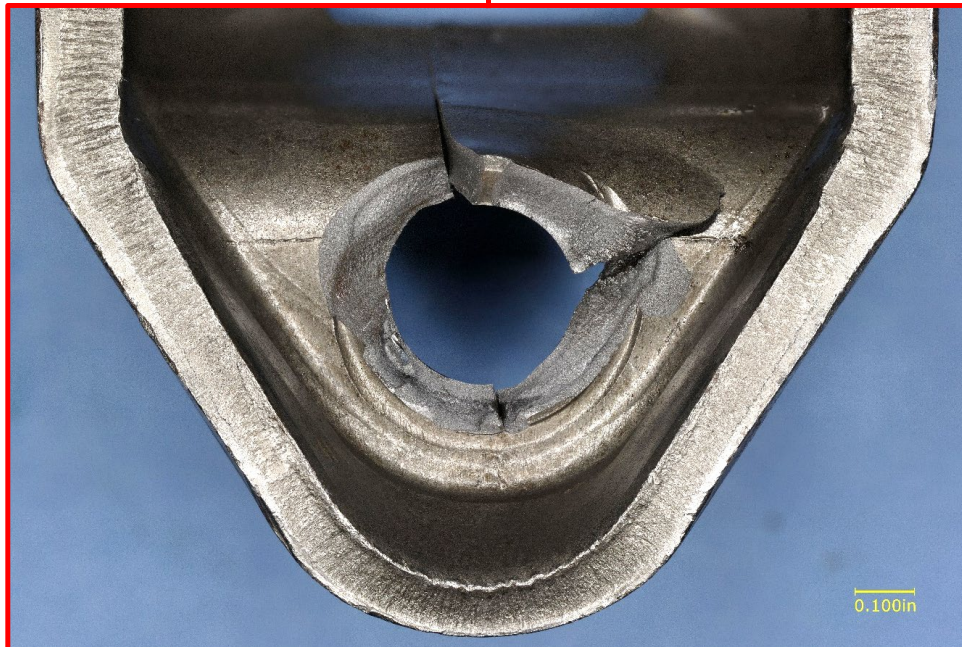
**Figure 4.** Overall photo (top) and digital microscope image (bottom) showing the inner surface of the rocker arm after the pushrod had been removed.

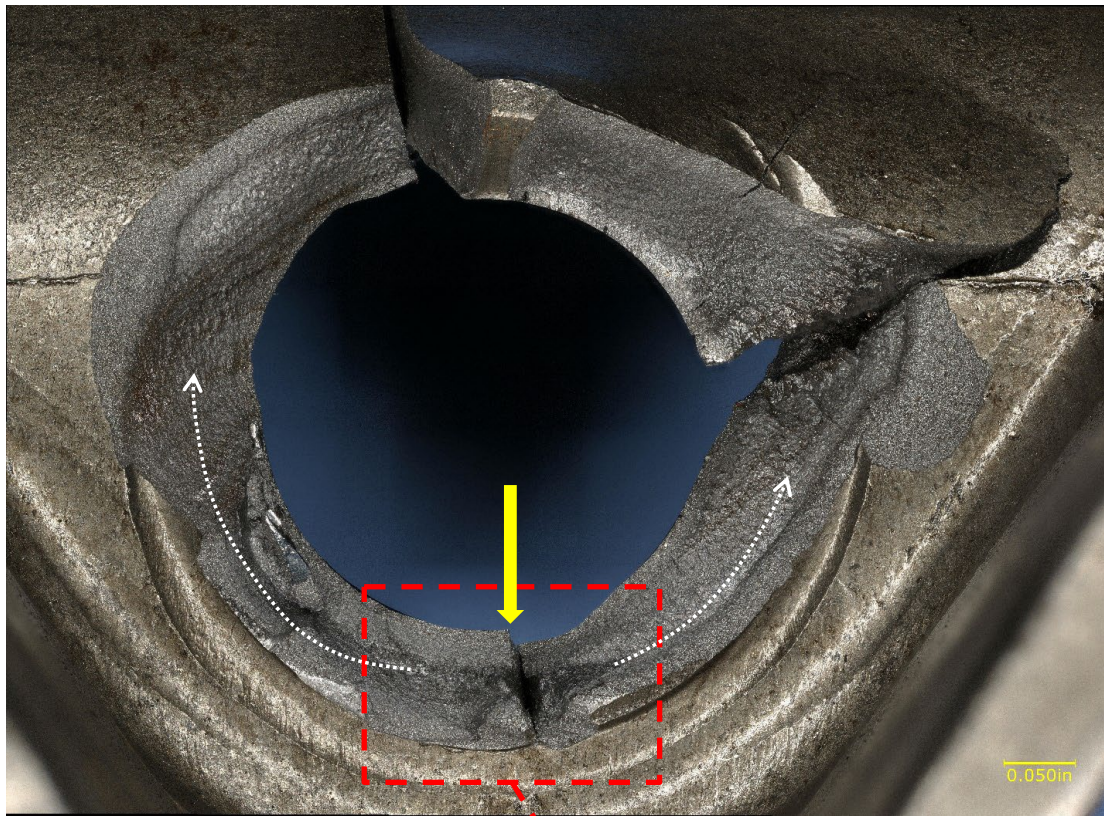
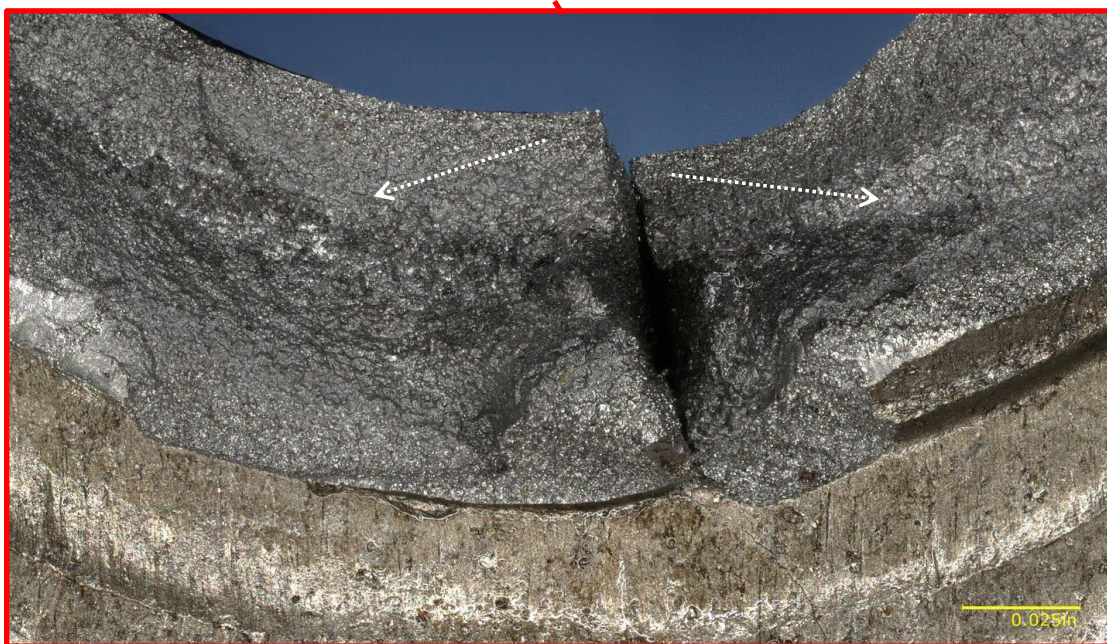
The rocker arm was cleaned with methanol and examined using stereomicroscopy. Digital microscope images of the fracture surface are shown in Figure 5. The circumferential fracture surface was relatively flat with visible crack arrest marks consistent with fatigue. The crack arrest marks indicated the fatigue emanated from the outboard side of the rocker arm.

There were three radial fractures branching from the circumferential fracture - one nearly aligned with the centerline of the outboard curved geometry of the rocker arm, one diametrically opposite the first, and the last approximately halfway between the other two. Small thumbnail-shaped patterns emanated from the outboard radial crack, as indicated by the white dotted arrows in the bottom image of Figure 5. The macro fracture surface features were consistent with the fatigue cracking progressing circumferentially from that same location, as indicated by the white dotted arrows in the top image of Figure 5. This is consistent with the radial crack occurring prior to the circumferential cracking.

Rocker arms with similar damage have been observed previously by the manufacturer. Lycoming Service Bulletin No. 639 (dated January 17, 2020) details the damage anticipated to the rocker arm oil squirt hole due to contact with the mating pushrod and methodology to inspect for it. Radial cracks are highlighted as warning signs that damage is occurring and that once observed, the rocker arm should be replaced. In the subject rocker arm, the missed and/or unaddressed radial cracks likely led to the circumferential fatigue cracking and subsequent failure of the rocker arm and pushrod assembly.

**Figure 5.** Digital microscope images of the inner surface of the rocker arm with a circumferential fracture surface and radial cracks at the oil squirt hole. The yellow arrow indicates the radial crack on the outboard side of the hole from which the circumferential fatigue cracking emanated, with the direction of fatigue propagation indicated by the white dotted arrows.
