CEN23LA188

## INVESTIGATION PHOTOGRAPHS

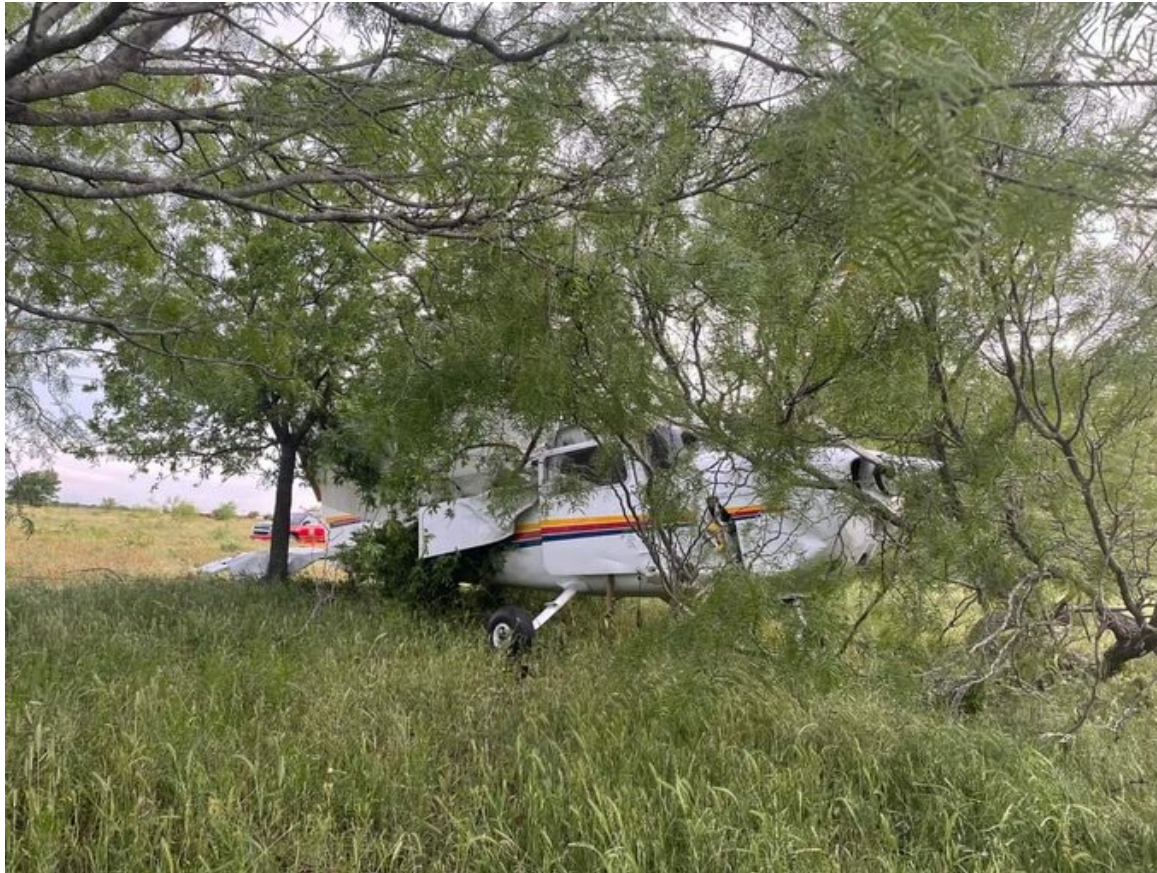
**Photograph 1 - Accident Overview (Photo Source Unknown)**

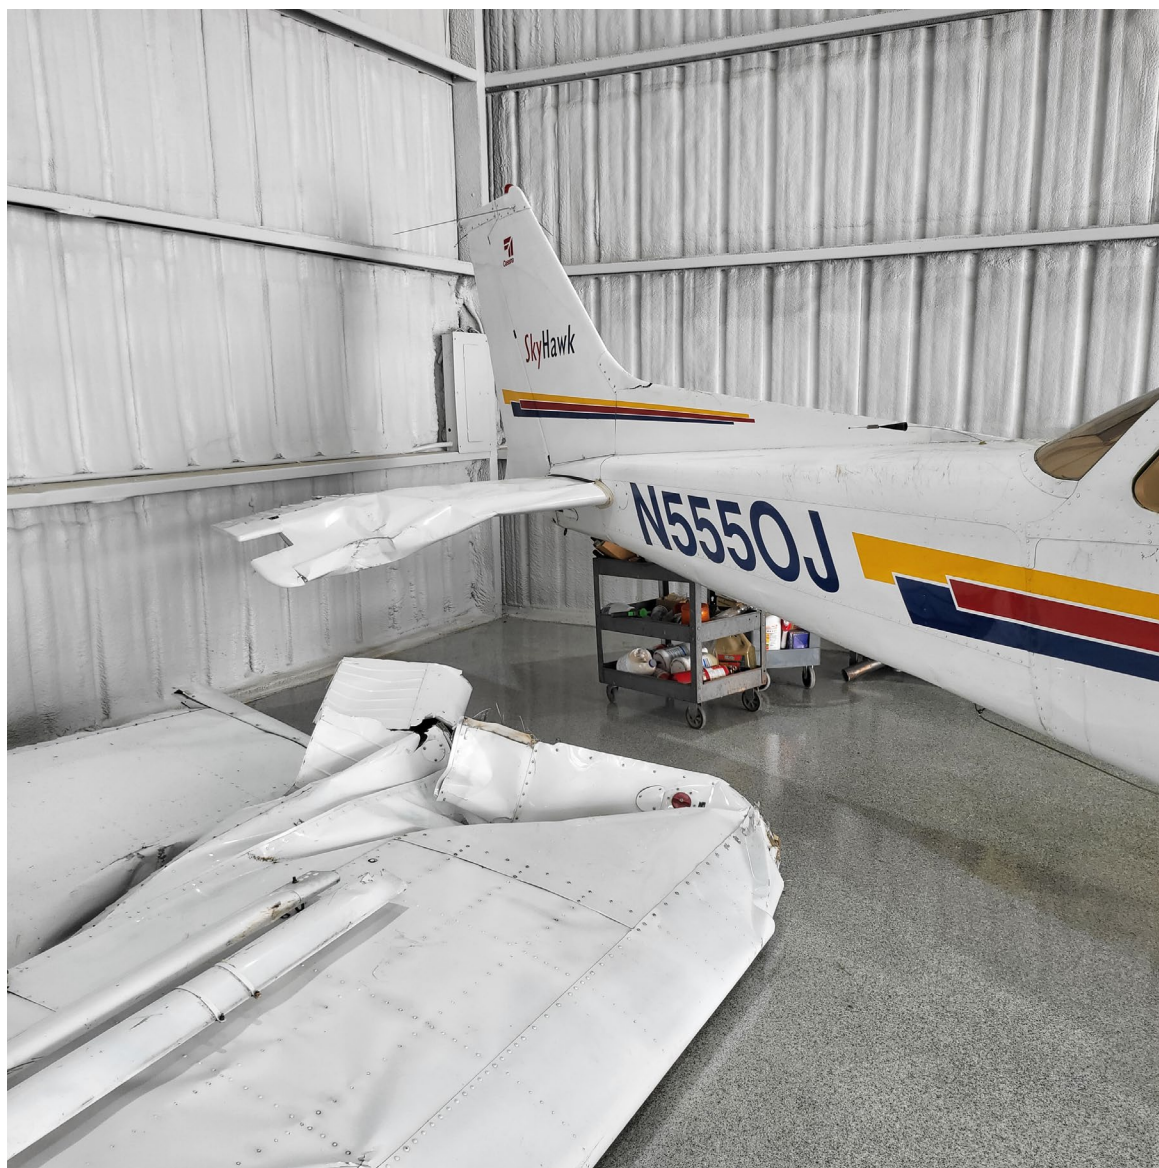
**Photograph 2 - Damage to Right Horizontal (Courtesy of FAA)**

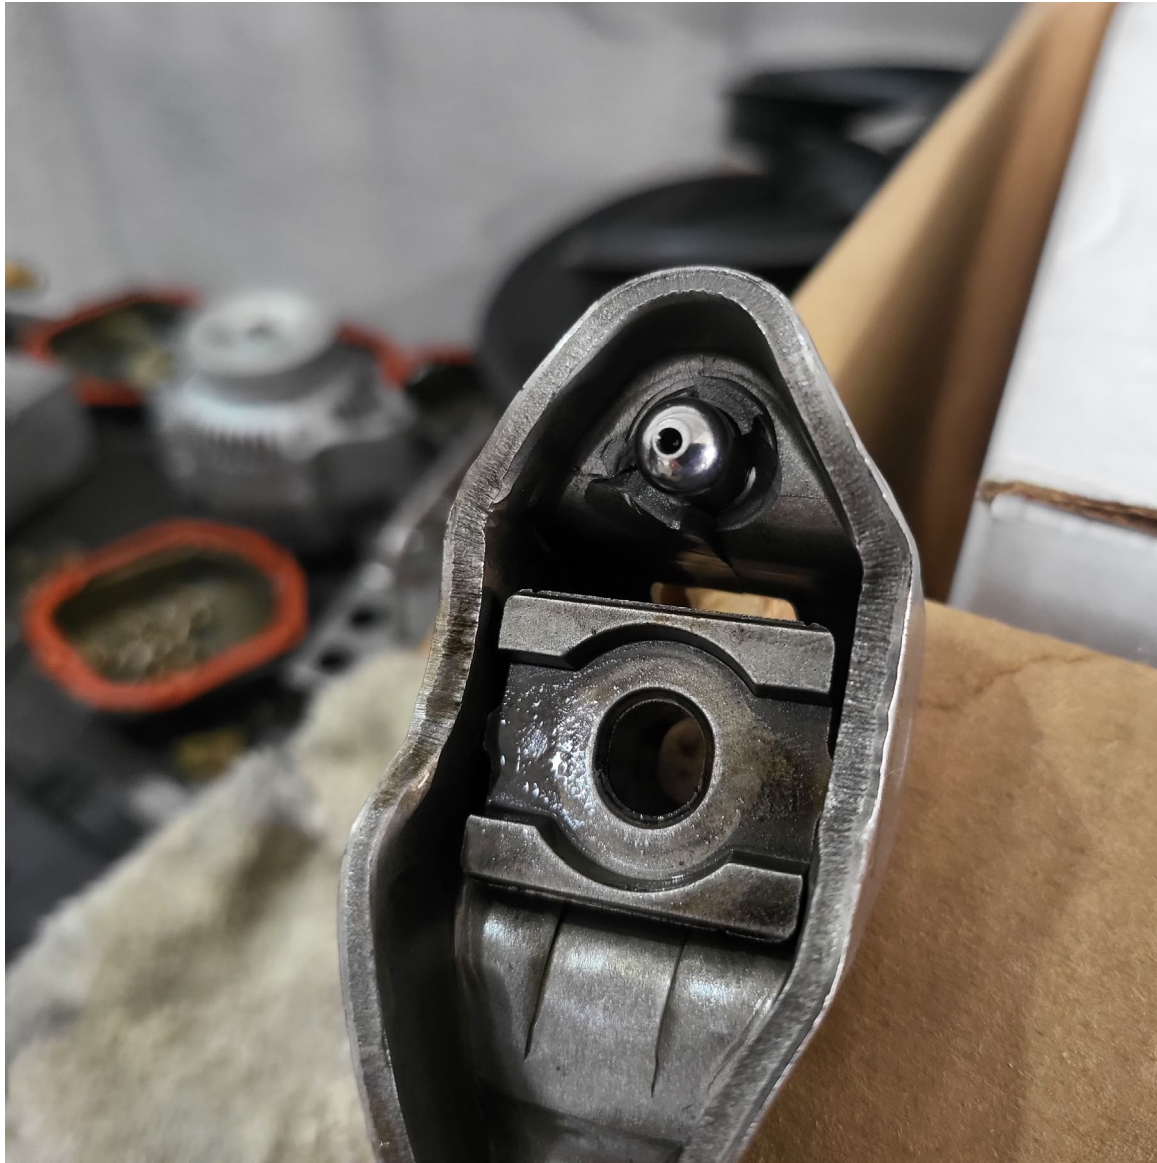
**Photograph 3 - Rocker Arm (Courtesy of FAA)**
