CEN23LA200

## INVESTIGATION PHOTOGRAPHS

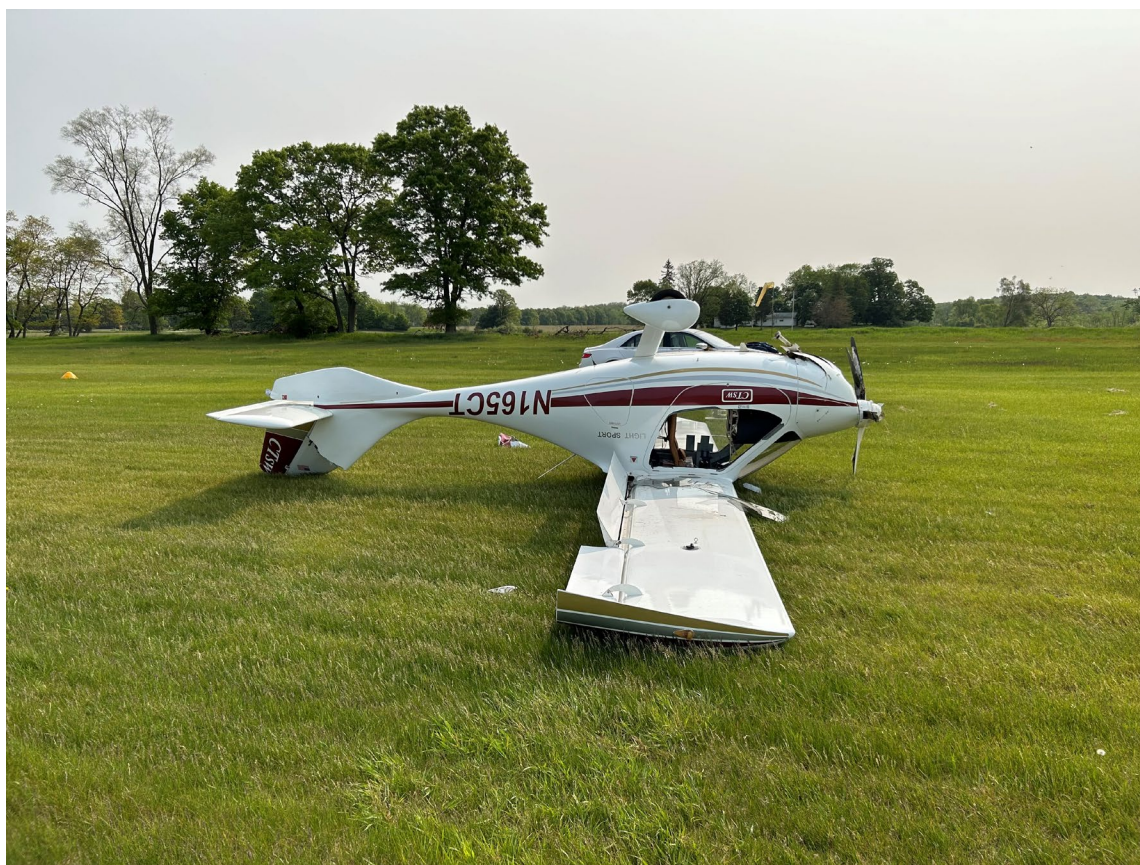
**Photograph 1 - Fractured vertical stabilizer (Courtesy of FAA)**

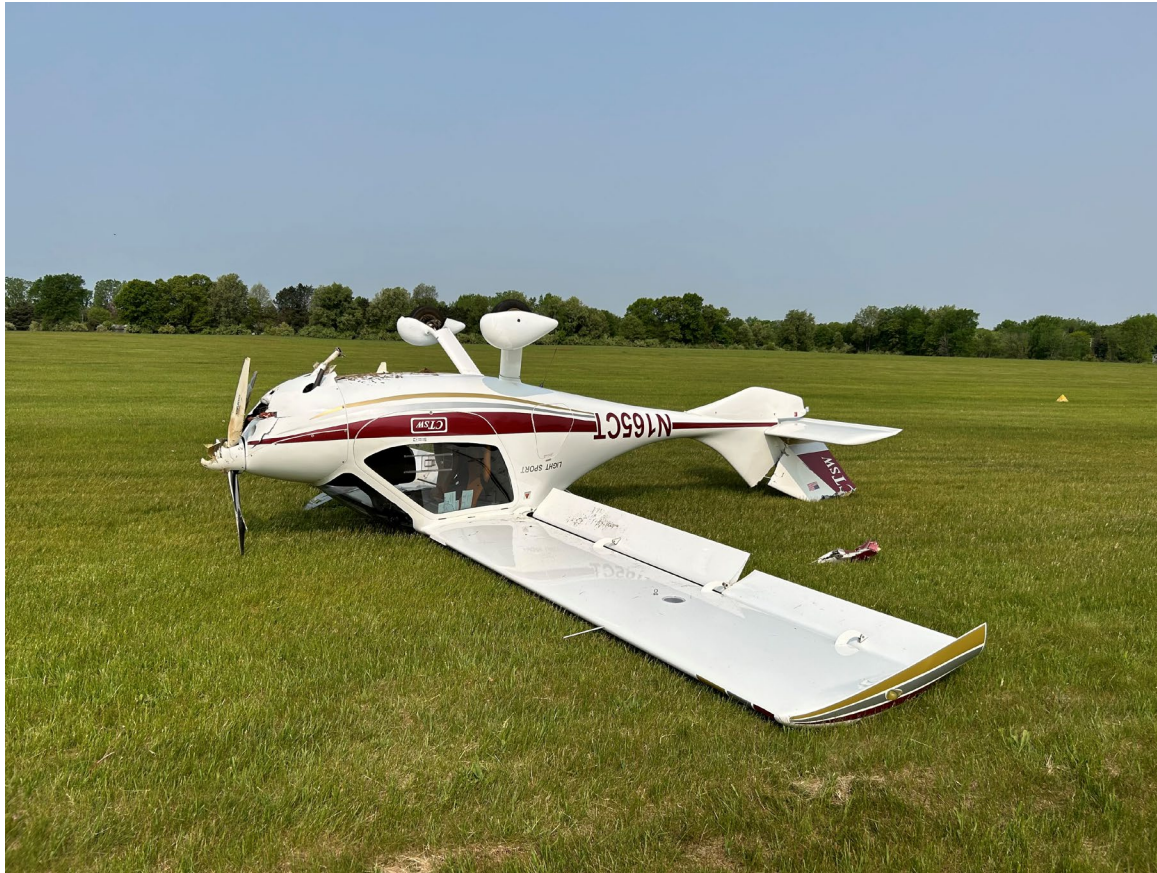
**Photograph 2 - Fractured vertical stabilizer (Courtesy of FAA)**

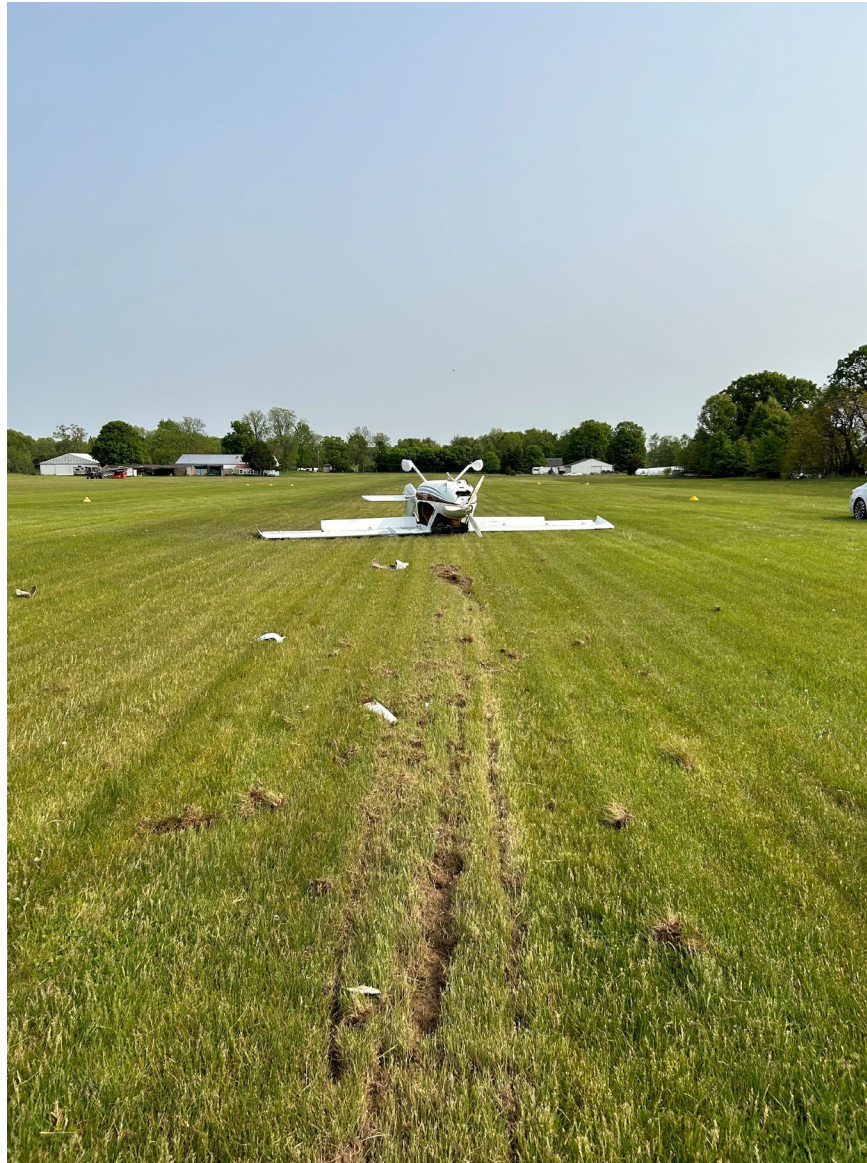
**Photograph 3 - Ground scars from landing (Courtesy of FAA)**

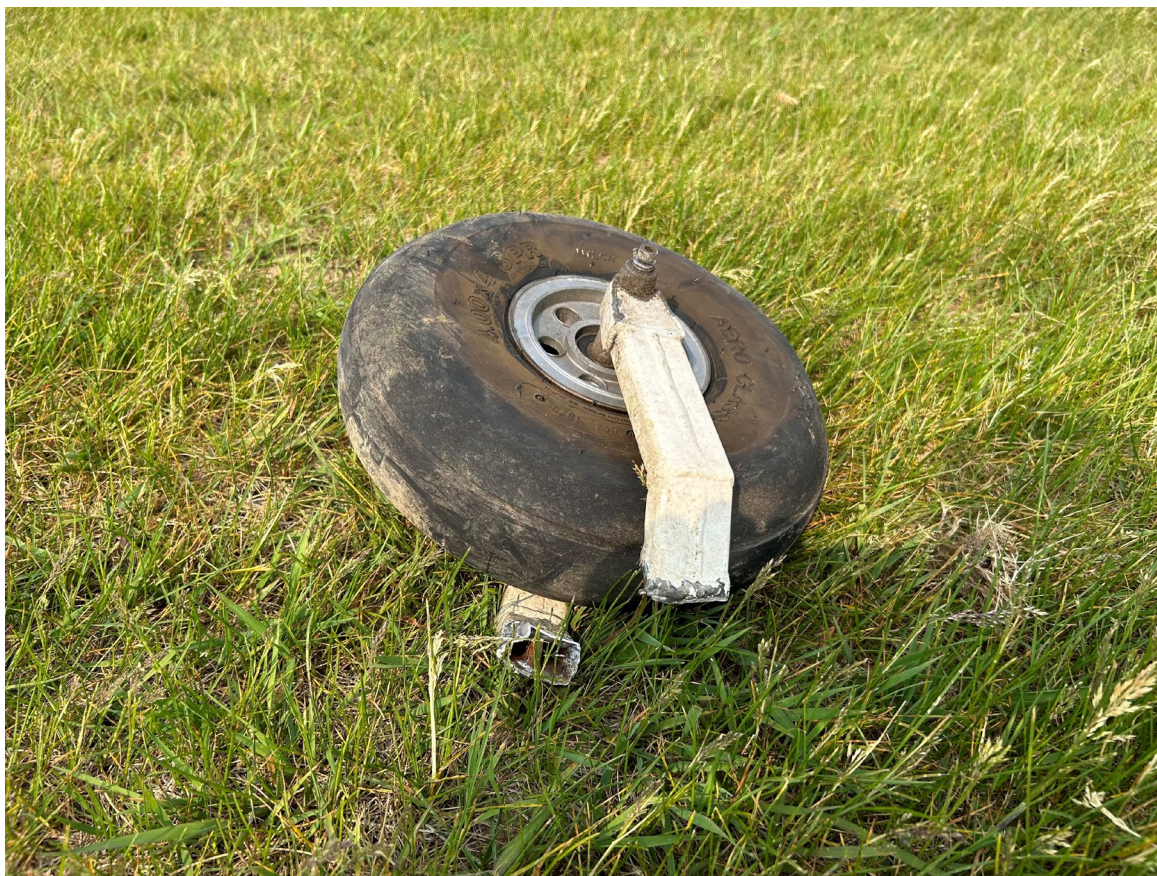
**Photograph 4 - Separated section of the nose landing gear (Courtesy of FAA)**
