# National Transportation Safety Board

CEN23LA208

## **MATERIALS LABORATORY**

Factual Report 24-001

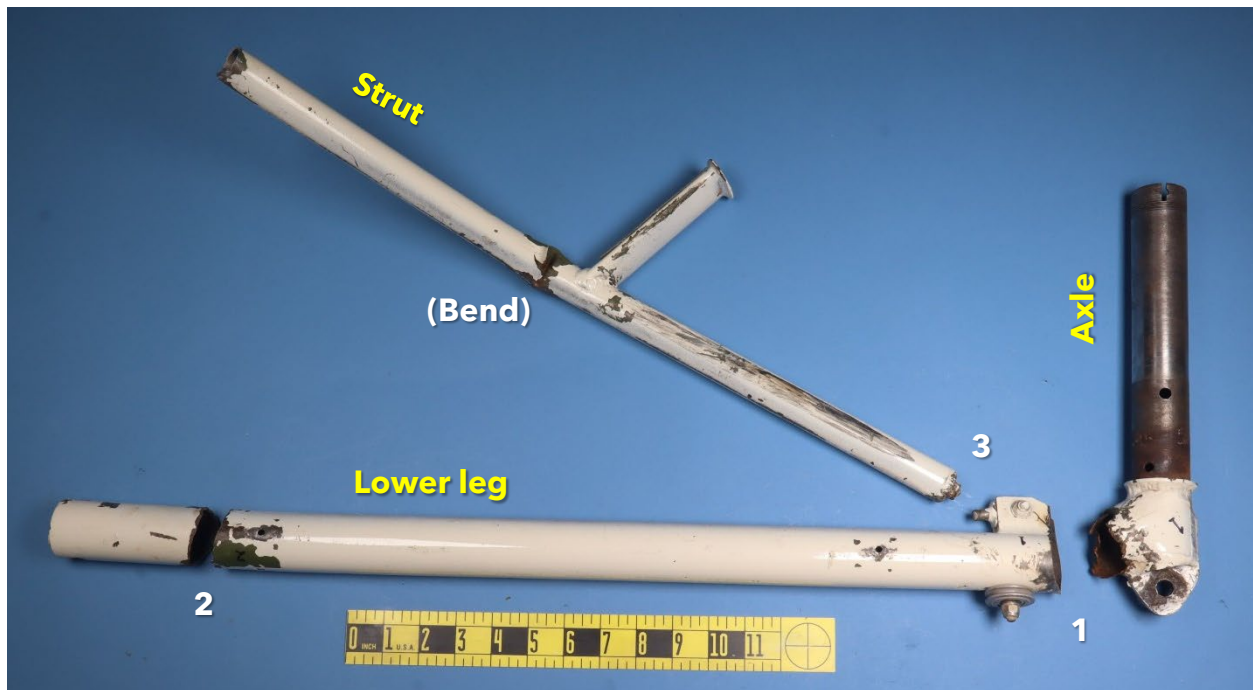
Figure 1 shows the components of the right main landing gear as received. The gear assembly had fractured in three locations, labeled 1 through 3 before receipt, and will be used for reference in this report. Fracture 1 was located where the lower leg transitioned to the collar welded to the axle. Fracture 2 was located along the lower leg, approximately 3 inches from the top of the tube. Fracture 3 had occurred in the threaded fork end that affixed the strut to the lower leg. The strut also had been deformed in bending, collocated with an area of spalled white topcoat paint.

**Figure 1.** View of the remnants of the landing gear assembly, as received. The pre-received fracture labels are annotated on the figure in white numbers.

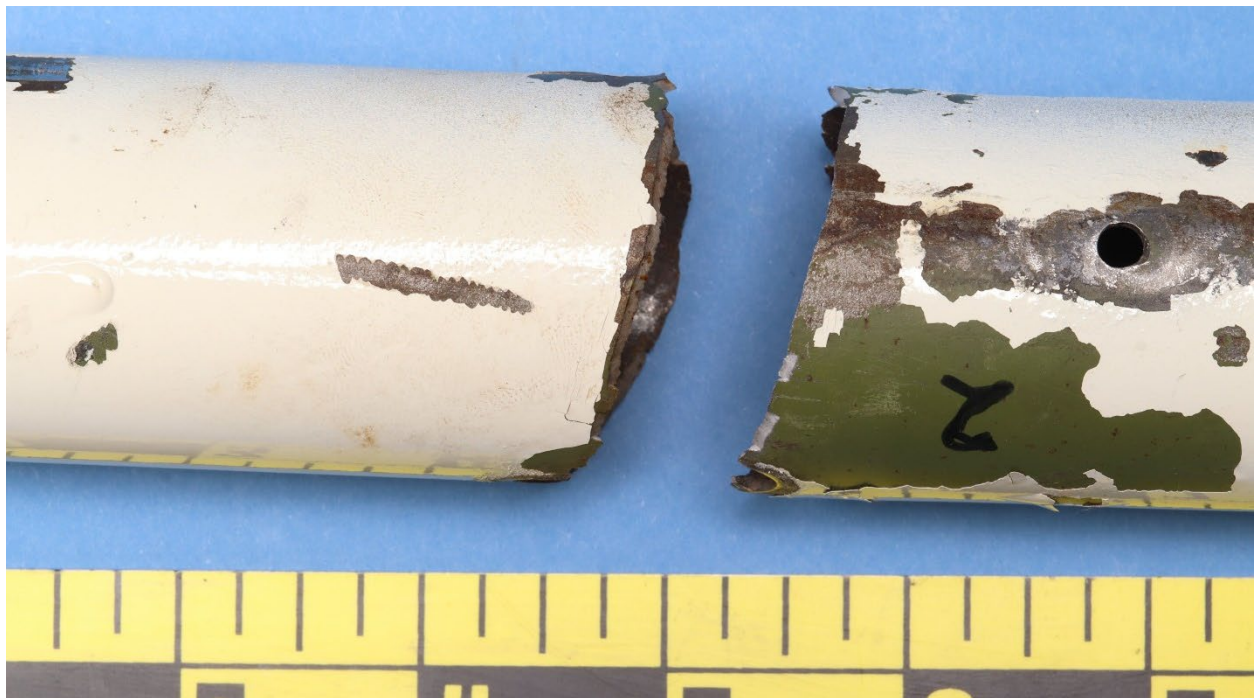
Figure 2 shows a closer view of Fracture 2 on the lower leg. This fracture exhibited mating cup and cone shapes without any out-of-plane deformation. The fractures themselves exhibited 45° slant orientations, as shown in Figure 3. The fracture surfaces were dull gray in luster, with a rough, fibrous texture. These features were consistent with subsequent overstress fracture of this part of the lower leg.

**Figure 2.** View of the mating sides of fracture 2, located along the lower leg.

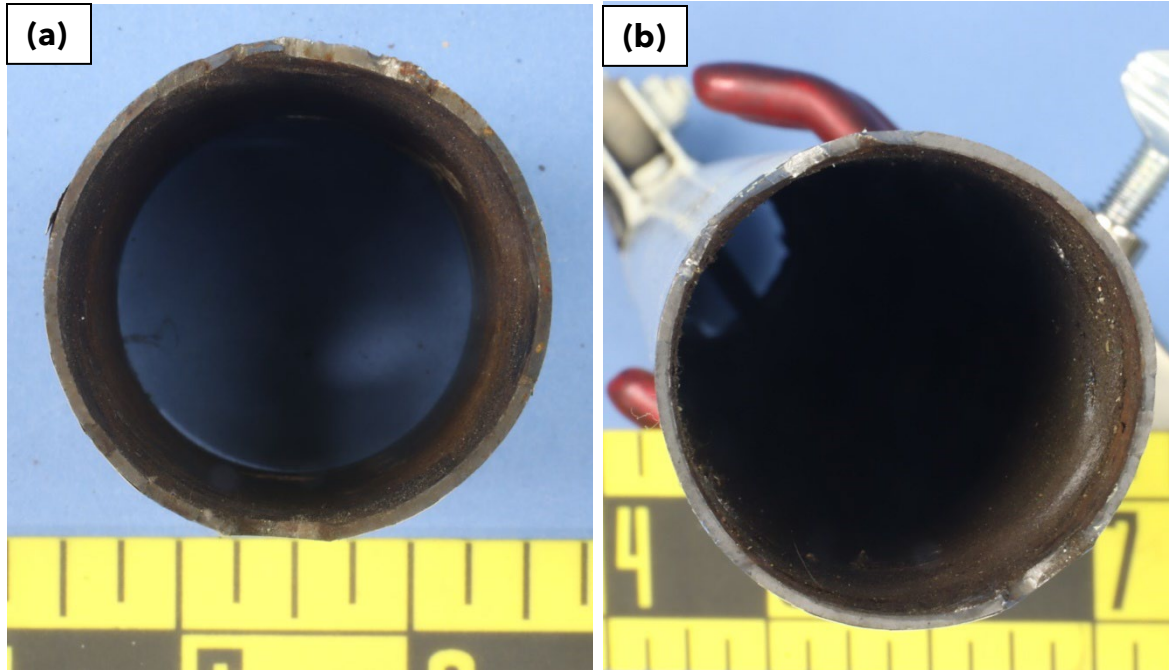
**Figure 3.** Mating sides of the fracture surface from (a) the upper side and (b) the lower side of the lower leg.

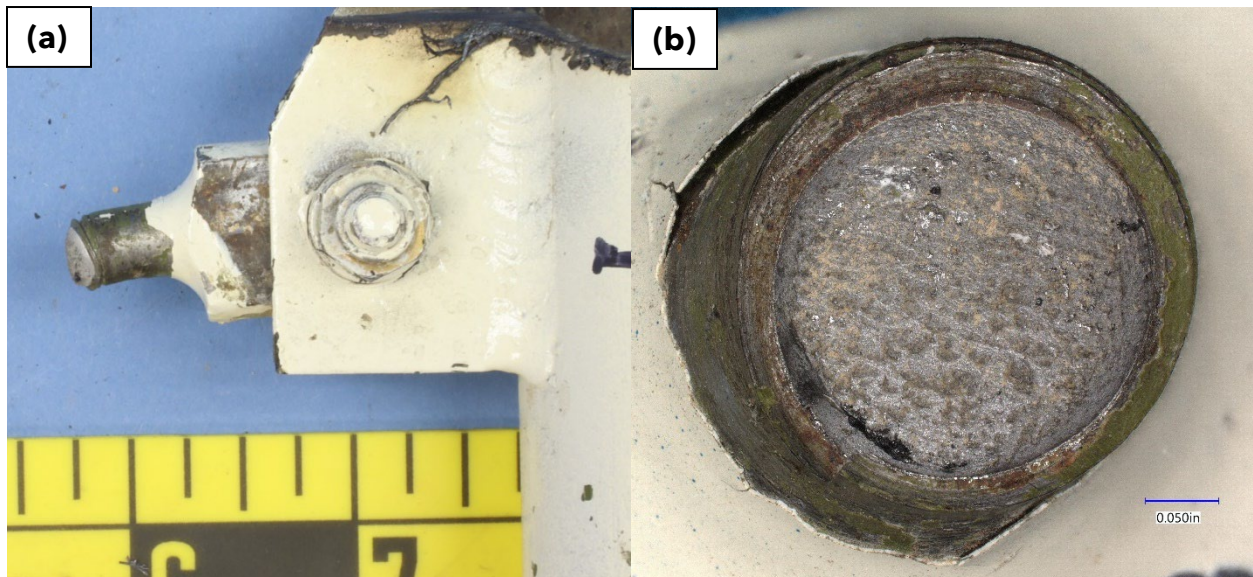
Figure 4 shows a closer view of the threaded fork end fracture at Fracture 3. The end remnant exhibited downward bending deformation next to the fracture surface, as oriented in Figure 4. Examination of the end fracture surface showed a dull gray appearance on a rough, fibrous surface texture. The general shape of the fracture surface was conical, with small 45° angled shear lips along the edges. These features were consistent with bending overstress fracture of the threaded fork end.

**Figure 4.** View of the bent and fractured threaded fork end at fracture 3 from (a) the side and (b) the fracture surface.

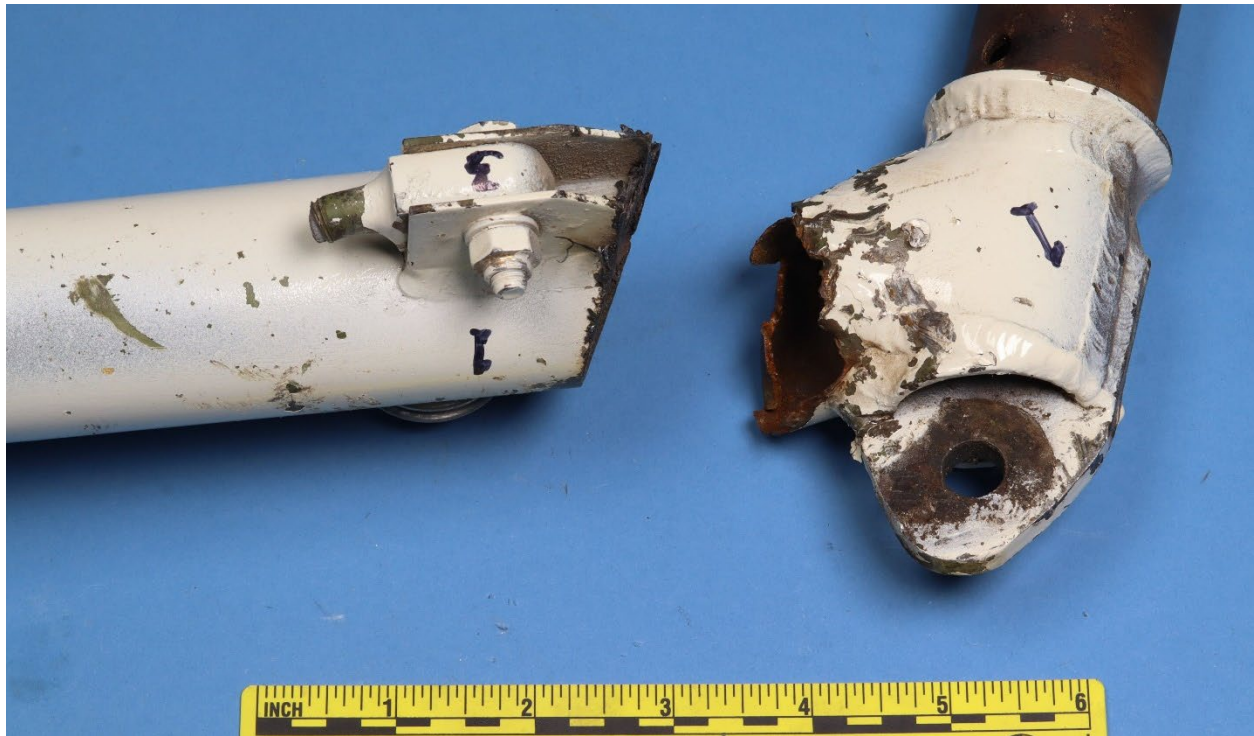
Figure 5 shows the mating sides of the Fracture 1 location. The mating fracture surfaces did not mirror each other in shape, with the upper fracture face on the lower leg exhibiting a flat planar shape, oriented at an angle off perpendicular to the leg direction. The mating fracture surface on the collar was jagged and partially deformed.

**Figure 5.** View of the mating sides of fracture 1 along the lower landing gear leg.

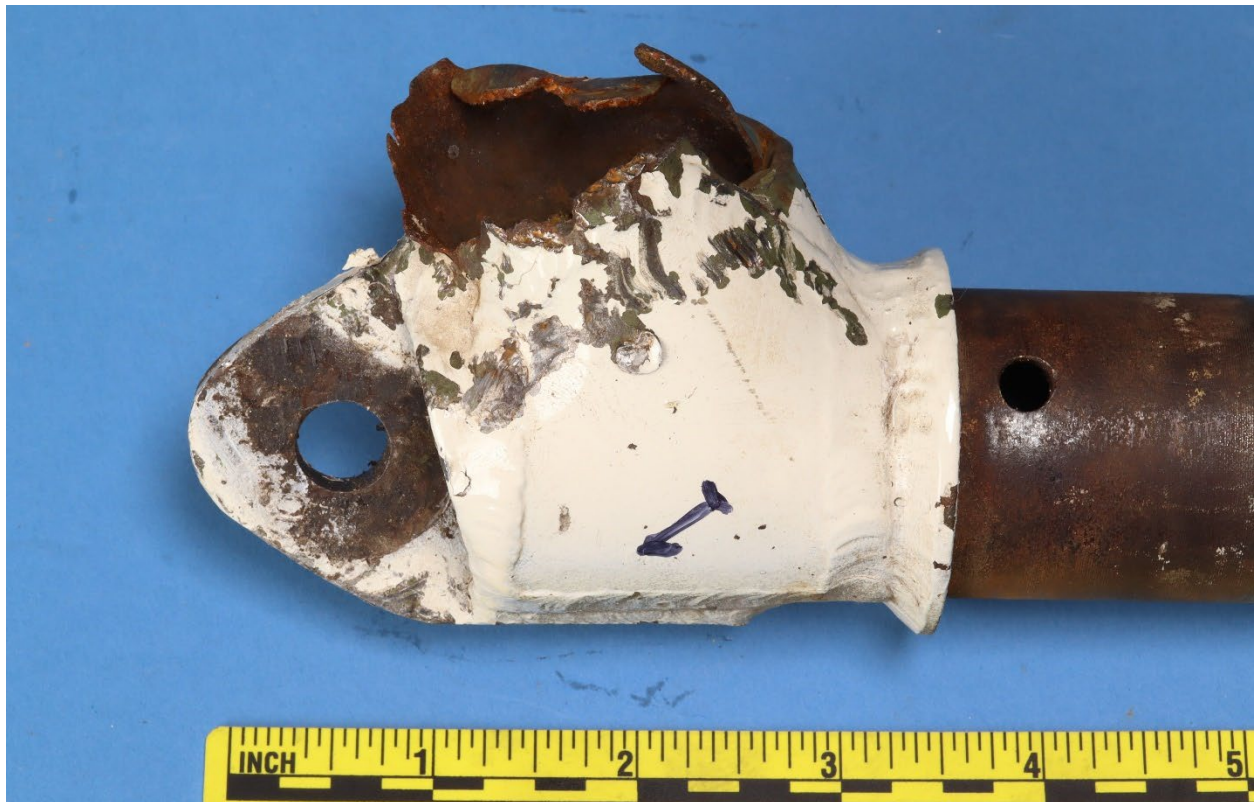
Figures 6 through 8 show different angles of the collar side of Fracture 1. As shown in the figures, approximately half of the fracture surface was parallel to the direction of the lower leg (shown in the upper portion in Figure 8). The other half of the fracture had been bent inward, with areas of S-shaped buckling on the edges. This bending deformation, being out-of-plane with the fracture surface, was consistent with subsequent deformation post-fracture. The fracture surface exhibited a mottled surface texture, with maroon-colored corrosion product (rust) prevalent on the surface and the interior of the leg remnant up to the collar with the axle.

**Figure 6.** View of the collar side of fracture 1, showing material deformed inward on the far side, and fractures oriented in line with the leg on the near side of the figure.

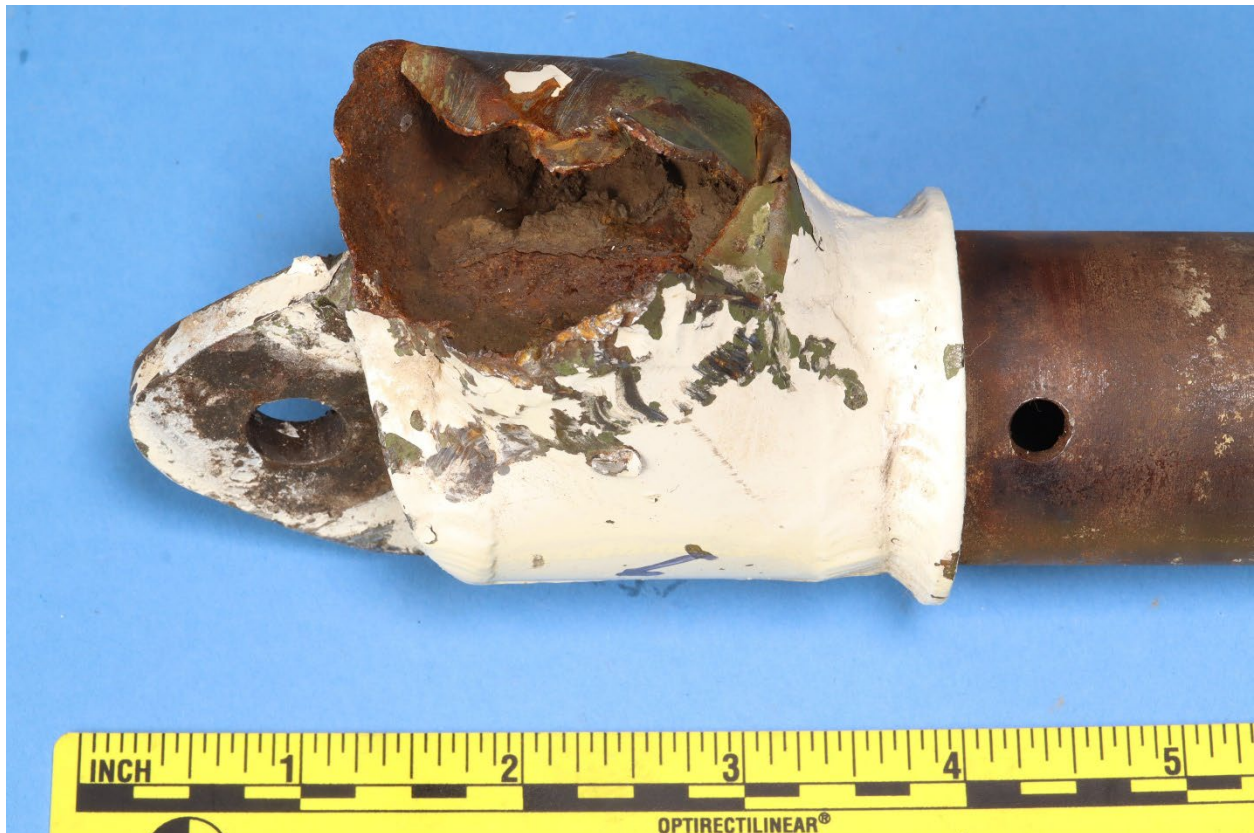
**Figure 7.** Angled view of Figure 6, showing the deformed side of the collar, and interior corrosion products.

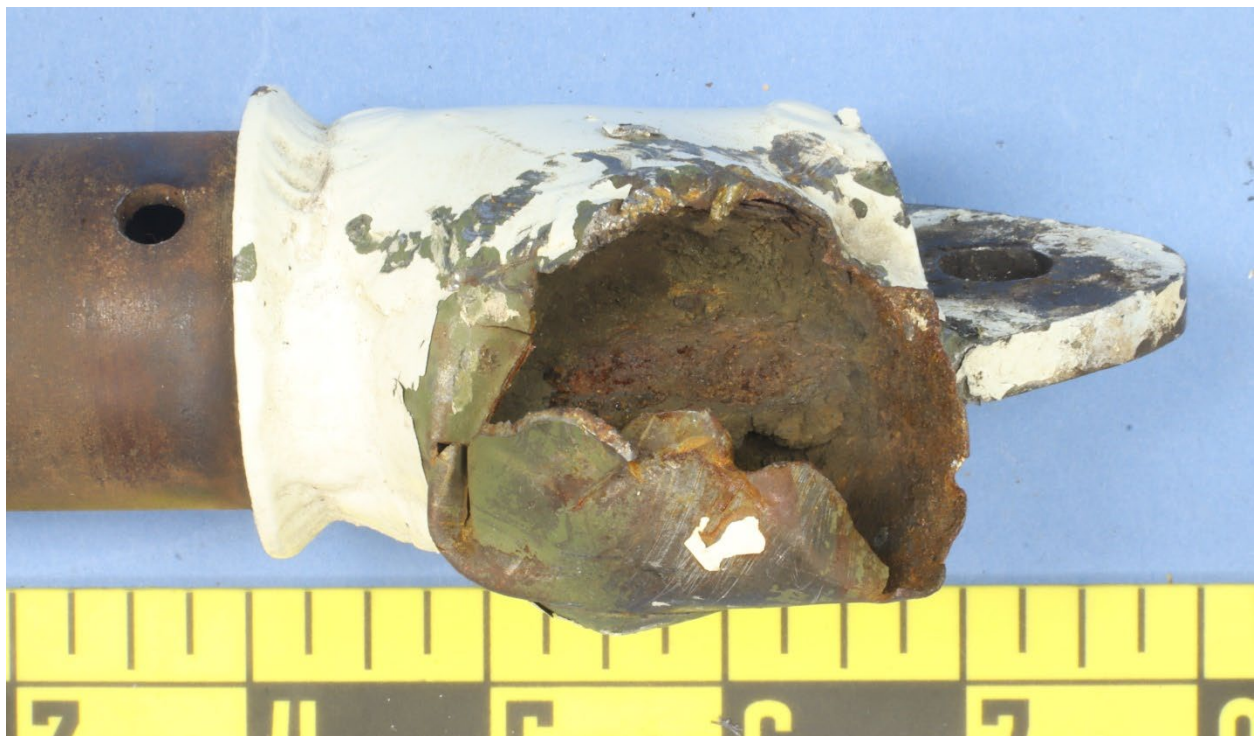
**Figure 8.** Inverted view of Figure 6, showing the in line half of the leg tube fracture.

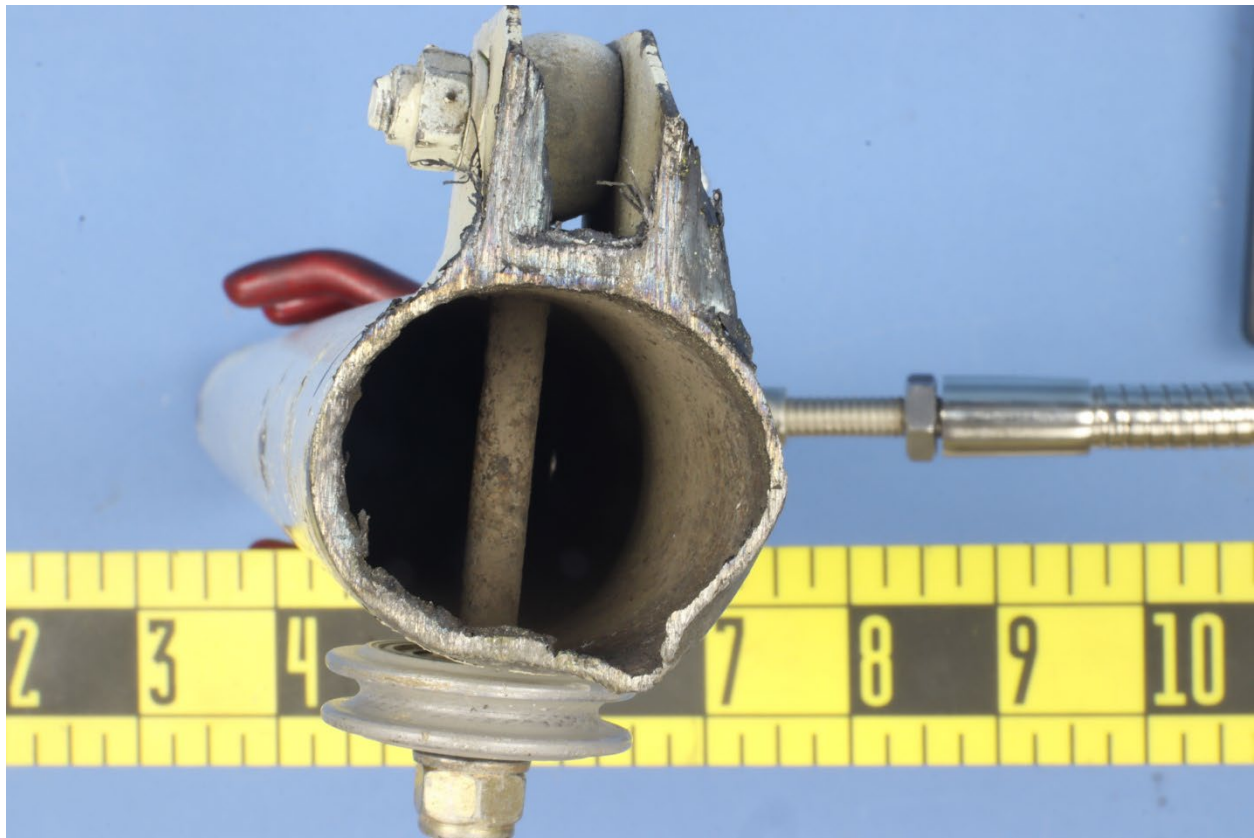
Figure 9 shows the mating upper fracture surface of Fracture 1. This surface exhibited a reflective metallic color and was generally flat and planar. The surface exhibited unidirectional streaks and gouge marks. Material from the fracture exuded over the edges and flanges of the leg, but only in the one direction of the streaks (the top-facing surface edges as shown in Figure 9). These features were consistent with subsequent grinding against a planar surface of this part of the leg post-fracture.

**Figure 9.** View of the mating side of fracture 1, showing unidirectional gouge marks.

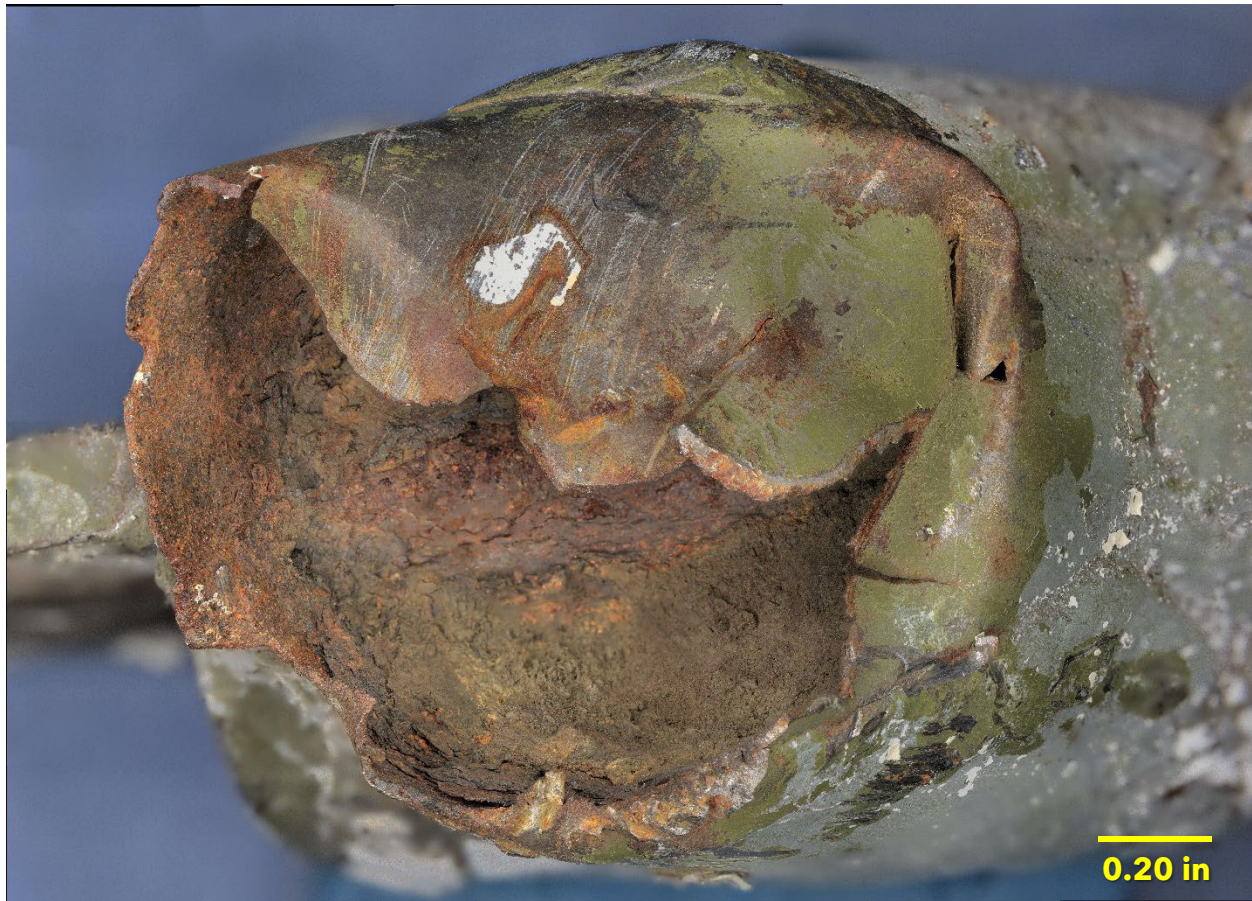
The fracture portion of the collar was sectioned from the axle and cleaned in an ultrasonic bath of acetone to remove the paint and loose corrosion product on the part. Figure 10 shows a closer view of the fracture. The inward bent portion of the fracture surface exhibited surface streaks and grinding marks, consistent with contact from another material that deformed this wall of the fractured leg. The other half of the fracture showed two regions—one that exhibited gouging marks and localized surface damage (lower side in Figure 10) and an area absent post-fracture damage (left in Figure 10).

**Figure 10.** Closer view of the deformed area of the tube fracture near the collar at fracture 1.

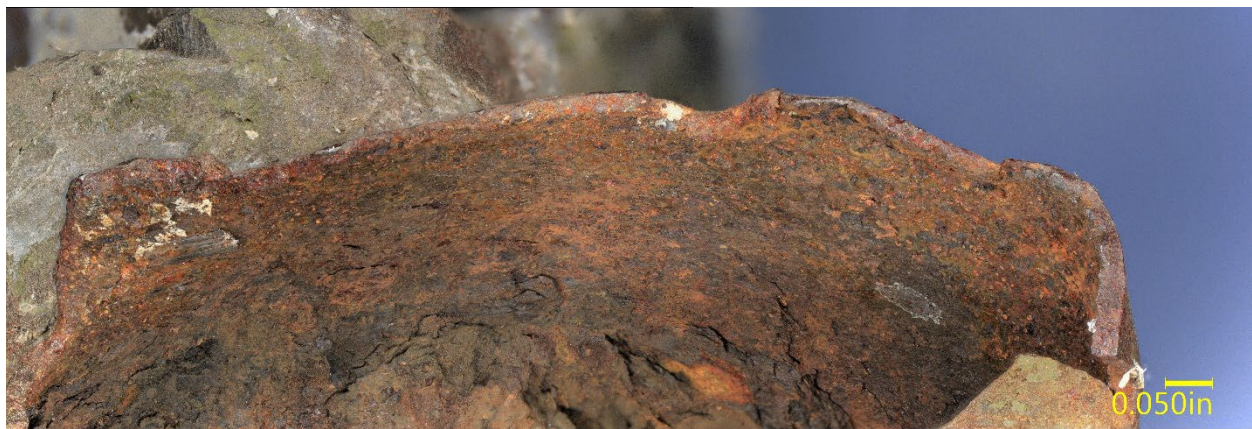
The undamaged region of the collar fracture surface is shown closer in Figure 11. This area exhibited localized thinning in some areas near the fracture surface. These areas were measured using digital calipers; the walls of the leg near the collar had thinned from 0.040 inches next to the axle to under 0.025 inches near the fracture. Some of the thicker areas of this part of the fracture exhibited slant fracture orientations, as illustrated in Figure 12. These areas also revealed flatter, faceted faces on the fracture

**Figure 11.** Closer view of the un-deformed portion of the collar fracture surface.

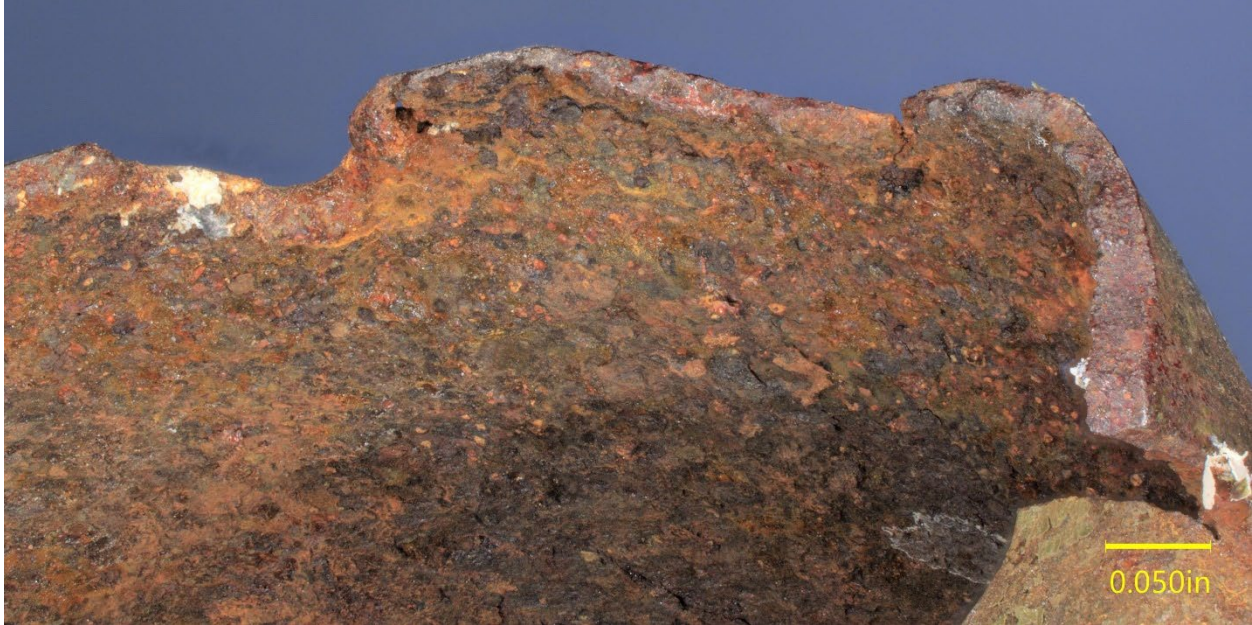
**Figure 12.** Closer view of the right side of the fracture in Figure 11, showing material thinning.

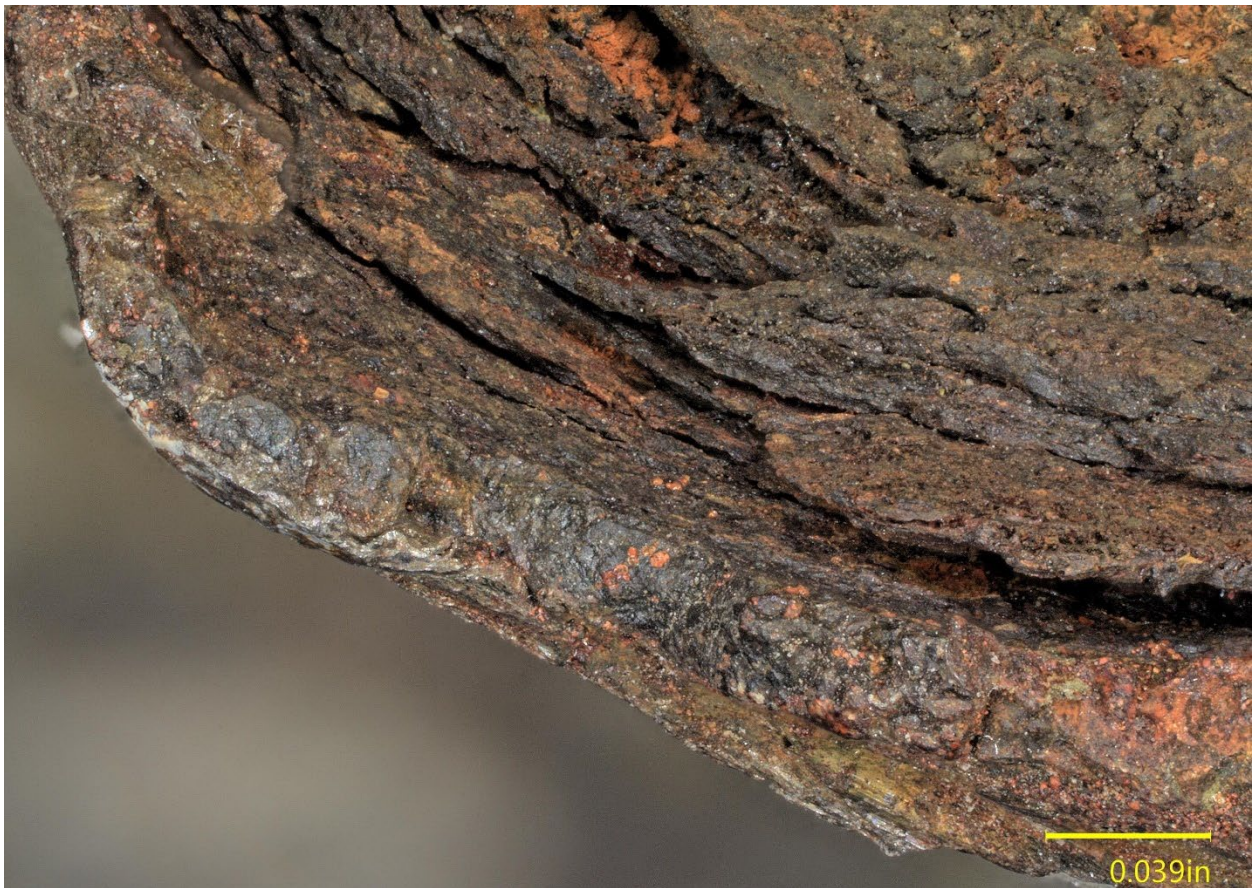
surface, though they were obscured by surface oxide thick enough to diminish underlying features visually (Figure 13). Further, the interior of the fracture exhibited layered surface oxidation and corrosion product, as illustrated in the middle and upper right in Figure 13.

**Figure 13.** View of a thicker area of the fracture surface, showing layered interior compounds.

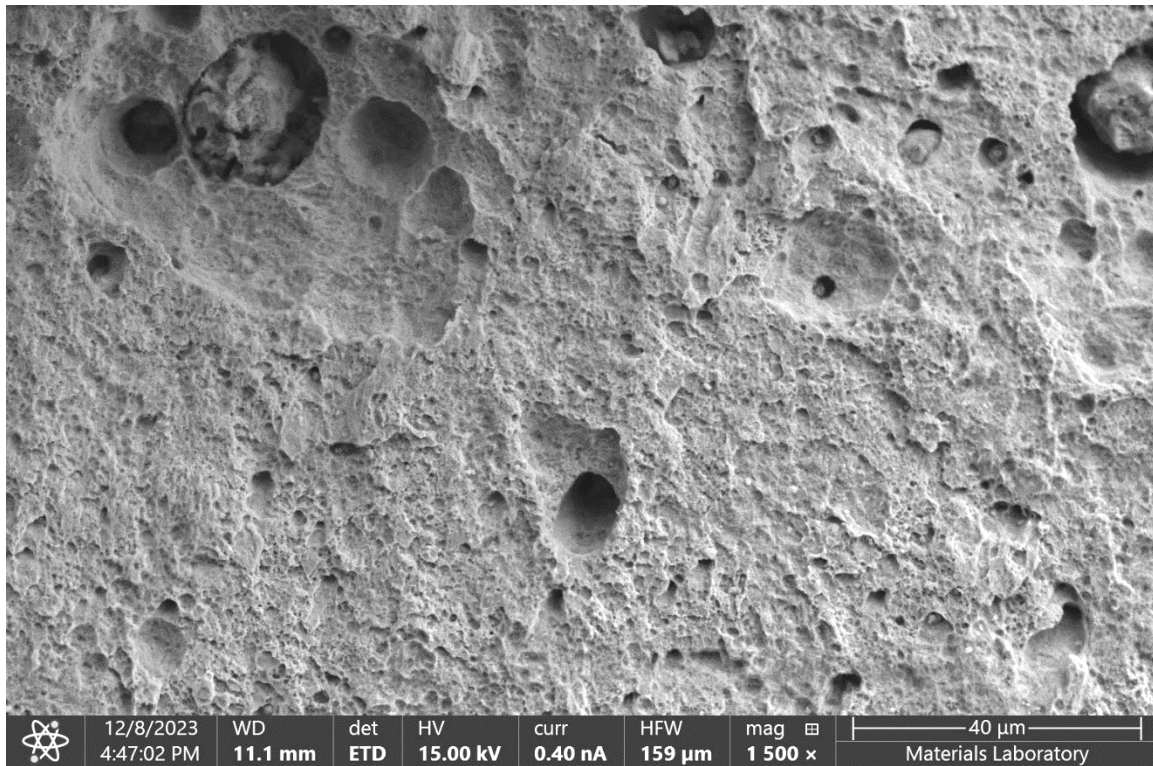
The thinnest section of the fractured leg wall near the collar was sectioned and cleaned in an ultrasonic bath with water and Evapo-rust chelating agent to remove much of the surface oxide.<sup>1</sup> This fracture surface was examined using a field-emission scanning electron microscope (SEM). Figure 14 shows a typical area of the thicker portions of the fracture surface, exhibiting dimpled rupture consistent with overstress fracture. However, many areas of the fracture exhibited larger pock-marked features similar to dimpled rupture but were an artifact of the oxide removal cleaning process.

**Figure 14.** Secondary electron (SE) micrograph of the thicker part of the fracture surface in Figure 13, after removing the surface oxide.

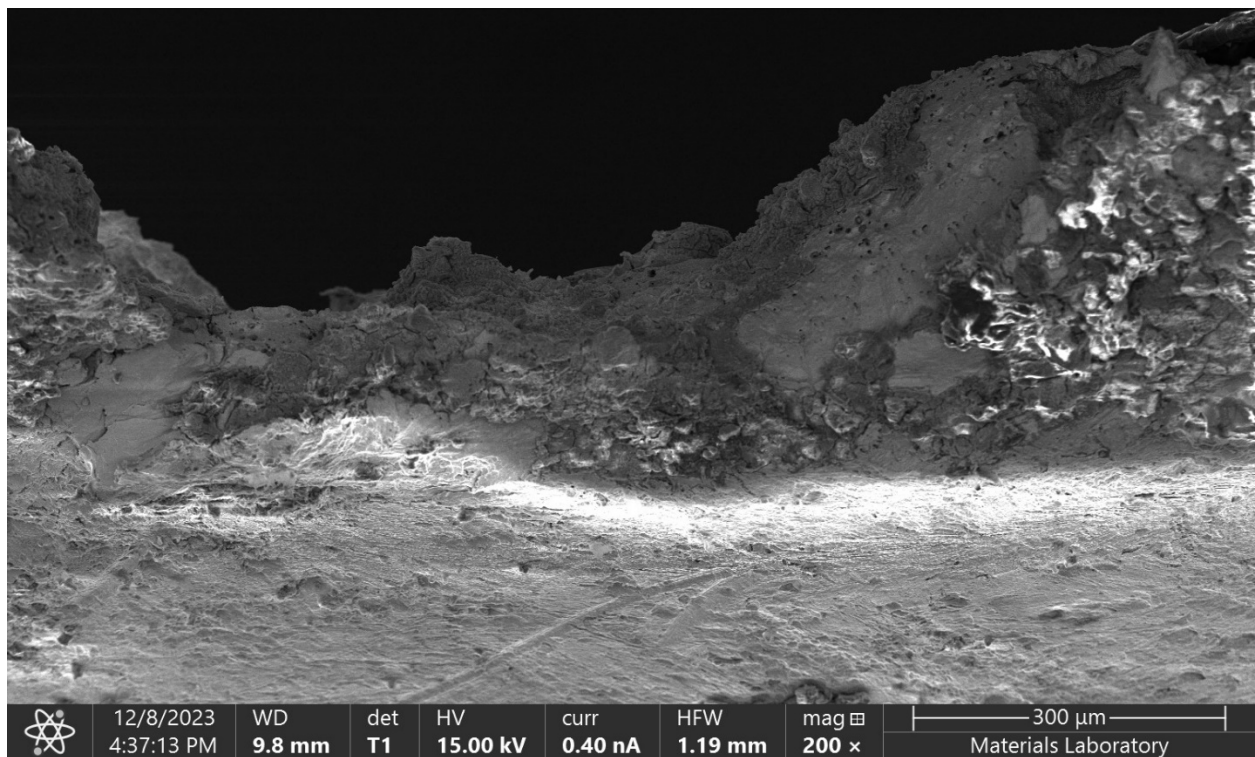
Figure 15 shows a closer view of the thinnest area of the fracture surface, which exhibited a general semicircle shape. Much of the surface still contained corrosion compounds, which presented as nonconductive material in the SEM. Figure 16 shows a closer portion of the edge, which, though still mainly covered in corrosion compounds, exhibited areas of exposed underlying metal from the cleaning process. The corrosion compounds still present were faceted and layered (Figure 17). The underlying metal either exhibited a flatter faceted appearance, as illustrated in the lower corner of Figure 17, or dimpled rupture, as shown in Figure 18. The dimples in Figure 18 were both equiaxed and slanted, indicative of mixed loading directions. These thinned areas exhibited fracture features consistent with overstress fracture.

**Figure 15.** SE micrograph of the thinned area of the fracture surface in Figure 12.

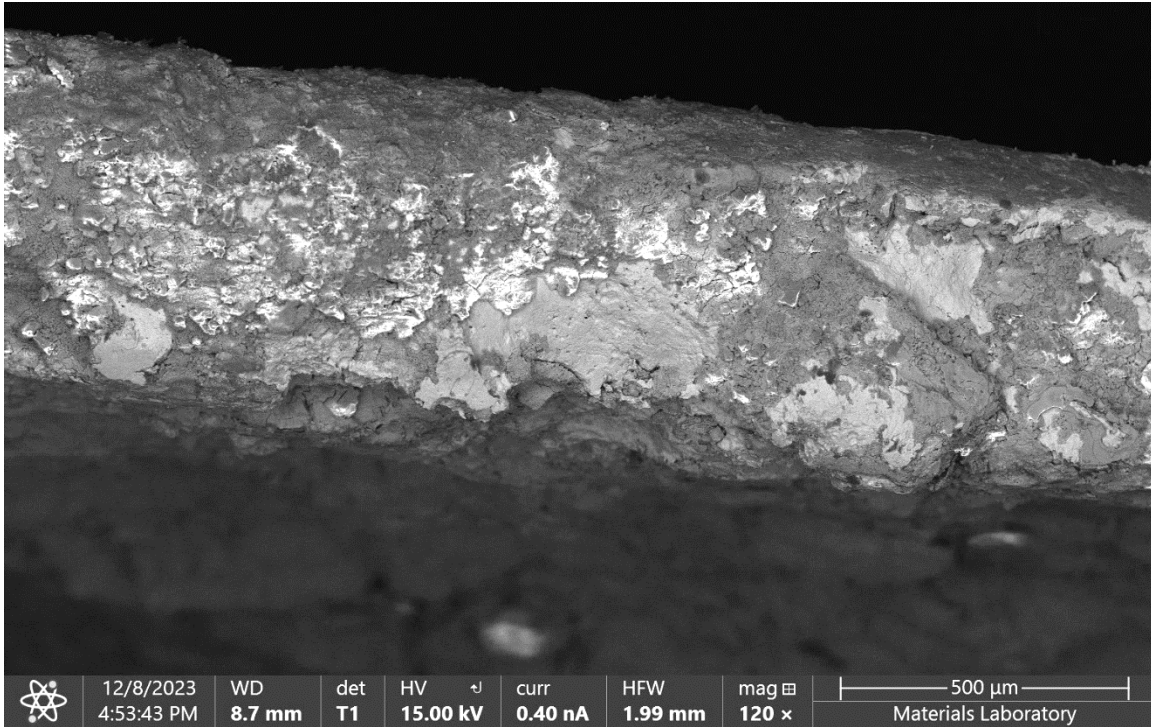
**Figure 16.** Backscattered electron (BE) micrograph of another portion of fracture surface that thinned to 605  $\mu\text{m}$  (0.024 in).

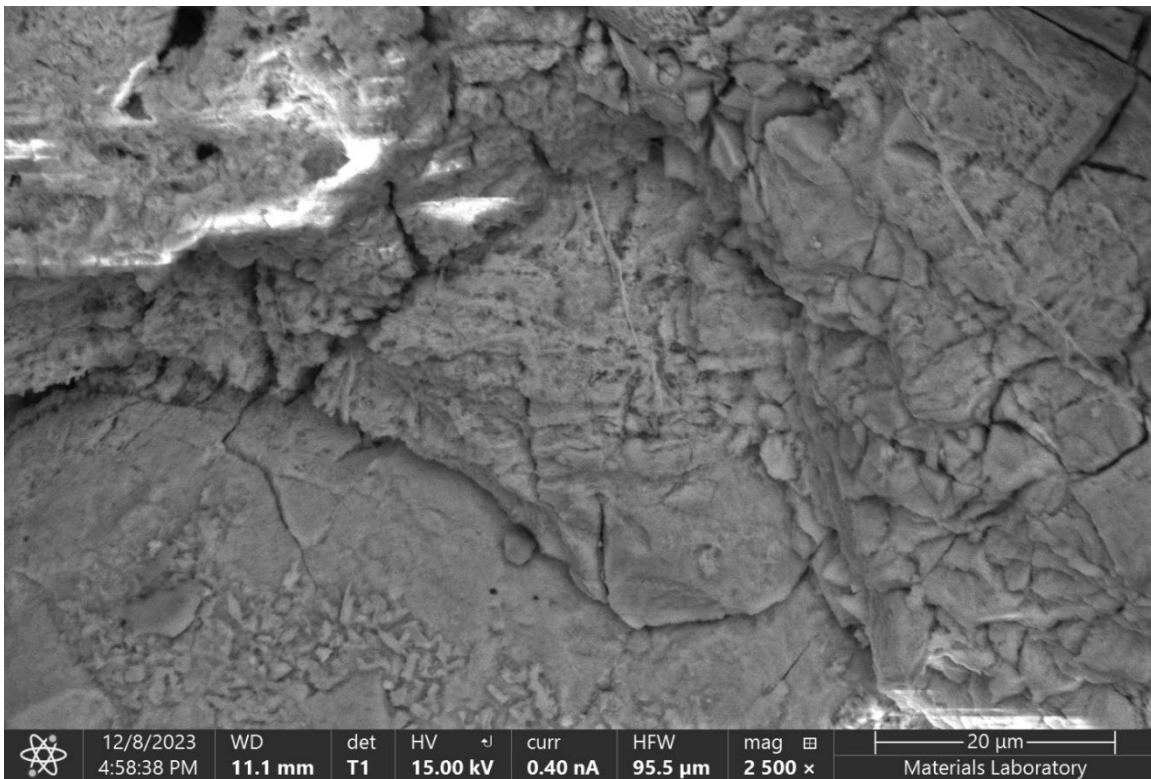
**Figure 17.** BE micrograph of layered surface oxide on the surface of the thin fracture surface

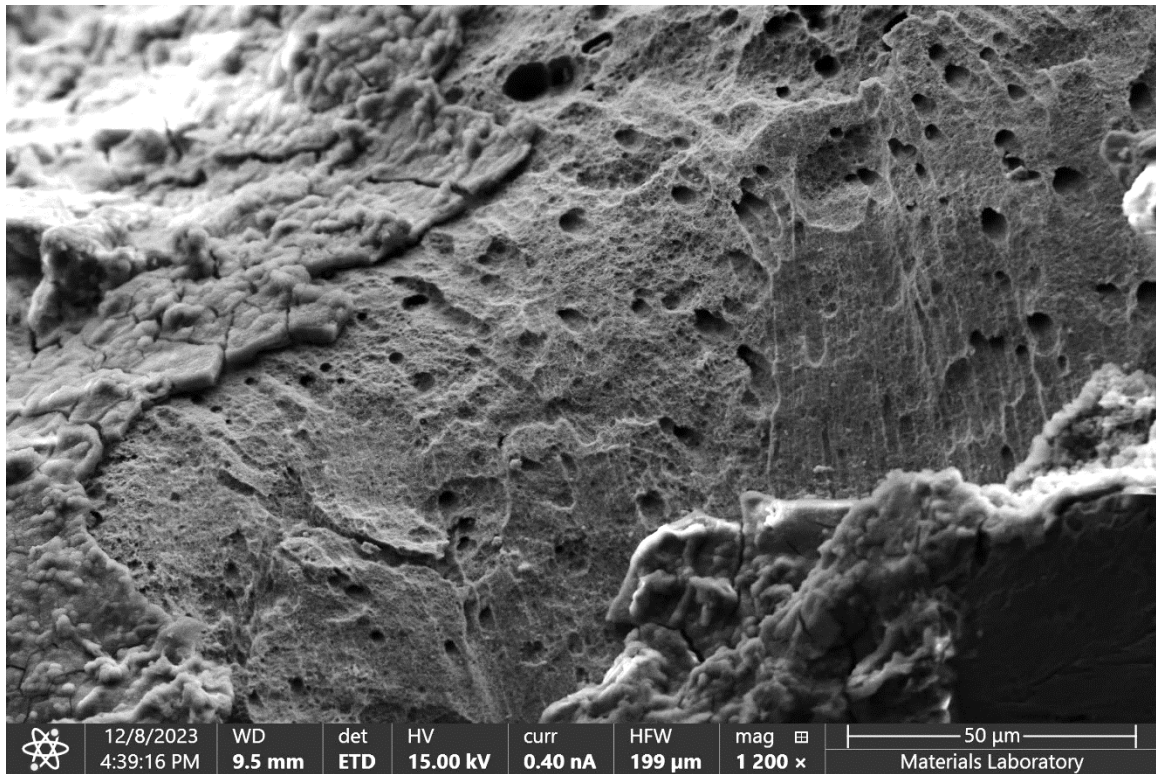
**Figure 18.** SE micrograph of the thinned area of the fracture where oxide had been removed.

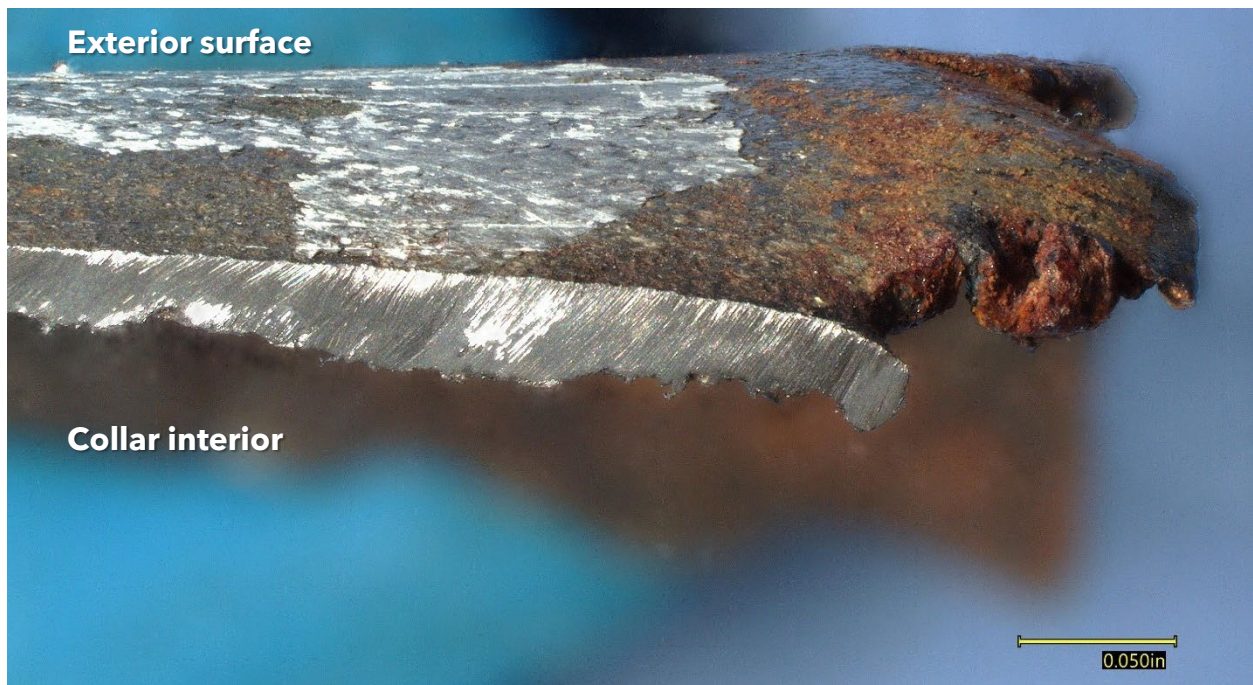
The thinned area of the collar fracture was cross-sectioned for metallographic examination. Figure 19 shows one of the cut surfaces after sectioning, illustrating the thinning that occurred toward the tip of the fracture. Figure 20 shows a second cut and the degree of thinning revealed in the sections, as opposed to slanted or cup-and-cone morphologies typical of overstress fractures.

**Figure 19.** Cross section through the thin fracture surface, viewed from the side.

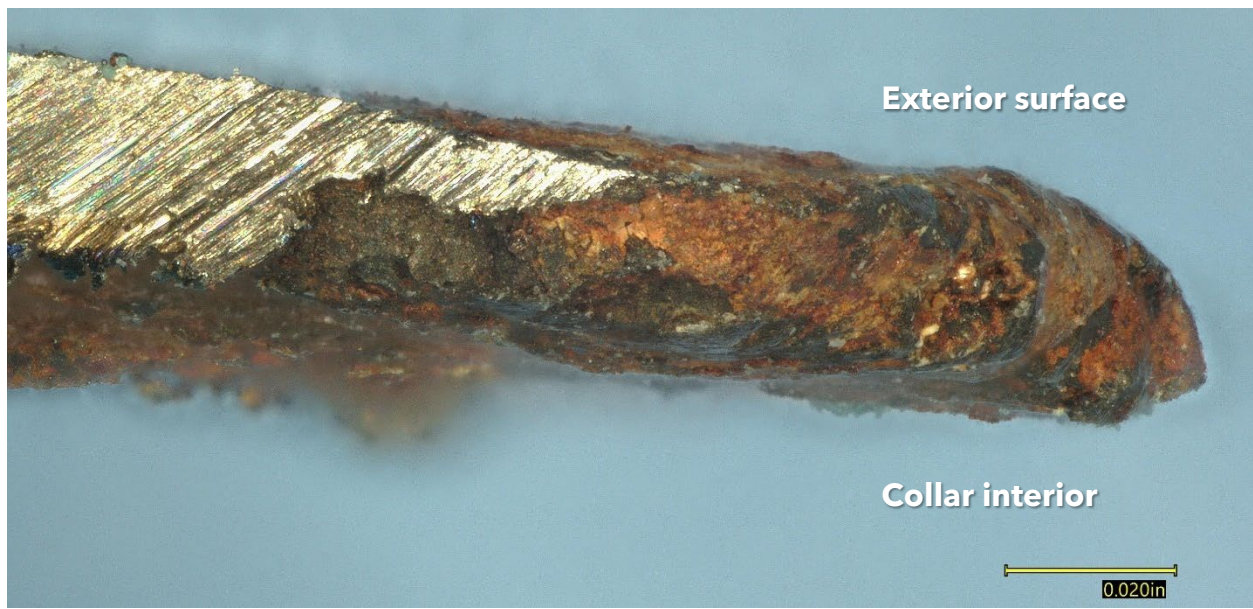
**Figure 20.** View of a second cross section through the thinned fracture surface.

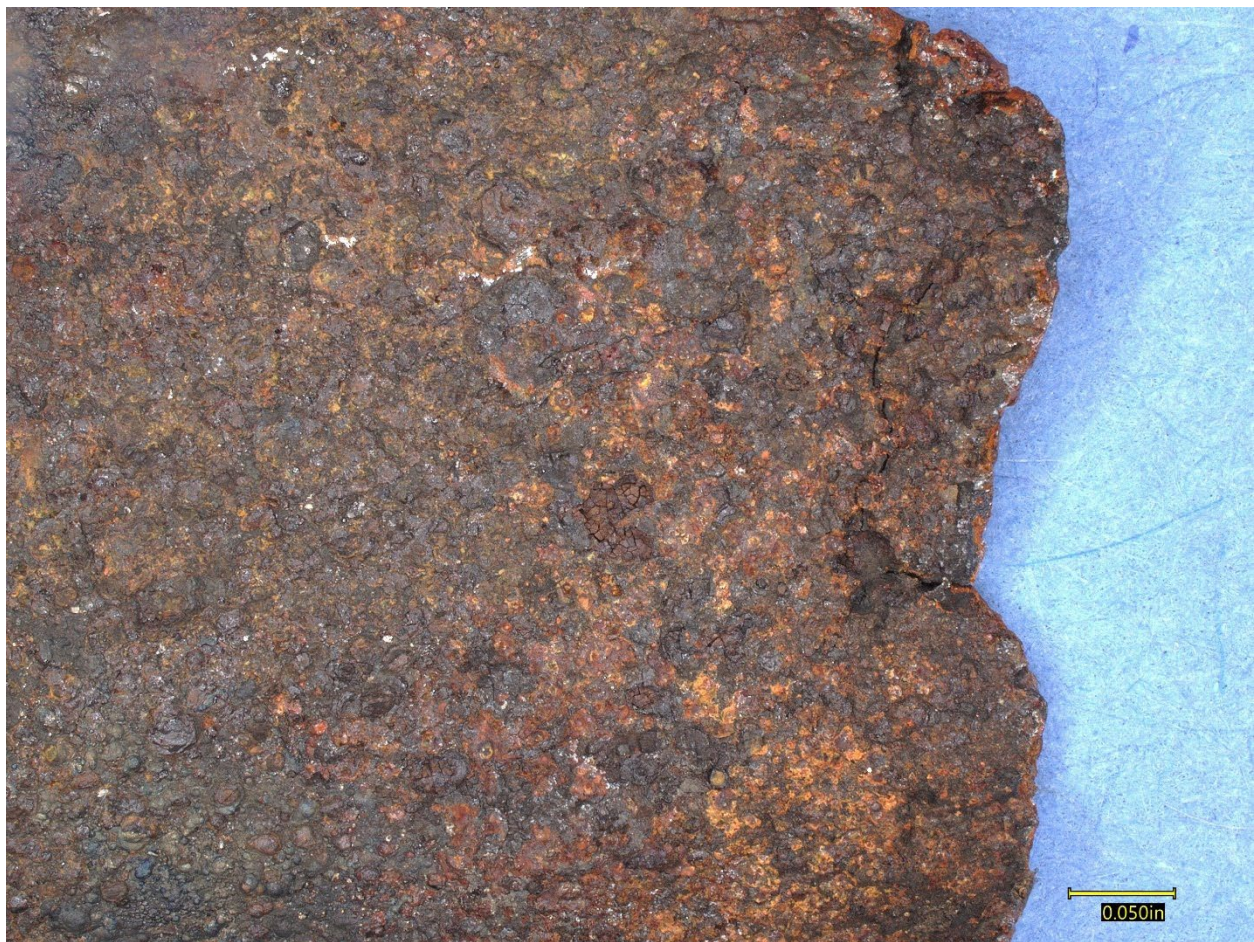
The interior of the leg near the fracture is shown in Figure 21. Besides thick corrosion product layers, the interior surface exhibited multiple pock-marked shapes consistent with corrosion pitting. One such pit near the fracture surface is highlighted in Figure 22, which is evident as connected depressions with two cracks emanating from the pit. These interior pits and cracks were common along the interior surface of the leg near the axle collar.

**Figure 21.** View of the inside surface of the leg tube of the collar (oriented downward in Figure 20).

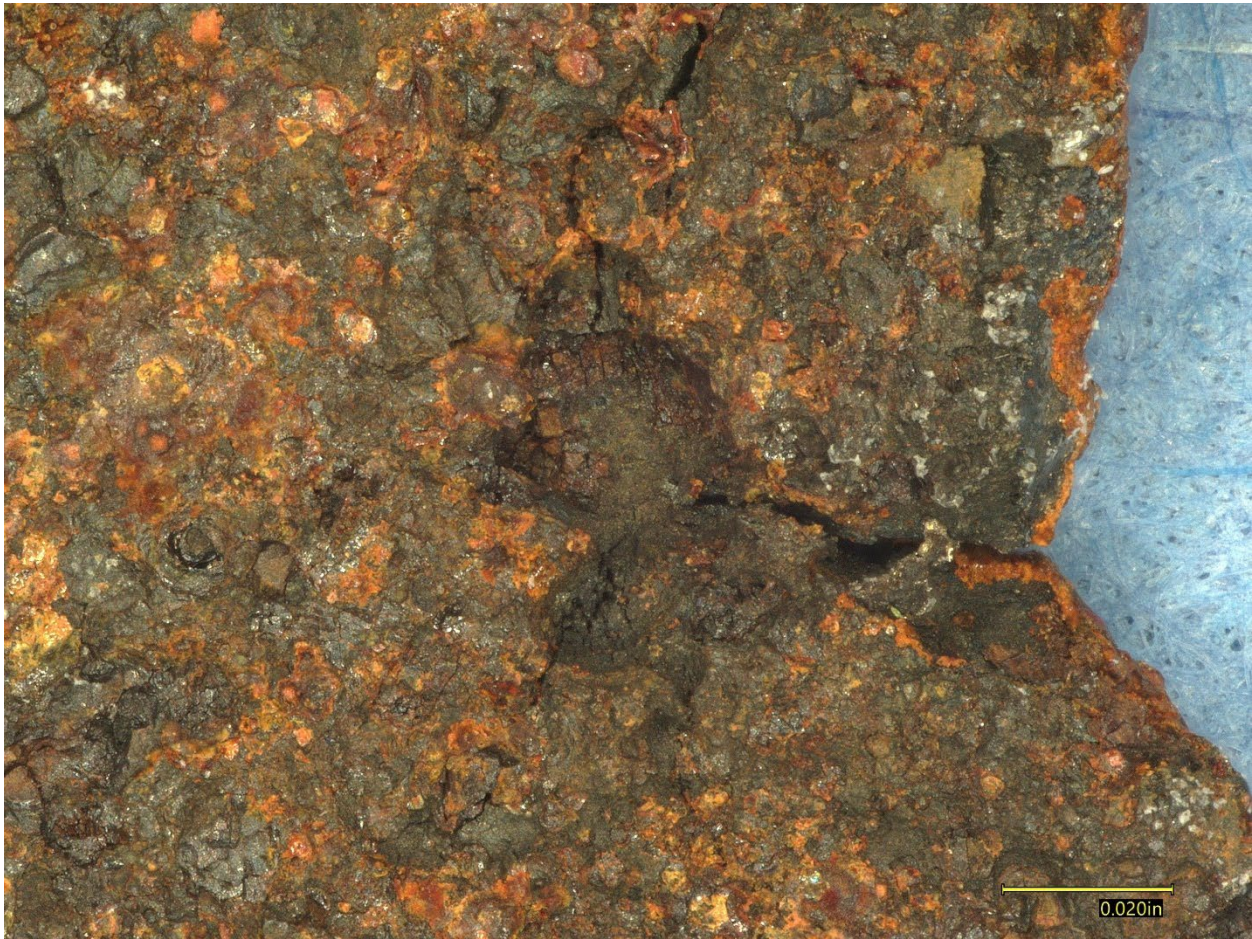
**Figure 22.** Closer view of a pit in Figure 23.
