# National Transportation Safety Board

CEN23LA208

## **MATERIALS LABORATORY**

Factual Report 24-001

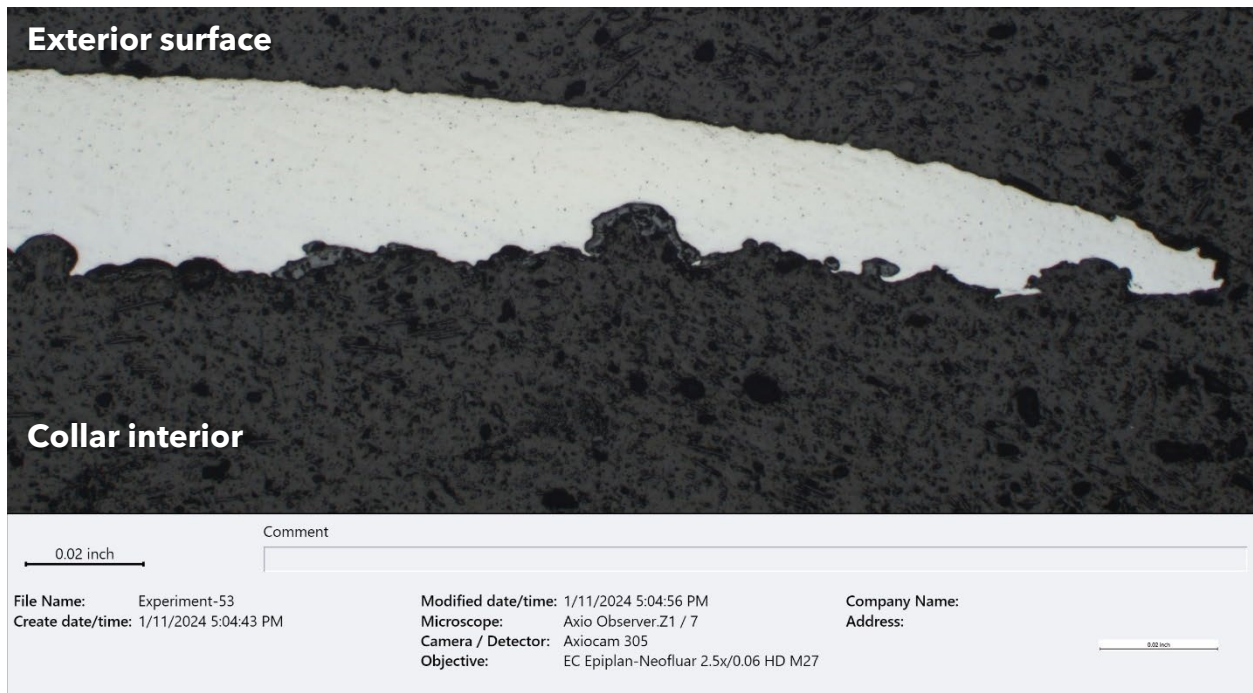
Figures 23 through 25 show bright-field optical micrographs of a polished cross-section through the fracture surface. The surface thinned to a small point, less than 0.01 inches in thickness, shown in Figure 25. While the exterior surface was generally smooth, the interior exhibited multiple pits, which contained corrosion products

**Figure 23.** Bright field (BF) optical micrograph of a cross section through the thinnest part of the landing gear leg collar side fracture (~25X, as polished).

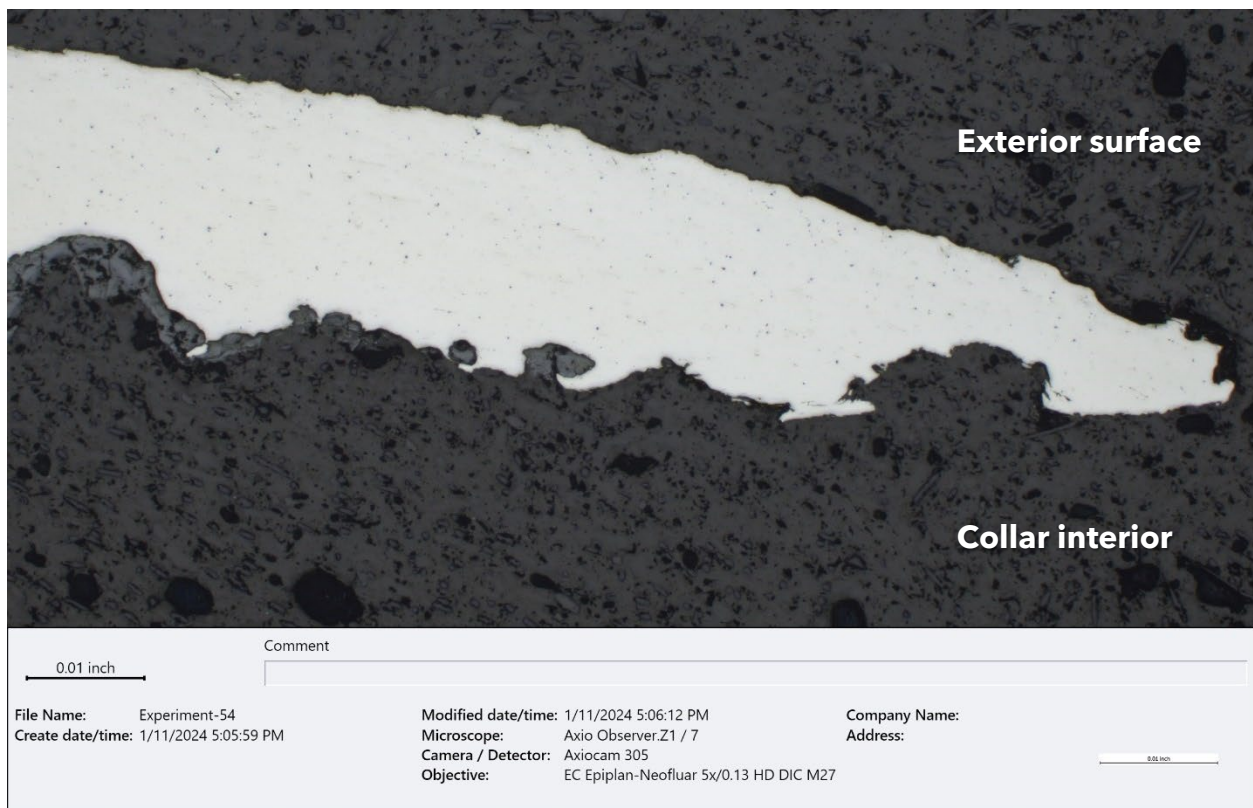
**Figure 24.** BF optical micrograph of the tip of the cross section in **Figure 23**, showing areas of pitting in the interior surface (~100X, as-polished).

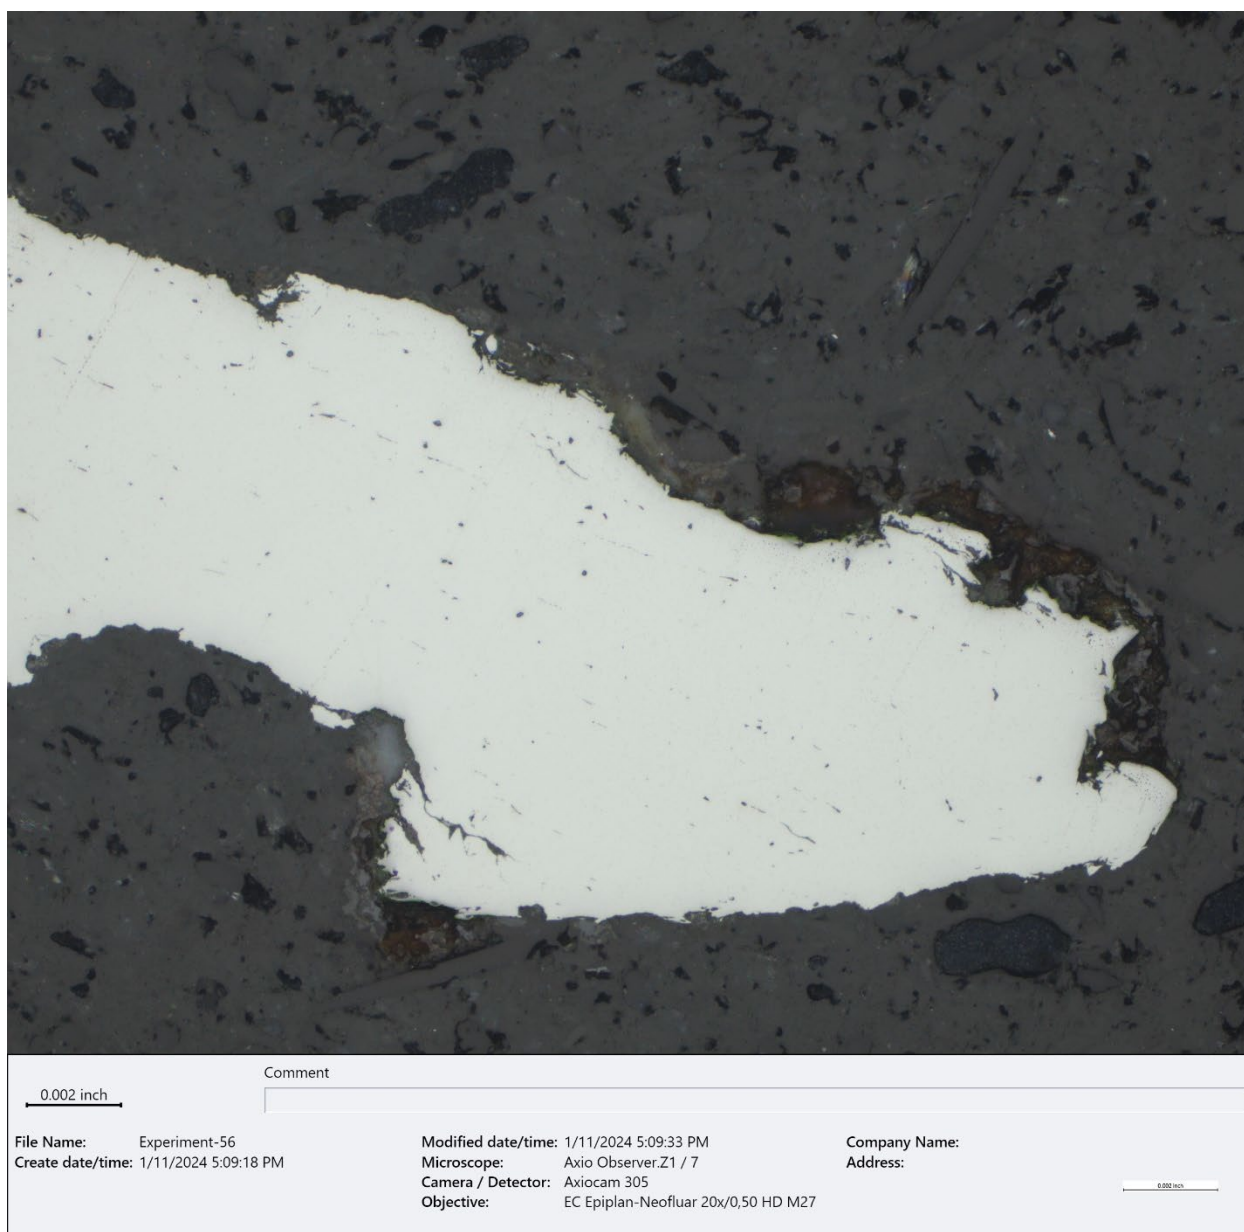
evident as light gray in the micrographs. A closer view of the largest pit in this area is shown in Figure 26. These pits were present along the interior surface and even exhibited microcracks emanating from them, as seen near the tip in Figure 25.

These features were consistent with general corrosion with deep pits on the interior of the lower leg at the collar joint near the axle. The corrosion progressively thinned the leg tube walls over time. The combination of missing material, pitting, and microcracks led to an overstress fracture of the leg at this location on the final landing, which led to two other subsequent overstress fractures.

**Figure 25.** BF optical micrograph of the pit in **Figure 24**, showing pitting along the surfaces, with internal cracks emanating from the interior pit (~200X, as-polished).

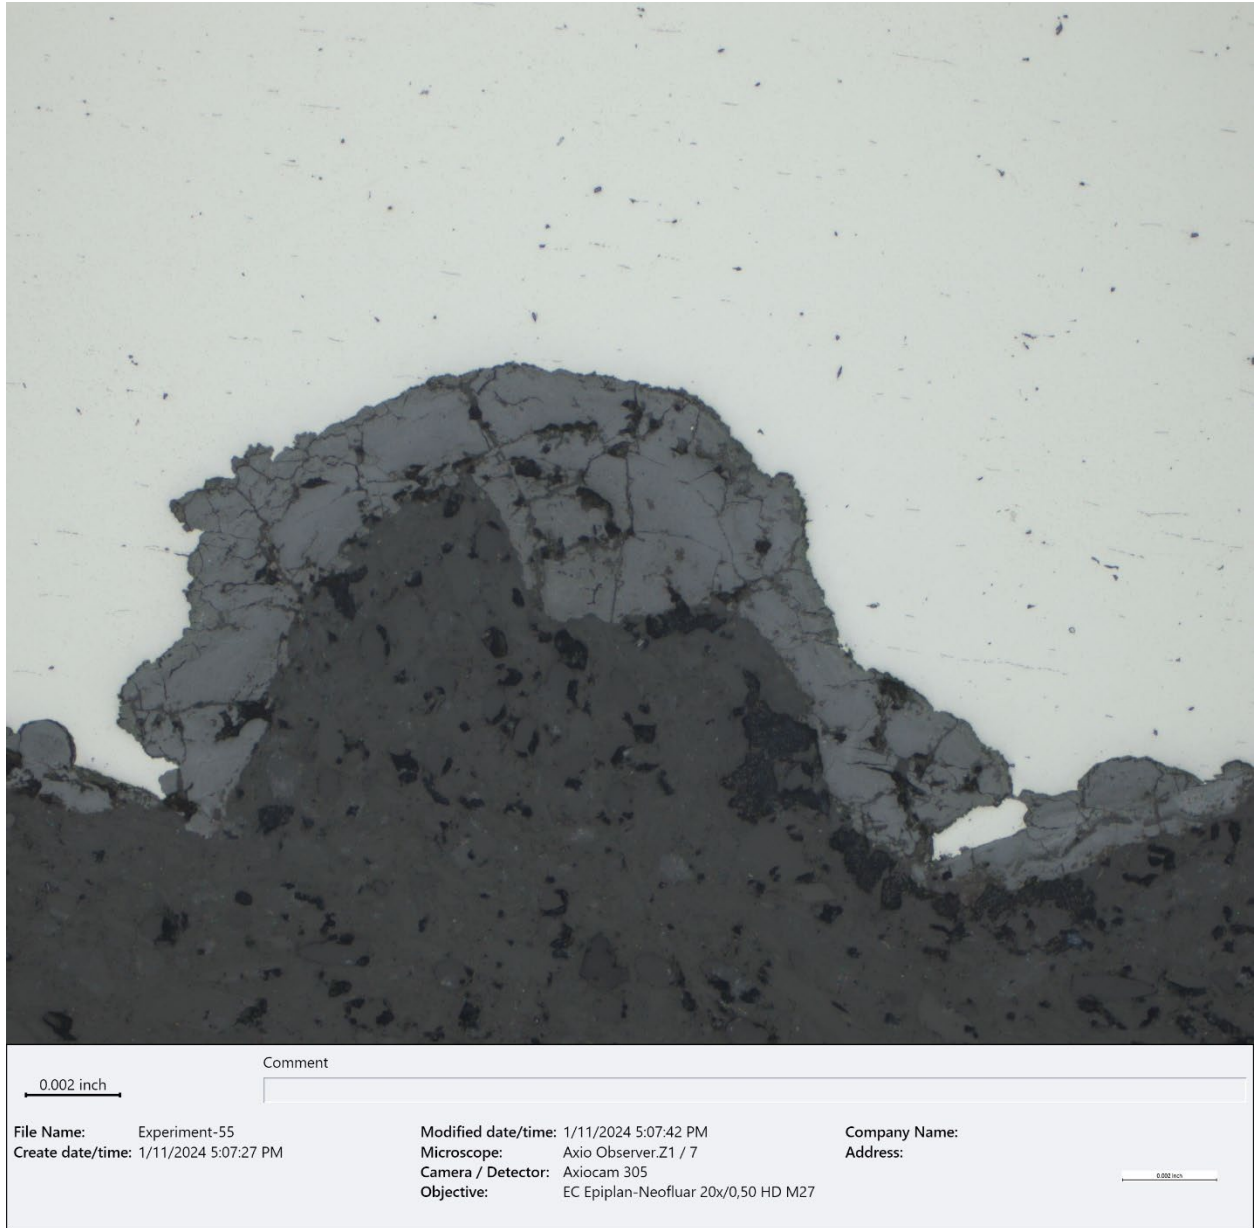
**Figure 26.** BF optical micrograph of a interior surface pit, showing nonmetallic compounds (light gray) inside the pit (~200X, as-polished).

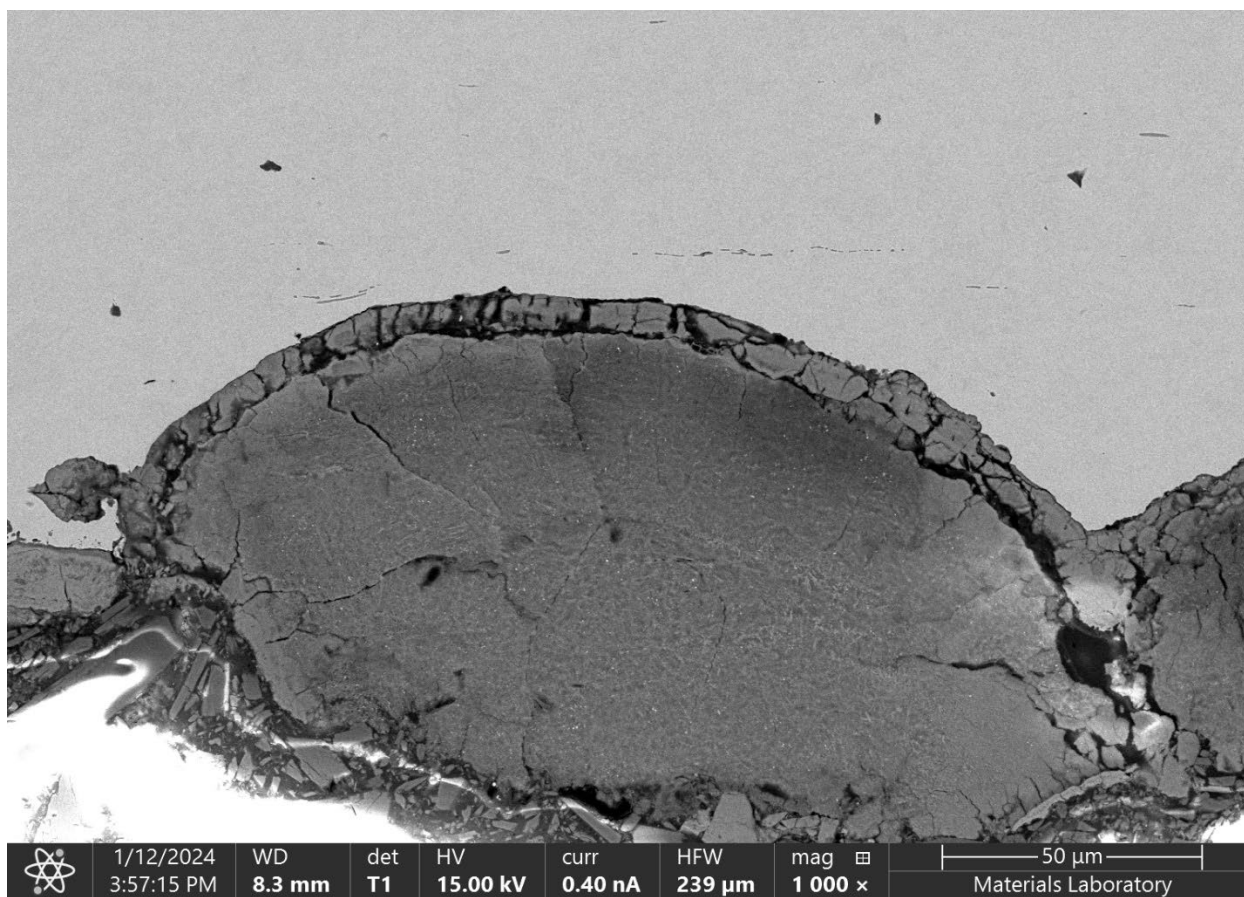
The polished cross-section was examined in an SEM for chemical analysis. One of the cross-sectioned pits examined is illustrated in Figure 26—this location was filled with corrosion products. The chemical composition of the sectioned leg was examined using energy dispersive x-ray spectroscopy. A typical spectrum of the polished metal is shown in Figure 28—this composition was consistent with alloy steel. The composition of the corrosion compound in the pit, demonstrated in Figure 29, was consistent with iron oxide. In addition, this oxide contained minor amounts of chlorine.

**Figure 27.** BE micrograph of a smaller, but intact pit, showing the non-metallic corrosion compounds in darker gray.

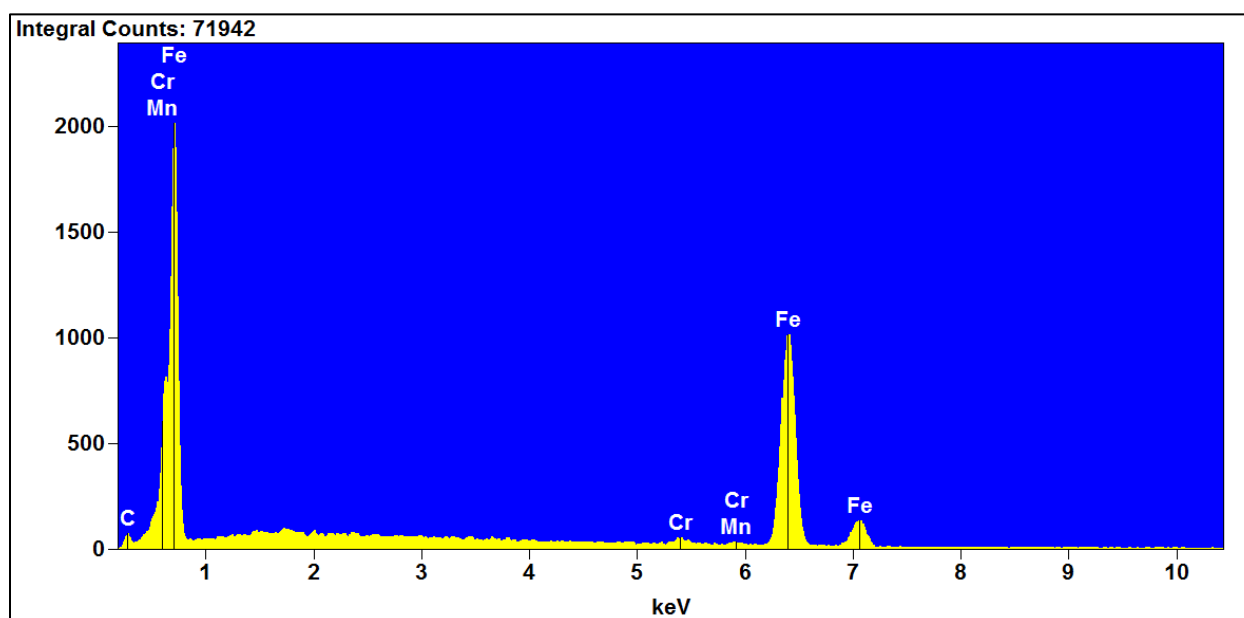
**Figure 28.** EDS spectrum of a typical area of the cross sectioned landing gear remnant (lighter colored) in **Figure 27**.

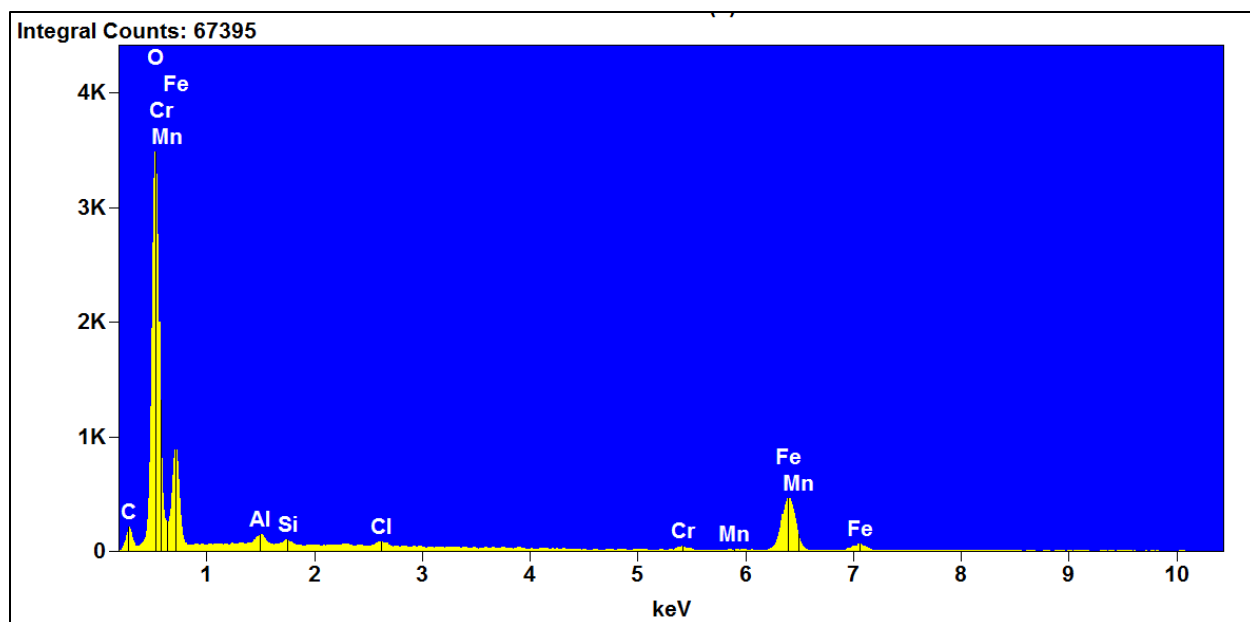
**Figure 29.** EDS spectrum of the nonmetallic (dark gray) material in the corrosion pit in **Figure 27**.
