## THE DON LUSCOMBE AVIATION HISTORY FOUNDATION

Luscombe Silvaire model 8 Aircraft Type Certificate Holder

### SERVICE RECOMMENDATION #4

January 22, 1996

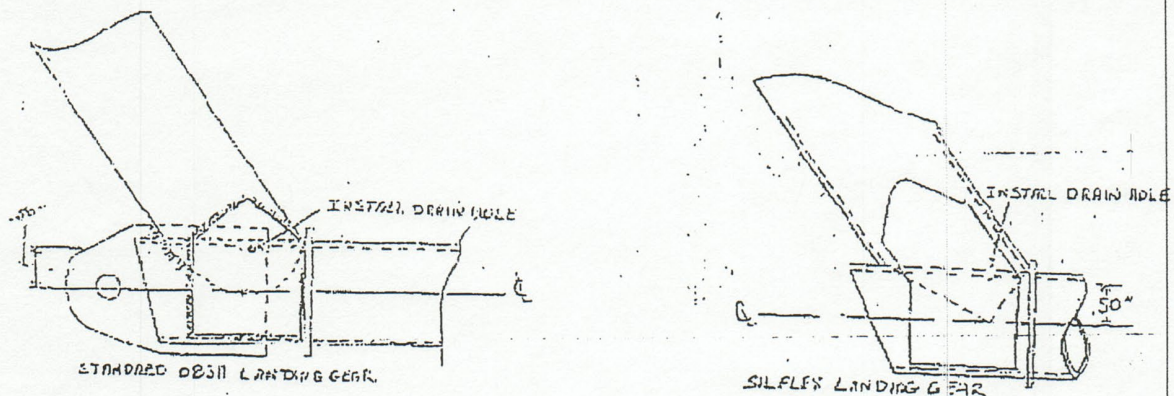
**FIGURE A**

**Background:** NTSB and several owners have reported failure of the main landing gear leg within the 2" area just above the axle weldment (see fig A). Corrosion damage in this area can be exacerbated by loose attachments and fittings to the gear leg which can lead to metal fatigue. The past few years of Luscombe operations have been punctuated by owner/operator reports of rust damage, or in several occasions, complete failure of the lower main gear leg from corrosion just above the axle shaft weld joint. Mechanics in the field have also reported "weld" repairs to gearlegs which are not authorized on Luscombe landing gear.

Condensation within the gear leg lets moisture accumulate in the sealed leg between the axle tube and the first hole up the leg where the brake pulley mounting bolt pierces the assembly, which makes this section particularly susceptible to corrosion.

**Compliance procedure:** Remove the gear fairings as necessary to gain access to the lower gear leg area for inspection. Locate the reinforcement patch on the rear side of the gearleg and centerpunch the reinforcement as noted on figure A. Drill the reinforcement and gearleg with a small hole (1/8") in the center of the reinforcement patch area where the upper leg joins the axle, just slightly (1/2") above the axle centerline. This drain hole at the rear of the gear leg will allow any trapped moisture to drain from the leg and minimize corrosion to this area. It will also allow some "drying air" access to the area to keep corrosion to a minimum.

**Inspect:** Inspect the area and note any water draining, or rust dust/flakes that might come out on the drill or a wire inserted into the hole. Use a small ballpeen hammer and scratch awl or punch to prick the base of the upper gear leg above the weld. If you are able to pierce the tubing, replace the lower leg with a new unit. Legs with no water or rust indicated may be returned to service. If there is any question as to the integrity of the leg, complete items 1-3 below. Treatment in accordance with #3 below is advised. NOTE: Inspect for weld repairs to the gear leg. Weld repairs to the gear leg is not an approved procedure. Components containing weld repairs are considered UNAIRWORTHY and must be removed and replaced because welding destroys the heat treat properties of the part.
