Josh,  
N458TW rudder pedal failure [REDACTED]

WITTMAN 2 PLACE - MODEL W-10

RUDDER PEDALS

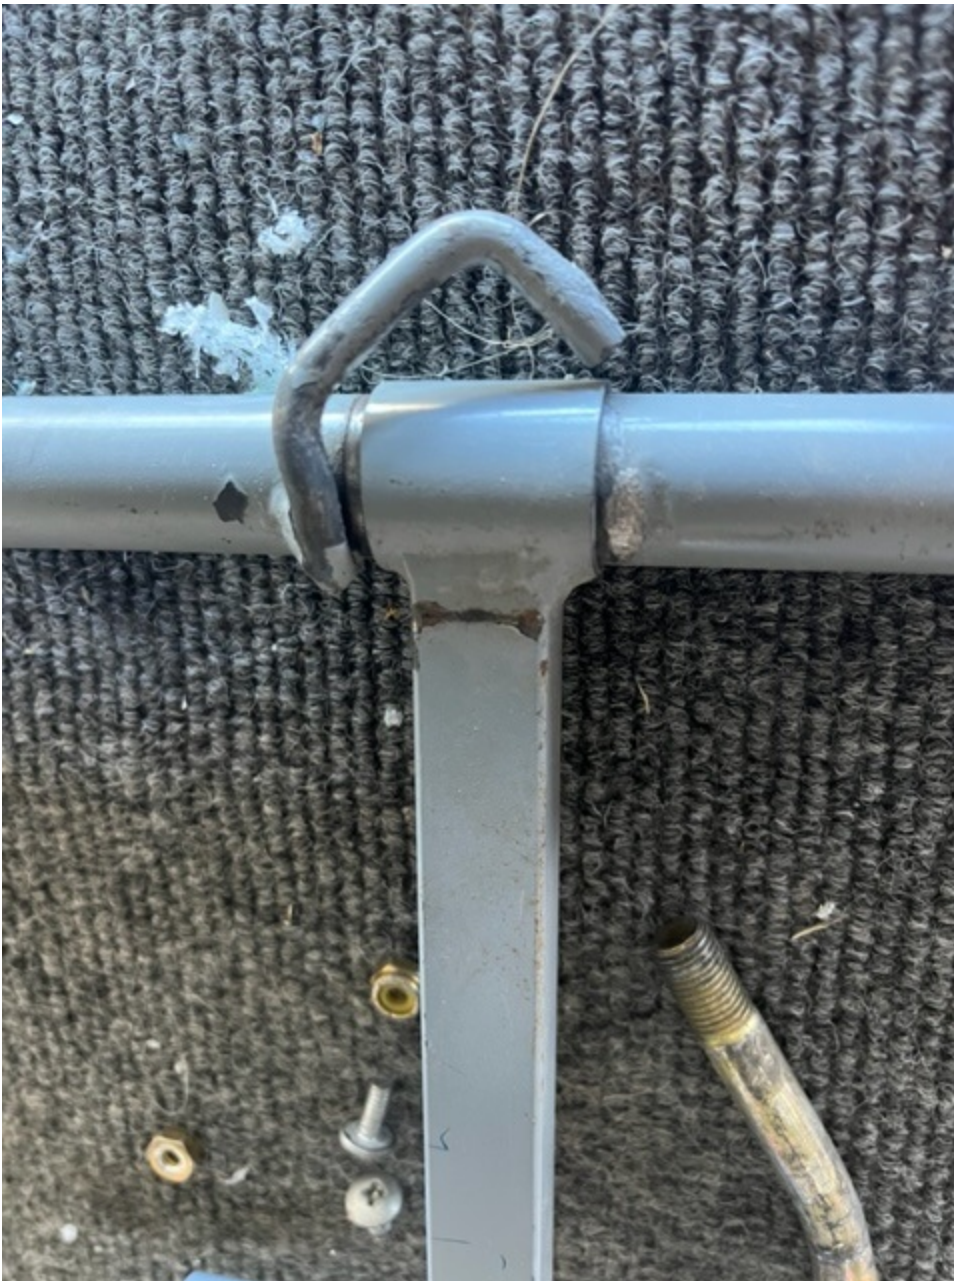
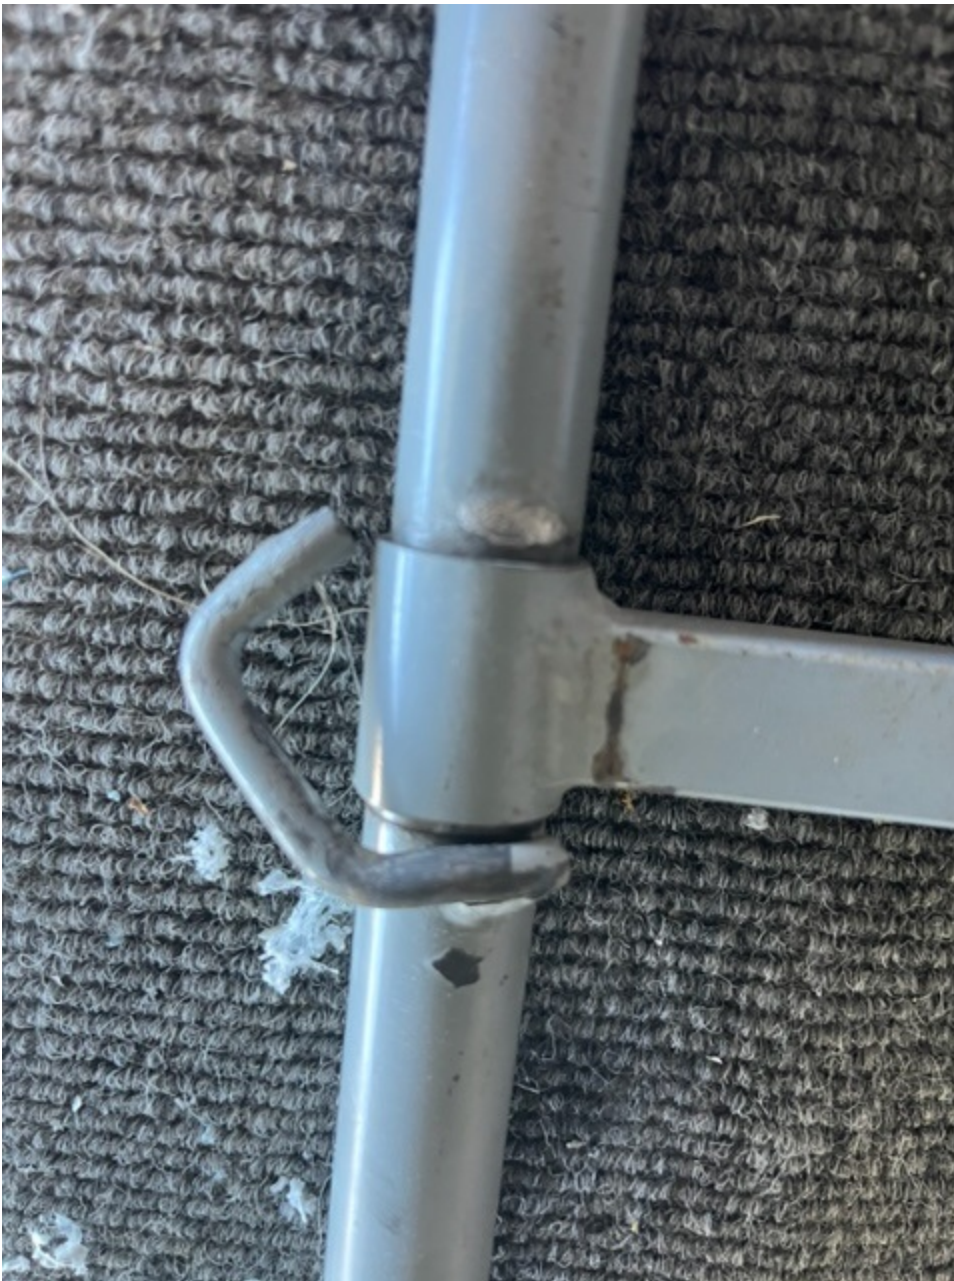
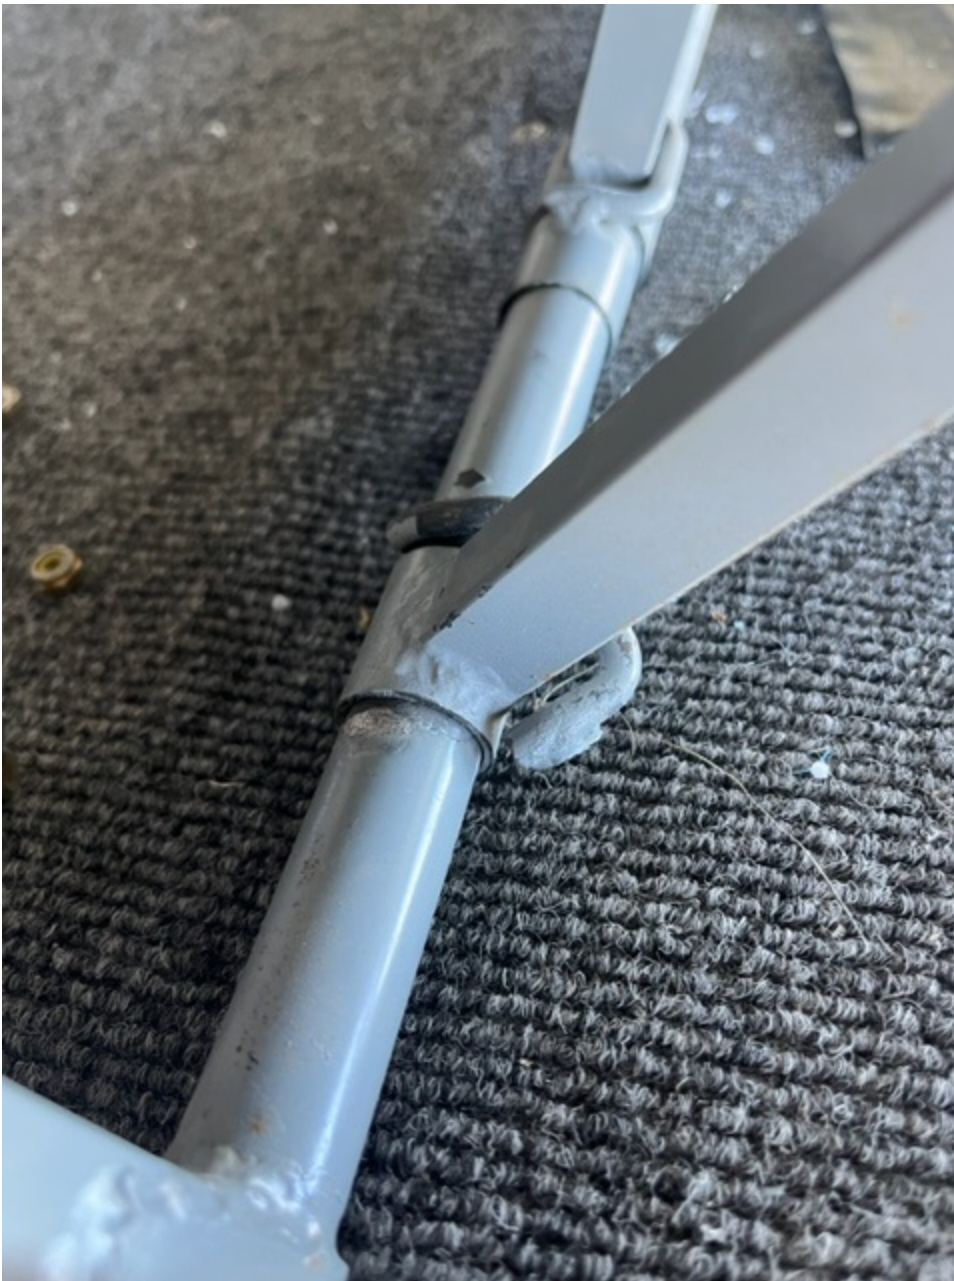
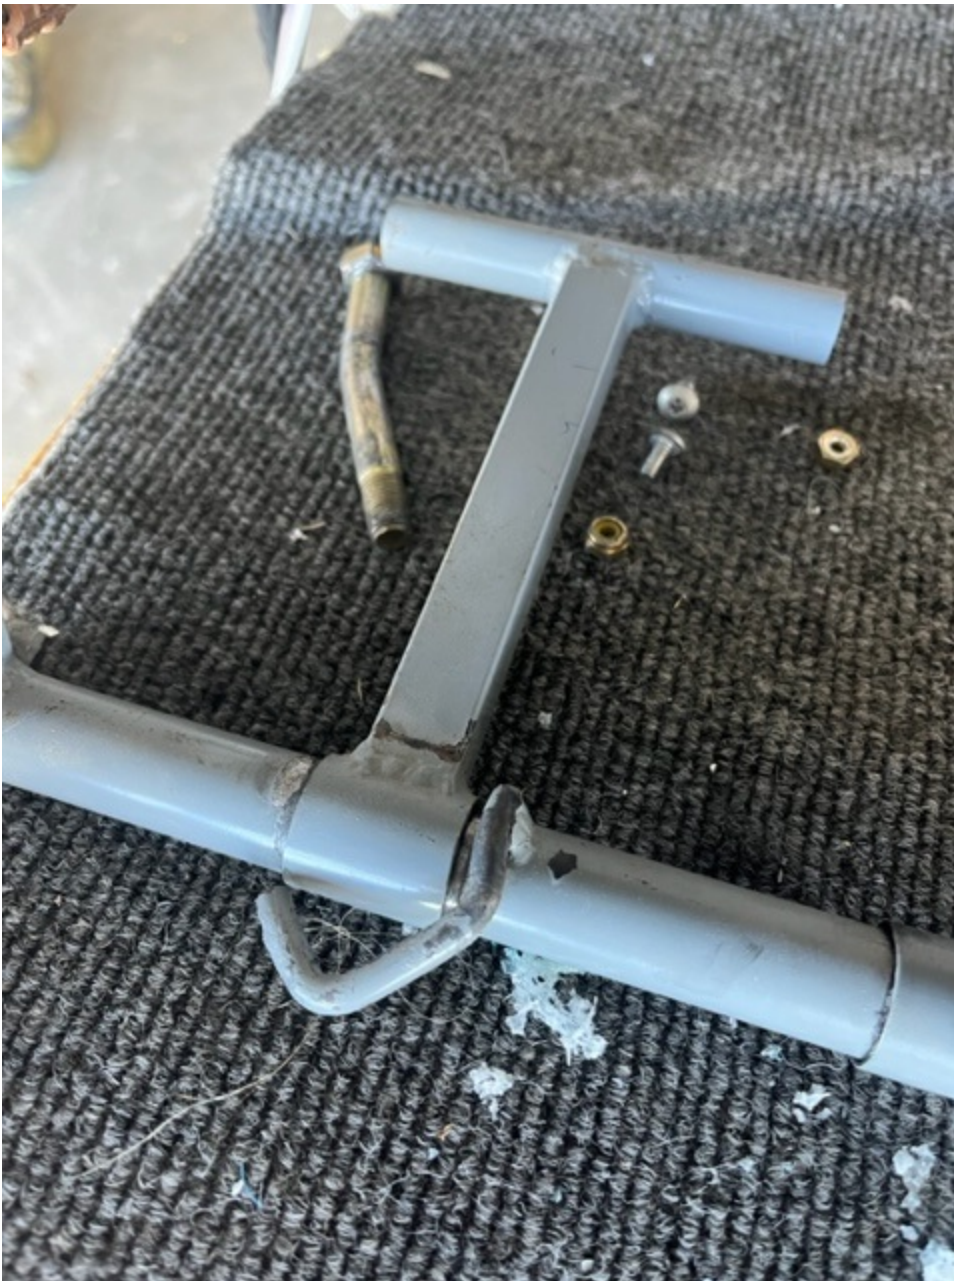
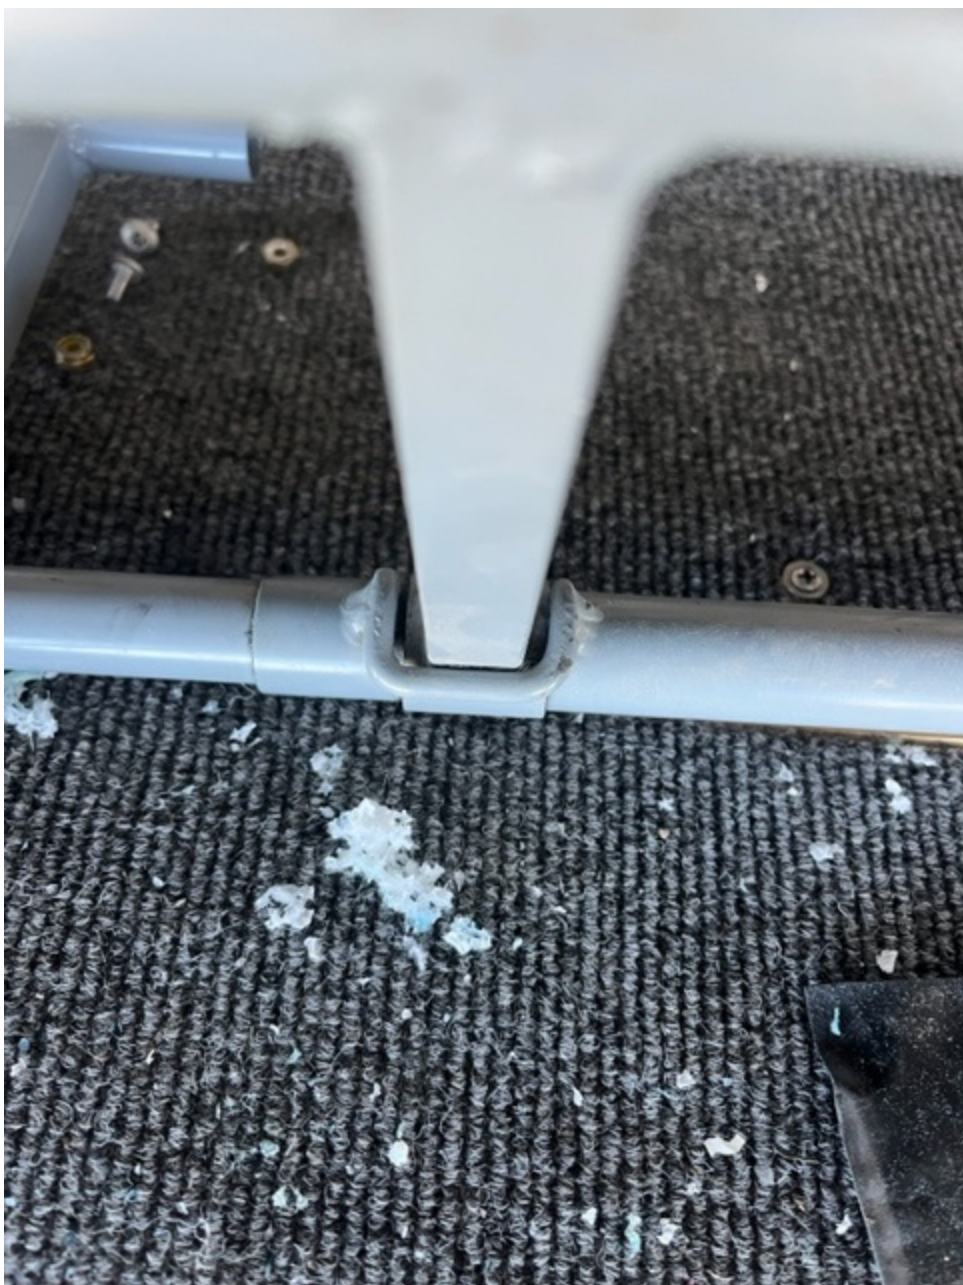
Yep Ill text them to ya..looks like when the rudder bar was made using the 3/16 rod there was no penetration of the metals when welded together. No corrosion

N456TW pics 2 ... experimental in Canon City, Co!
