CEN23LA211

## INVESTIGATION PHOTOGRAPHS

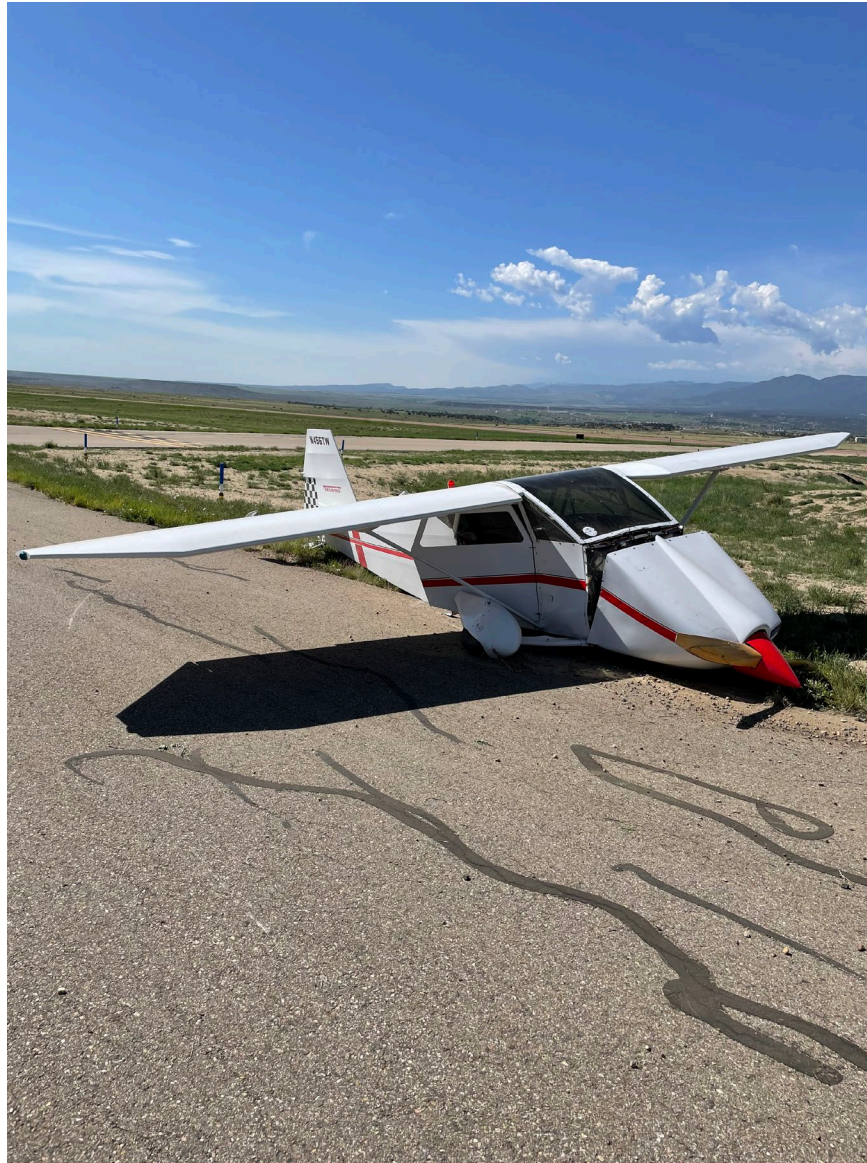
**Photograph 1 - Airplane front right side (Courtesy of pilot)**

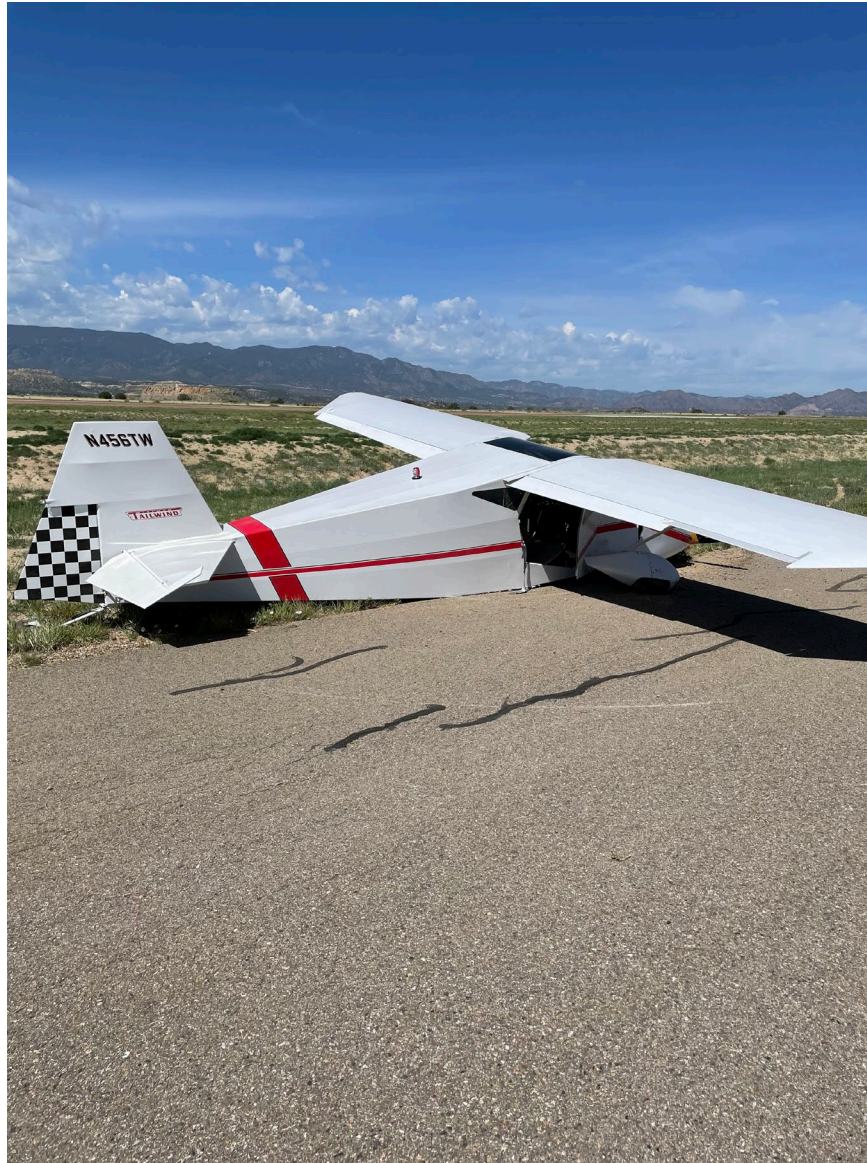
**Photograph 2 - Airplane back right side (Courtesy of pilot)**

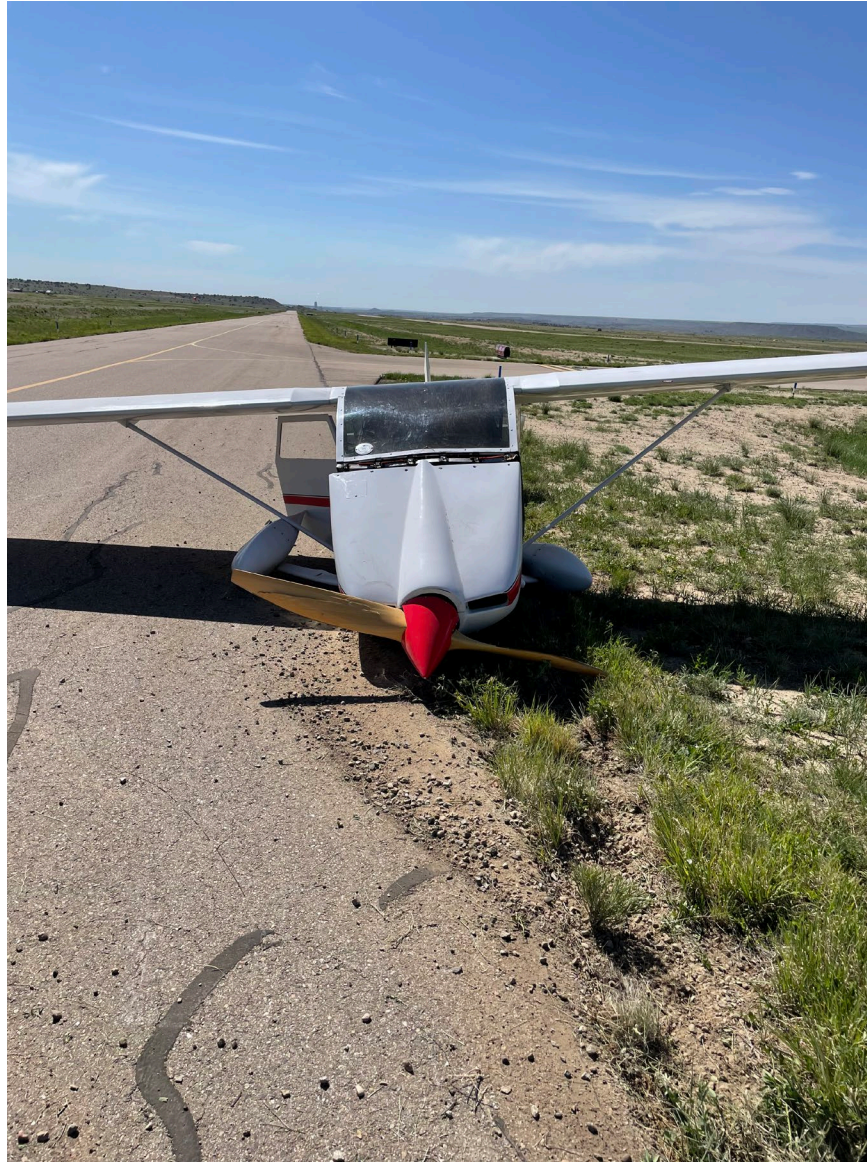
**Photograph 3 - Airplane front side (Courtesy of pilot)**

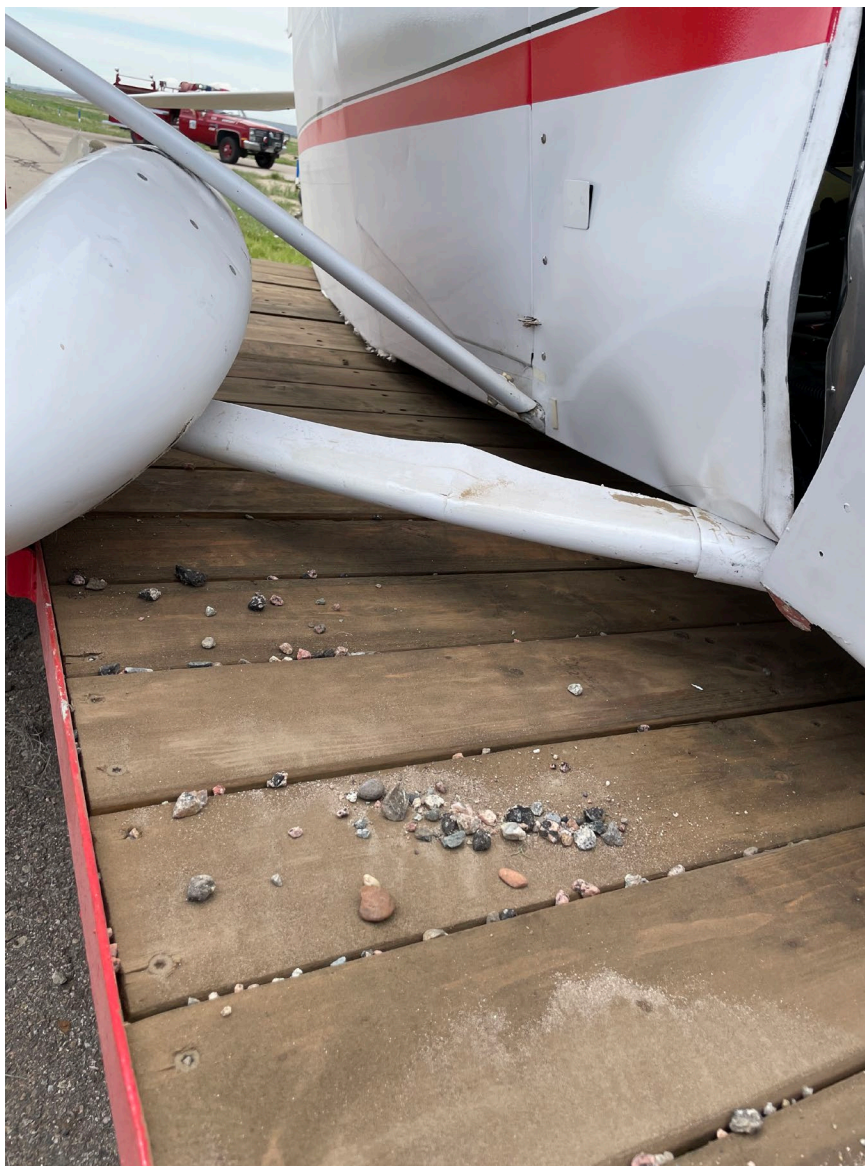
**Photograph 4 - Damaged fuselage (Courtesy of pilot)**

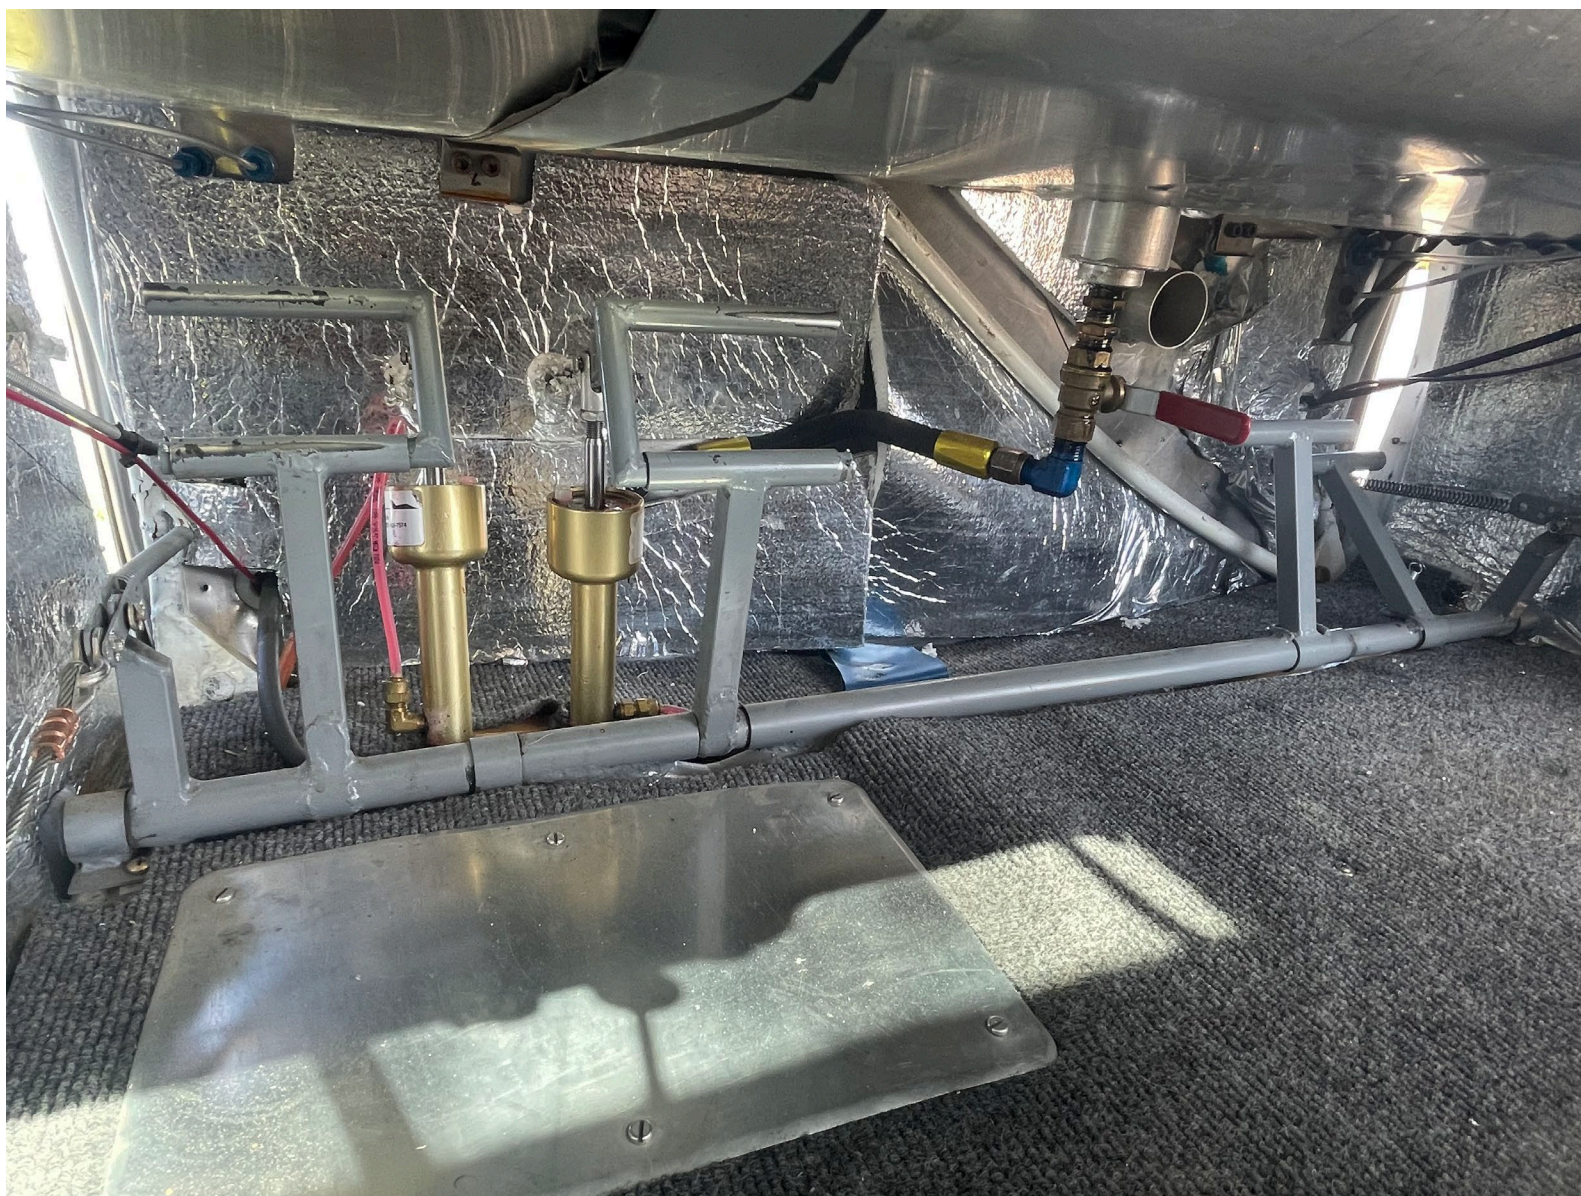
**Photograph 5 - Left and right pedals (Courtesy of pilot)**

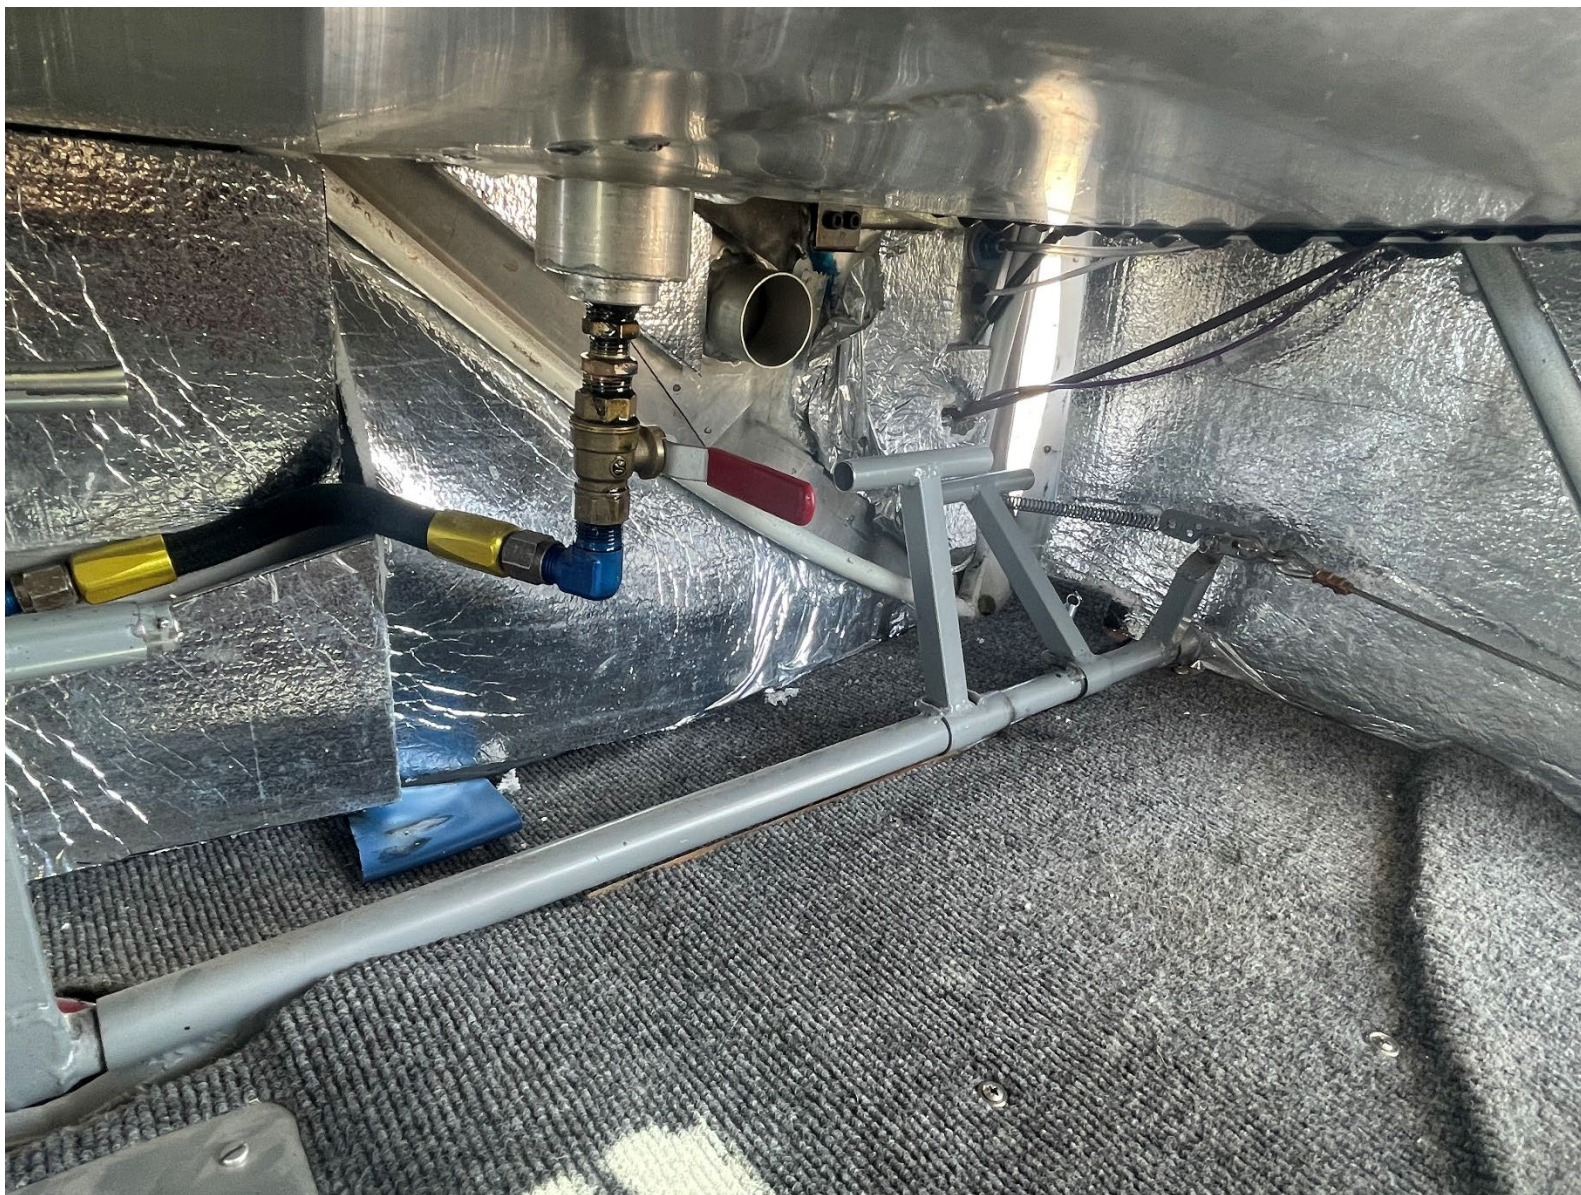
**Photograph 6 - Right side pedals (Courtesy of pilot)**

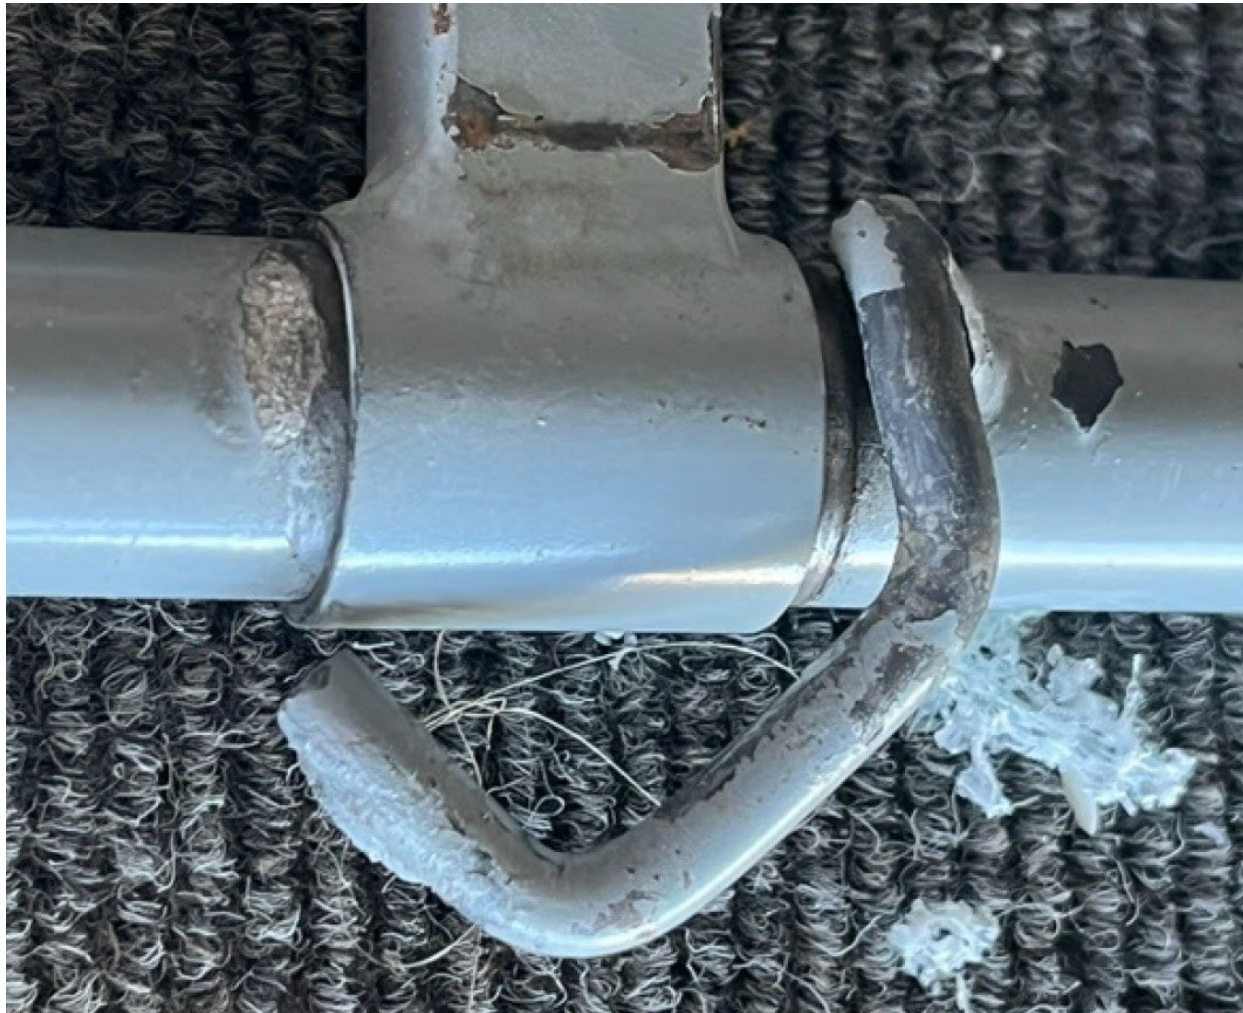
**Photograph 7 - Failed weld (Courtesy of FAA)**

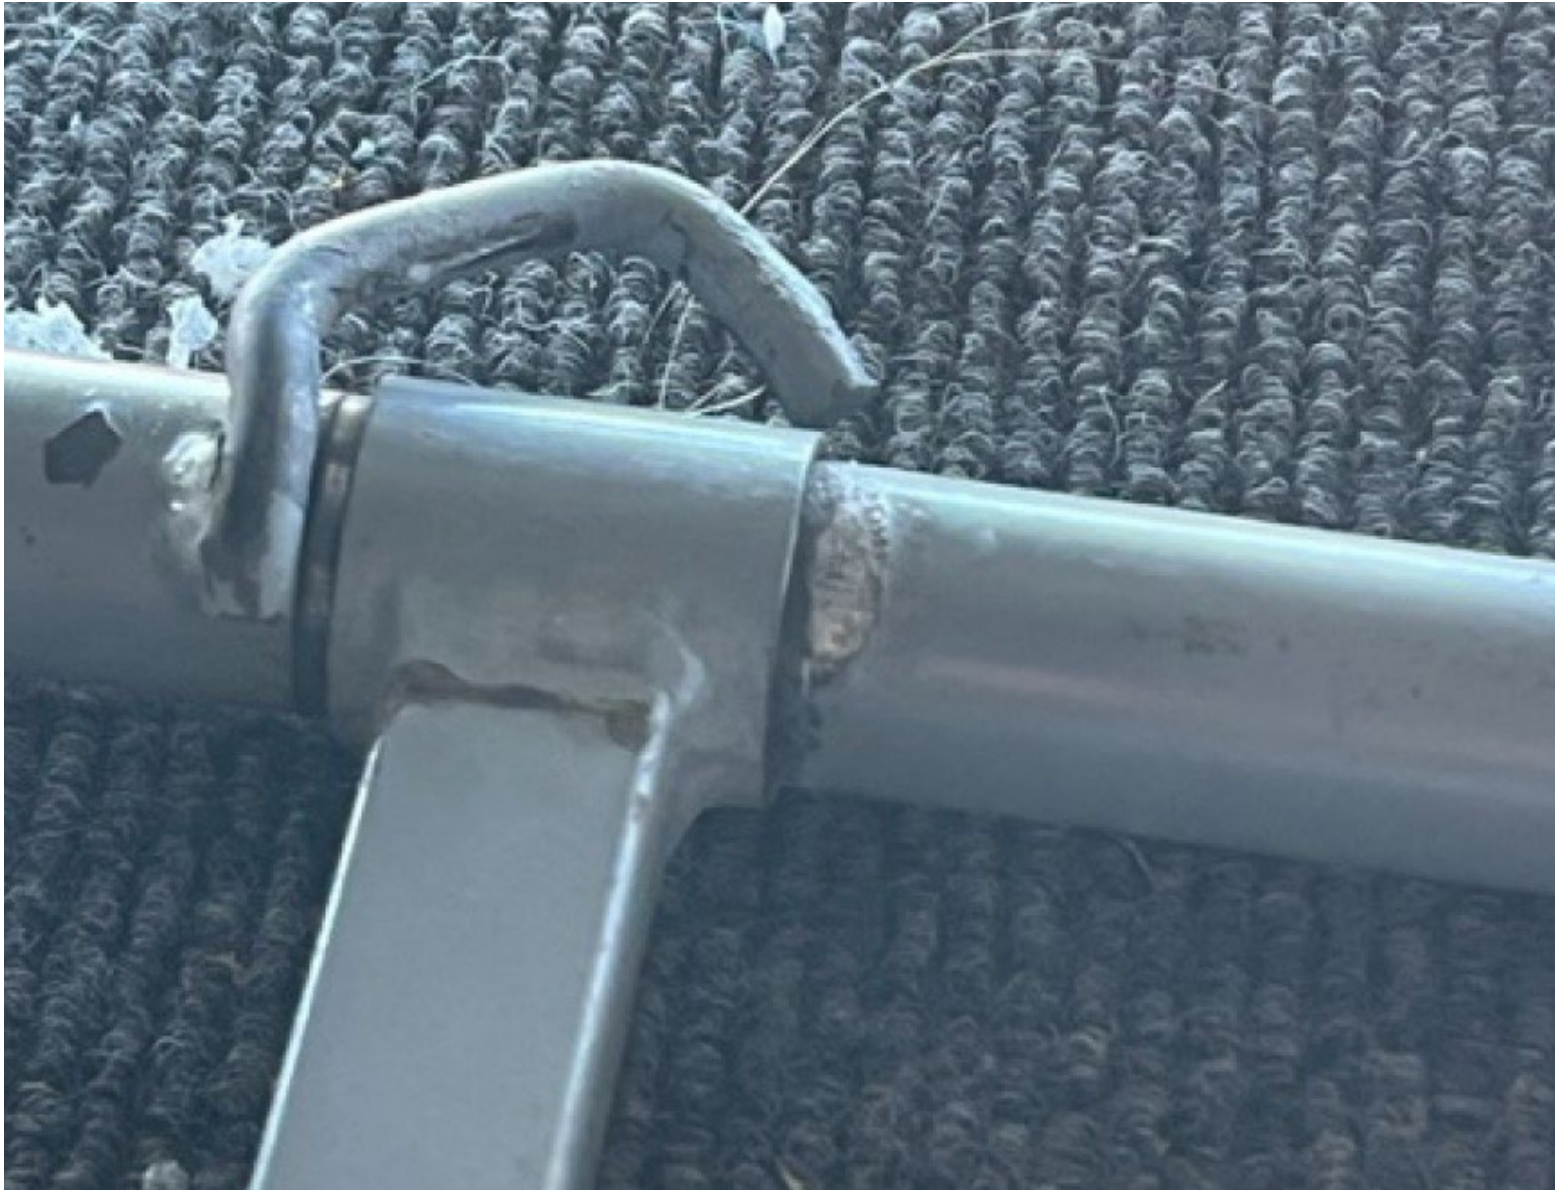
**Photograph 8 - Failed weld (Courtesy of FAA)**

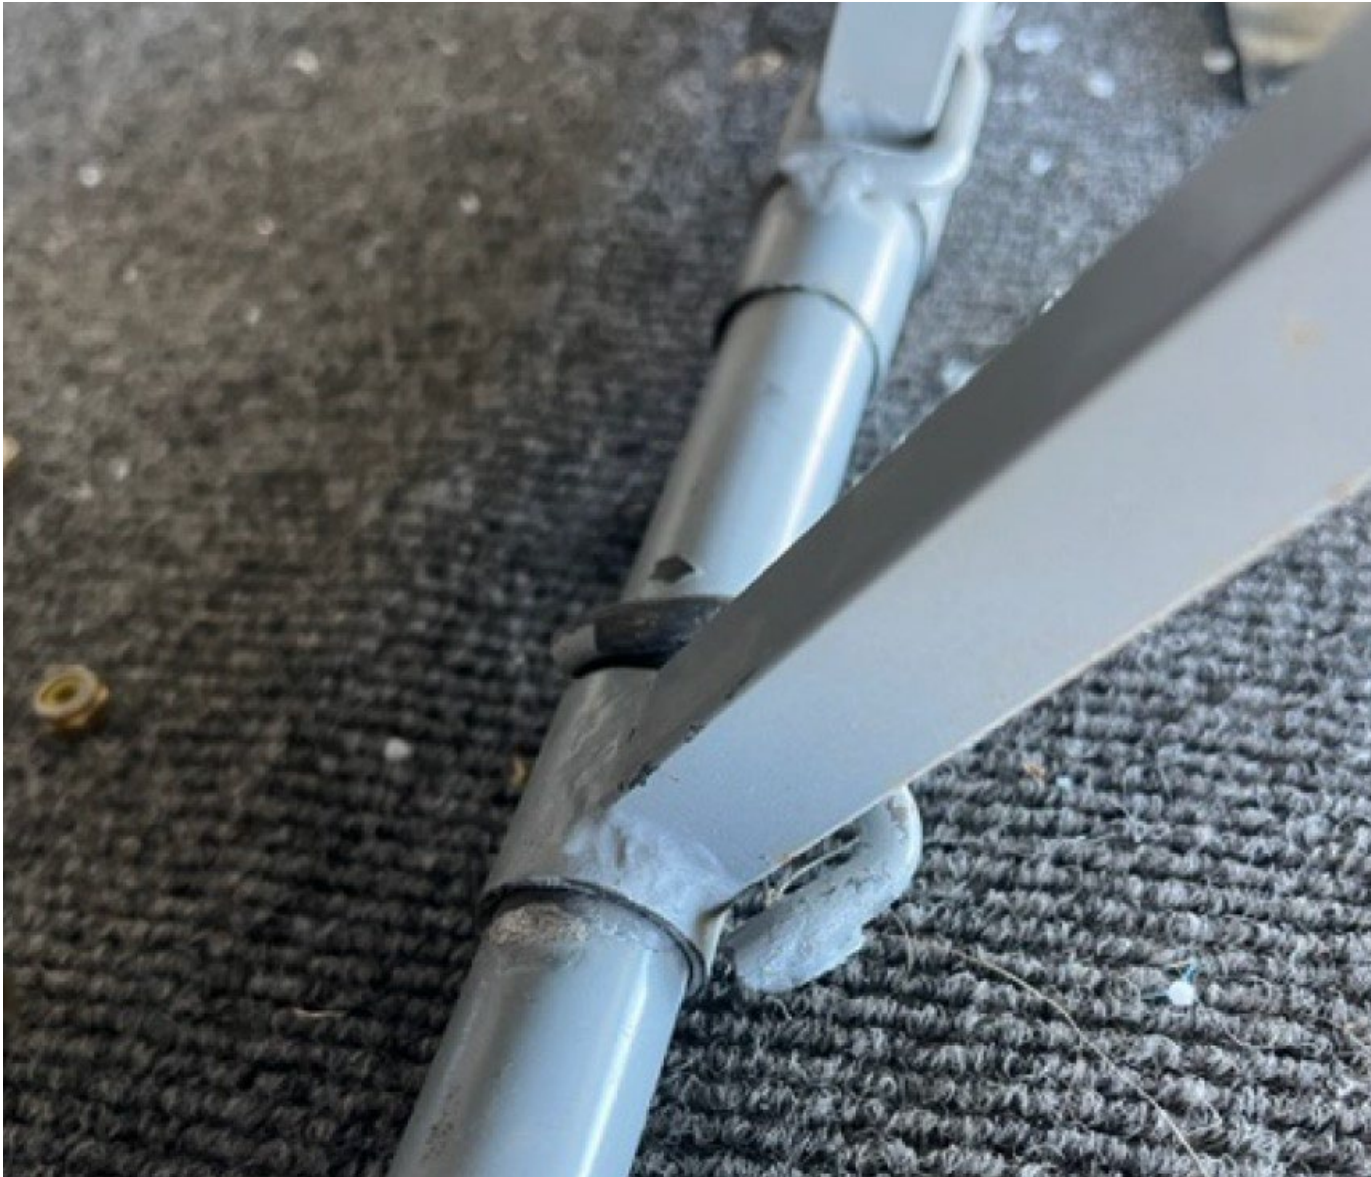
**Photograph 9 - Failed weld (Courtesy of FAA)**

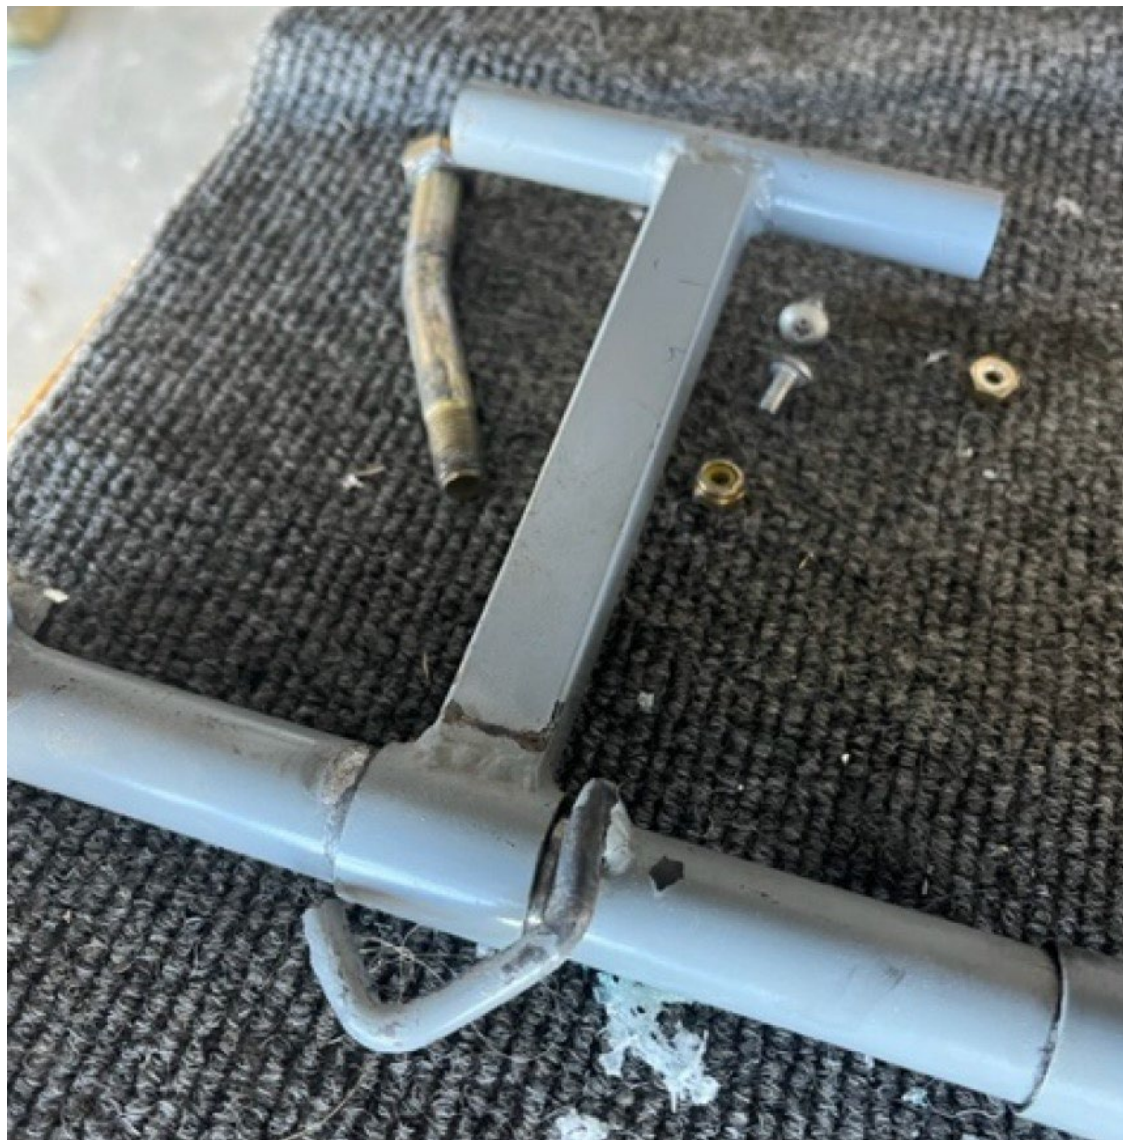
**Photograph 10 - Failed weld (Courtesy of FAA)**
