# National Transportation Safety Board

CEN23LA217

## **MATERIALS LABORATORY**

Factual Report 23-090

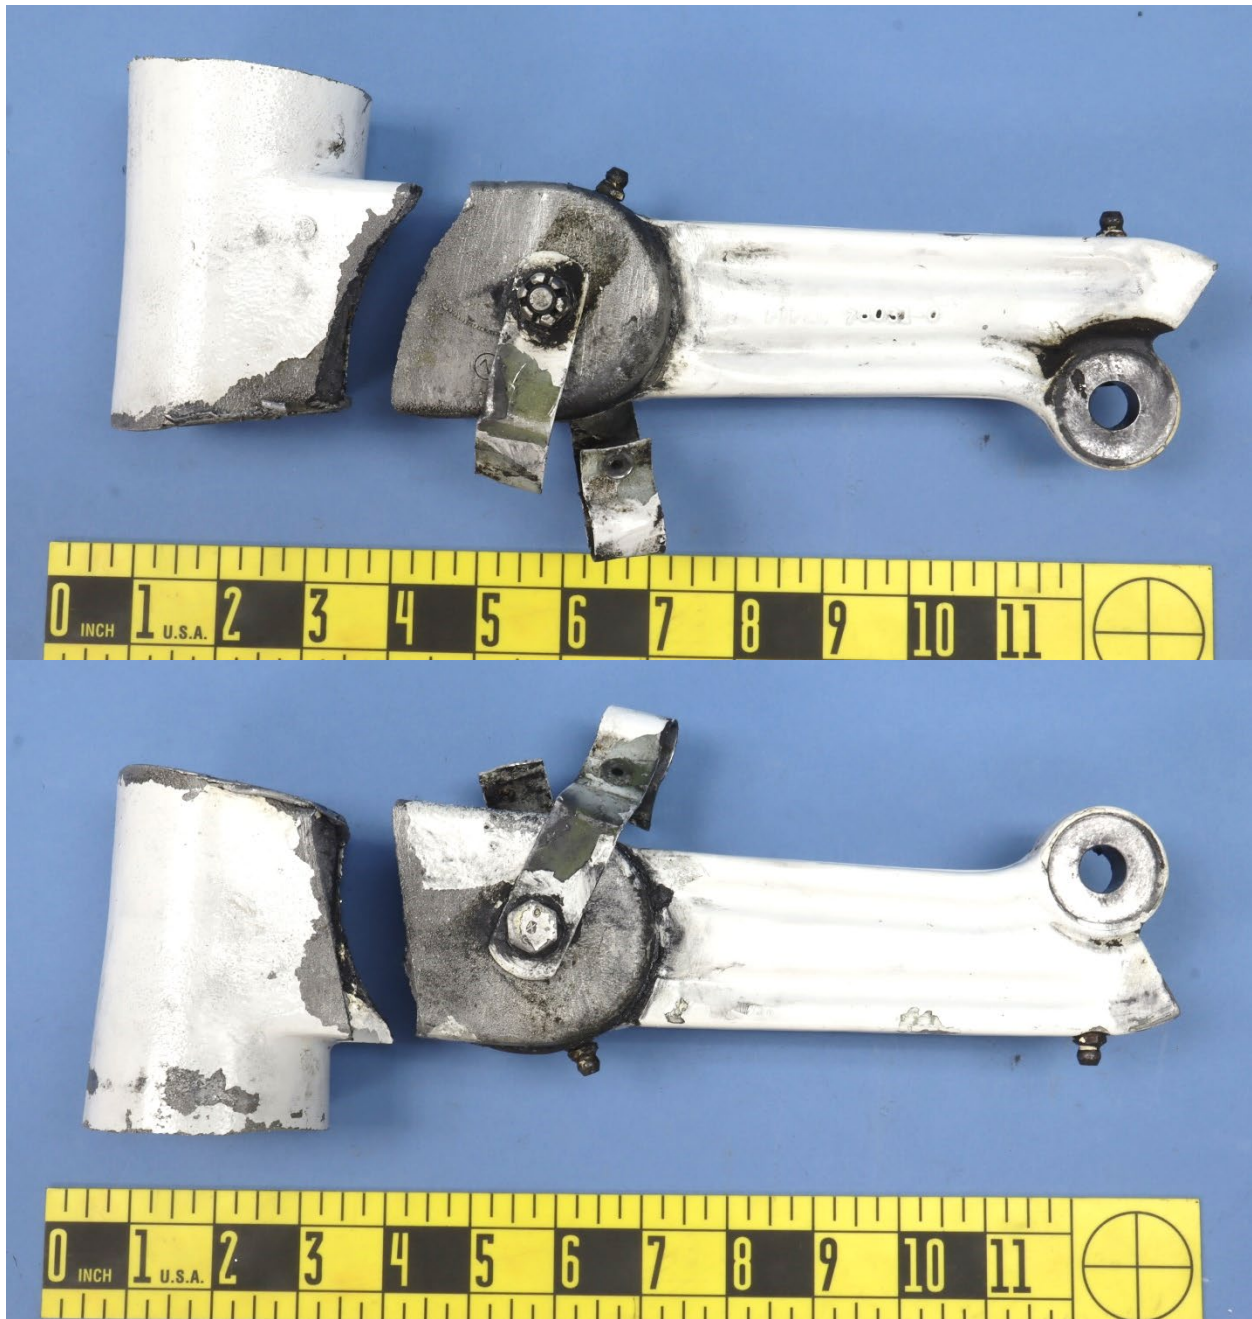
Figure 1 shows the fracture on the strut assembly, consisting of the fractured cylinder, which had been sectioned before receipt, and the torque link assembly arm still affixed to the broken cylinder clevis via the attachment bolt. The cylinder had fractured near the radius with the clevis. The arm shown in Figure 1a exhibited embossed markings that stated, "PIPER 78031-0."

**Figure 1.** View of the opposite sides of the fractured strut assembly clevis remnants attached to the torque link arm, and the sectioned cylinder remnant, as received.

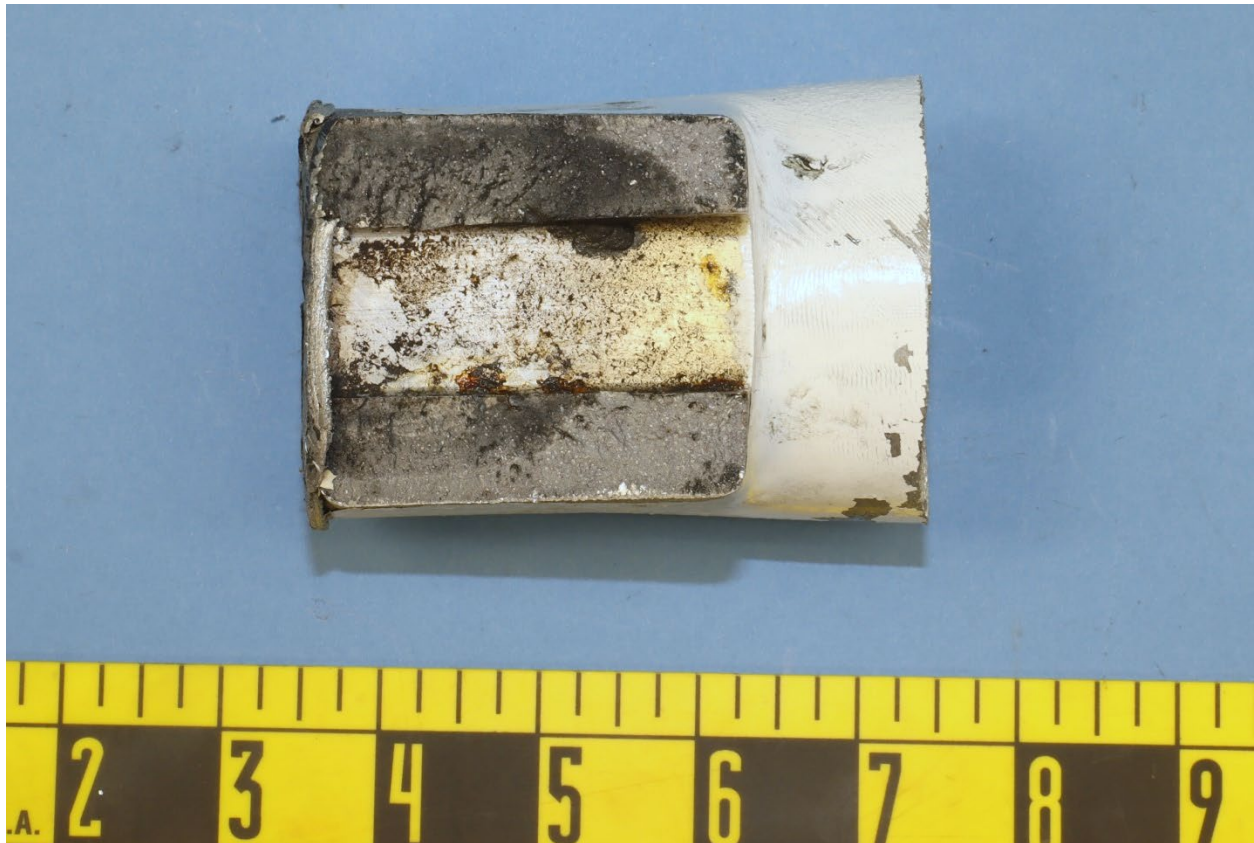
Figures 2 and 3 show the mating fracture surfaces of the separated clevis arms. The separated pieces were still attached to the upper torque arm link via the attachment bolt, secured with the nut and cotter pin, as shown in Figure 3. The fracture surfaces were generally rough in texture, with a dull luster. The fractures exhibited a darker, thumbnail-shaped region and a flat gray region, consistent with distinct fracture

modes. The dimensions of the darker thumbnail fractures were 2.04 inches long and 0.59 inches wide on the upper fracture, and 1.38 inches long and 0.46 inches wide on the lower fracture.

**Figure 2.** View of the fracture surface from the sectioned side of the upper cylinder.

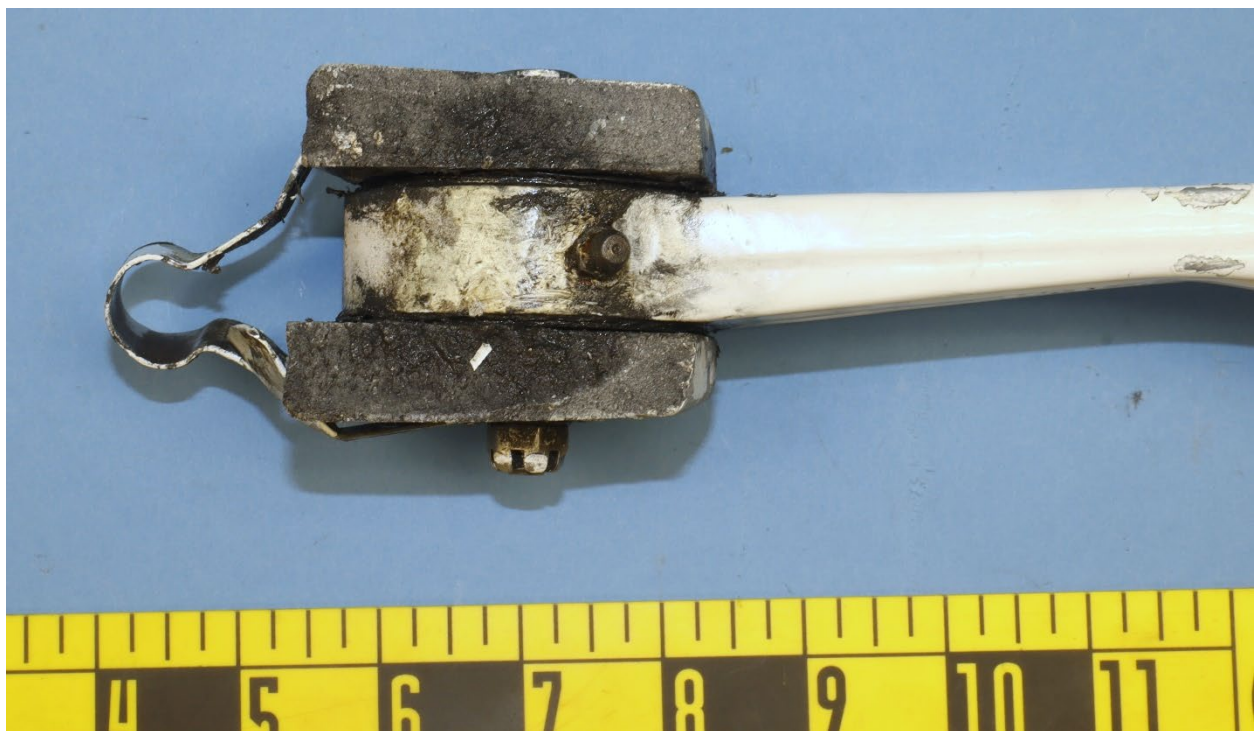
**Figure 3.** Mating cylinder clevis fracture surfaces from Figure 2, still affixed to the strut remnant.

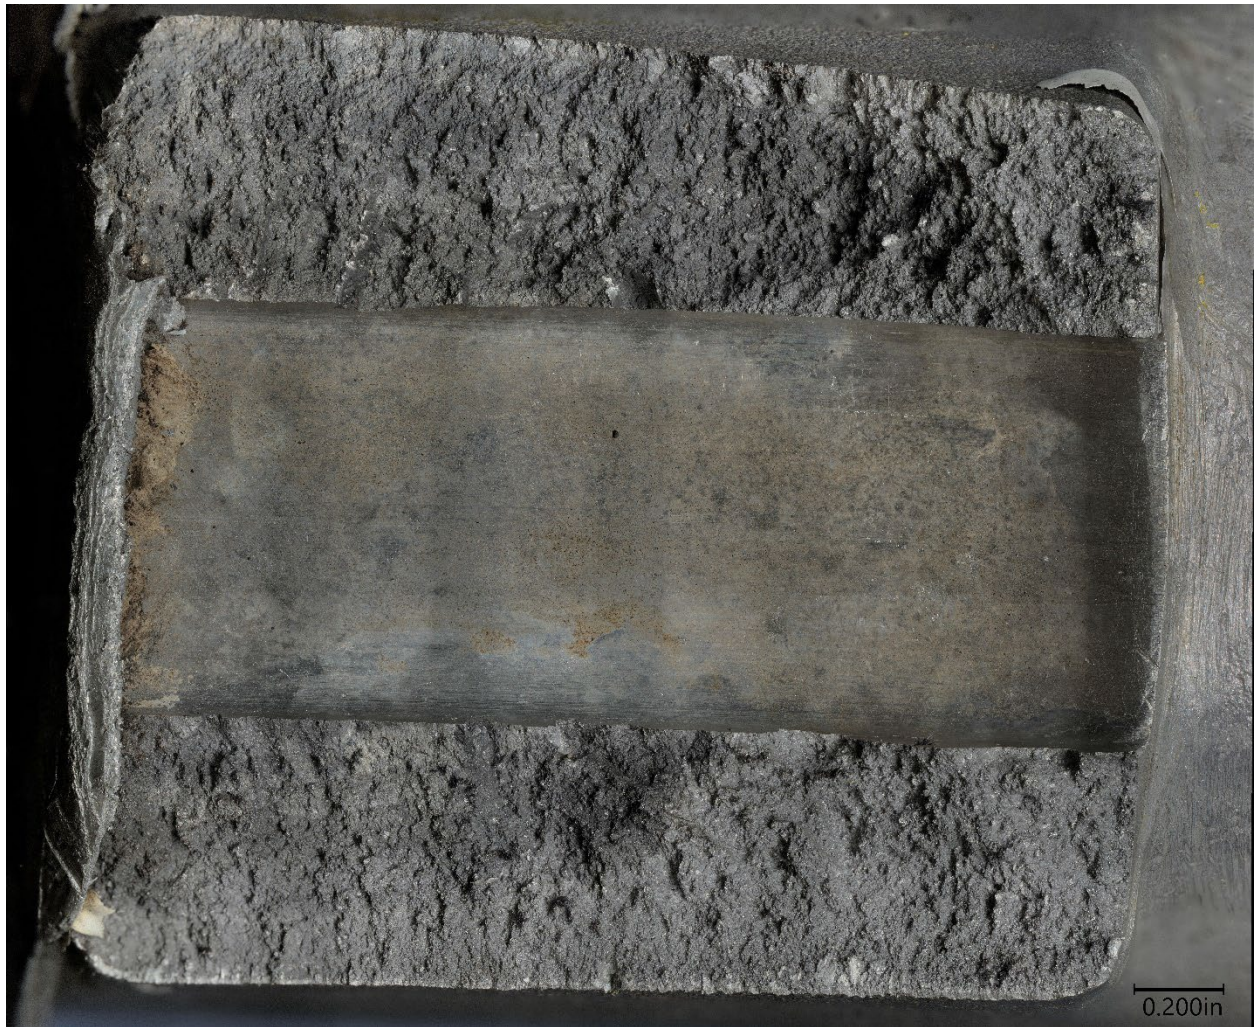
The fracture surfaces from the cylinder side were cleaned in an ultrasonic bath of acetone to remove the grease and some of the exterior paint and primer. Figure 4 shows a montage of optical micrographs after cleaning. The thumbnail regions exhibited crack arrest marks, consistent with progressive fracture, and ratchet marks, indicative of multiple crack initiation sites. As illustrated in Figures 5 and 6, the crack features were consistent with initiation along the interior surface between the clevises, which was machined smoother than the exterior surfaces. Some of these areas along the machined surface exhibited whitish compounds, later found to be consistent with salt deposits (see Figure 6). Further, small cracks were present along the machined surface, including those that intersected crack initiation sites, as demonstrated in Figure 7.

**Figure 4.** Montage of the connection fracture surface in Figure 3, showing the difference in color between the progressive and instantaneous regions.

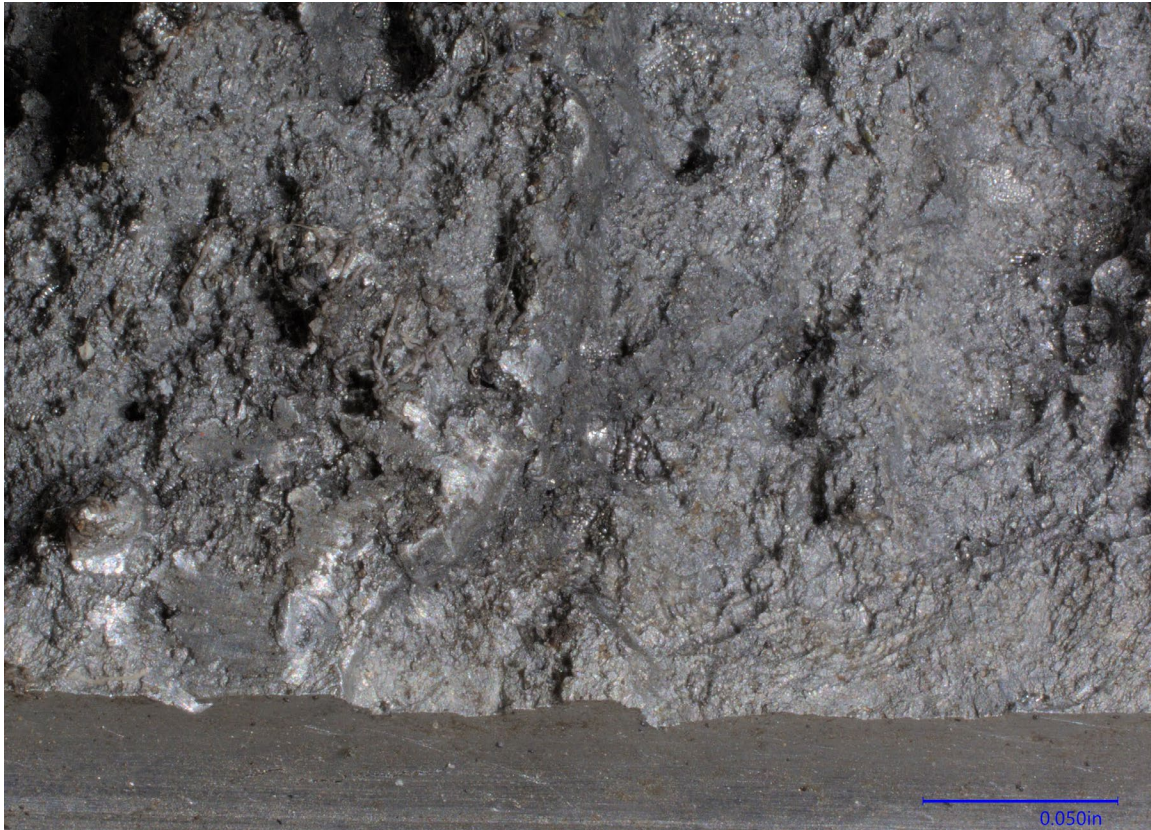
**Figure 5.** Closer view of the edge of the top fracture surface in Figure 4.

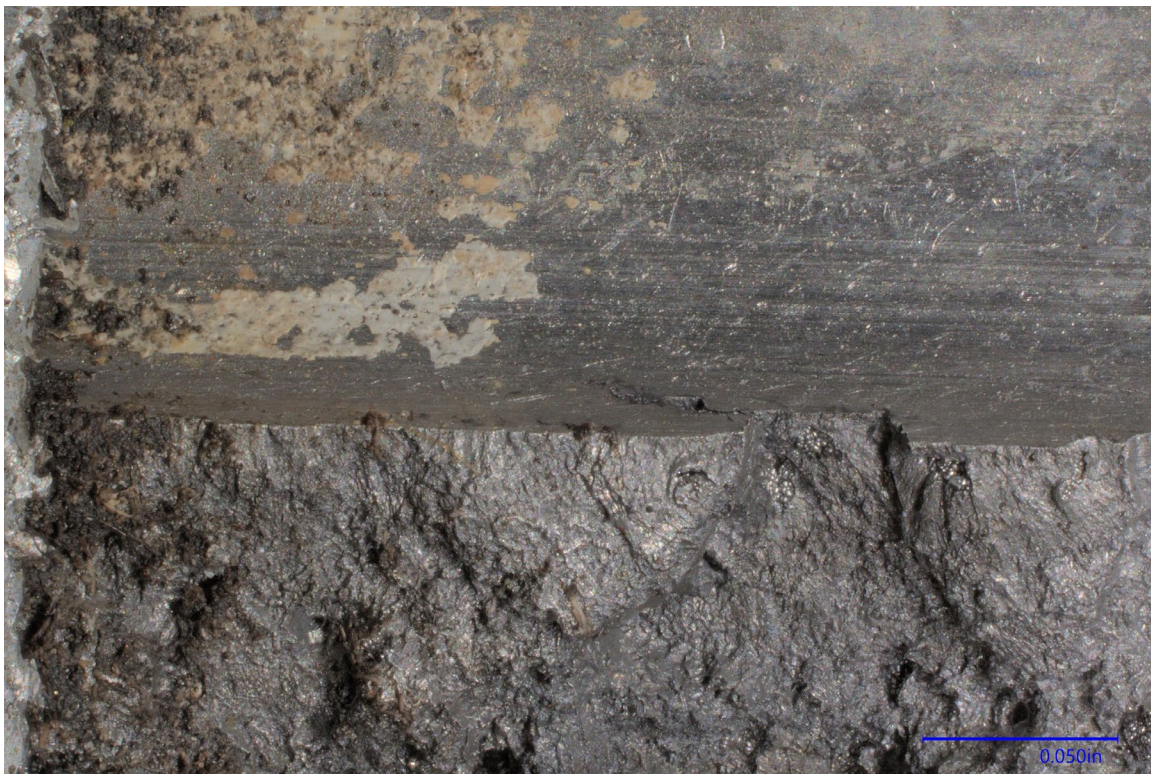
**Figure 6.** Closer view of the edge of the bottom fracture surface in Figure 4.

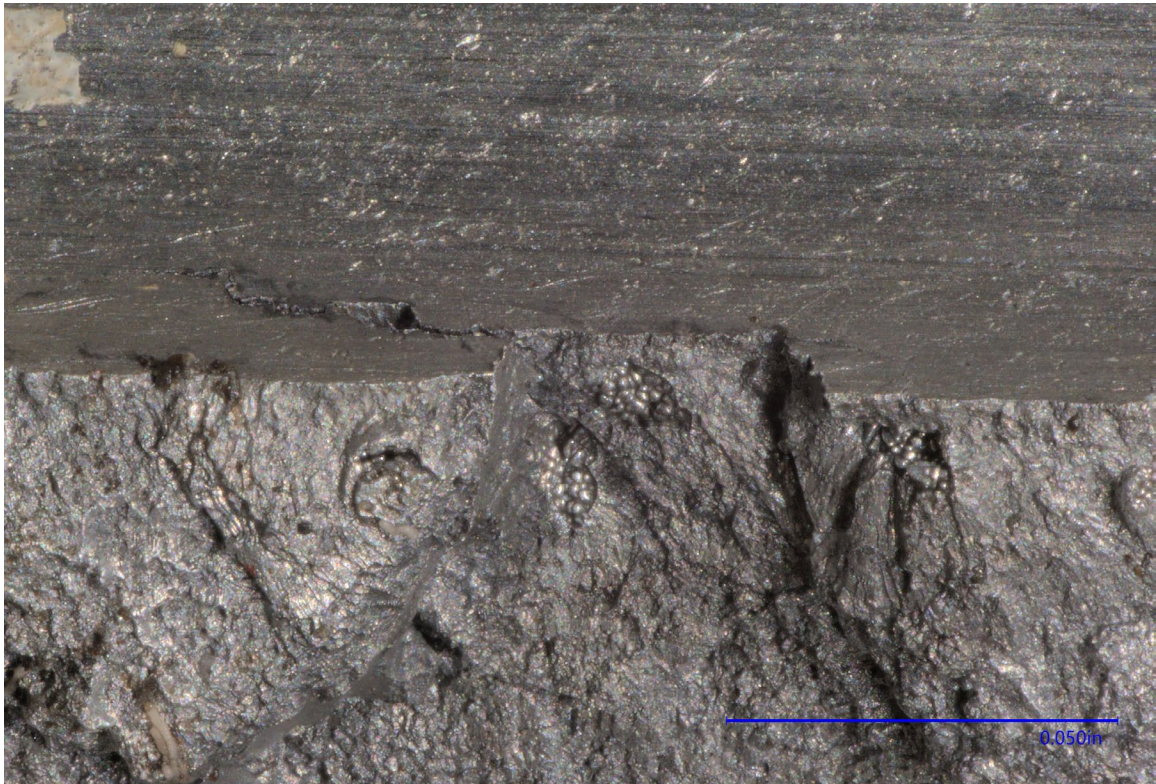
**Figure 7.** View of a crack initiation site at the edge in Figure 6, showing a crack along the machine bore.

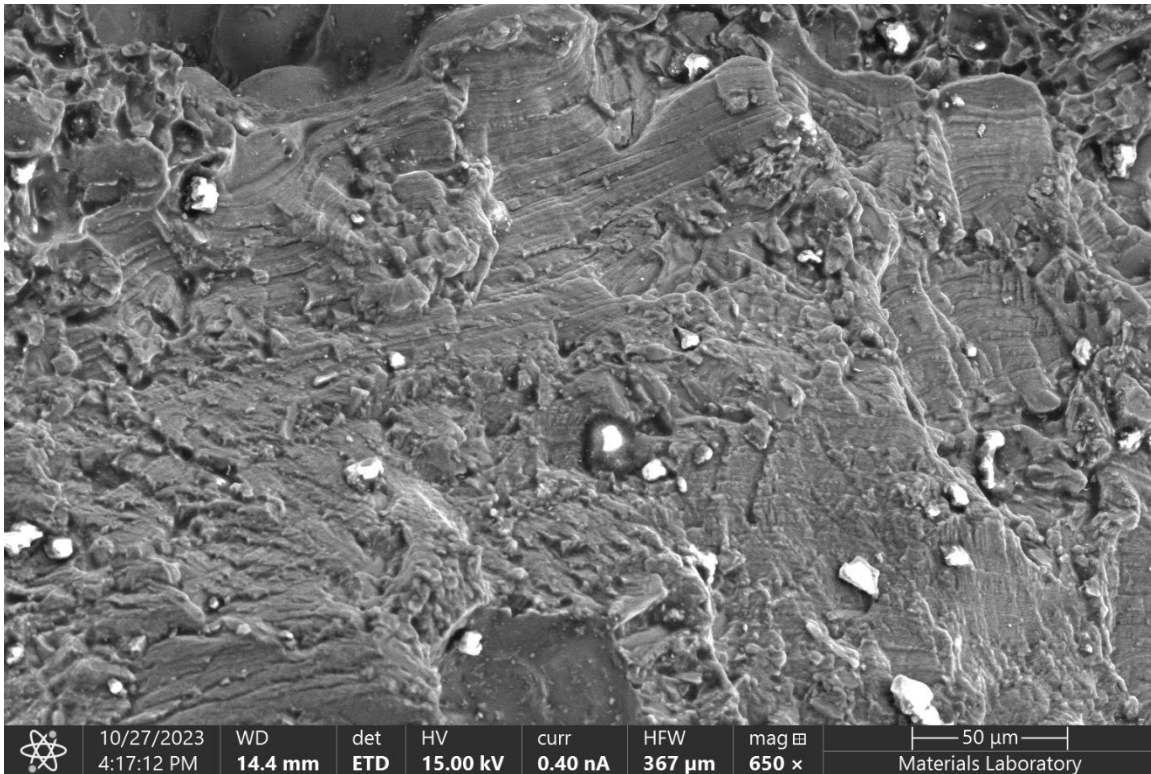
The cylinder-side fracture surfaces were examined using a field-emission scanning electron microscope (SEM). Figure 8 shows a typical area of the progressive fracture region, revealing fatigue striations consistent with fatigue crack propagation. Figure 9 shows a closer view of these striations, which had propagated in a transgranular path through the clevis arms. Outside the thumbnail cracks, the fracture surface exhibited dimpled rupture, consistent with subsequent overstress fracture.

**Figure 8.** Secondary electron (SE) micrograph of a typical area of the progressive region of the fracture surface.

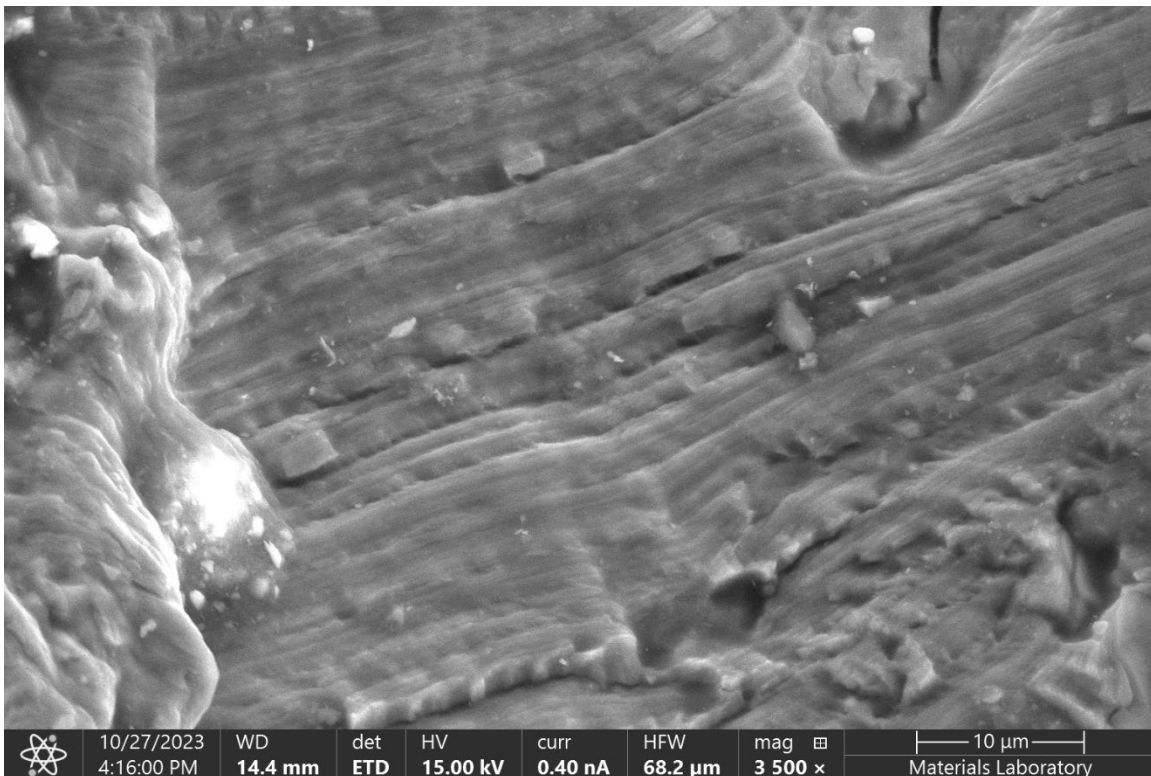
**Figure 9.** SE micrograph of fatigue striations in Figure 8.

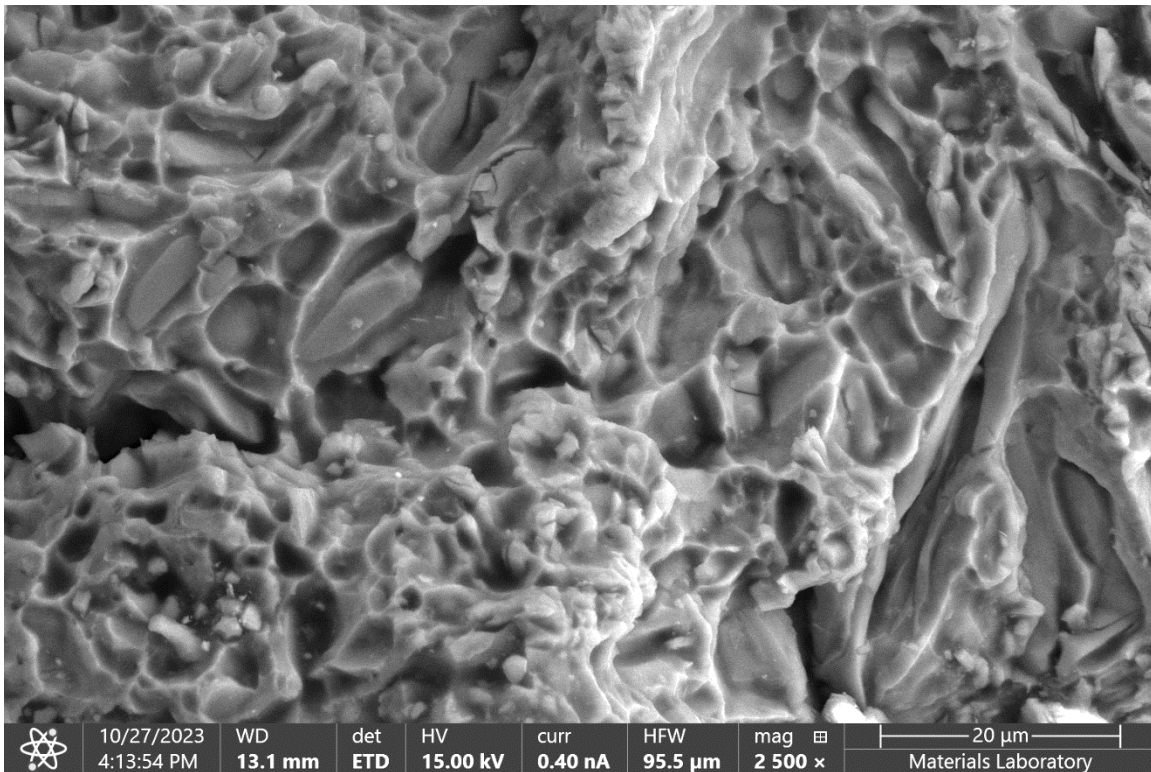
**Figure 10.** SE micrograph of dimpled rupture in the overstress region of the fracture.

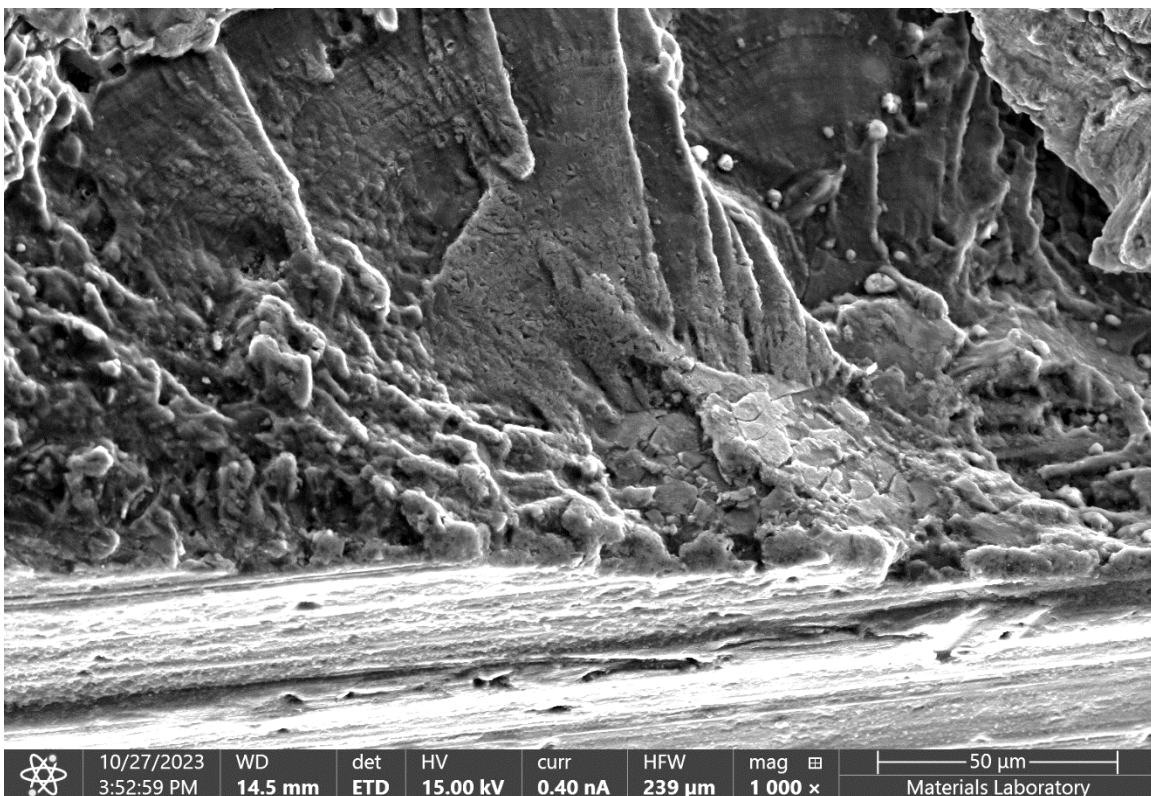
Several of the initiation sites were examined along the radius with the machined surface. Figure 11 shows one such initiation site, which exhibited a flat, faceted region from which river patterns and striations emanated. A closer examination of this site, shown in Figure 12, revealed layered hackles typical of localized brittle fracture. Probing this location using energy dispersive x-ray spectroscopy (EDS) found it was consistent with a silicon-rich phase, typical of constituents in many aluminum-silicon castings.

**Figure 11.** SE micrograph of a crack initiation site, with the boxed area shown in Figure 12.

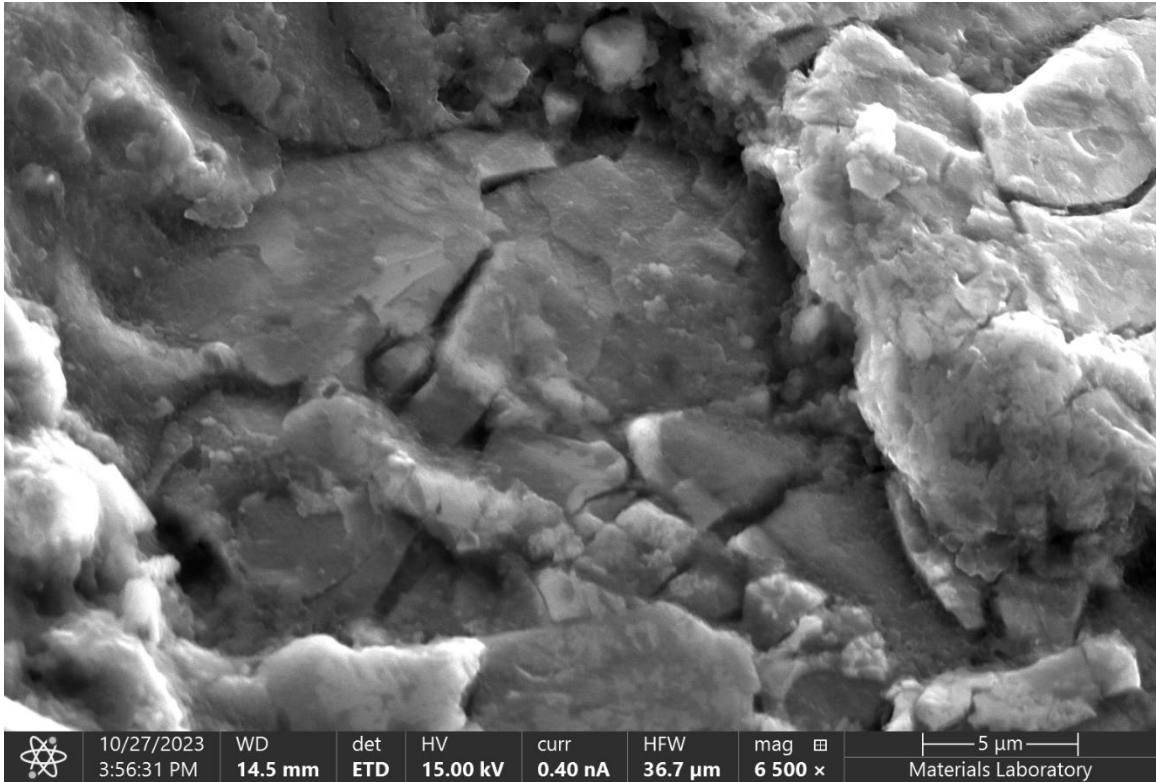
**Figure 12.** SE micrograph of the boxed area in Figure 11, showing faceted fracture features.

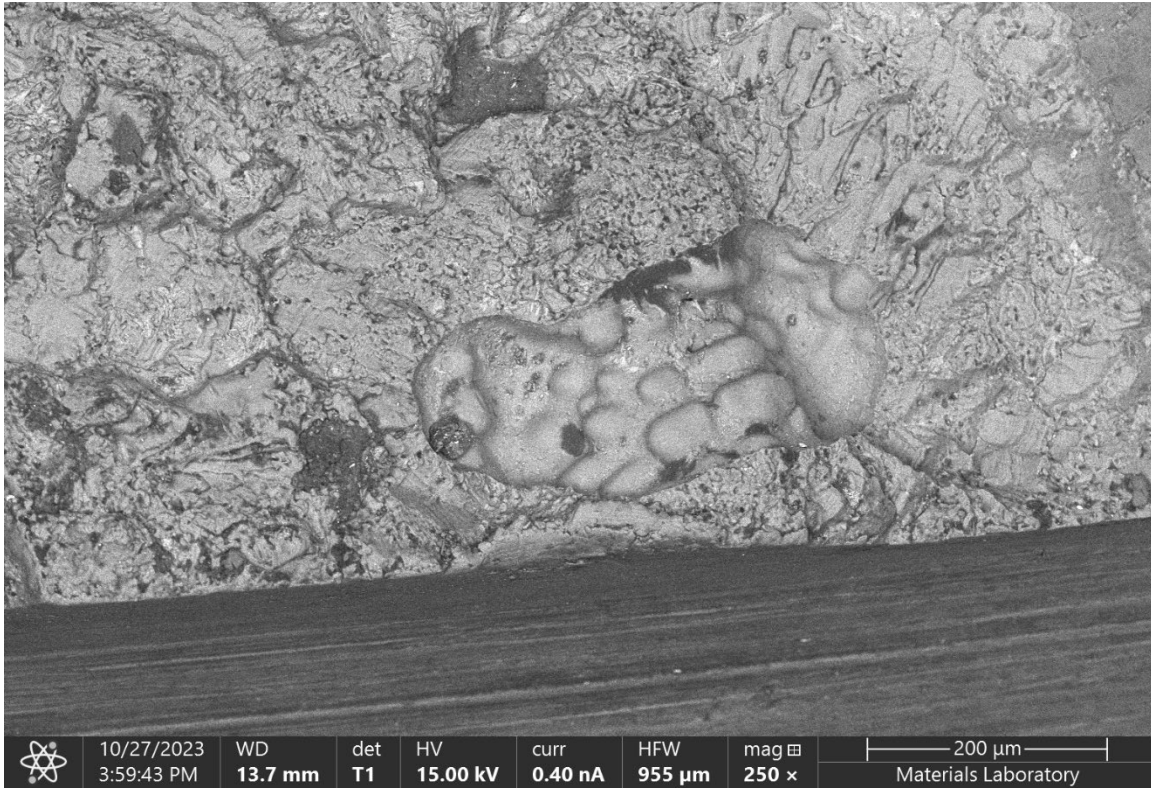
Figure 13 shows a rounded, smooth surface feature adjacent to the fracture edge at another location. This surface exhibited a spherical, dendritic morphology consisting of a solidification void from the casting of the part. A closer view of the fractured region between the void and the fracture edge showed fatigue striations propagating from the void rather than from the fracture edge (see Figure 14). These features were consistent with crack initiation from the solidification void at this location.

**Figure 13.** Backscattered electron (BE) micrograph of a void near the fracture surface edge.

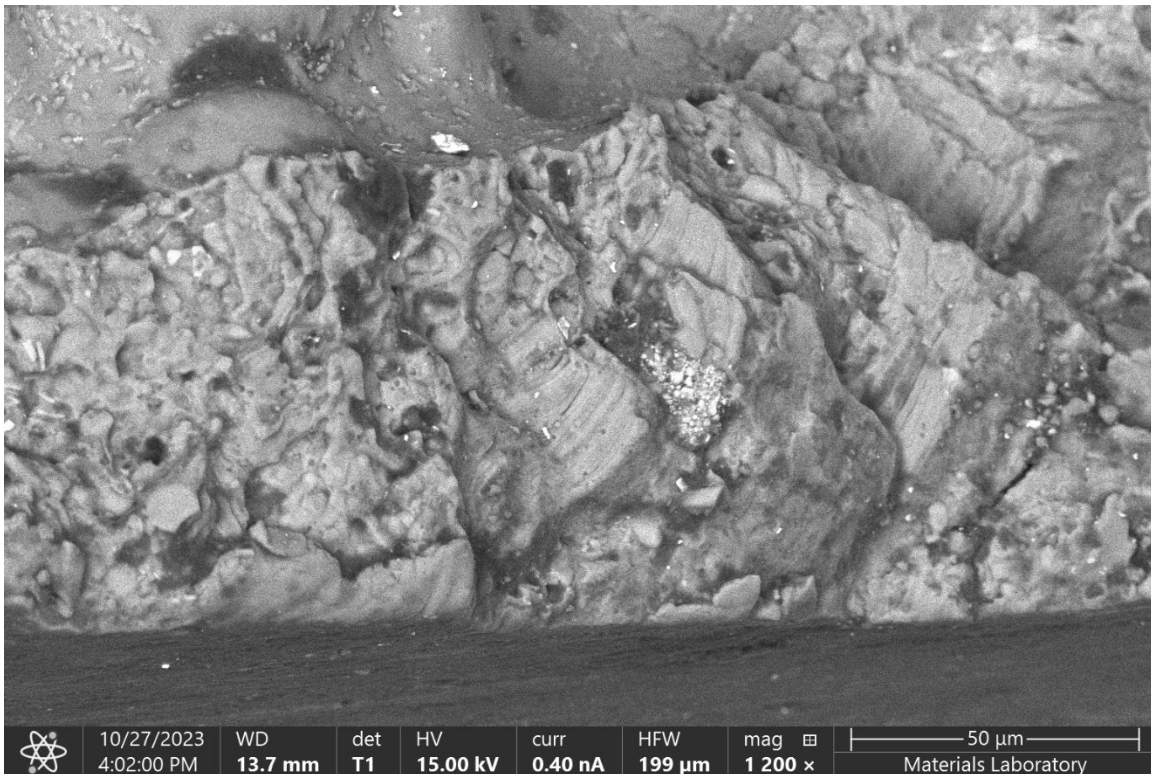
**Figure 14.** BE micrograph of striations propagating from the void in Figure 13.

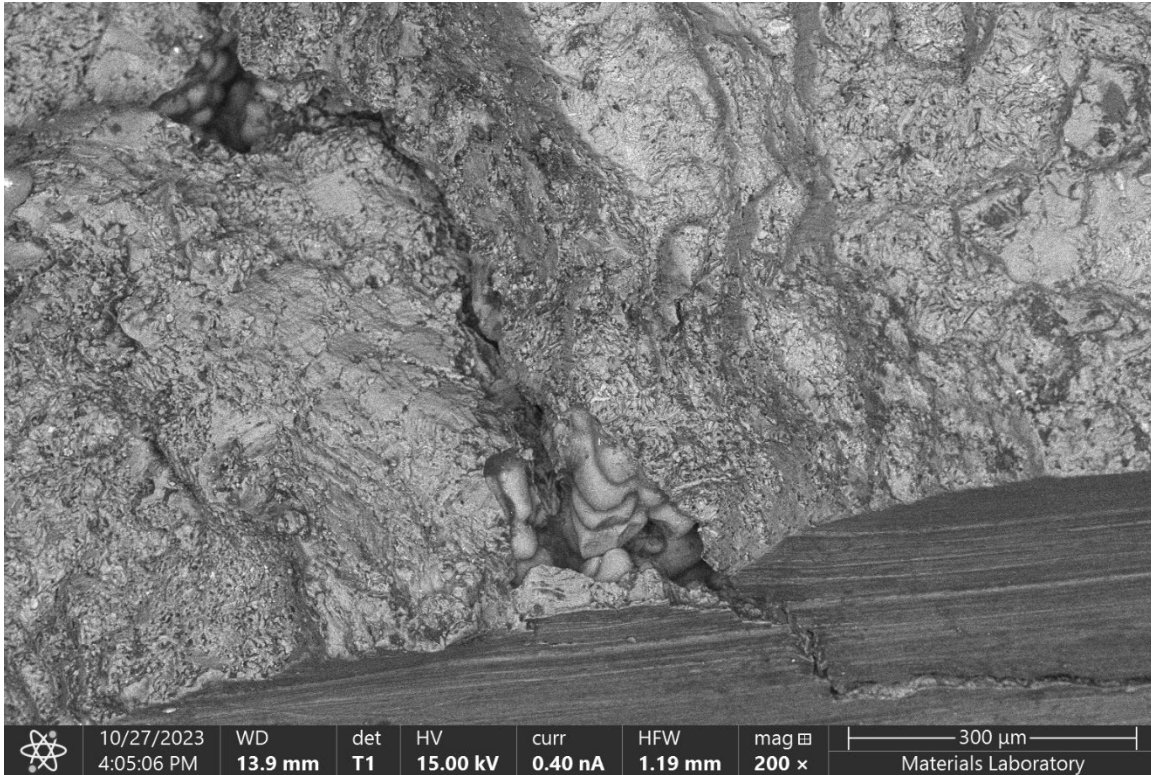
Figure 15 shows another solidification void, exhibiting smooth, rounded dendritic shapes along the fracture surface edge, with a secondary crack running through the feature. This crack was visible along both the fracture surface and the machined outer surface. Figure 16 shows fatigue striations propagating parallel to the edge, consistent with initiation along the secondary crack from the solidification void.

**Figure 15.** BE micrograph of a secondary crack along a void at the fracture edge.

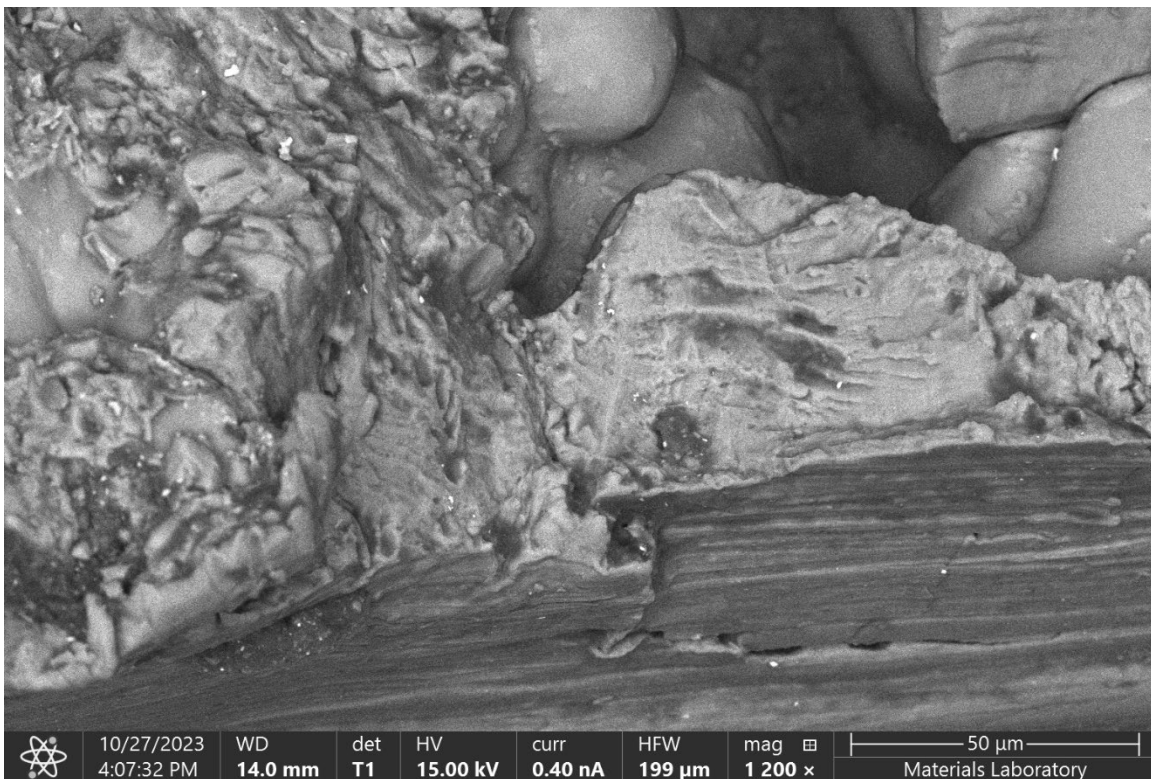
Figure 16 shows another crack initiation site exhibiting fatigue striations and crack arrest marks. This initiation location, along the fracture edge, exhibited small, rounded protrusions consistent with smoother dendritic surfaces from a solidification void. These voids were also present along the machined surface away from the fracture surface, as typified in Figure 17. Small cracks were also located at these solidification voids open to the surface.

**Figure 16.** BE micrograph of striations emanating from the crack and solidification void towards the left of the figure.

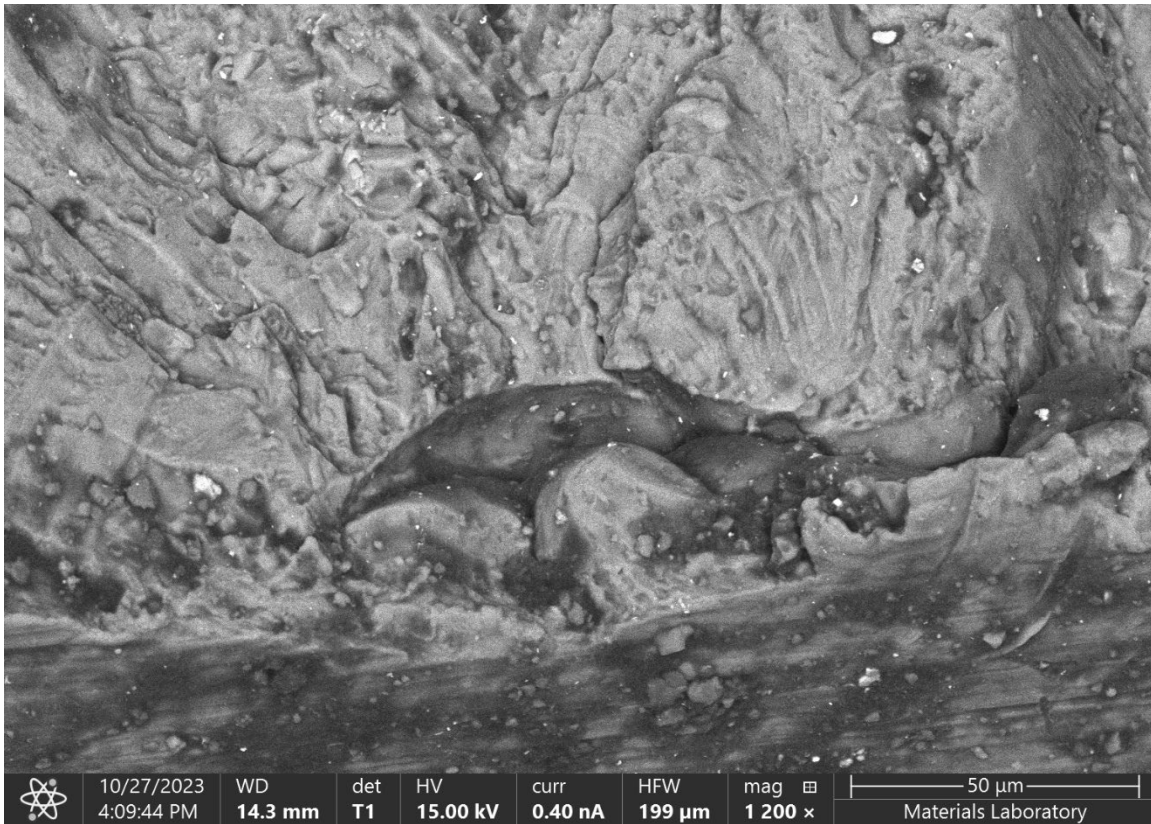
**Figure 17.** BE micrograph of an initiation site at a void on the fracture edge.

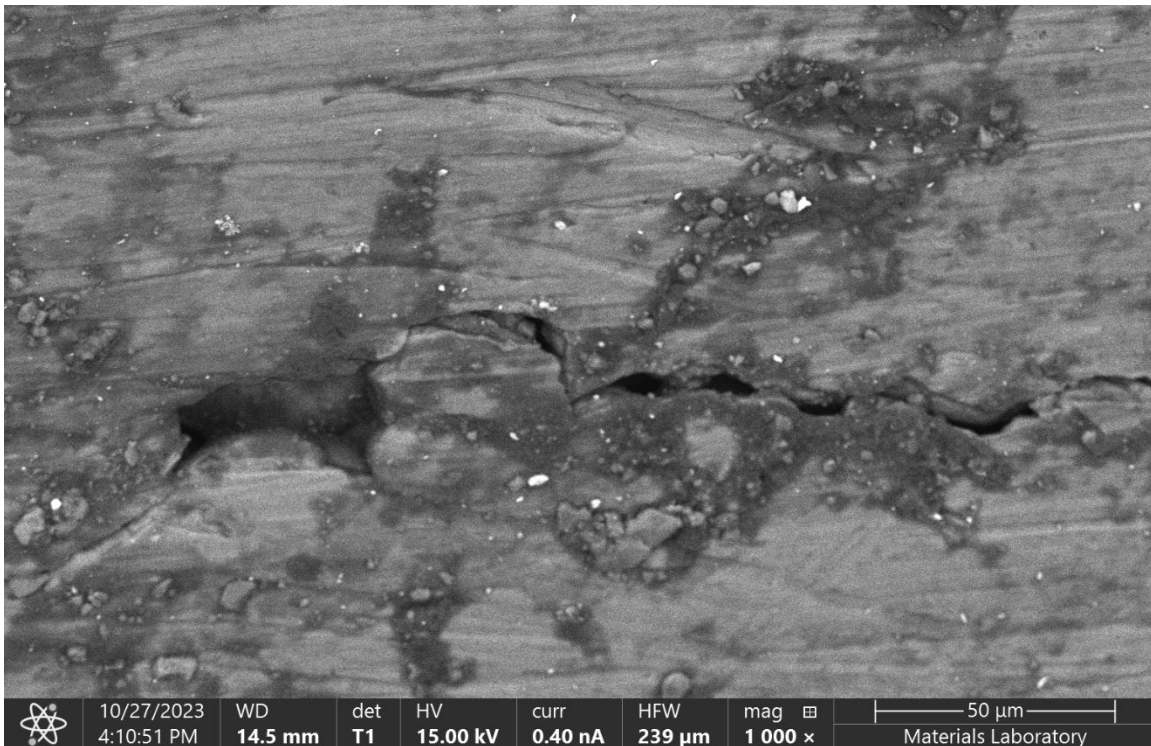
**Figure 18.** BE micrograph of a crack along the machined bore, initiating at an opened void.
